# Inspection Photos

API: 05-061-06363

Operator: ARMOR PETROLEUM INC

Inspection Date: 6/4/2019

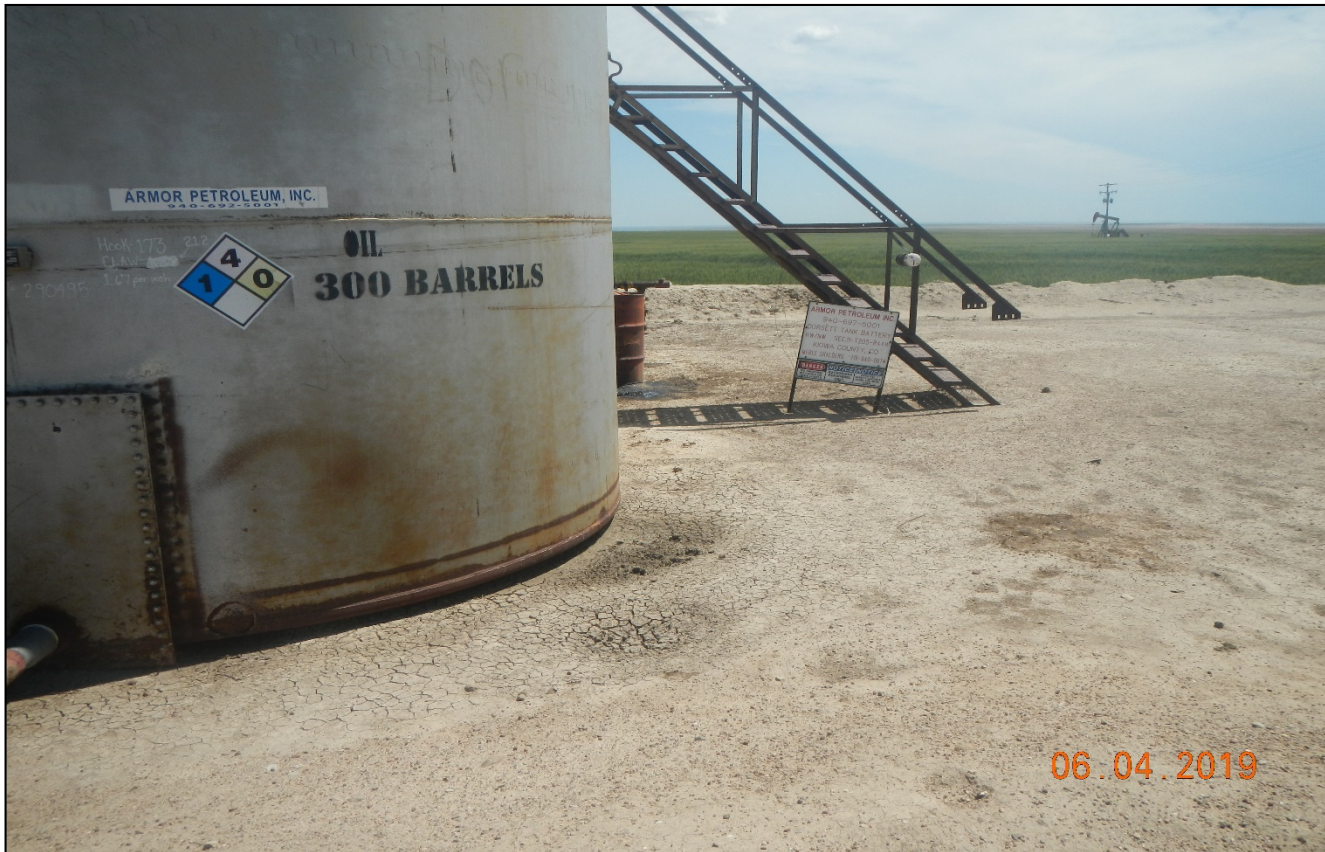
**Photo 1.** Dorsett Tank Battery.

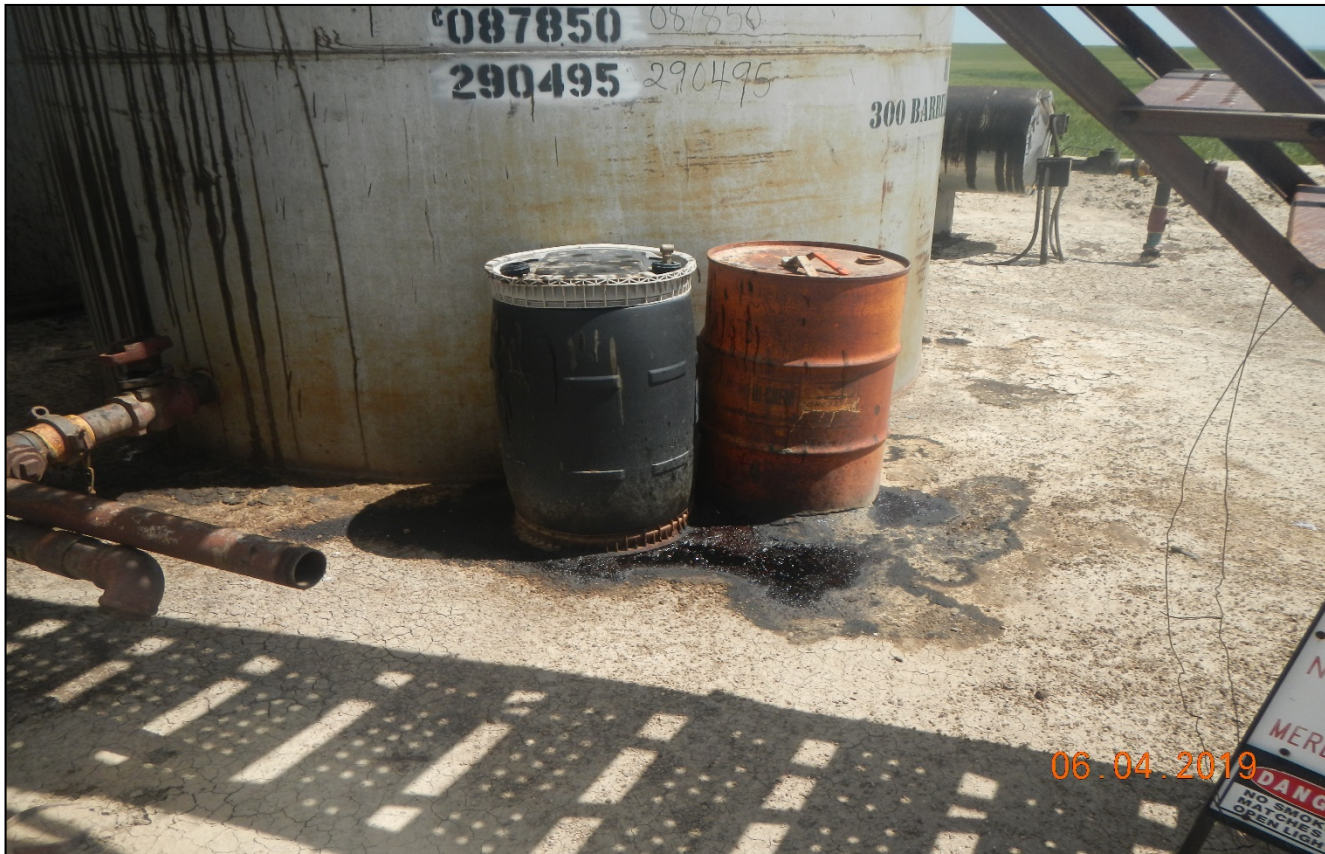
**Photo 2.** There are two barrels with no labeling and possible leakage with oil stained soil.

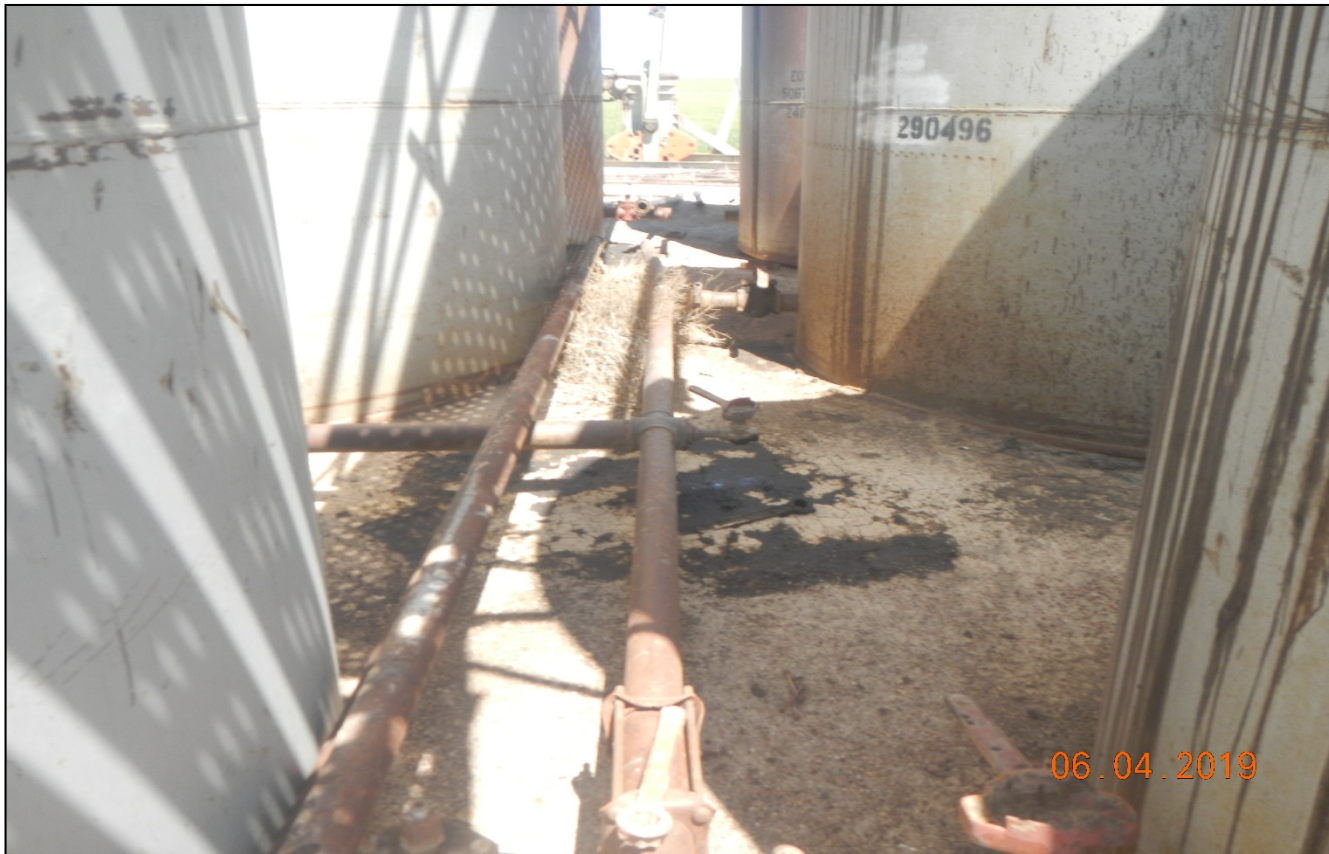
**Photo 3.** There is oil stained soil between the tanks.

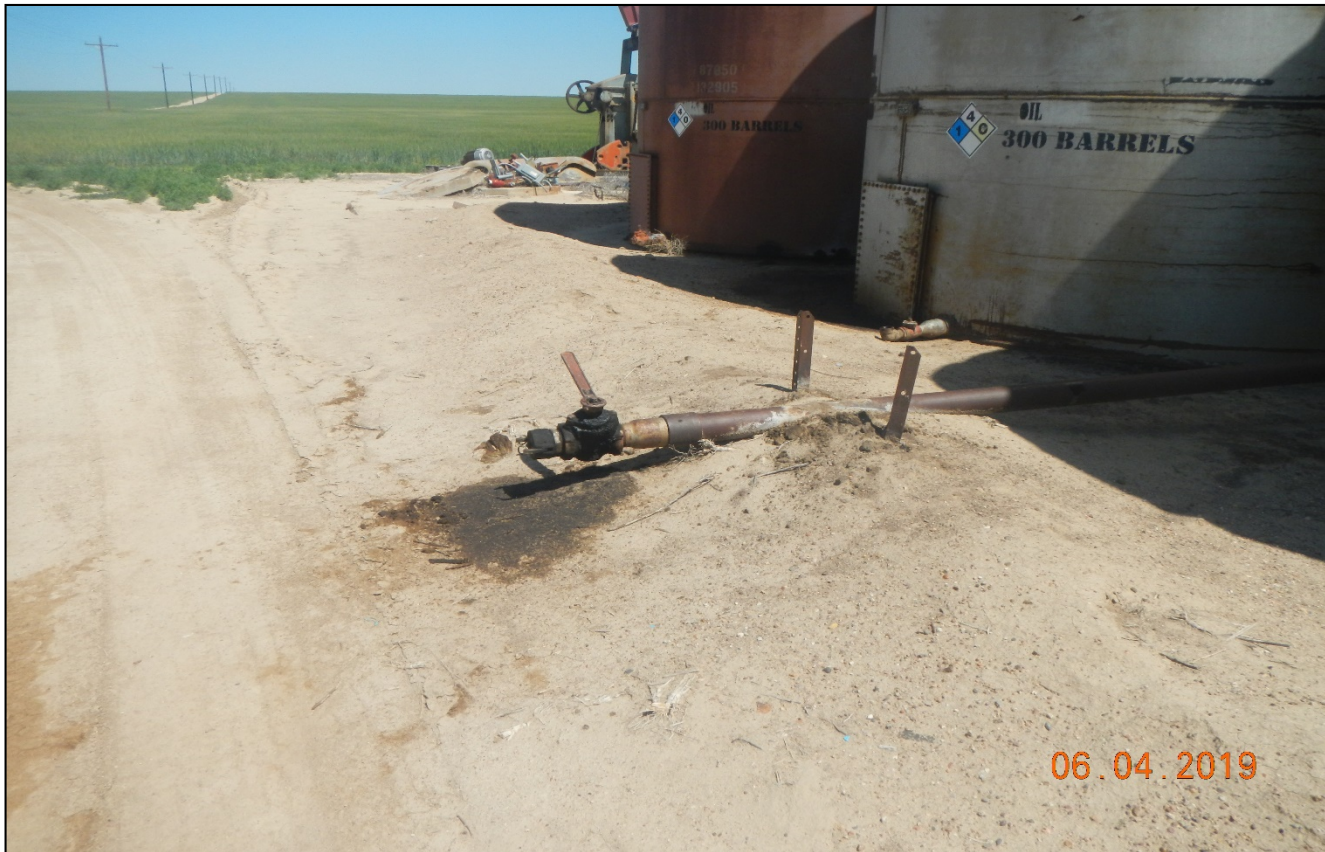
**Photo 4.** There is oil stain soil at the pipe valve.

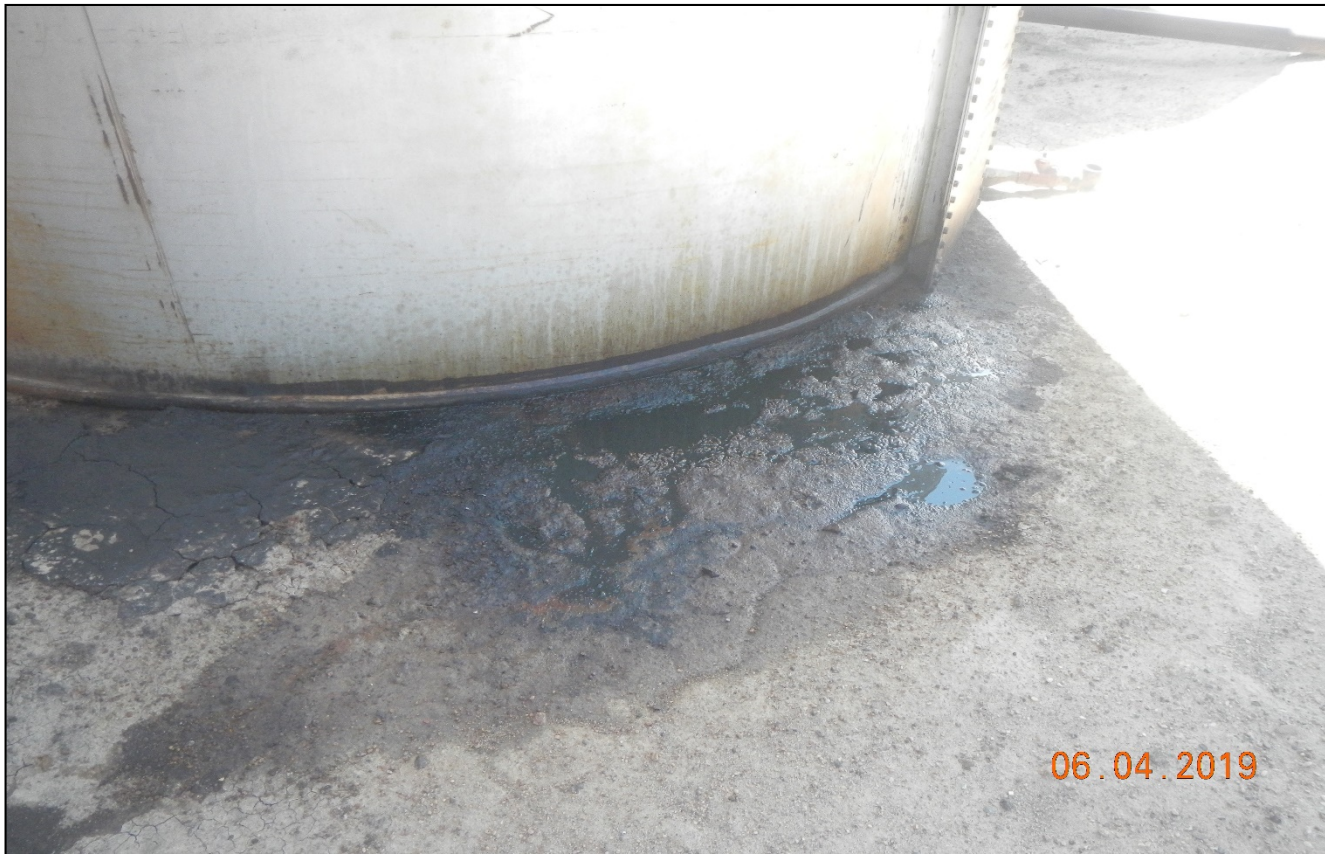
**Photo 5.** There is oil stained soil around the tank. Tank likely has leak.

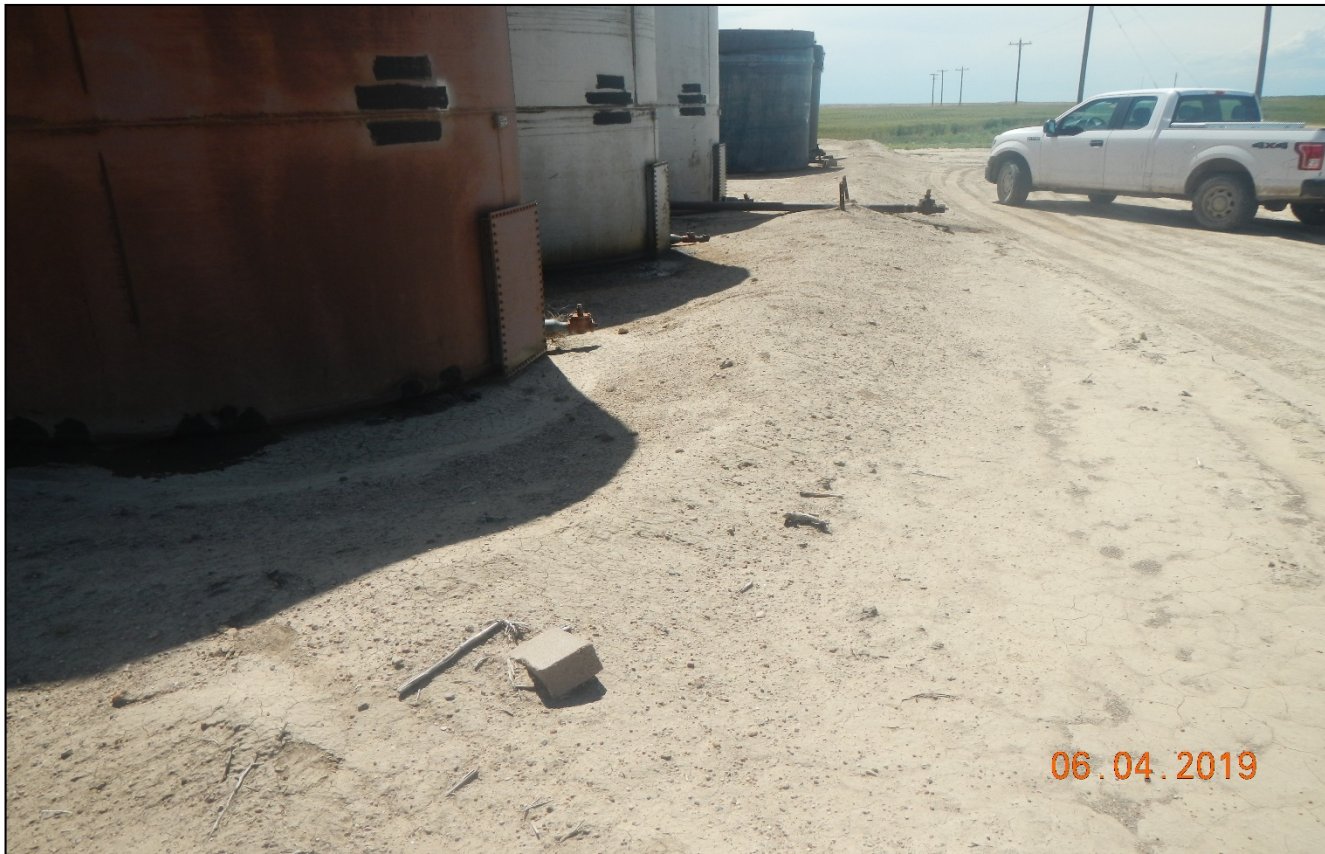
**Photo 6.** The berm around the north side of the tanks is insufficient for secondary containment.

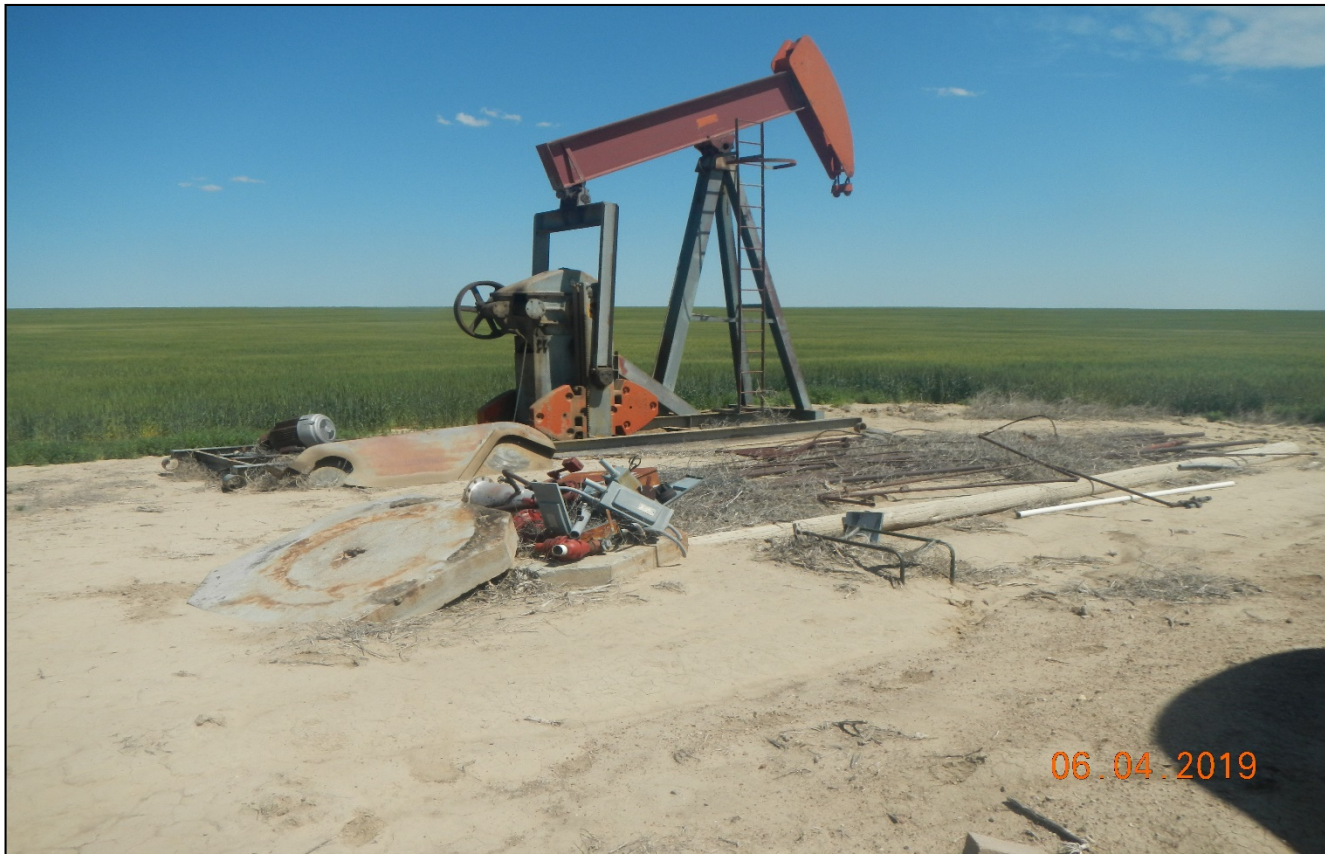
**Photo 7.** There is various unused equipment being stored at the south side of tank battery.
