Inspection Photos  
Location Name: BEM 32-19  
API#: 05-071-08925  
INSP. #: 695100814

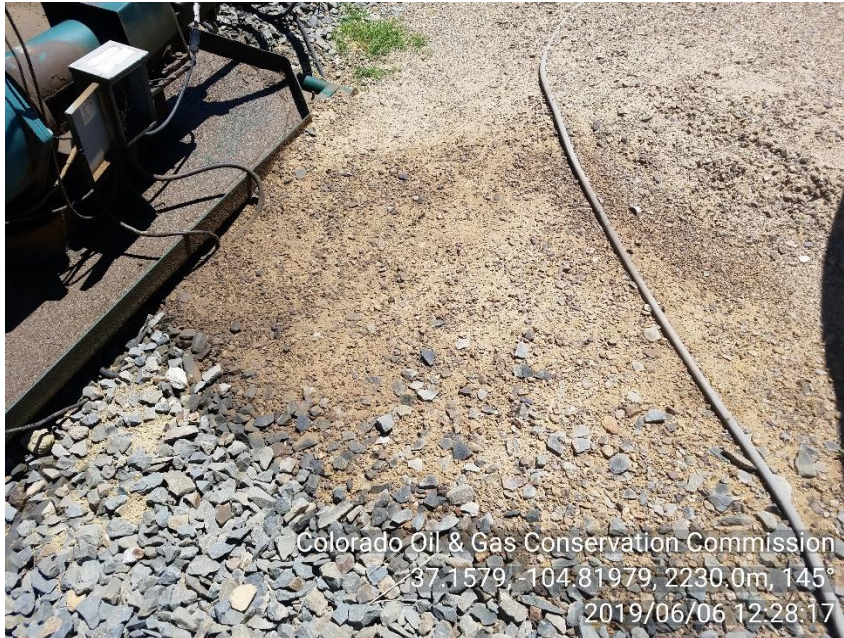
**PHOTO 3: AREA OF IMPACTED SOIL APP. 7' BY 3' BETWEEN COMPRESSOR SKID AND PUMPJACK. Remove and dispose impacted material in approved manner, service and maintain equipment and self inspect to prevent recurrence of conditions per 1002.f(2) and 907. CA DATE 7/6/19.**

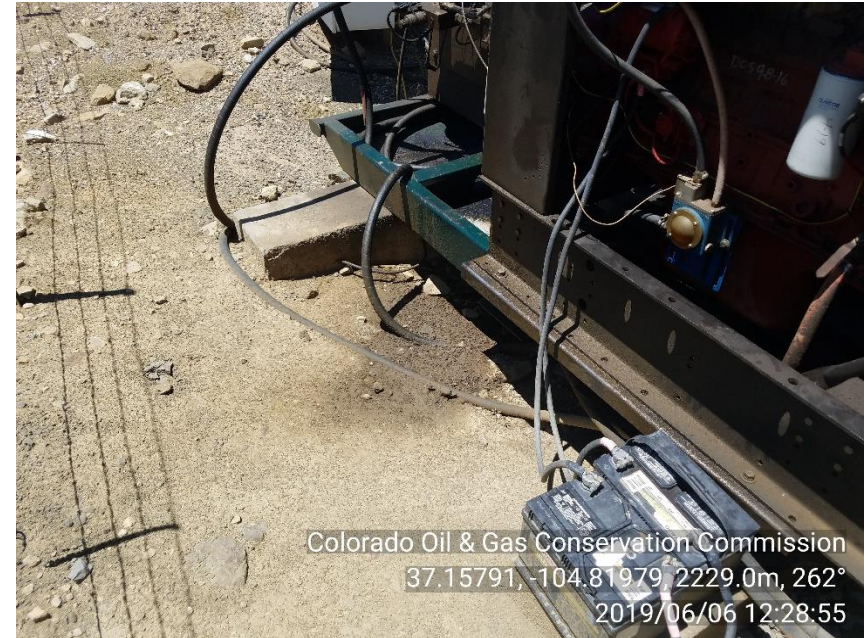
**PHOTO 3: AREA OF IMPACTED SOIL APP. 2' BY 2' ON EAST SIDE OF ENGINE SKID AND PUMPJACK. Remove and dispose impacted material in approved manner, service and maintain equipment and self inspect to prevent recurrence of conditions per 1002.f(2) and 907. CA DATE 7/6/19.**

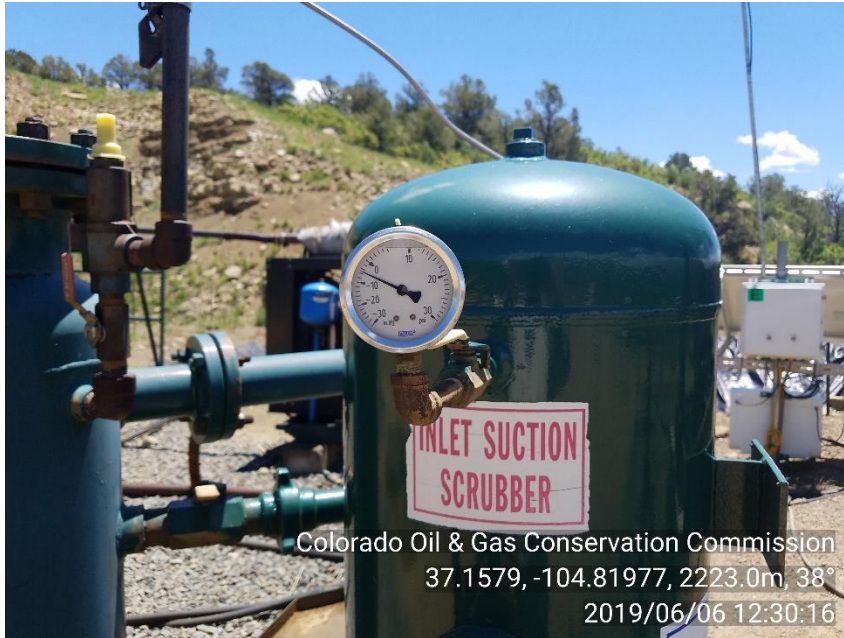
**PHOTO 5: Vacuum pump observed on well without COGCC approval. Provide COGCC with documentation showing approval of use of vacuum pump. CA DATE 6/21/19.**
