Inspection Photos  
Location Name: WOODSTOCK 43-19  
API#: 05-071-08677  
INSP. #: 695100820

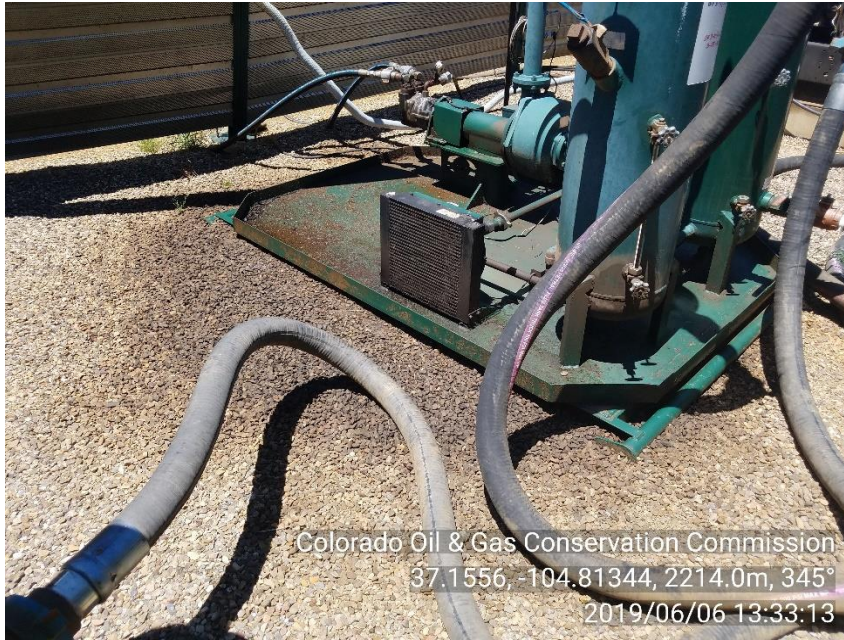
**PHOTO 3: AREA OF IMPACTED SOIL APP. 10' BY 5' AROUND COMPRESSOR SKID ON SOUTH SIDE OF COMPRESSOR.**  
**Remove and dispose impacted material in approved manner, service and maintain equipment and self inspect to prevent recurrence of conditions per 1002.f(2) and 907. CA DATE 7/6/19.**

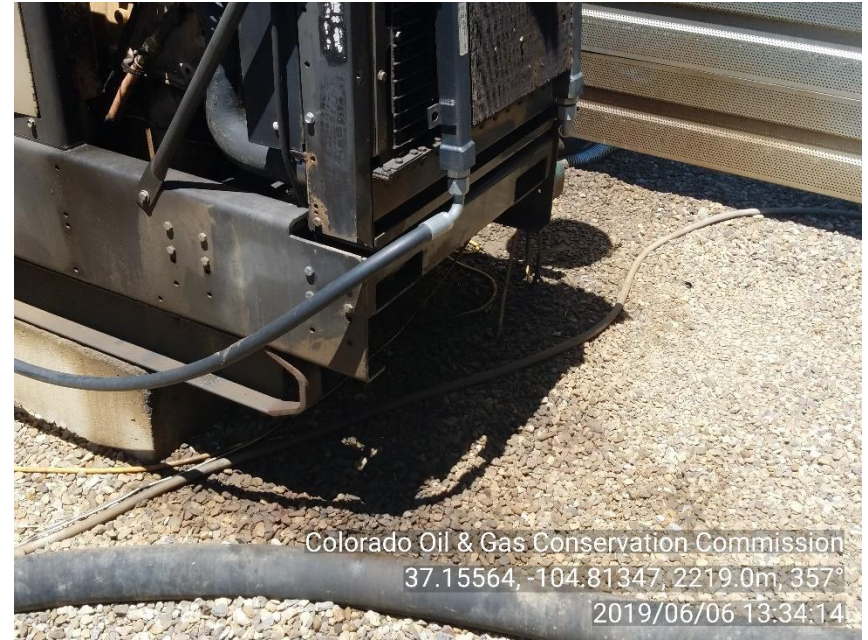
**PHOTO 4: AREA OF IMPACTED SOIL APP. 4' BY 2' ON EAST SIDE OF ENGINE SKID. Remove and dispose impacted material in approved manner, service and maintain equipment and self inspect to prevent recurrence of conditions per 1002.f(2) and 907. CA DATE 7/6/19.**

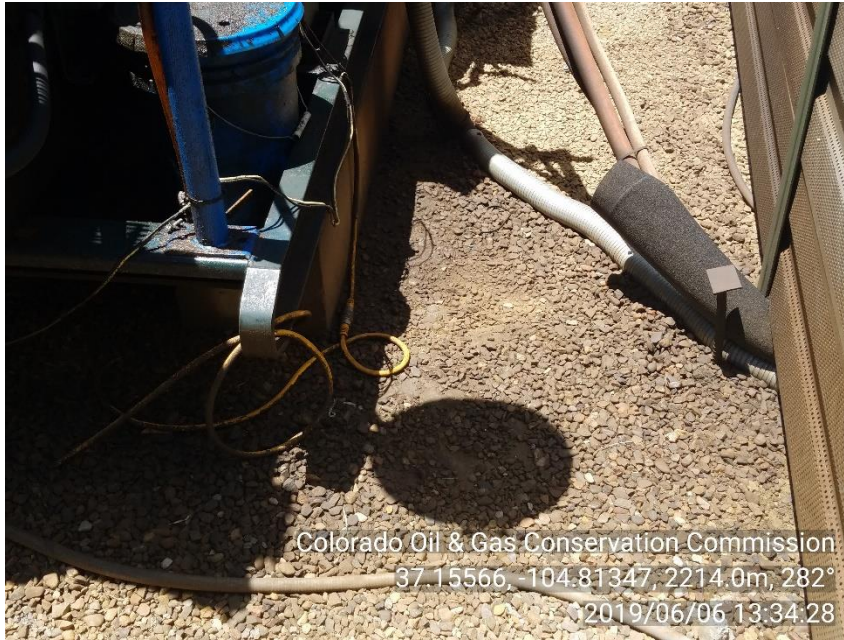
**PHOTO 5: AREA OF IMPACTED SOIL APP. 6' BY 5' ON NORTH SIDE OF ENGINE SKID EXTENDING UNDER SOUND WALL.**

**Remove and dispose impacted material in approved manner, service and maintain equipment and self inspect to prevent recurrence of conditions per 1002.f(2) and 907. CA DATE 7/6/19.**

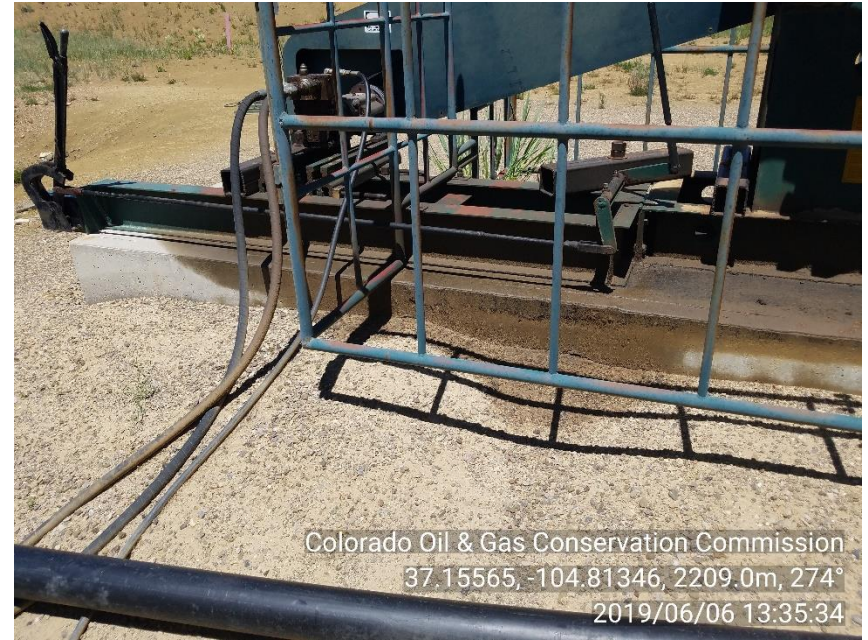
**PHOTO 6: AREA OF IMPACTED SOIL APP. 3' BY 2' ON SOUTH SIDE OF PUMPJACK CONCRETE PUMPJACK BASE IS SATURATED WITH WHAT APPEARS TO BE OIL.**

**Remove and dispose impacted material in approved manner, service and maintain equipment and self inspect to prevent recurrence of conditions per 1002.f(2) and 907. CA DATE 7/6/19.**

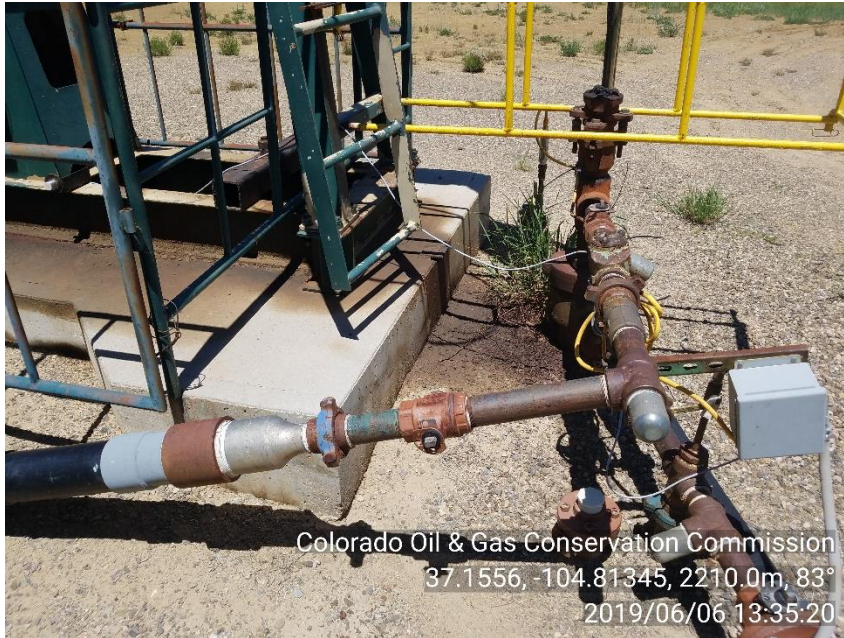
**PHOTO 7: AREA OF IMPACTED SOIL APP. 3' BY 2' ON EAST SIDE OF PUMPJACK BETWEEN WELL HEAD AND PUMPJACK CONCRETE PUMPJACK BASE IS SATURATED WITH WHAT APPEARS TO BE OIL. Remove and dispose impacted material in approved manner, service and maintain equipment and self inspect to prevent recurrence of conditions per 1002.f(2) and 907. CA DATE 7/6/19.**

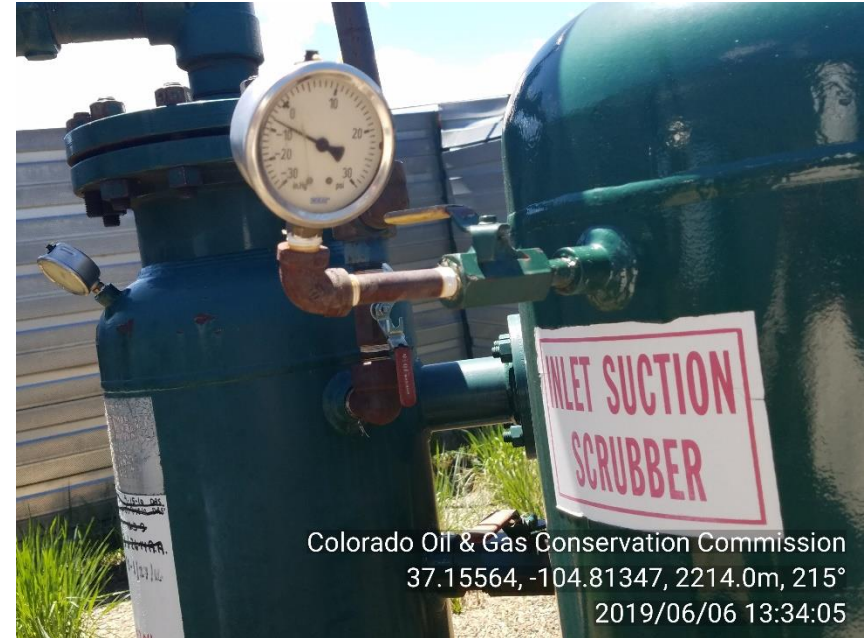
**PHOTO 8: Vacuum pump observed on well without COGCC approval. Provide COGCC with documentation showing approval of use of vacuum pump. CA DATE 6/21/19**

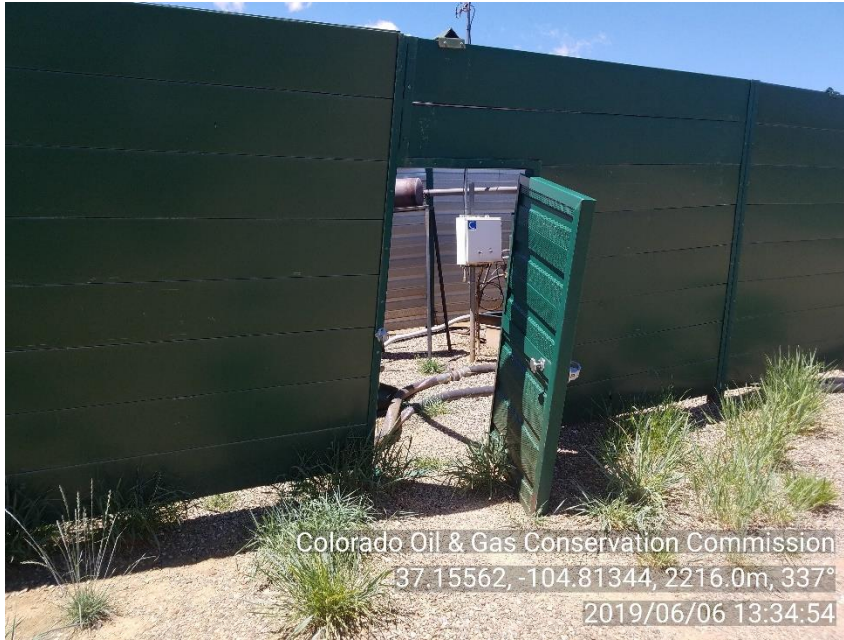
**PHOTO 9: SOUND WALLS ARE FALLING DOWN. IT APPEARS THE DOOR IS HOLDING THE SOUND WALLS UP. REMAIR SOUND WALLS IN ACCORANCE WITH 603.f. CA DATE 7/6/19**

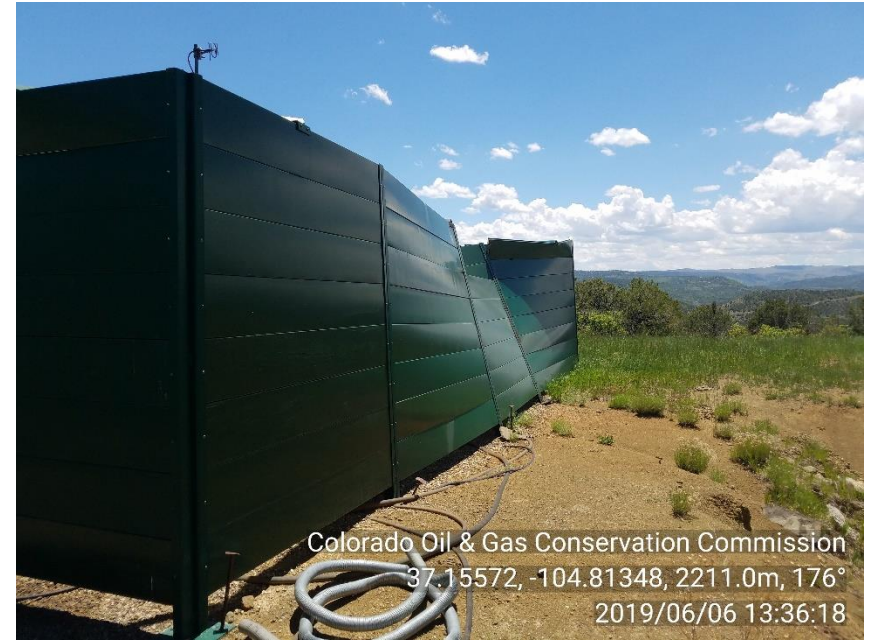
**PHOTO 10: IMAGE OF SOUND WALLS ON THE OPPOSITE SIDE FROM PREVIOUS PHOTO. SOUND WALLS ARE CONNECTED ACROSS THE TOP. REMAIR SOUND WALLS IN ACCORANCE WITH 603.f. CA DATE 7/6/19**
