Inspection Photos  
Location Name: LOUIS 41-30  
API#: 05-071-07521  
INSP. #: 695100822

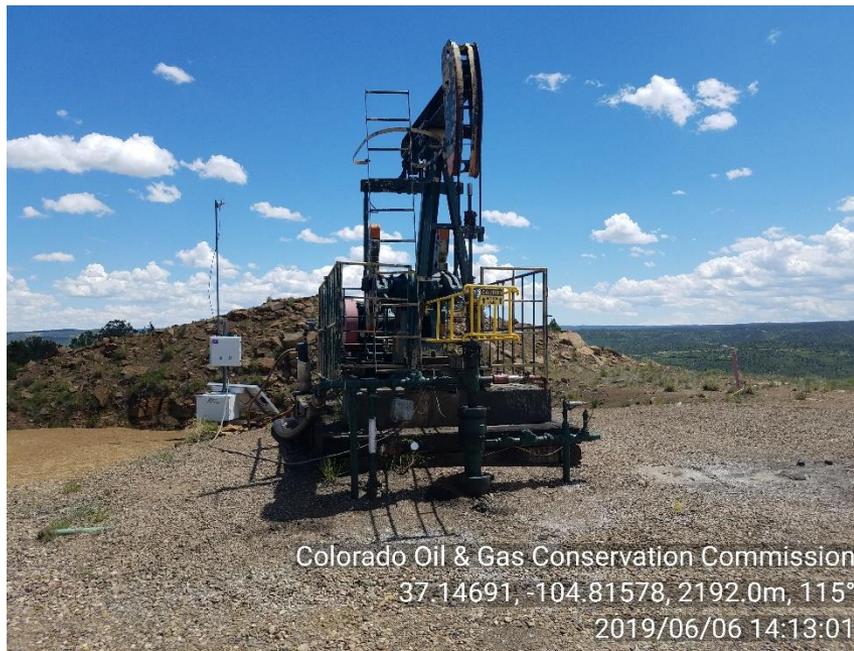
**PHOTO 1: WELLHEAD**

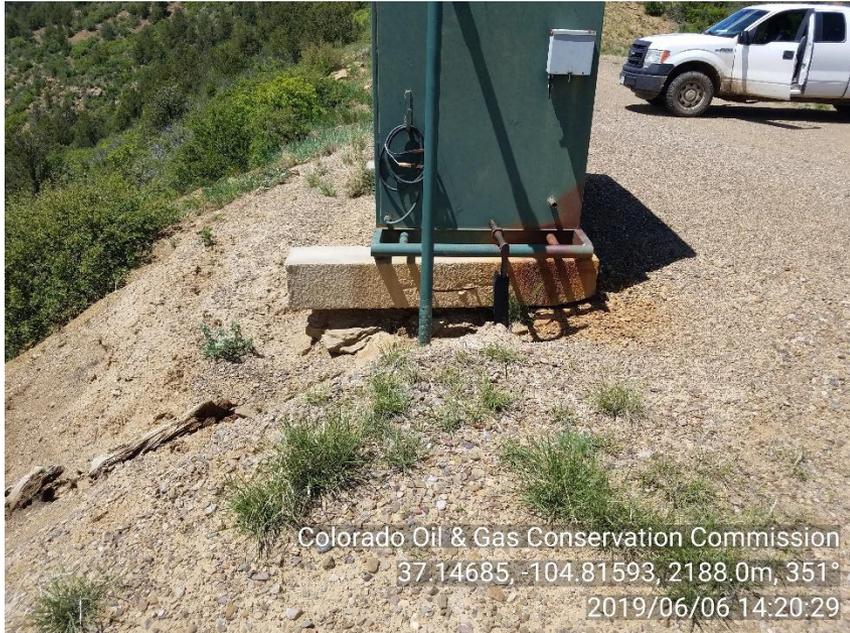
**PHOTO 3: EROSION THAT APPEARS TO BE CAUSED FROM DRAINING THE SEPARATOR IN THE METER HOUSE AS THE METER HOUSE IS UPGRADE FROM LOCATION AND STORM WATER WOULD TRAVEL AWAY FROM THE METER HOUSE TOWARD THE CENTER OF LOCATION IS UNDERMINING METERHOUSE. REPAIR EROSION AND DISCONTINUE DRAINING SEPARATOR IN LOCATION. CA DATE 7/6/19**

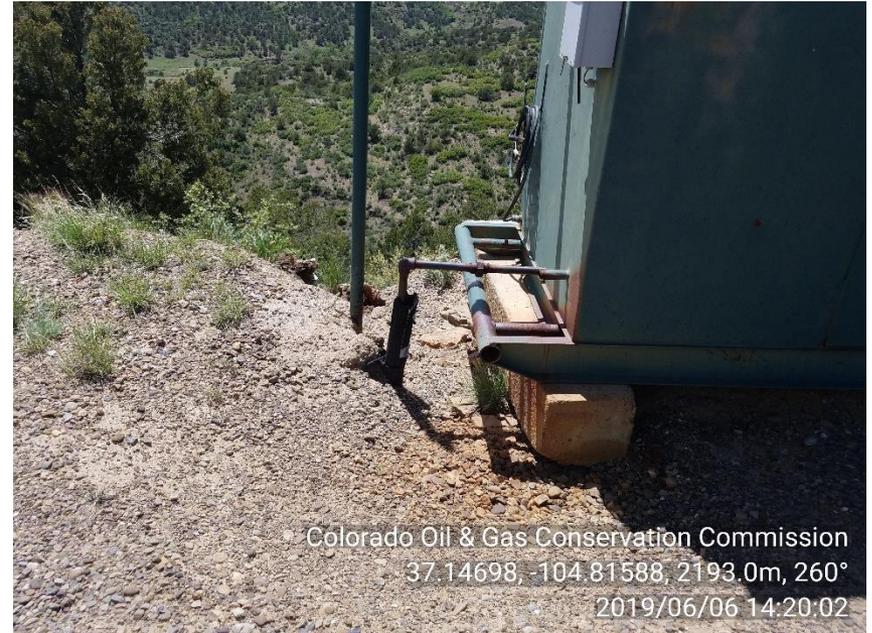
**PHOTO 4: ANOTHER ANGLE OF EROSION NOTED IN PREVIOUS PHOTO.**

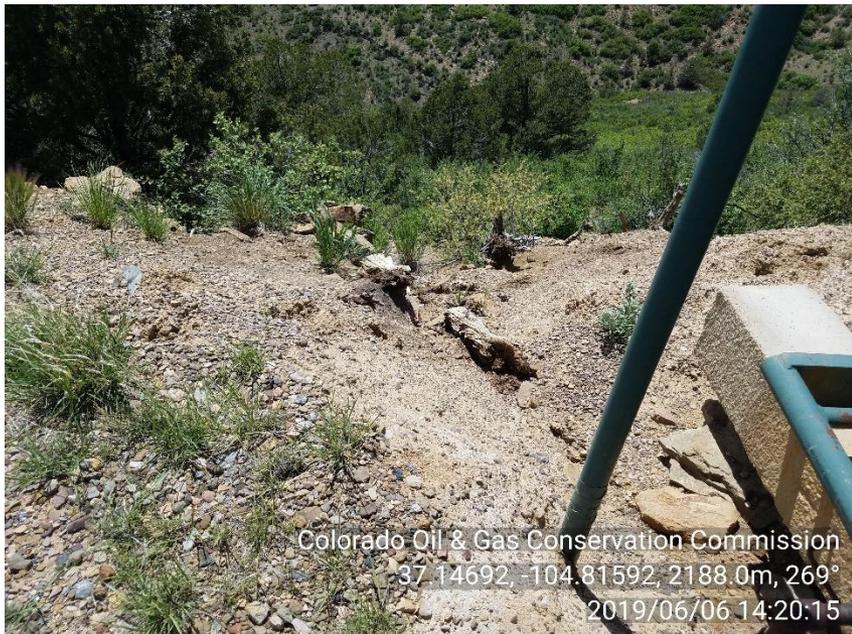
**PHOTO 5: EROSION CONTINUEING OF LOCATION. REPAIR  
EROSION AND DISCONTINUE DRAINING SEPARATOR IN  
LOCATION. CA DATE 7/6/19**
