Inspection Photos

API: 05-061-06851

Operator: VAL ENERGY INC

Inspection Date: 6/5/2019

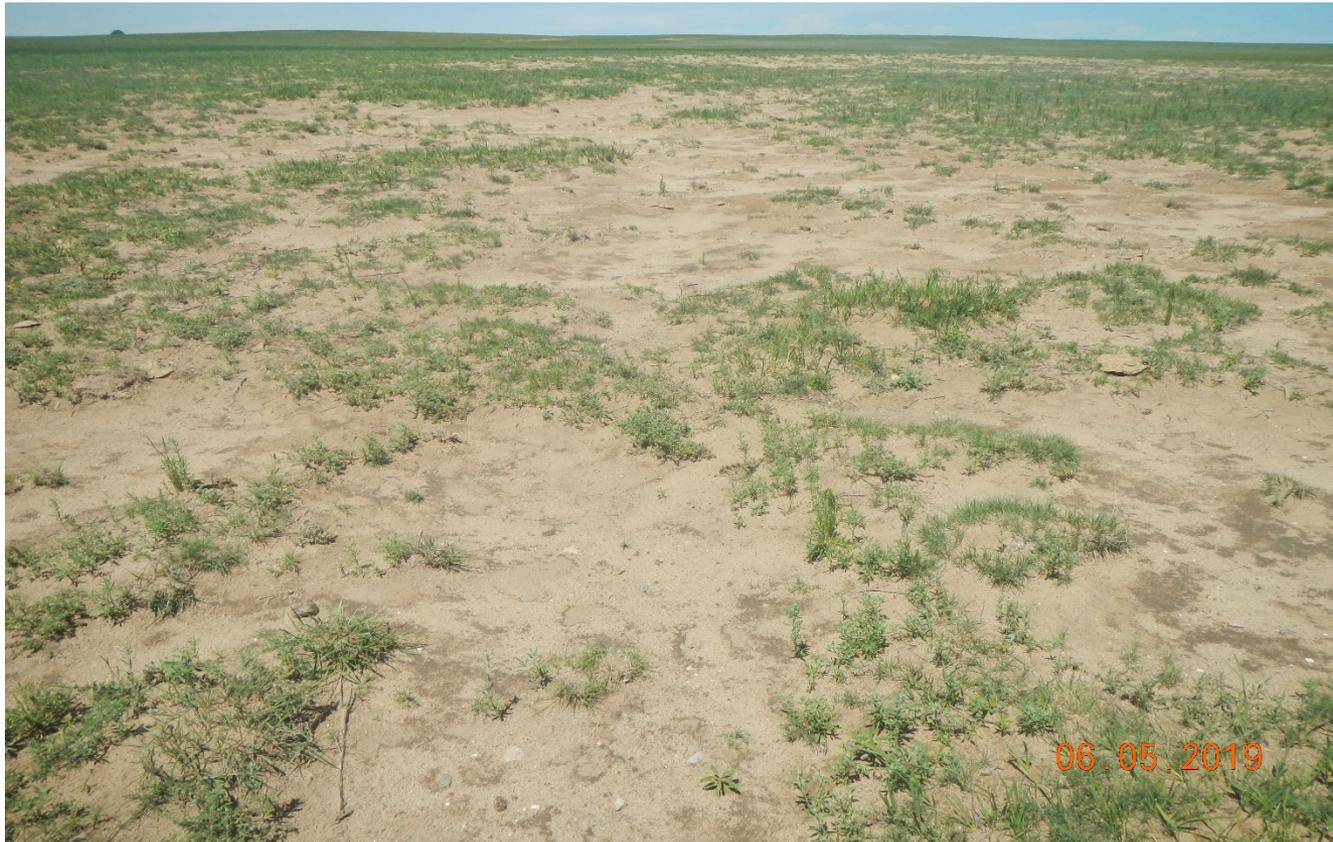
Photo 1. Facing west toward the southern portion of the location. Vegetation has not established and there are signs of wind erosion.

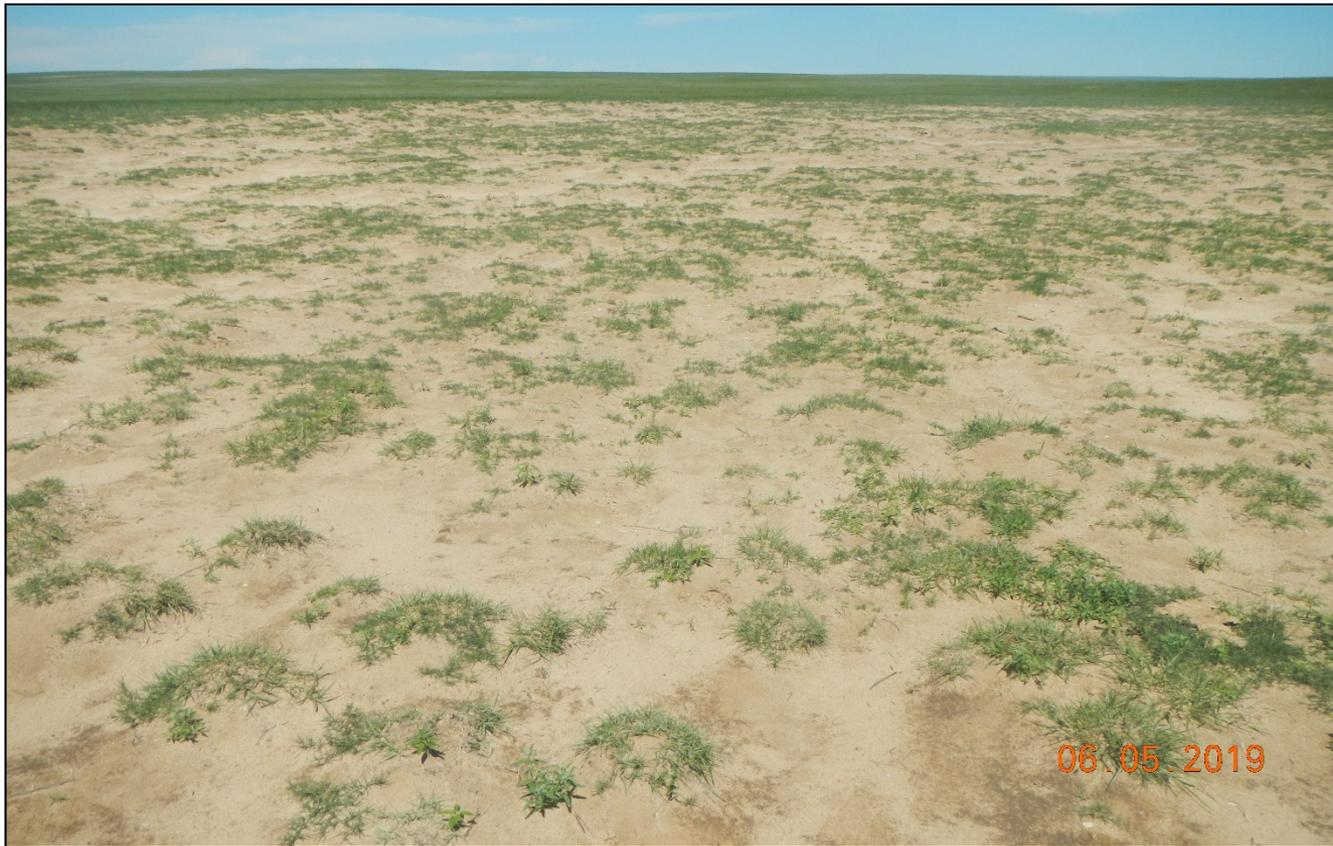
Photo 2. Facing west toward the location. Vegetation has not established and there are signs of wind erosion.

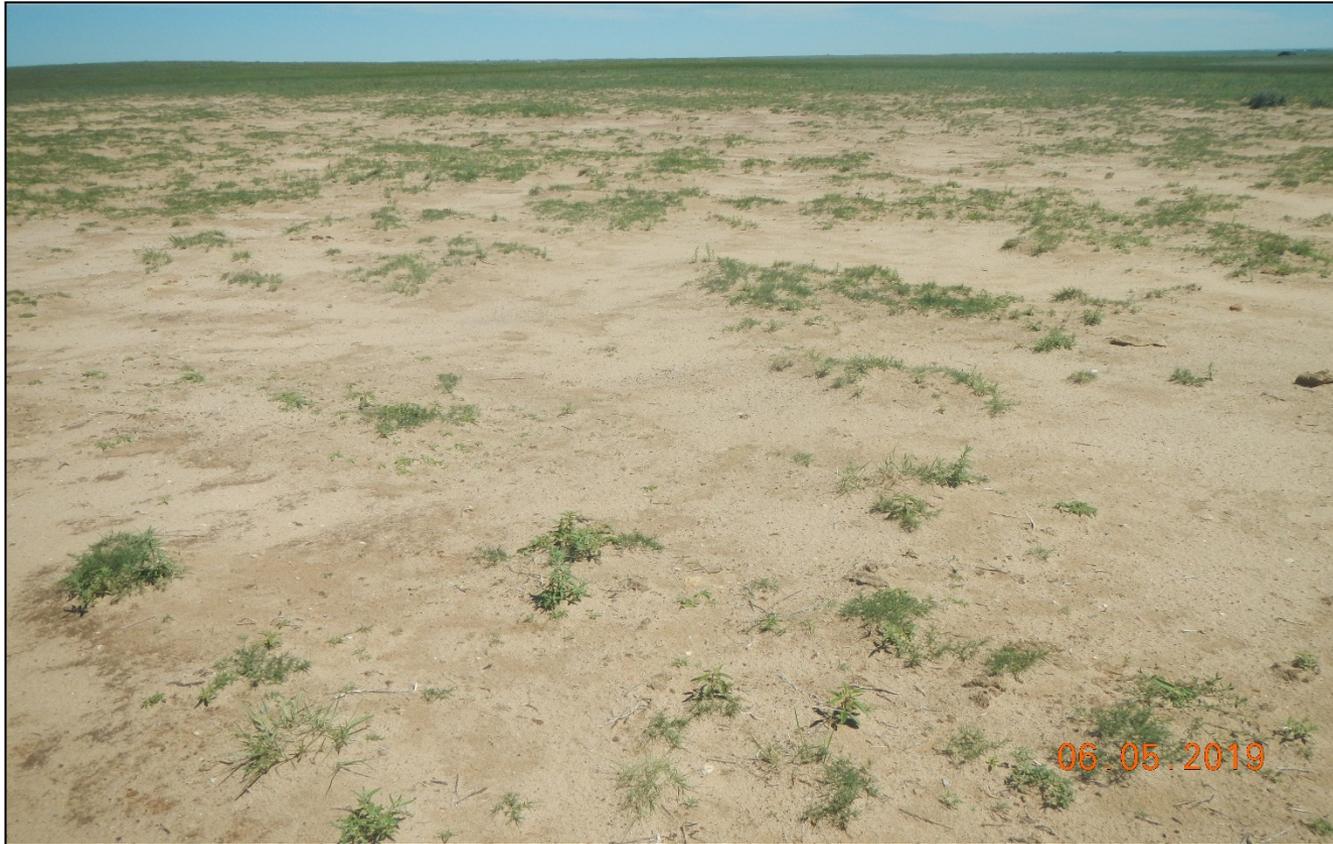
Photo 3. Facing north toward the location. Vegetation has not established and there are signs of wind erosion.

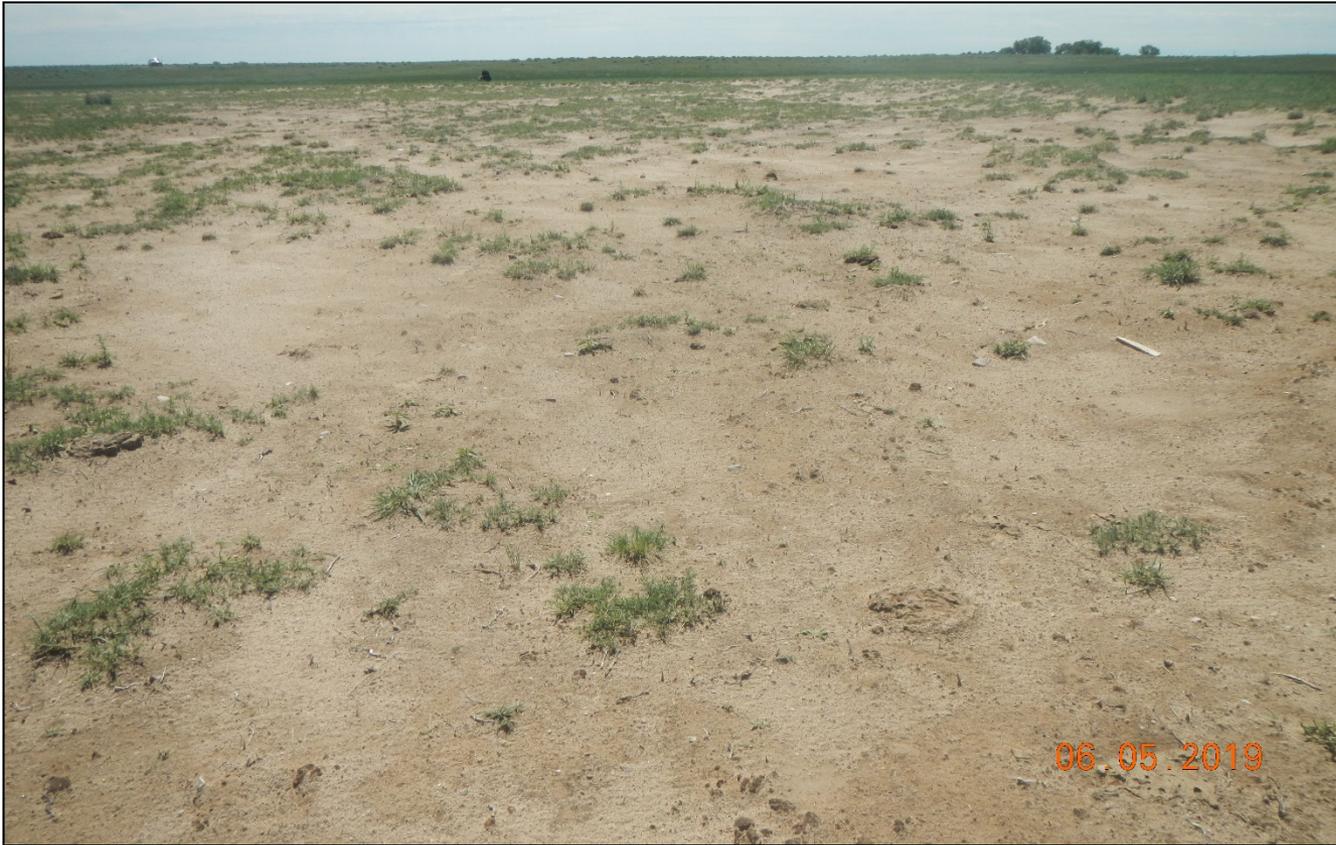
Photo 4. Facing southeast toward the location. Vegetation has not established and there are signs of wind erosion.

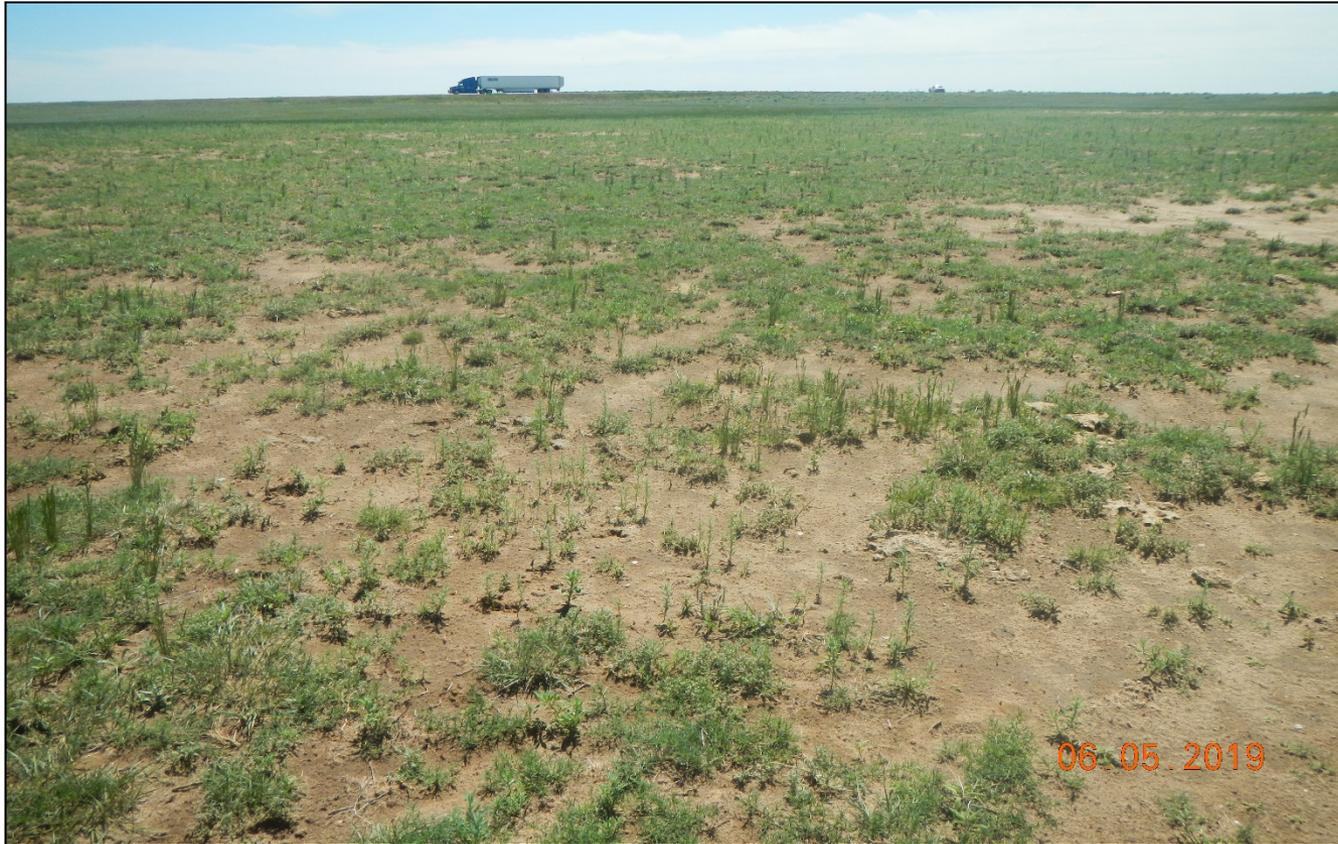
Photo 5. Facing east toward the location. There is predominately weeds growing in the northeast portion of the location.

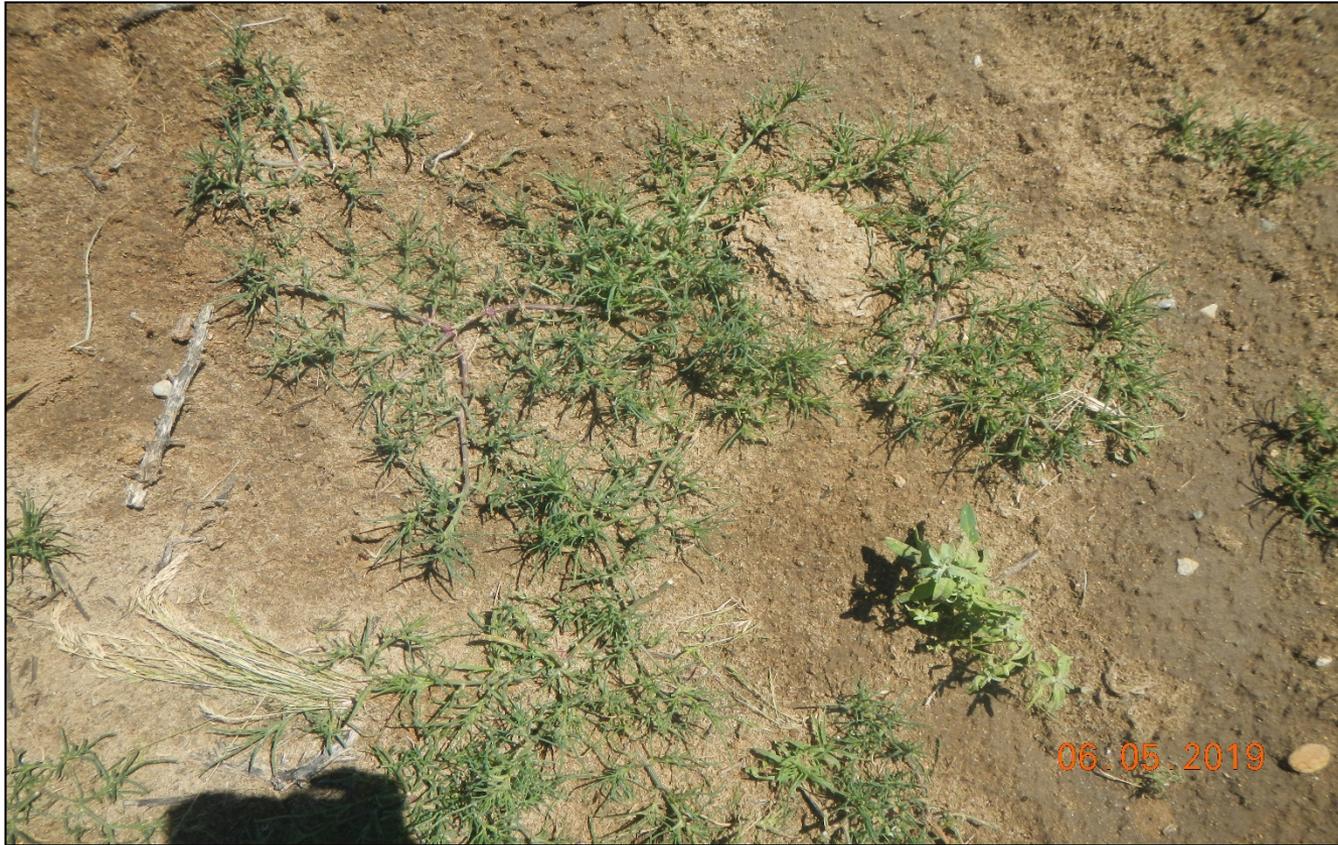
Photo 6. View of weed growth in the northeastern portion of the location.
(Russian thistle)

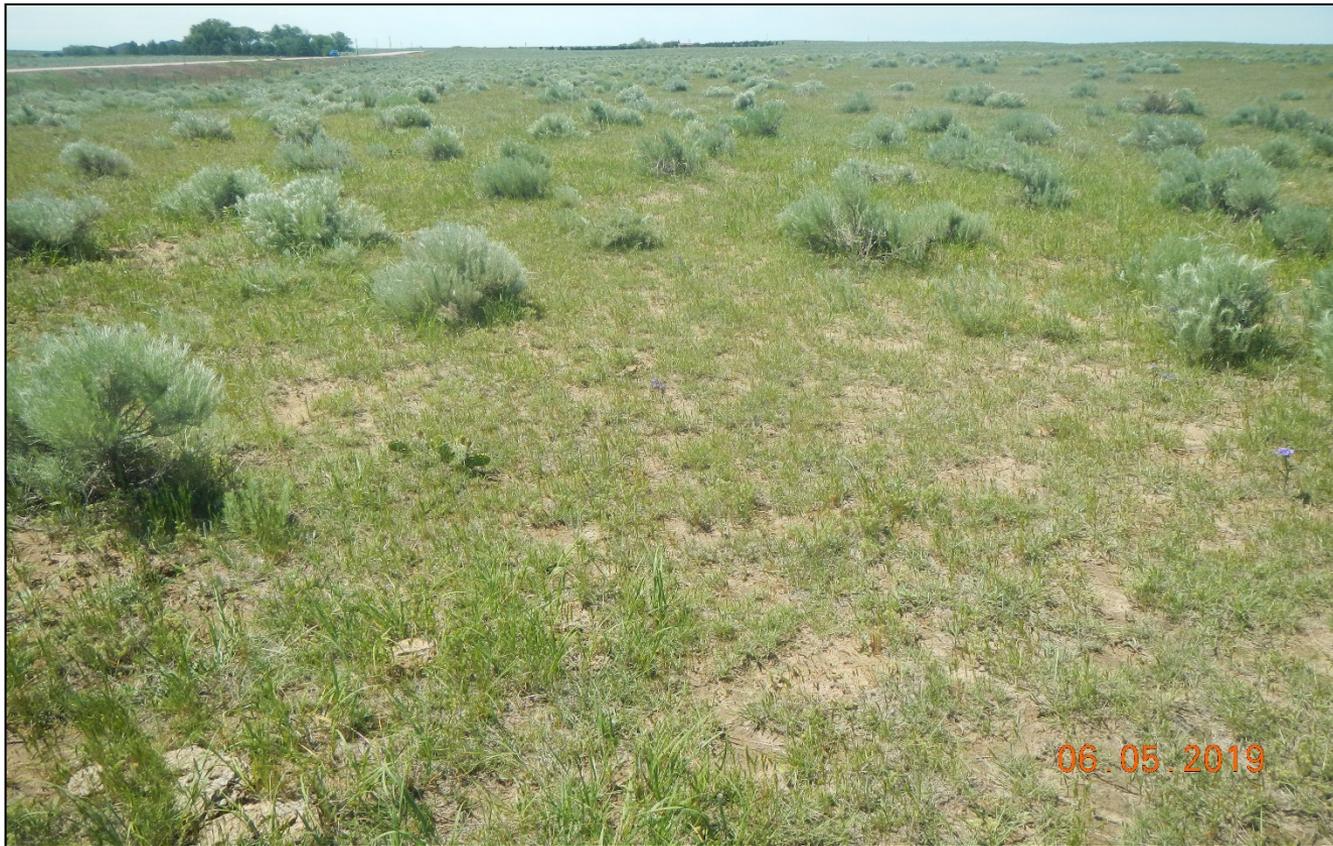
Photo 7. Facing south toward the undisturbed surrounding reference area that consist of native desirable vegetation.
