Inspection Photos

API: 05-017-07774

API: 05-017-07780

Operator: ANADARKO E&P ONSHORE LLC

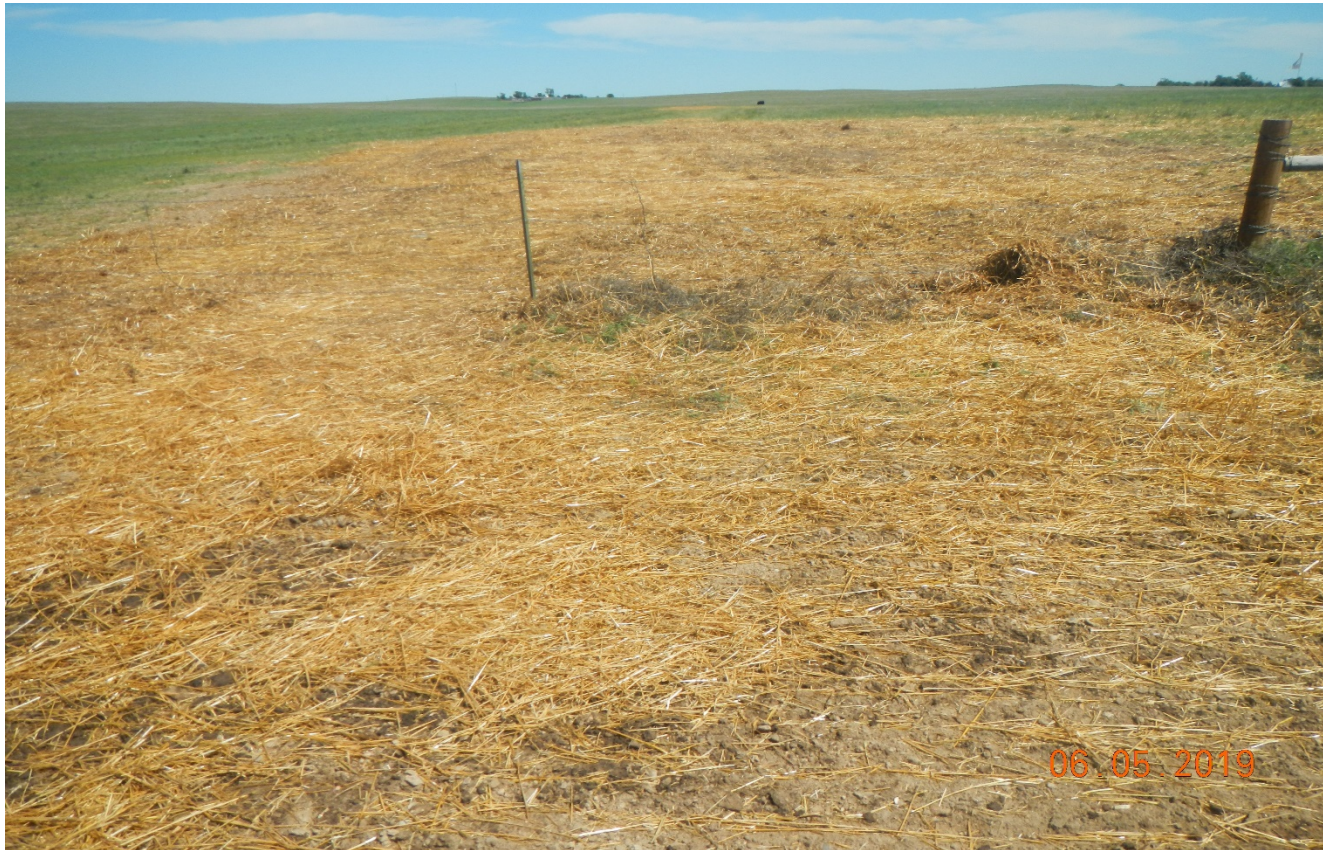
Photo 1. Facing north toward the location. There are areas that were recently seeded and straw mulched.

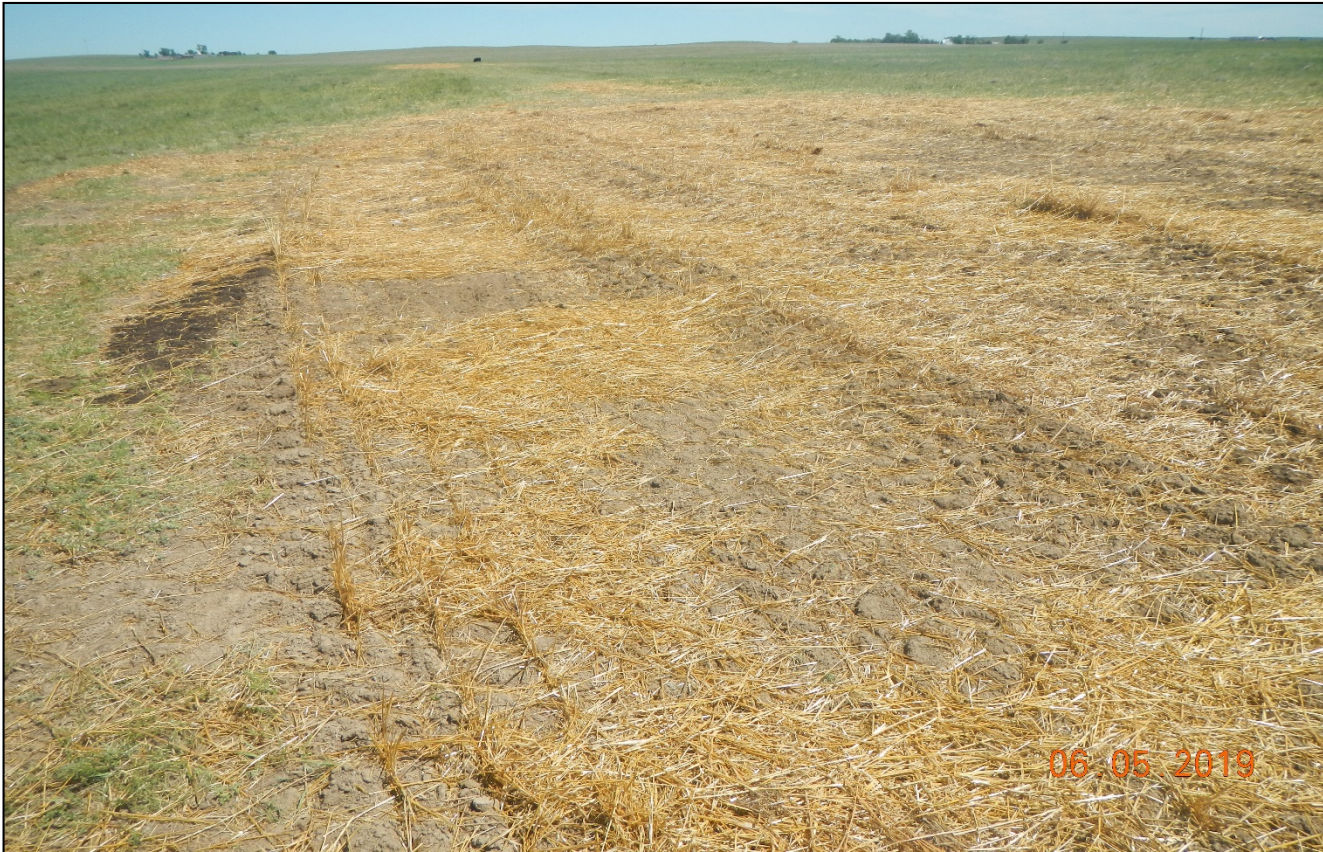
Photo 2. Facing north toward the location. There are areas that were recently seeded and straw mulched.

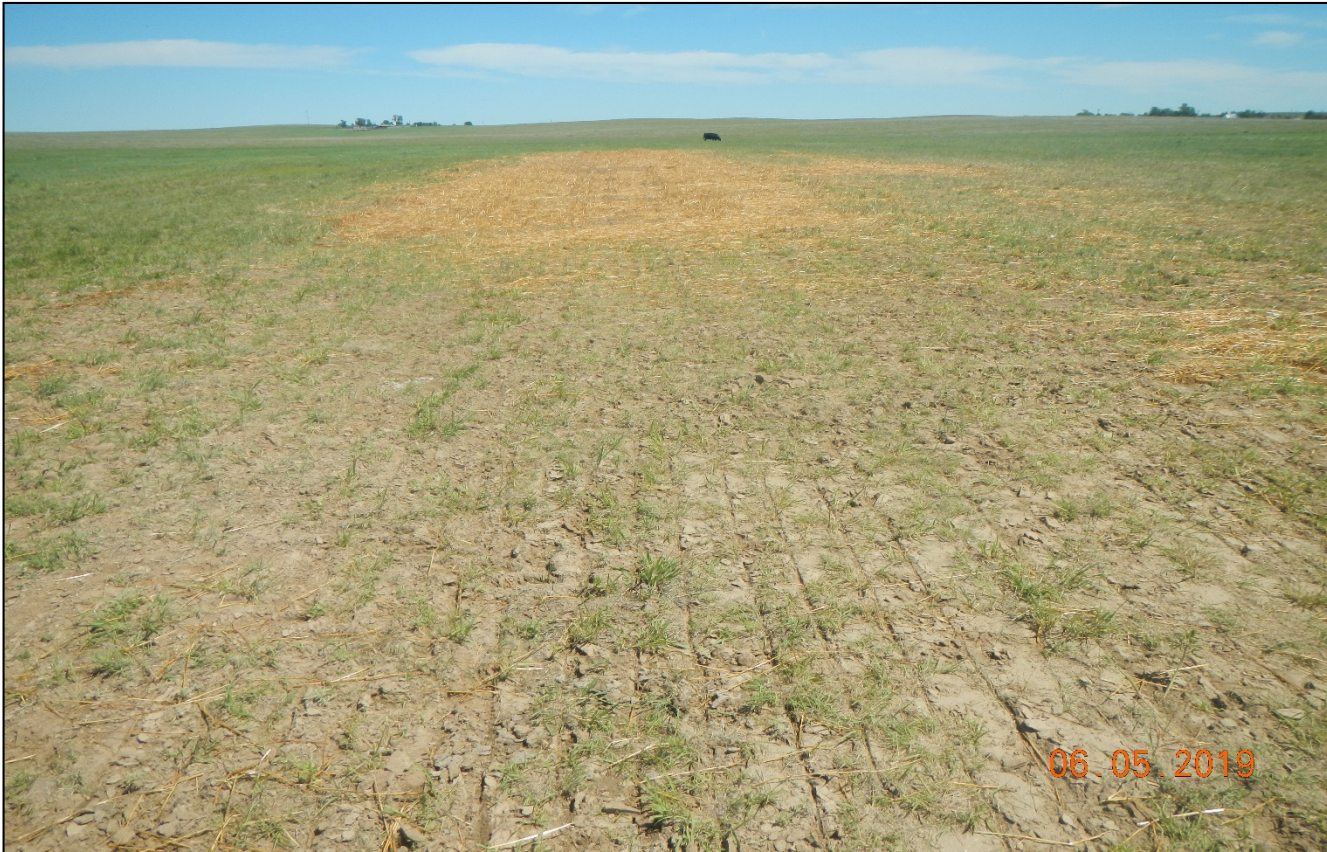
Photo 3. Facing north toward the location. There are areas that were recently seeded and straw mulched.

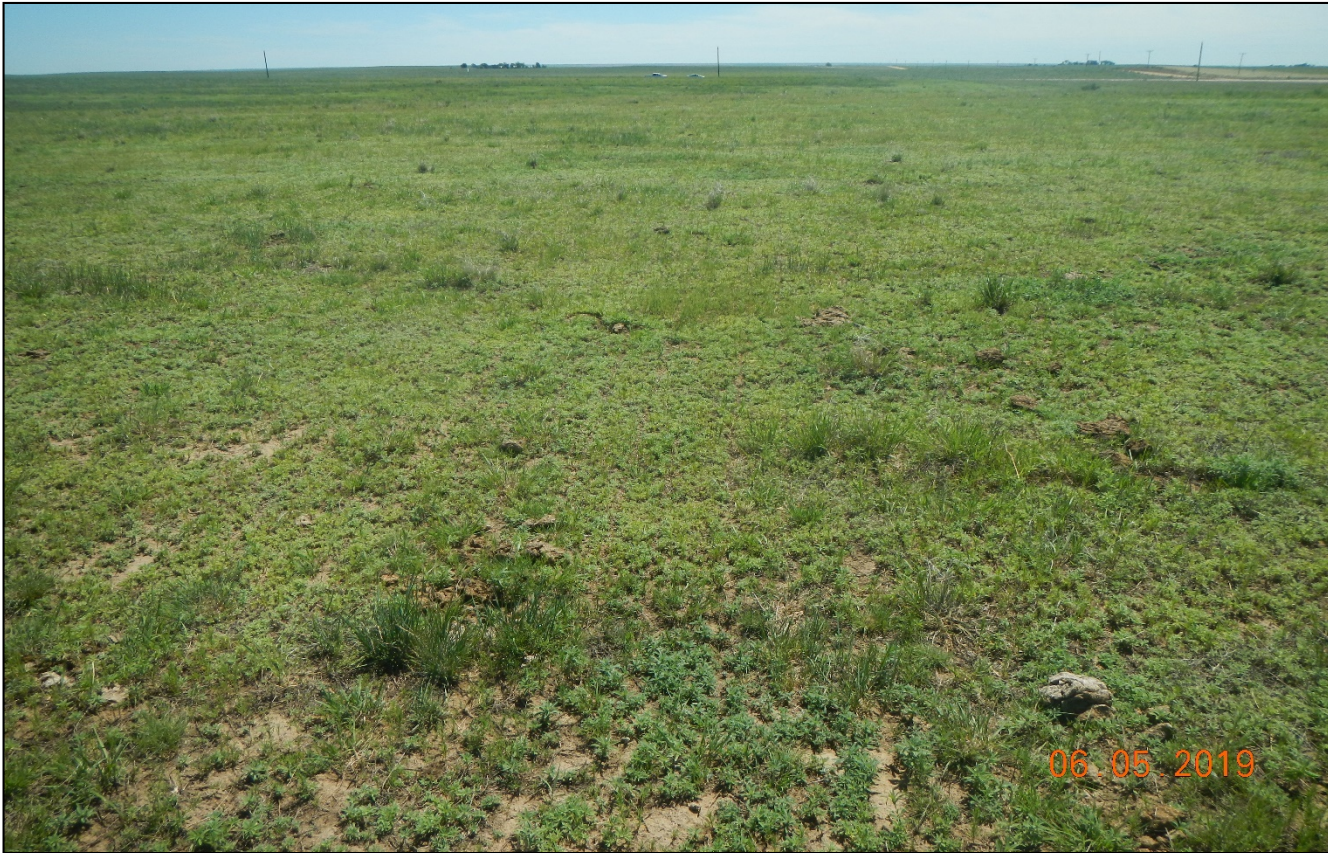
Photo 4. Facing east toward the location. This area has a dominance of weeds. There are signs the location was interseeded which may help to control the weeds.

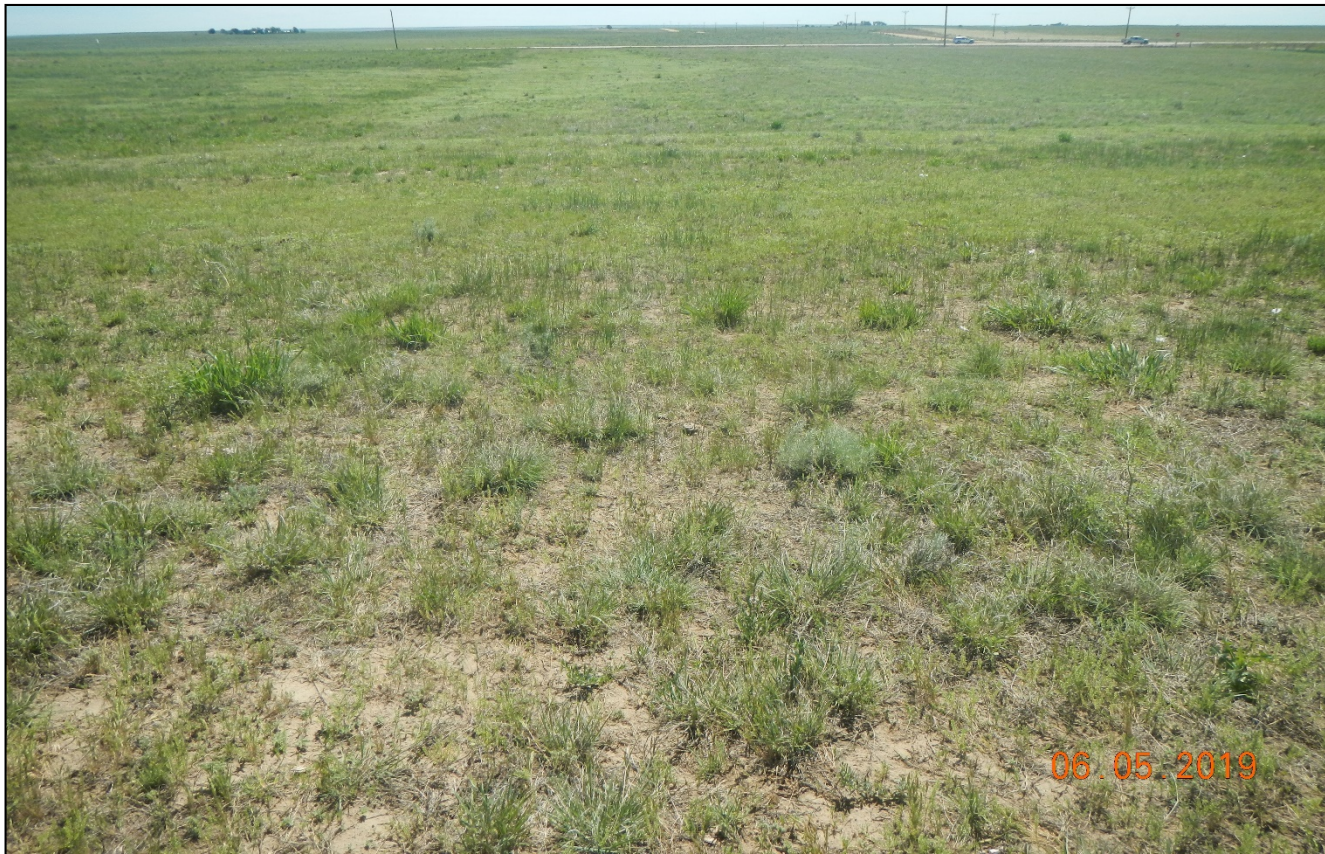
Photo 6. Facing east toward the location. The southern portion has good desirable vegetation establishment.

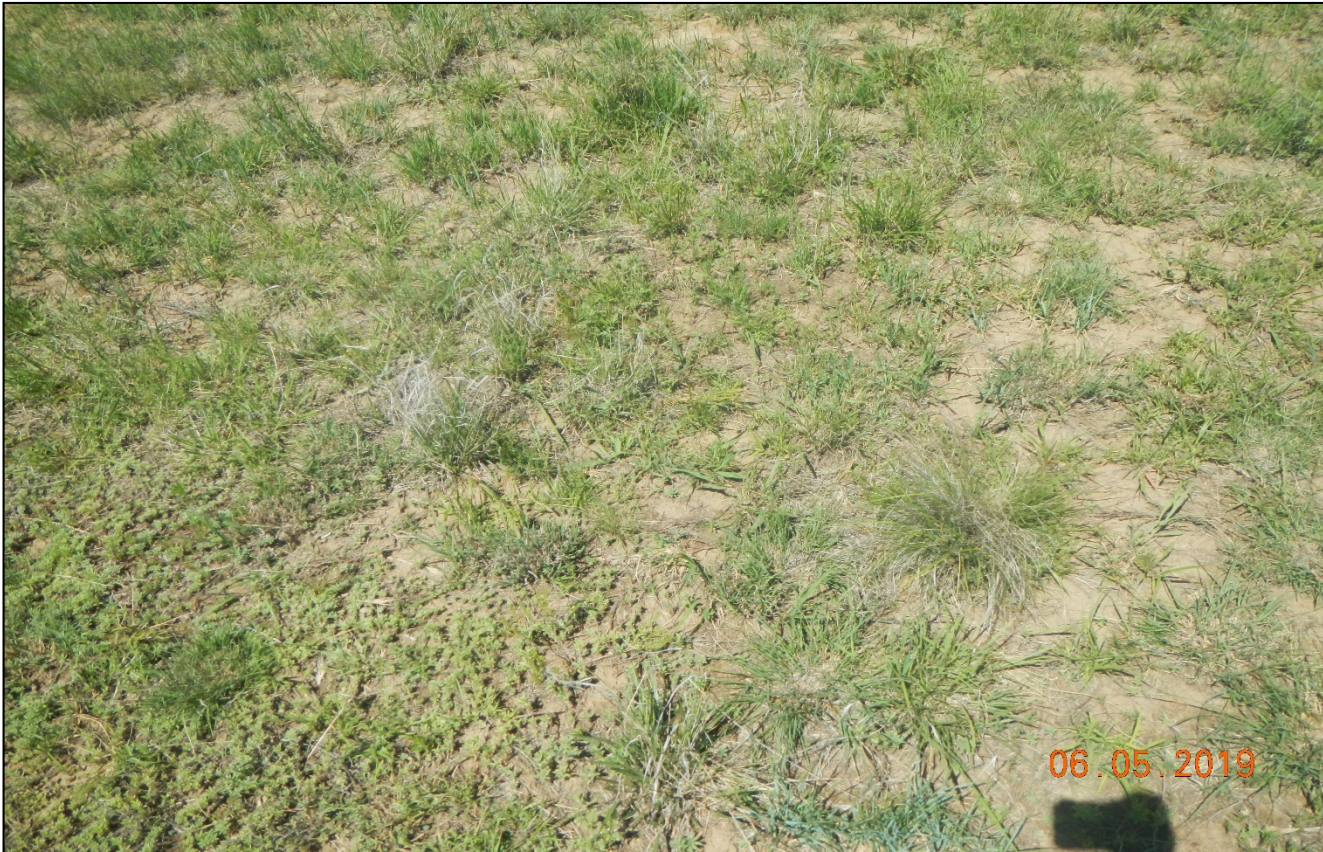
Photo 8. View of vegetation establishment containing some weeds and desirable vegetation establishment.
