Inspection Photos
Location Name: State 16-2
API: 05-081-06194

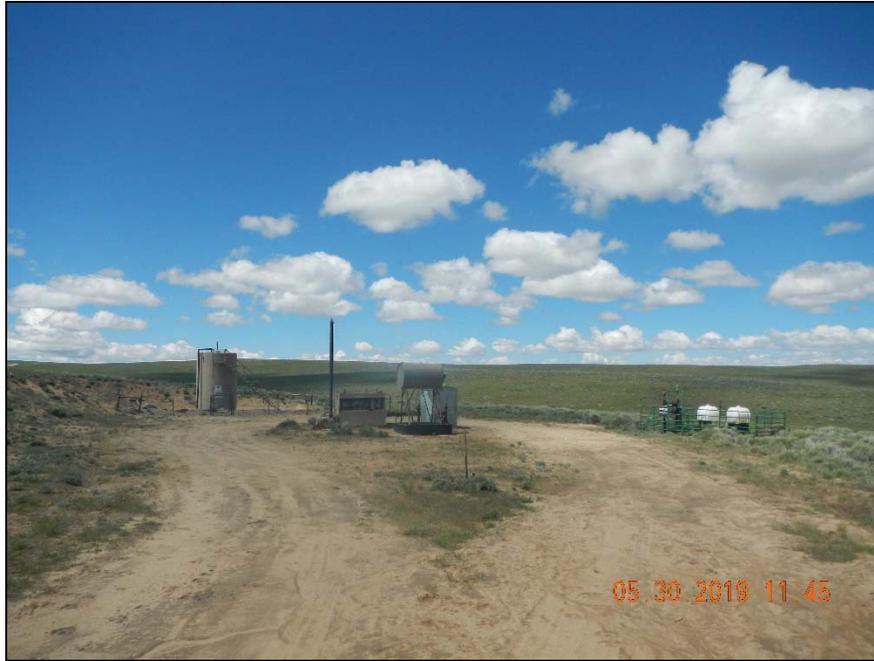
Photo 1. Overview of location taken at entrance facing southwest.

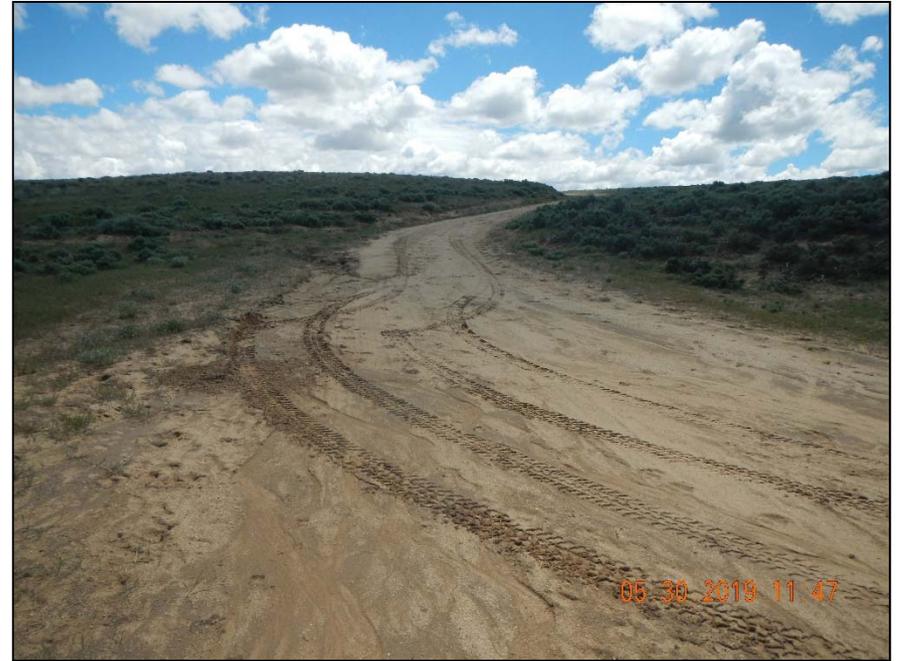
Photo 2. Evidence of sediment migration down access road. Photo taken at location perimeter looking away from location.

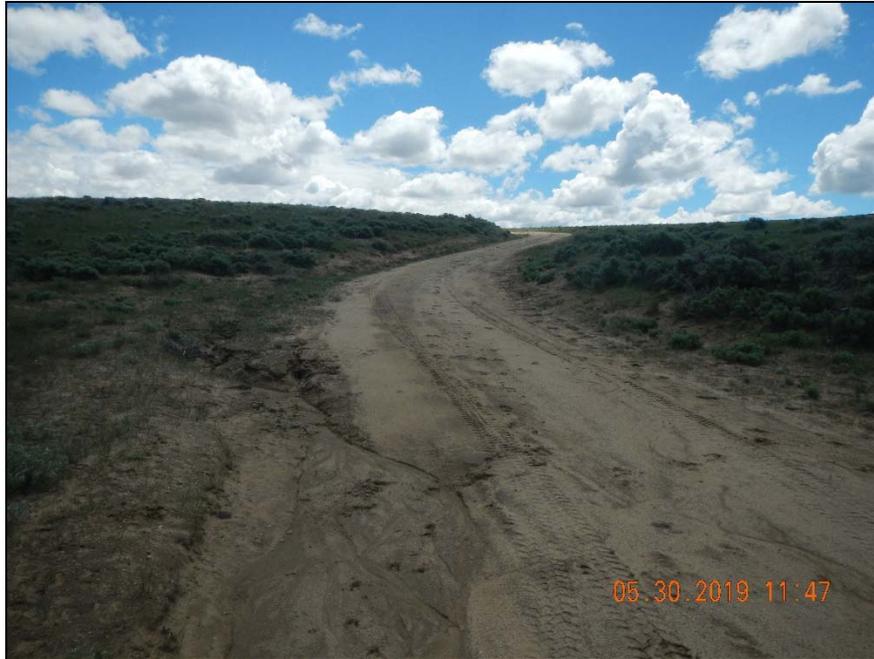
Photo 3. Evidence of sediment migration down access road. Photo taken near location perimeter looking away from location.

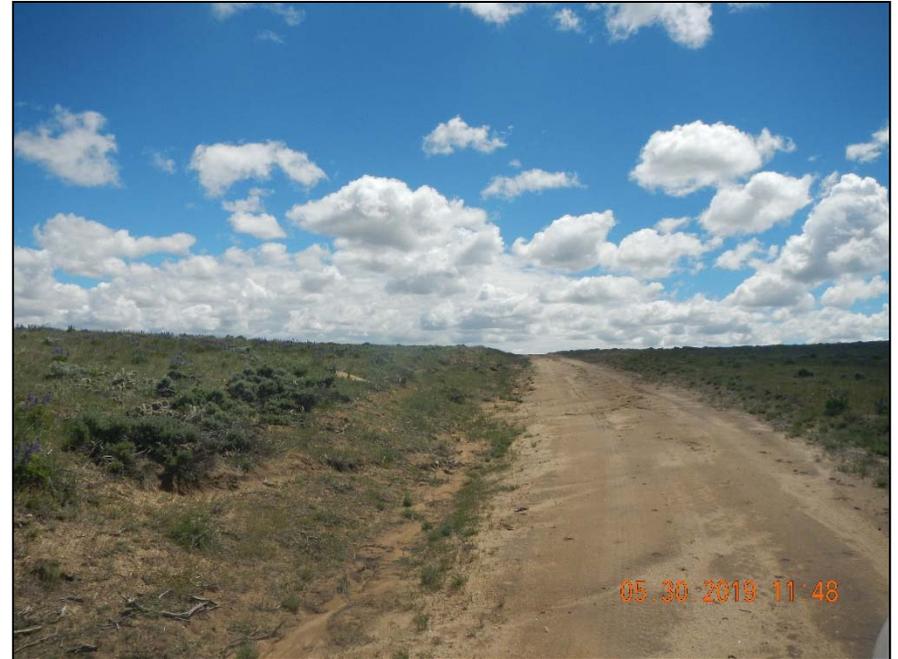
Photo 4. Evidence of sediment migration down access road. Photo taken halfway up access road looking away from location.
