Taiga Federal 9-J-21-4S-102W

API: 05-103-08088

Inspection: 679704399

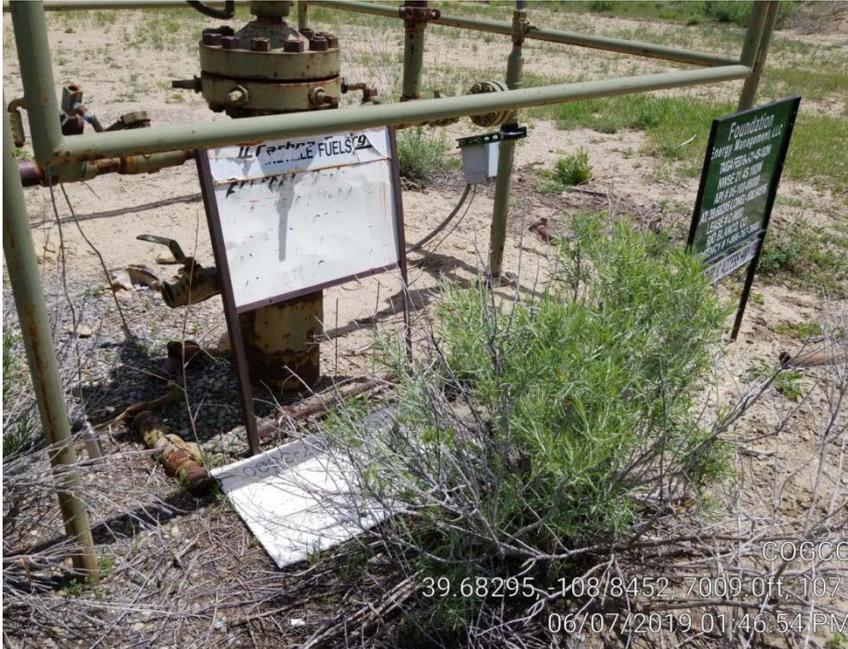
Photo 2. Old operator well heads, along with new operator sign.

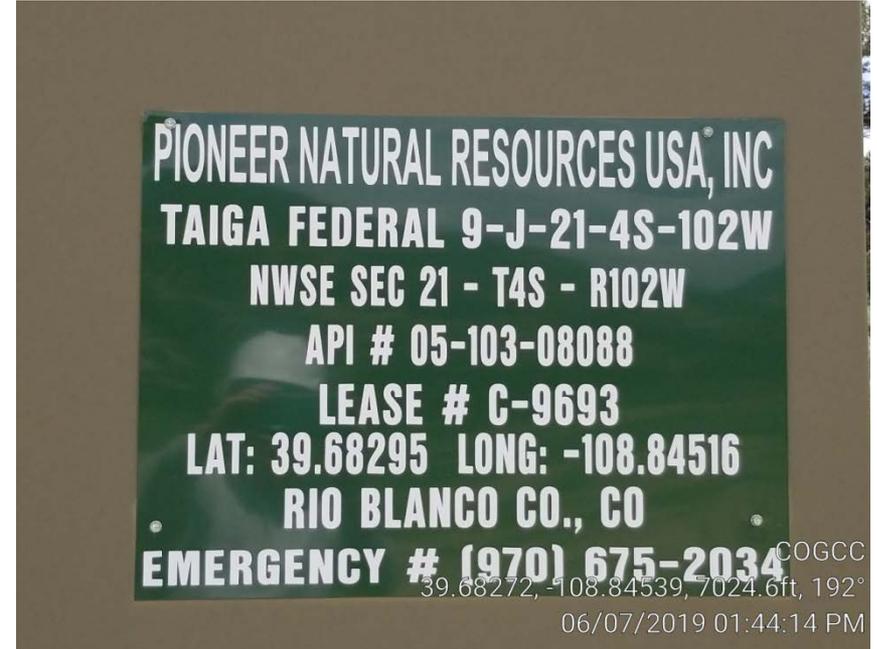
Photo 3. Tank battery sign with old operator information.

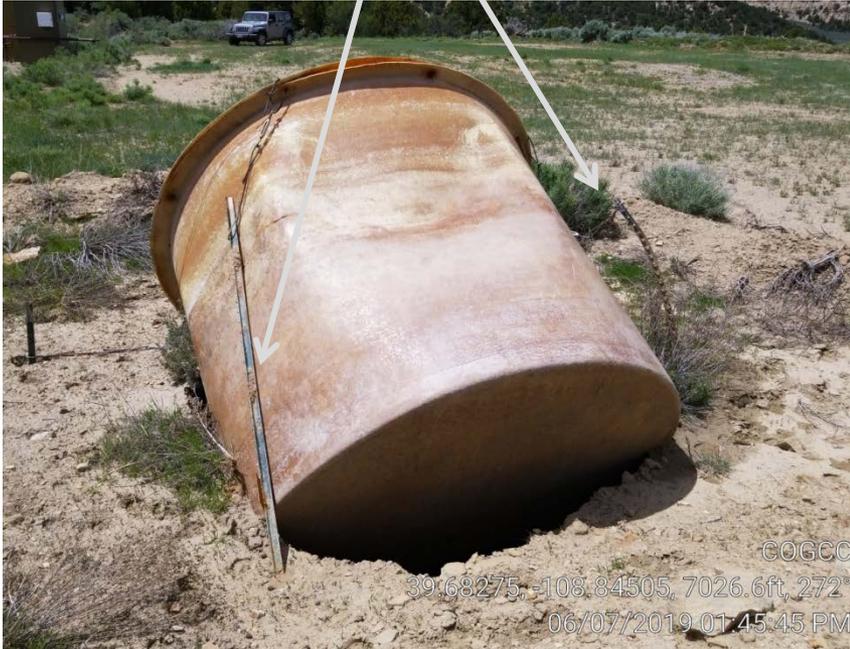
Tank anchor

Photo 4. Tank.

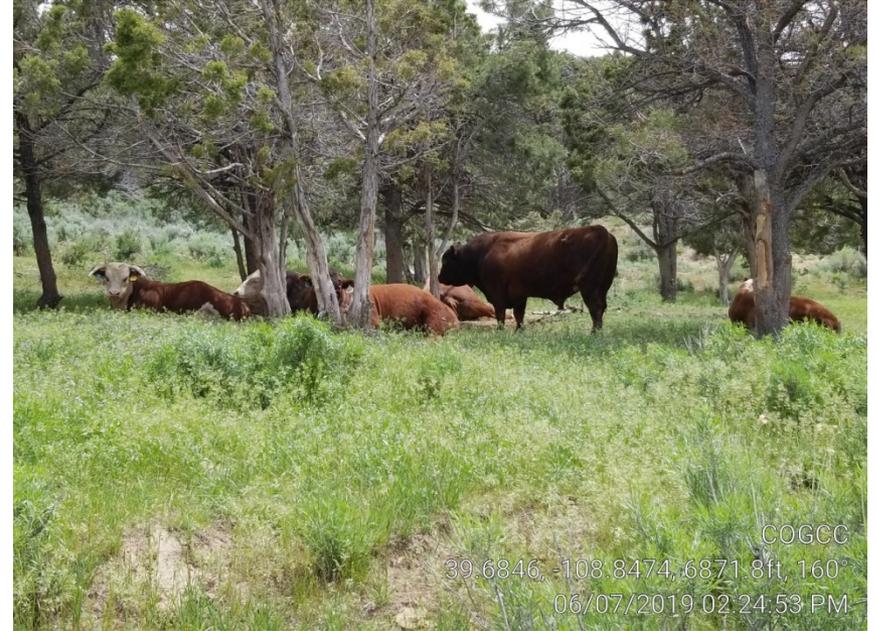
Photo 5. Bulls located 0.2 mile from well location.

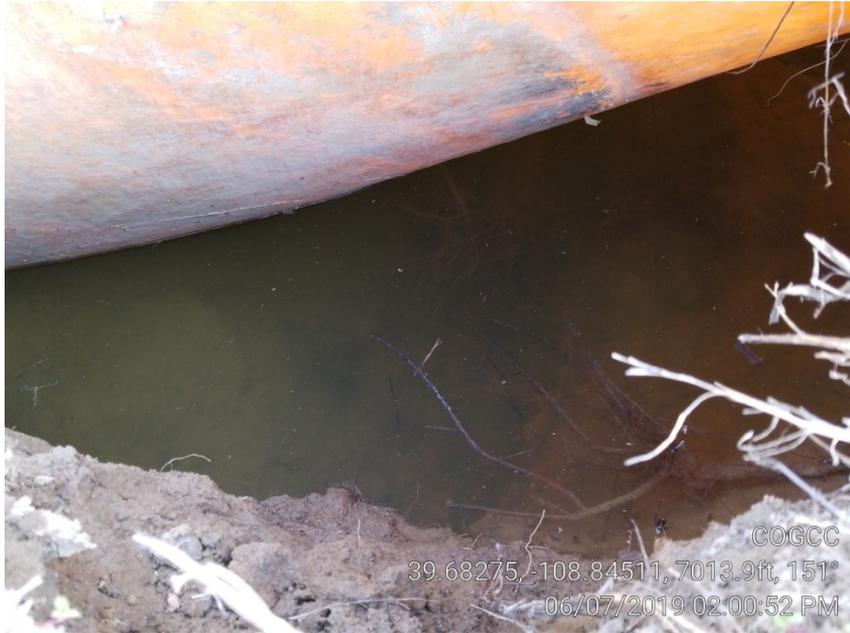
Photo 6. Fluid in hole created when tank tilted over.

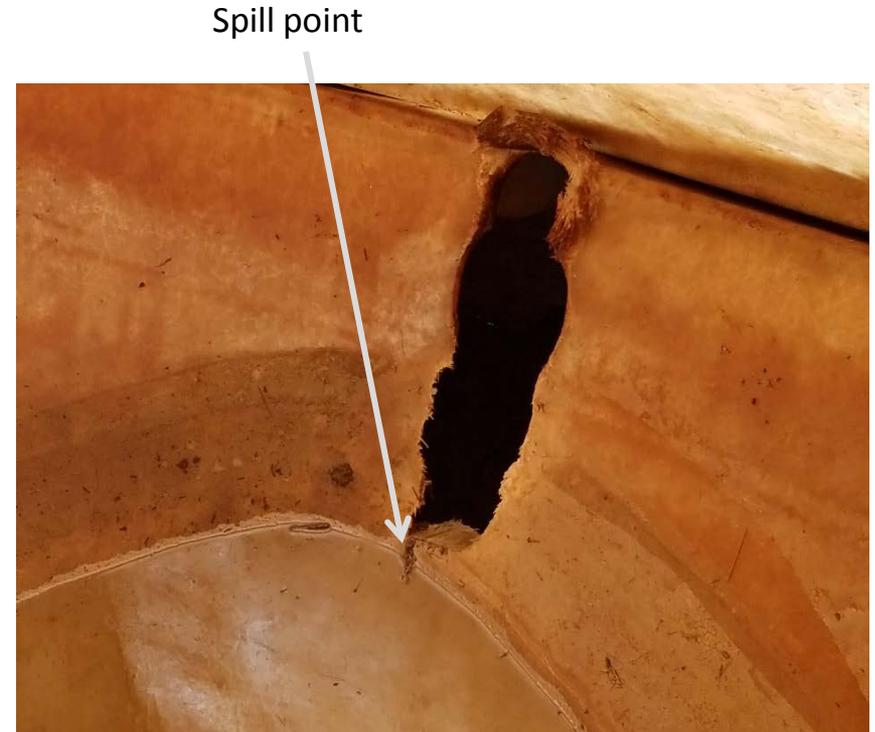
Photo 7. Inside of tank. Top of fluid at spill point of hole.
