Inspection Photos

Location Name: North Platte J-24 Dumpline Release

Facility ID: 429060

COGCC Environmental Inspection

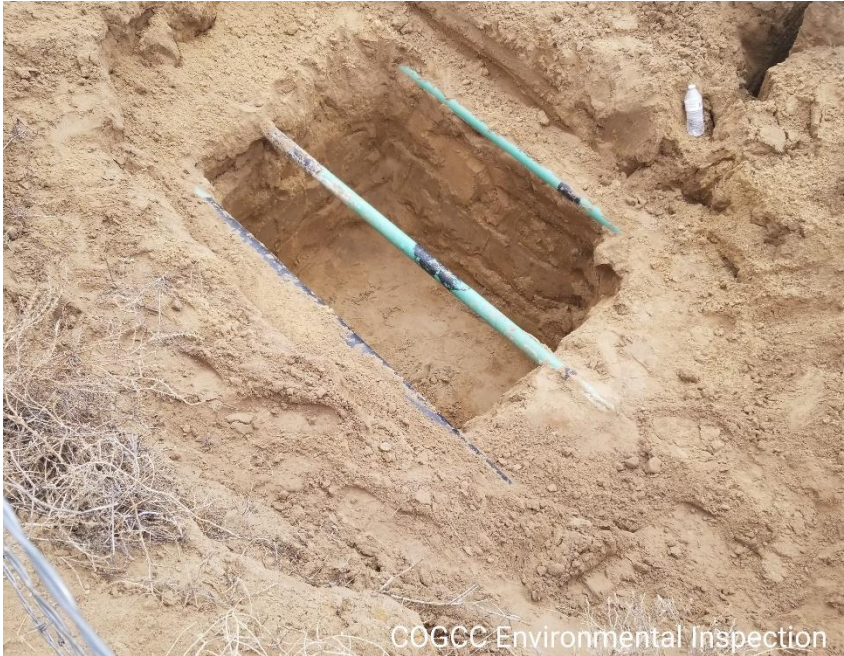
Photo 1 – Pipeline has been exposed via hydrovac and is awaiting spill cleanup.

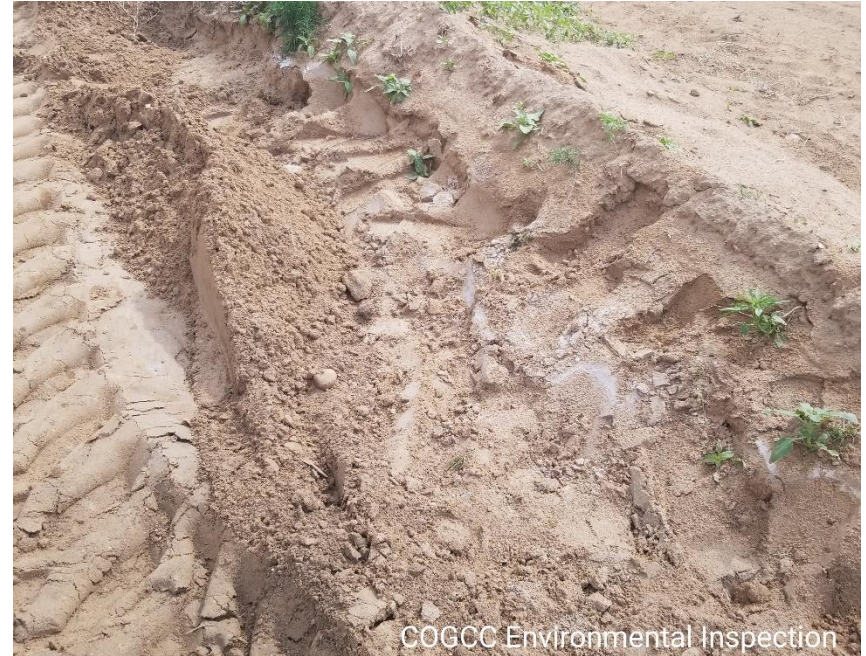
Photo 2 - Salt crust observed on surface soil adjacent to the hydrovac excavation. During site assessment Operator shall characterize impacts to top 0-6" in addition to subsurface impacts.

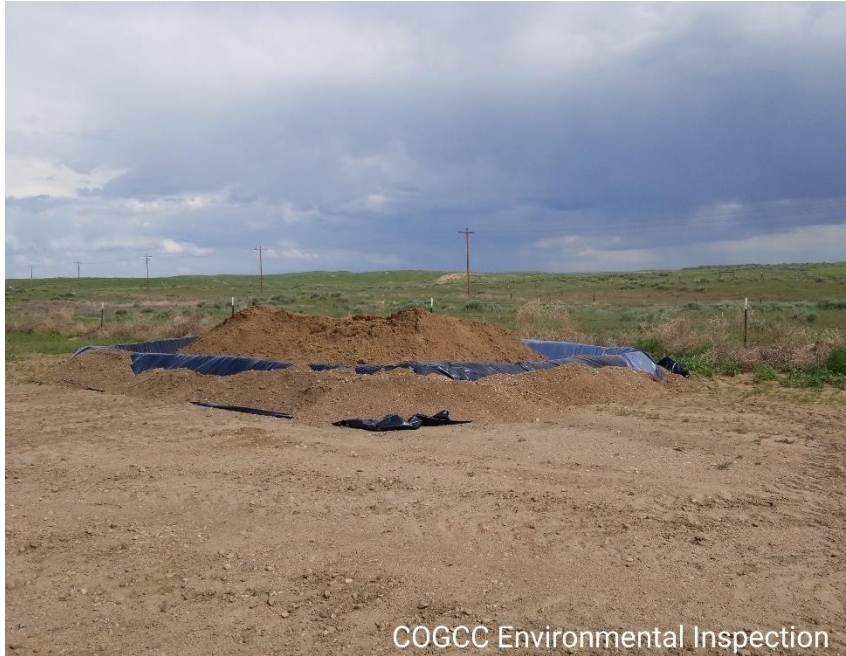
Photo 3 – Excavated impacted on plastic liner within berm.

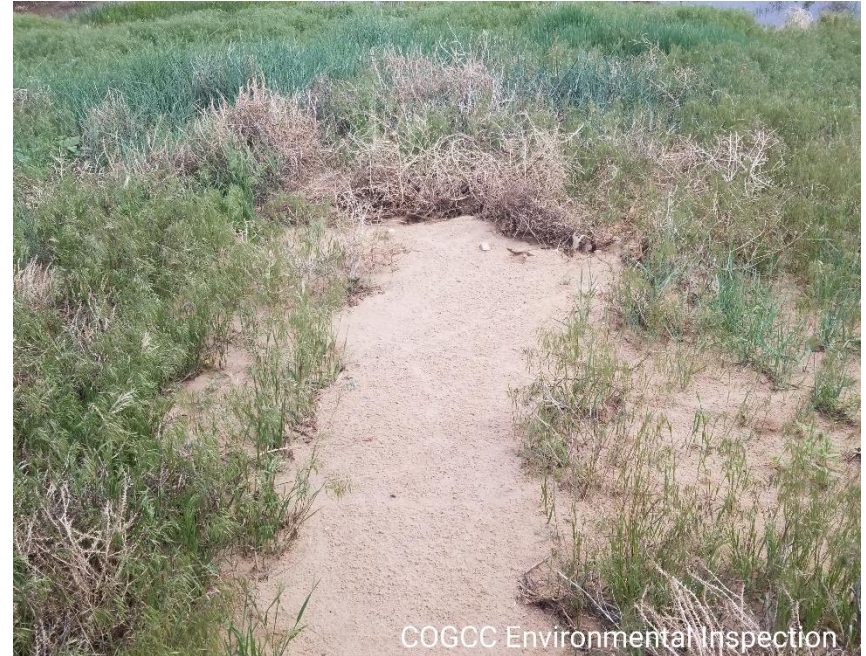
Photo 4 – Recent rains have caused heavy erosion and sediment migration throughout facility. Spoke with operator and issues were identified prior to COGCC inspection. Repairs pending.

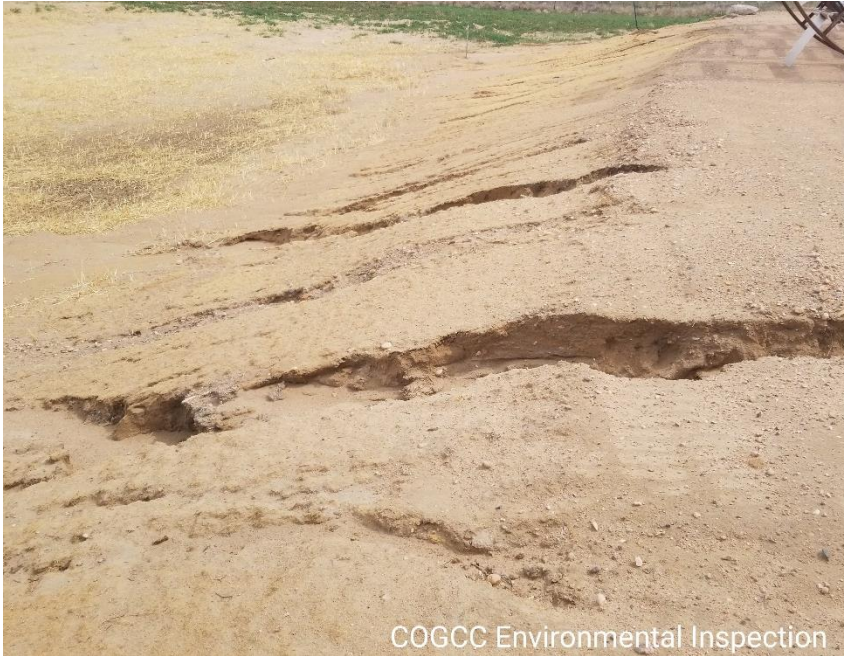
Photo 5 – Stormwater erosion caused by heavy storms have damaged hydromulch and other BMP's throughout facility. Spoke with operator and issues were identified prior to COGCC inspection. Repairs pending.

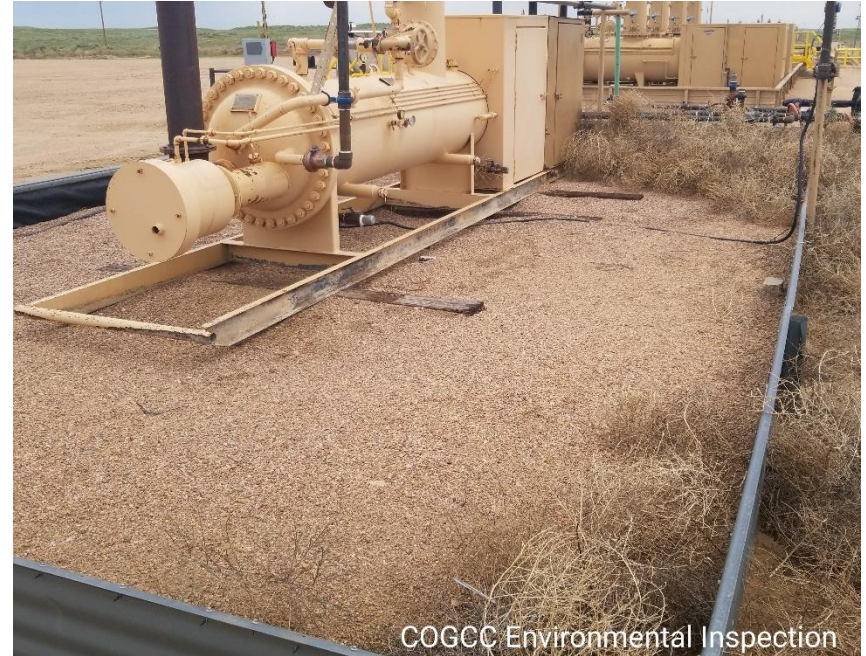
Photo 6 – Recent storms have also blown a significant amount of weeds on location. Clean up in compliance with Rule 603.f
