# Inspection Photos

API: 05-041-06072

Operator: HILCORP ENERGY COMPANY

Inspection and Photo Date: 5/14/2018

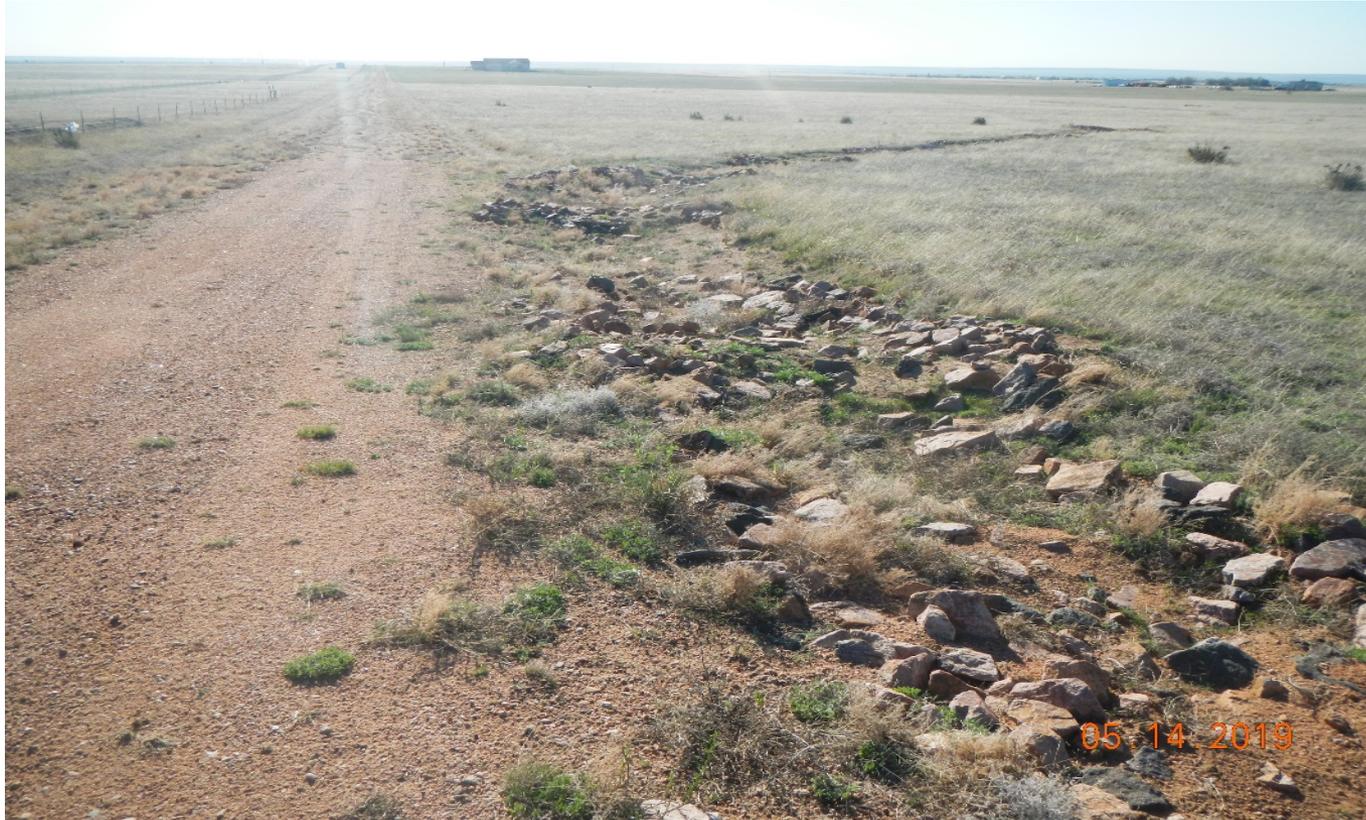
**Photo 1.** Facing east on the access road. Rock rip/rap can be seen in the drainage channel. Rock check dams have been lowered to allow water flow per previous inspection.

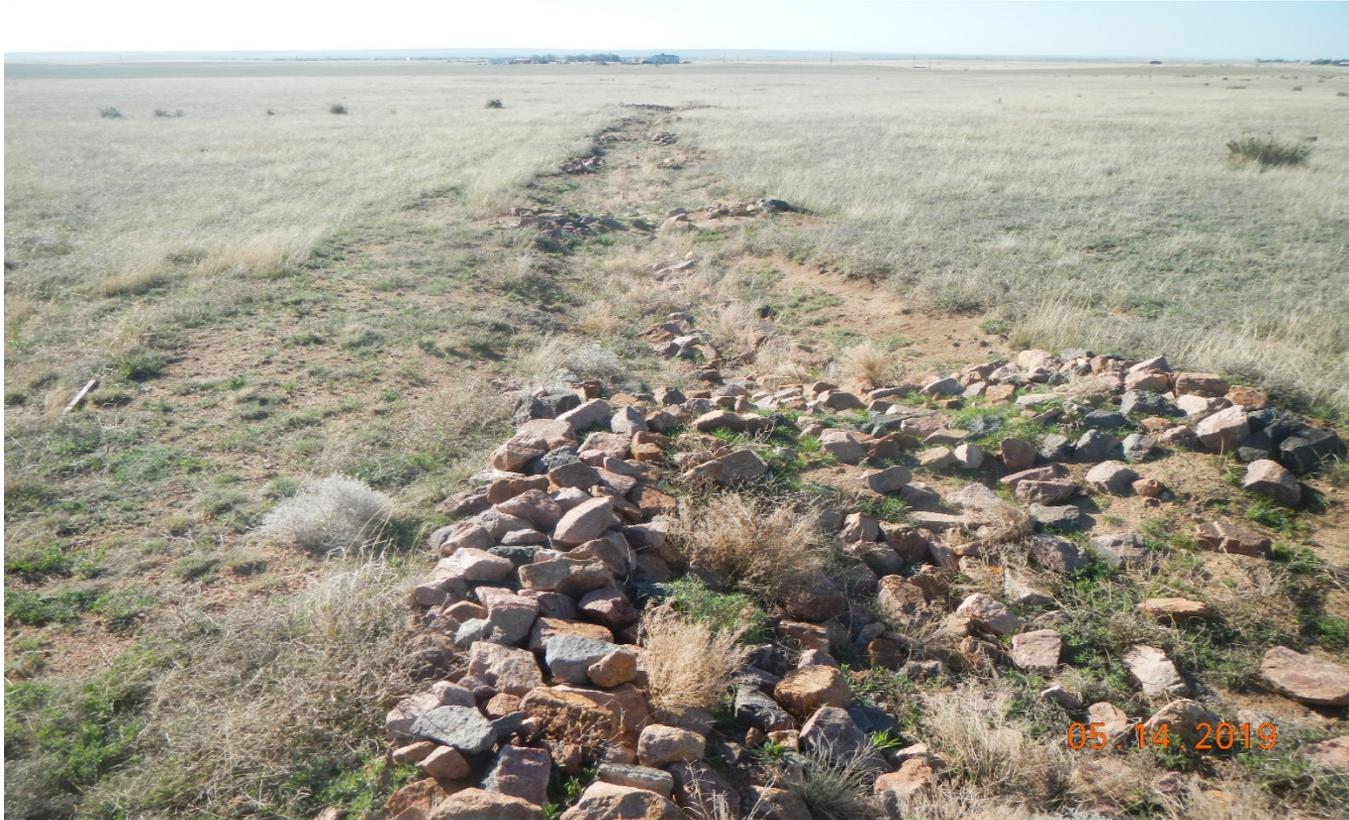
**Photo 2.** The drainage channel extends far out into the pasture. This is additional disturbance caused by erosion. The channel needs to be recontoured to grade and reclaimed/reseeded. A proper sediment trap should be constructed. This corrective action has not been completed. This photo depicts noncompliance of the corrective action.

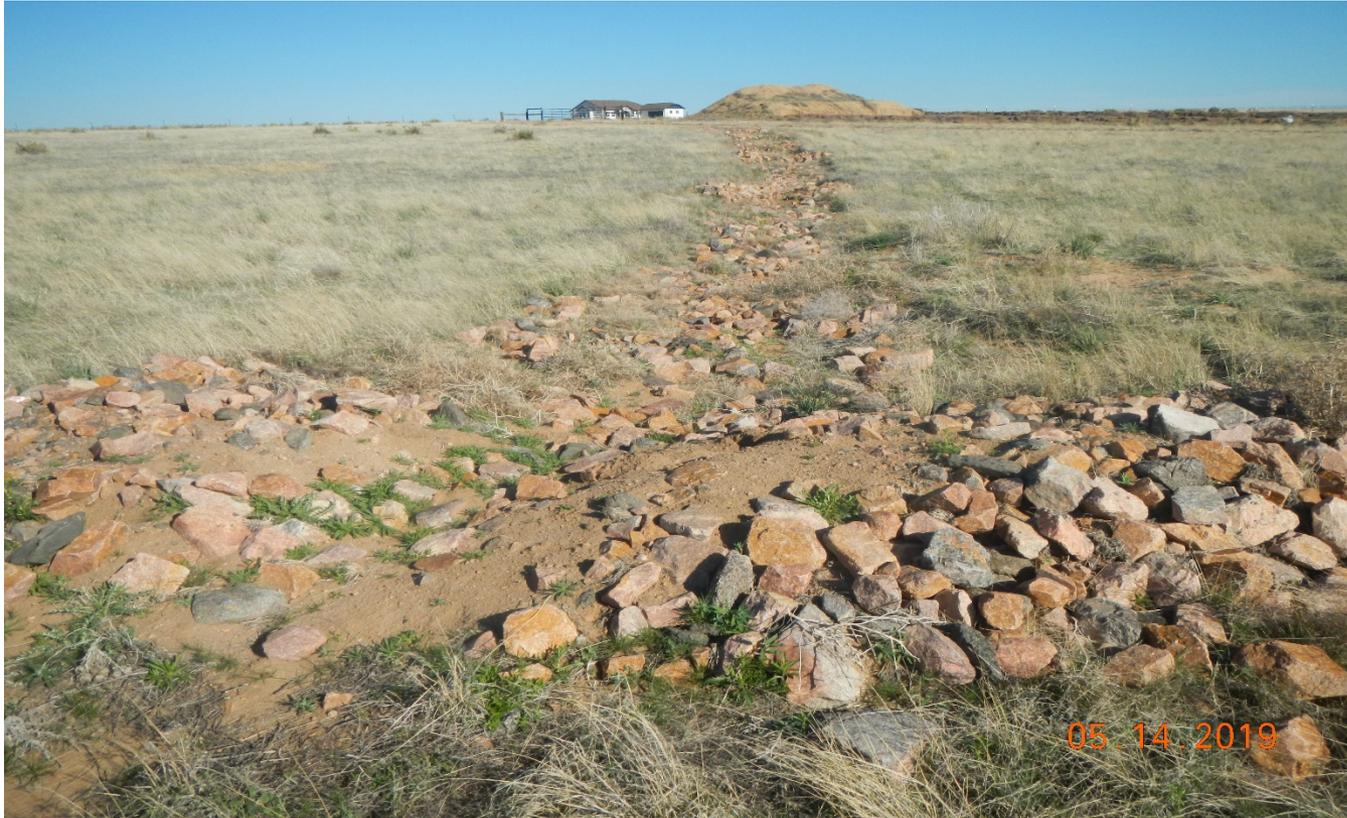
**Photo 3.** Standing out in the pasture facing northwest toward the road. The erosion channel has not been reclaimed and there is rock rip/rap scattered along the channel. This photo depicts noncompliance of the corrective action.

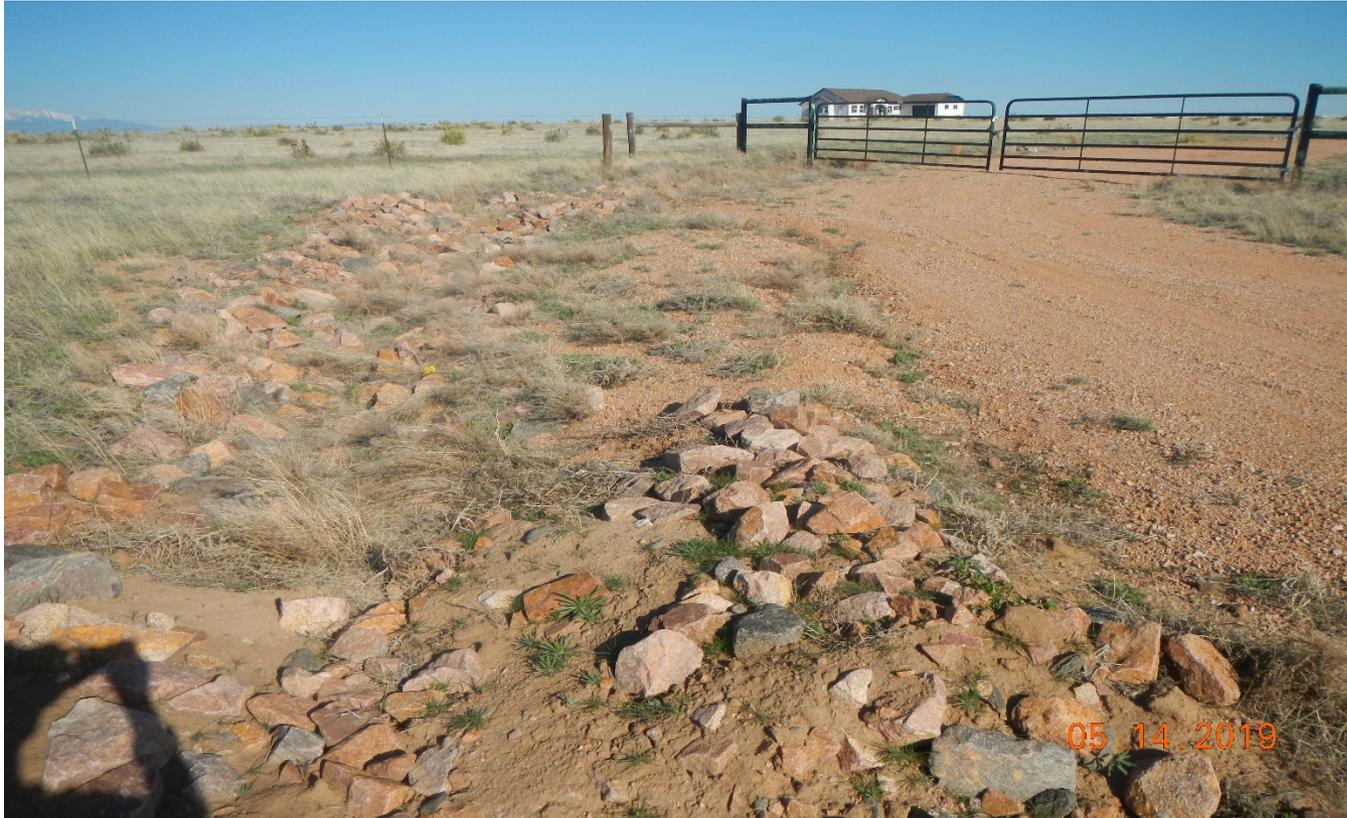
**Photo 4.** Rock rip/rap can be seen in the drainage channel. Rock check dams have been lowered to allow water flow. Weed debris has been removed from the channel. This photo depicts compliance of the corrective action.

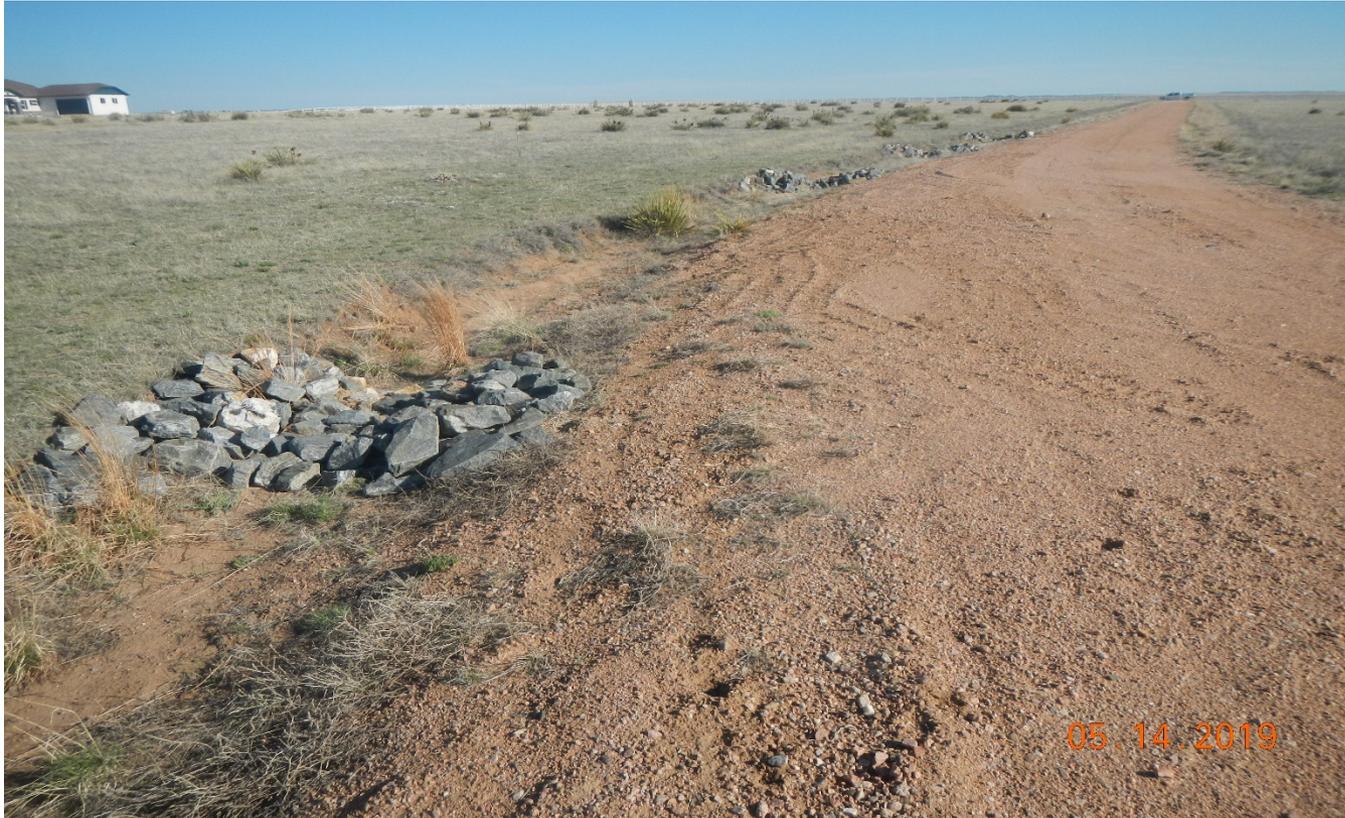
**Photo 5.** Rock check dams have been installed further up the road from the gate shown in photo 4. This photo depicts compliance of the corrective action.

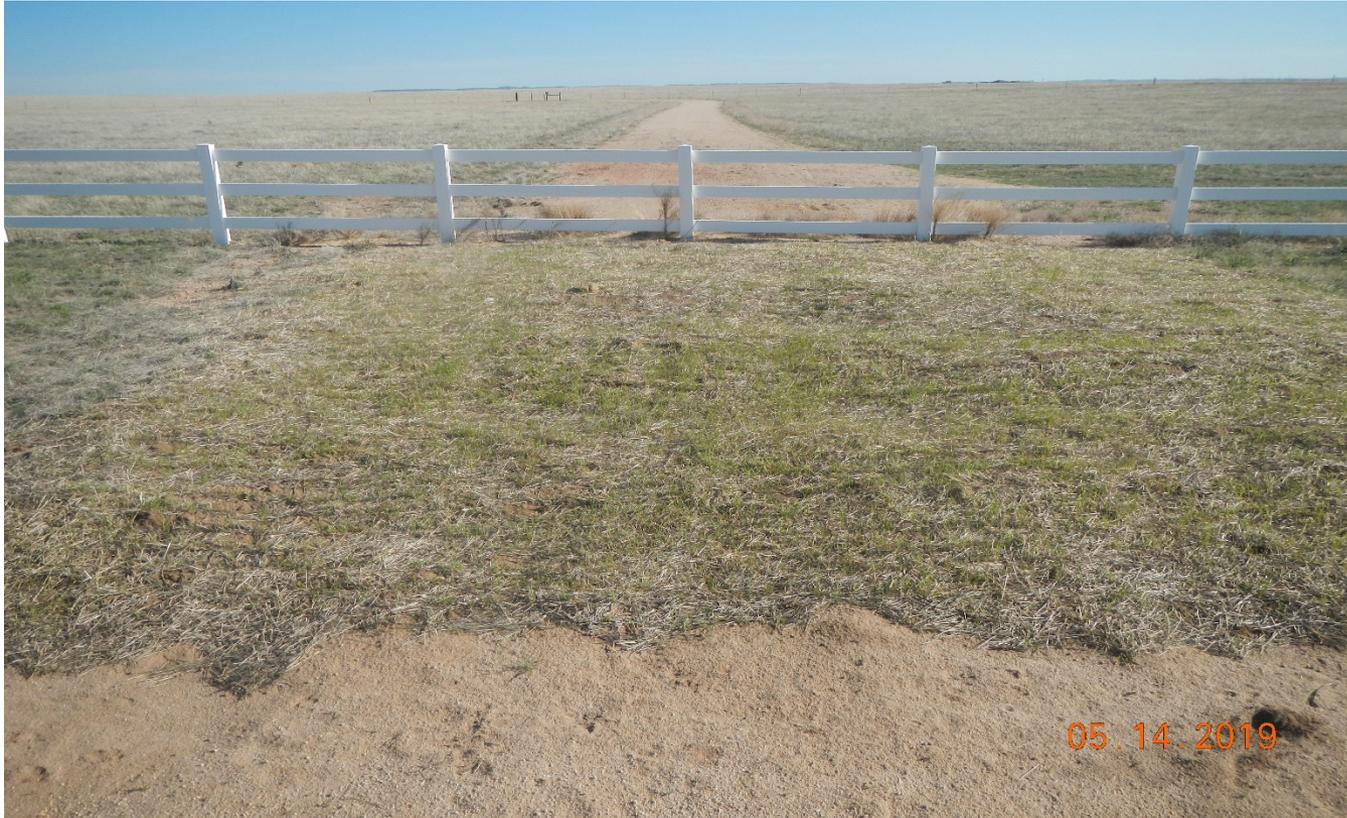
**Photo 6.** Facing north toward the access road. The side of the road was stabilized with straw blanket and vegetation is establishing. This photo depicts compliance of the corrective action.

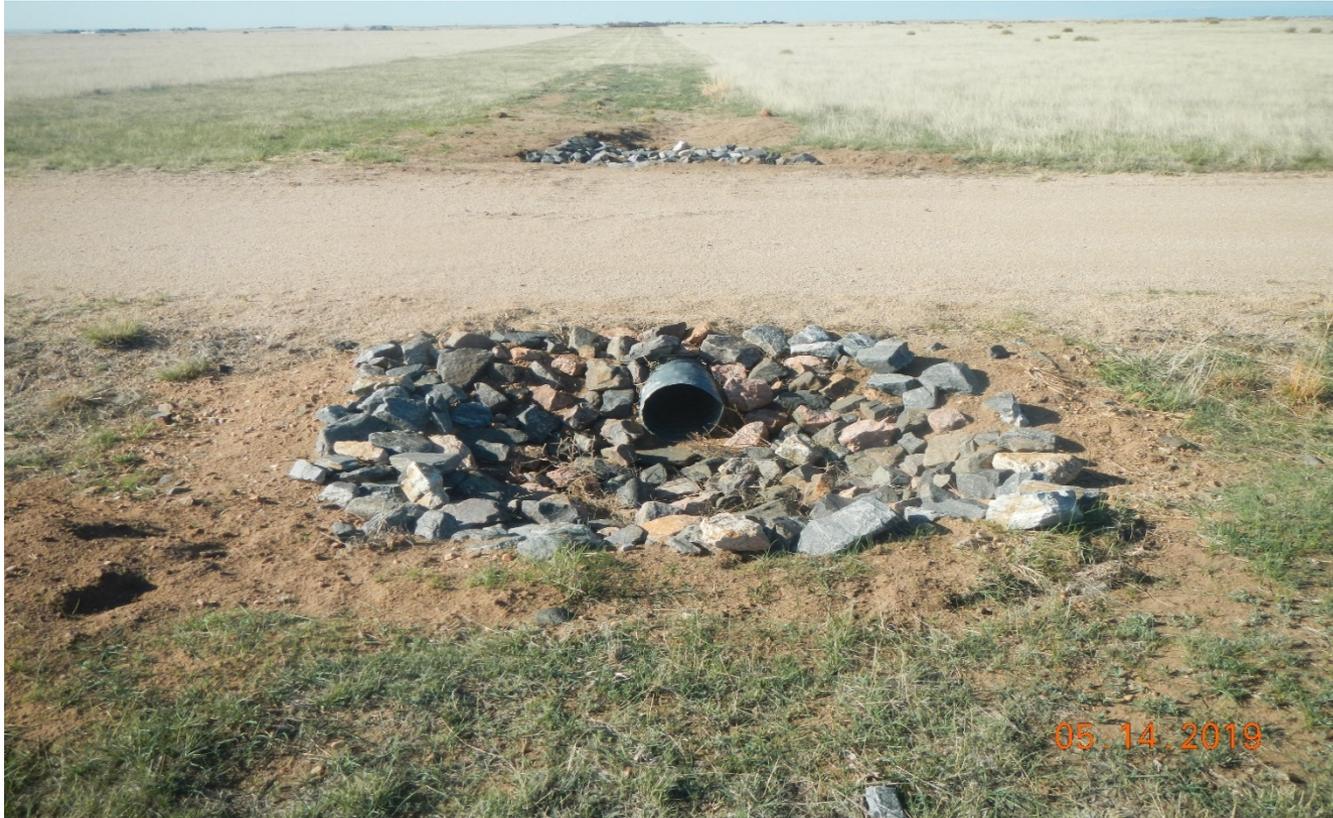
**Photo 7.** The inlet culvert rock rip/rap has been lowered to allow sediment to settle and not restrict stormwater flow. This photo depicts compliance of the corrective action.

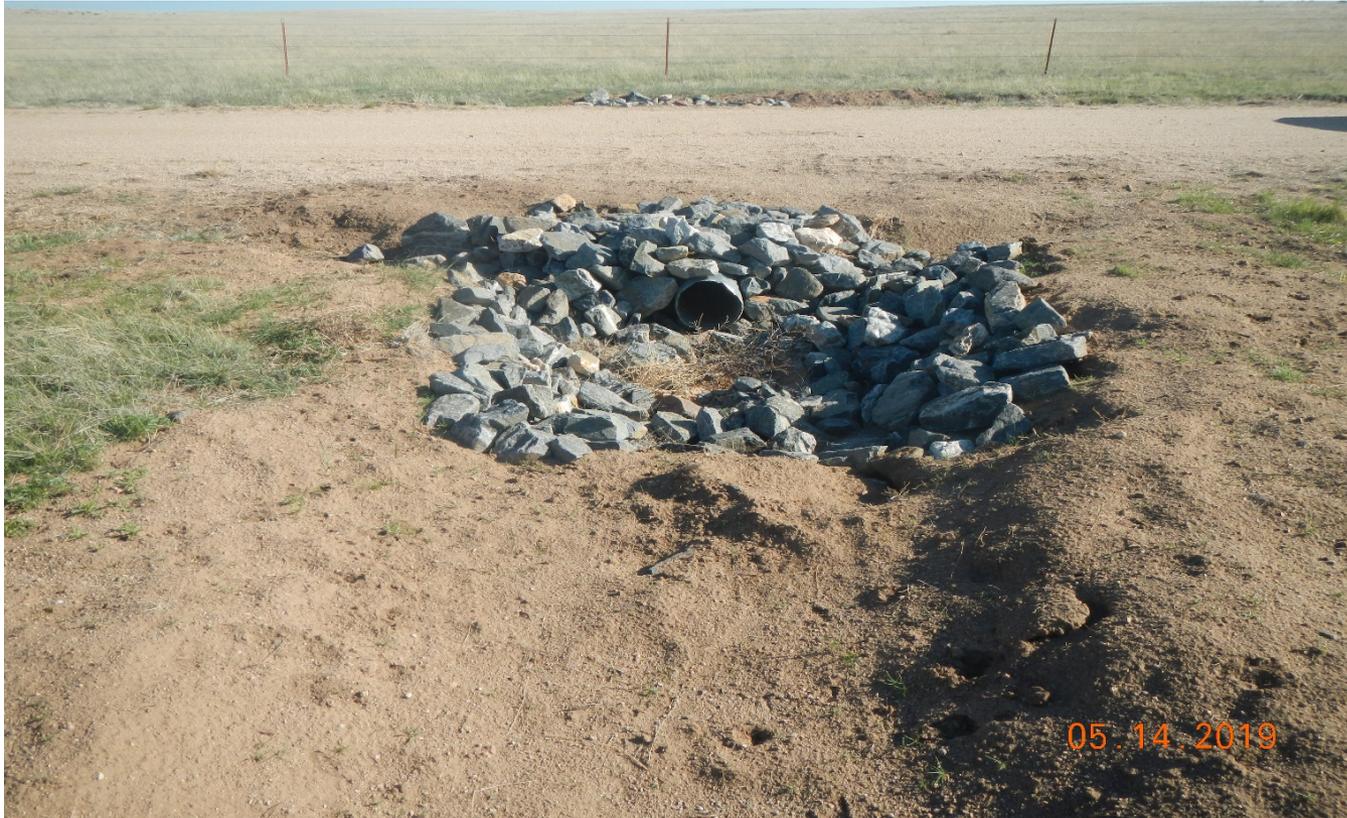
**Photo 8.** The outlet culvert rock rip/rap has been lowered to allow sediment to settle and not restrict stormwater flow. However, there was no geotextile installed underneath the outlet protection per good engineering practice. This photo depicts noncompliance of the corrective action.

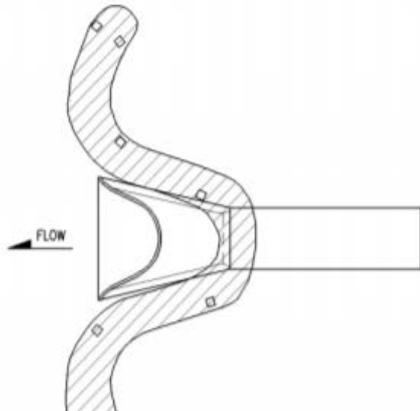
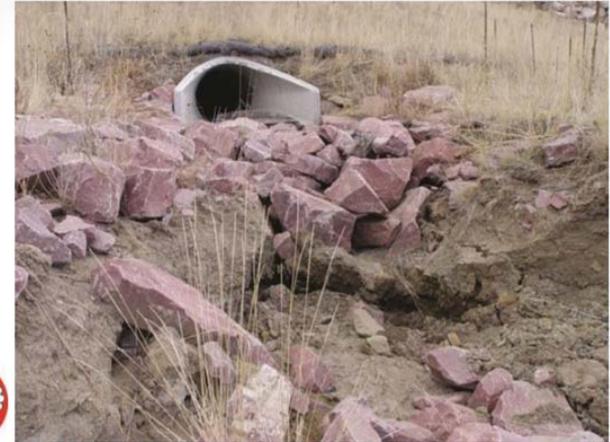
*Poor installation of outlet protection. Geotextile was not placed under the riprap and not enough rock was used. As a result, stormwater is undercutting the existing rock.*

**Photo 9.** These diagrams from CDOT manual describe the requirement for geotextile to be installed for outlet protection underneath rock rip/rap.

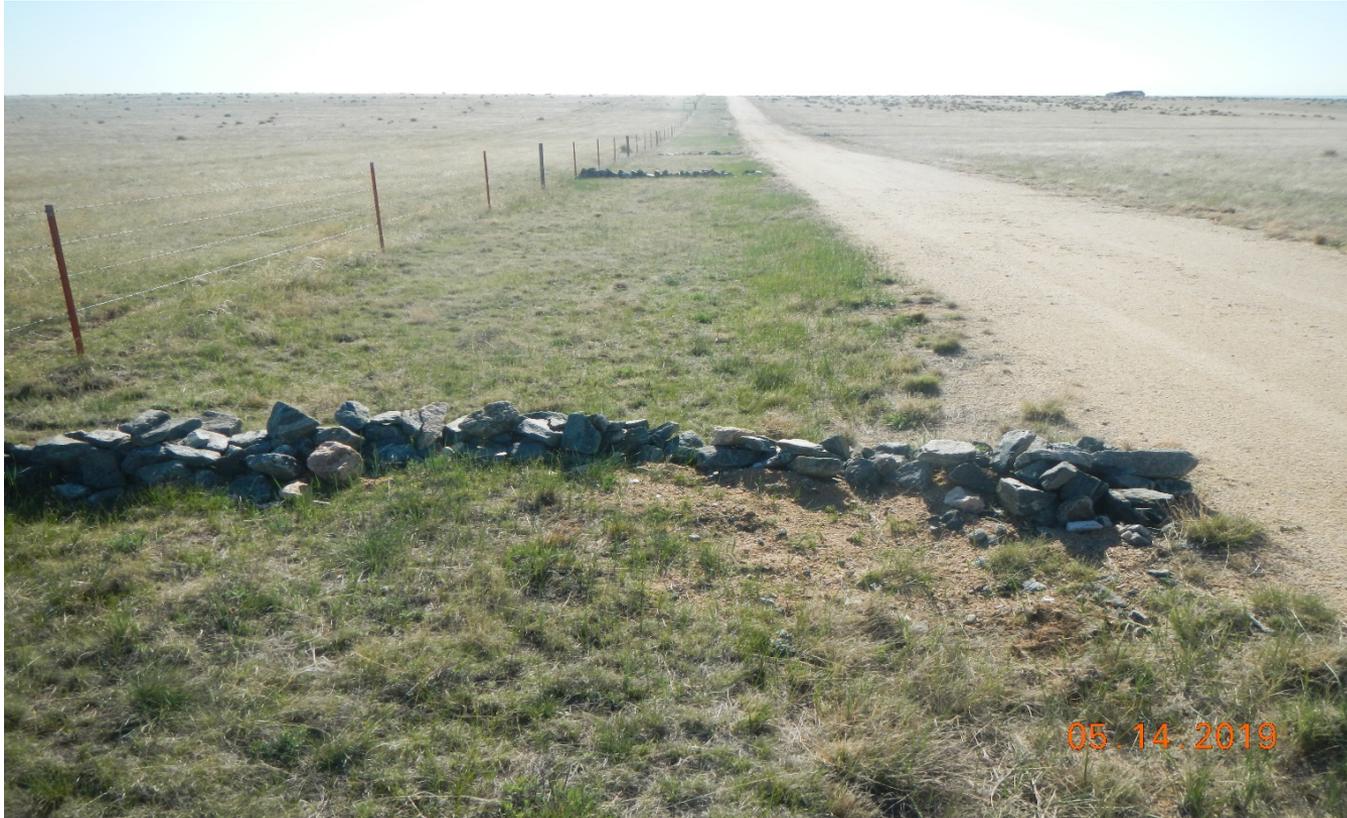
**Photo 10.** Rock check dams have been installed along the side of the road up gradient from the culverts. This photo depicts compliance of the corrective action.

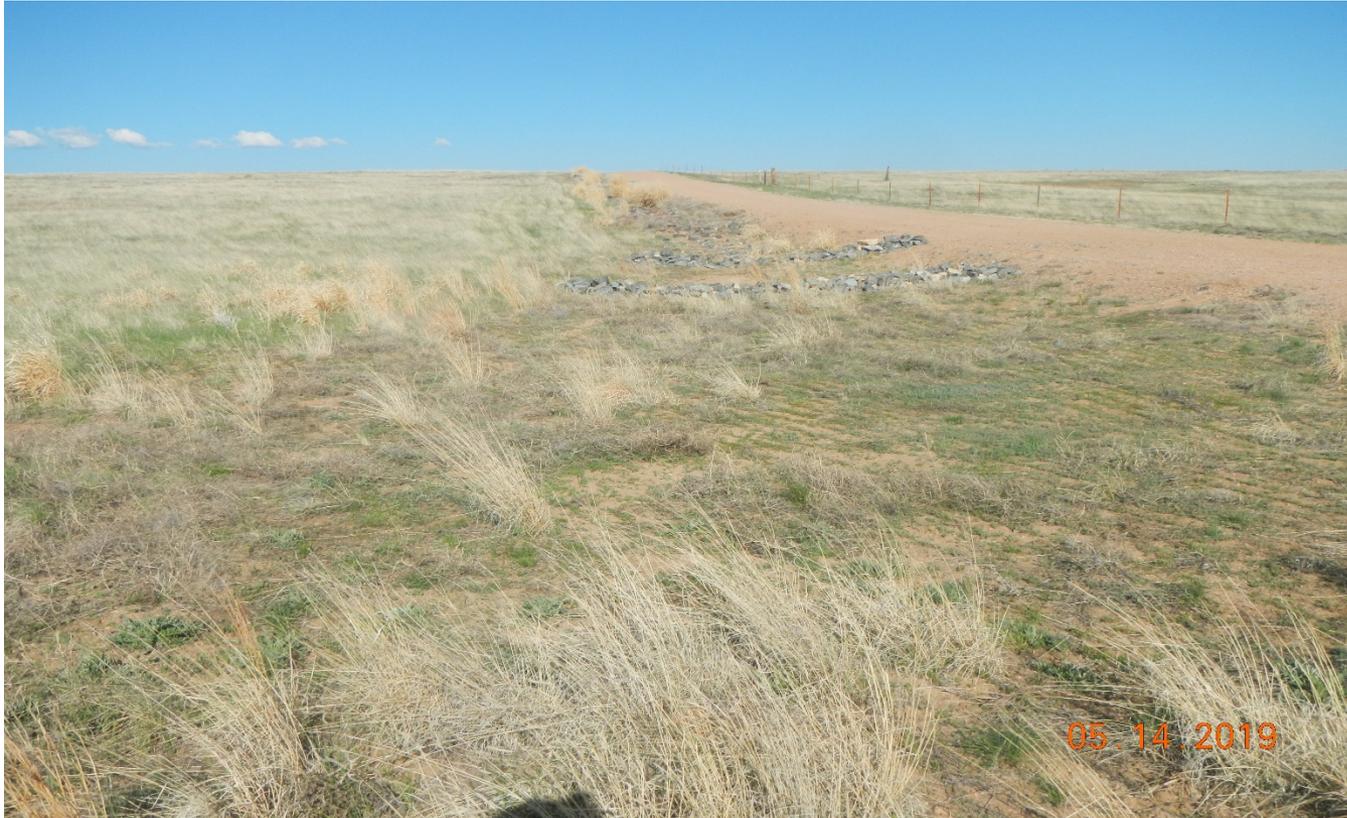
**Photo 11.** Vegetation is beginning to establish along the side of the access road where disturbance occurred. Rock check dams have been installed up gradient along the road. This photo depicts compliance of the corrective action.

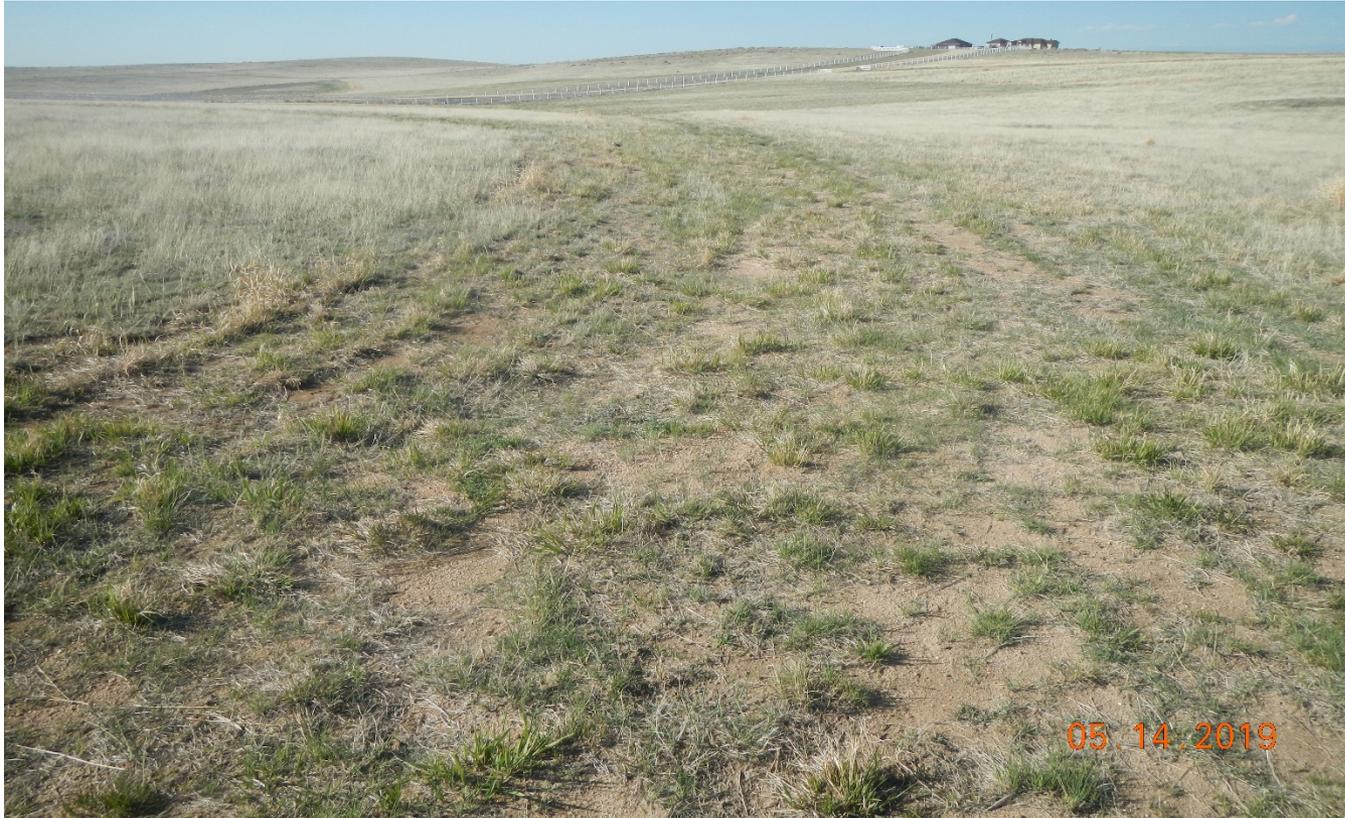
**Photo 12.** Facing south toward the reclaimed access road and location. Vegetation appears to be establishing. This photo depicts compliance of the corrective action.

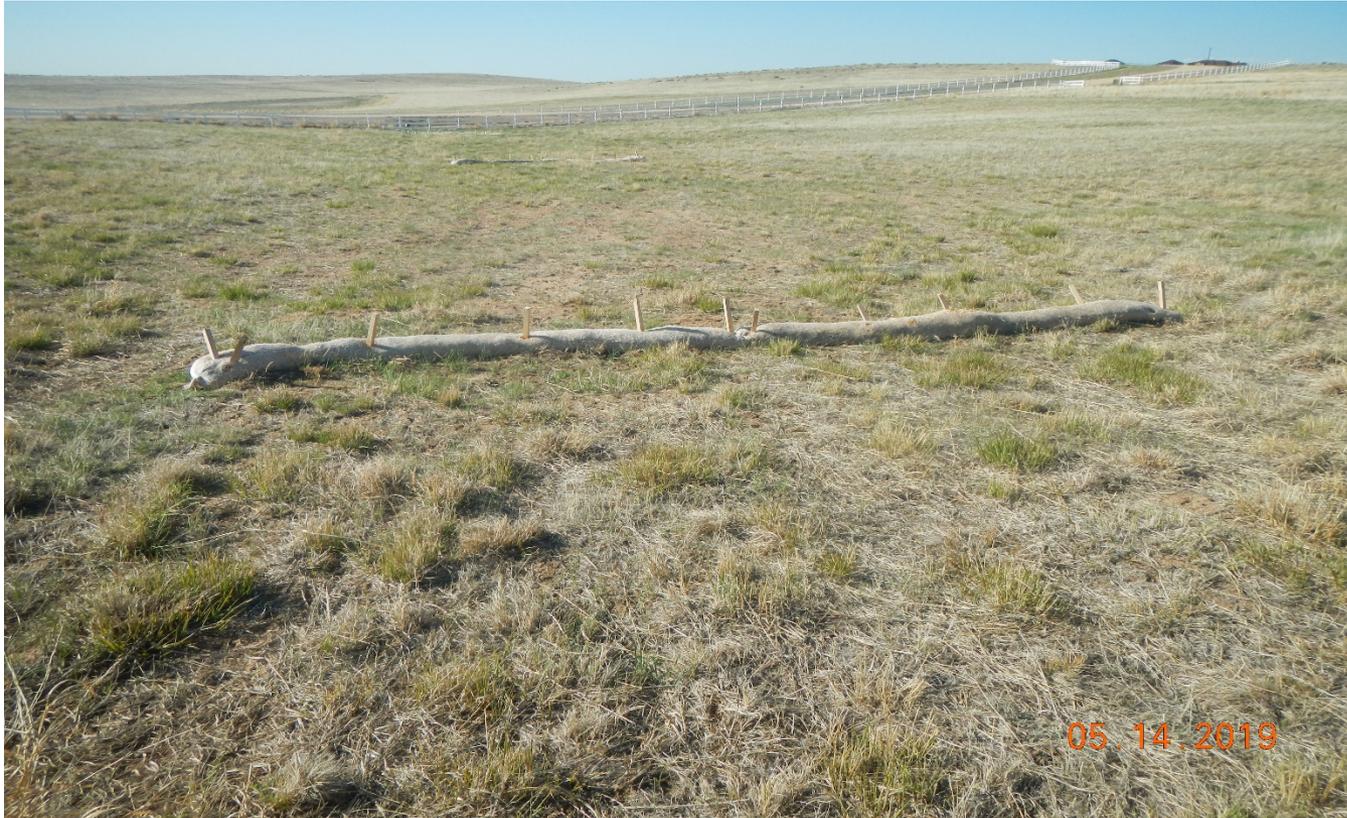
**Photo 13.** Facing south at the location. Wattles are installed at the bottom of the location. This photo depicts compliance of the corrective action.

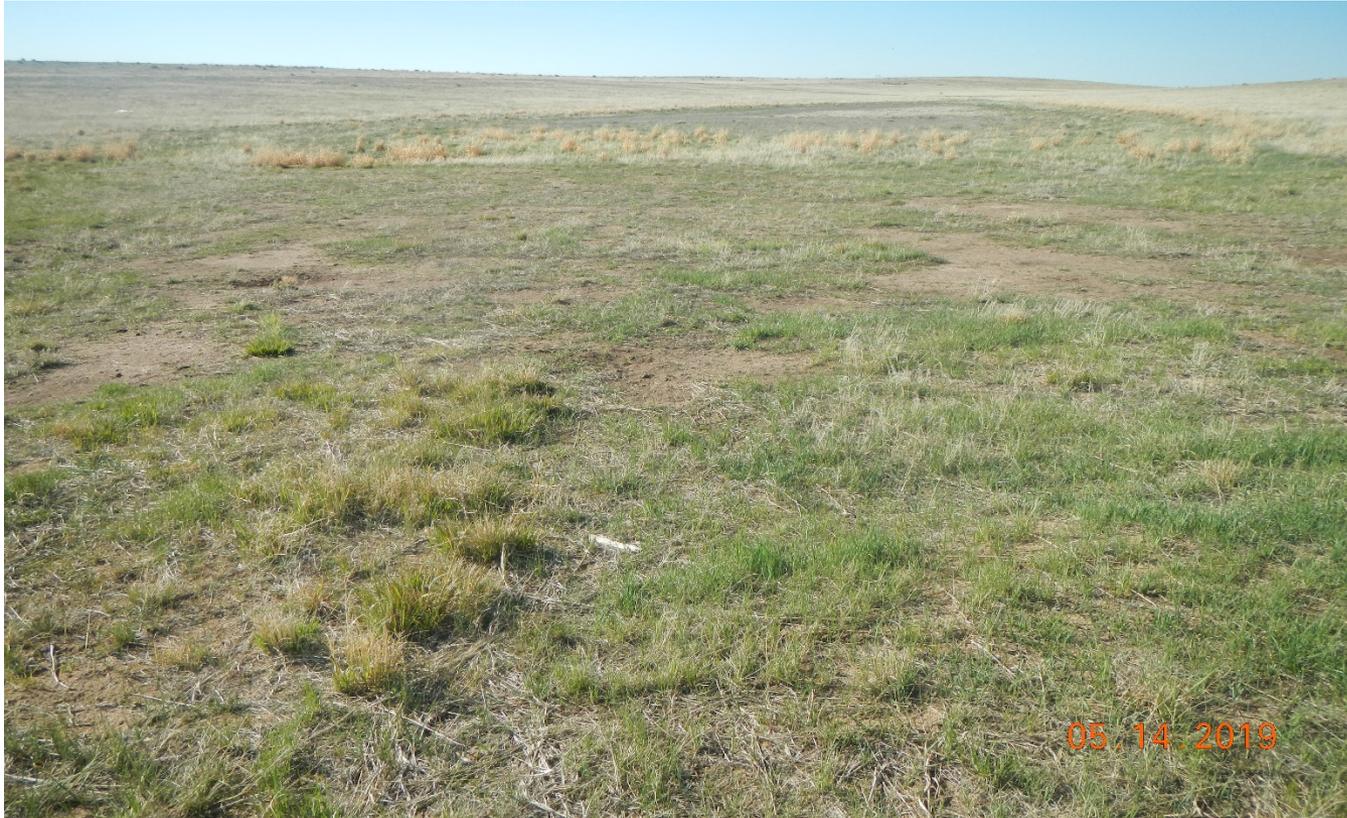
**Photo 14.** South side of the location. This area was reseeded and germination was observed. This photo depicts compliance of the corrective action, however this area needs to be monitored for successful revegetation.

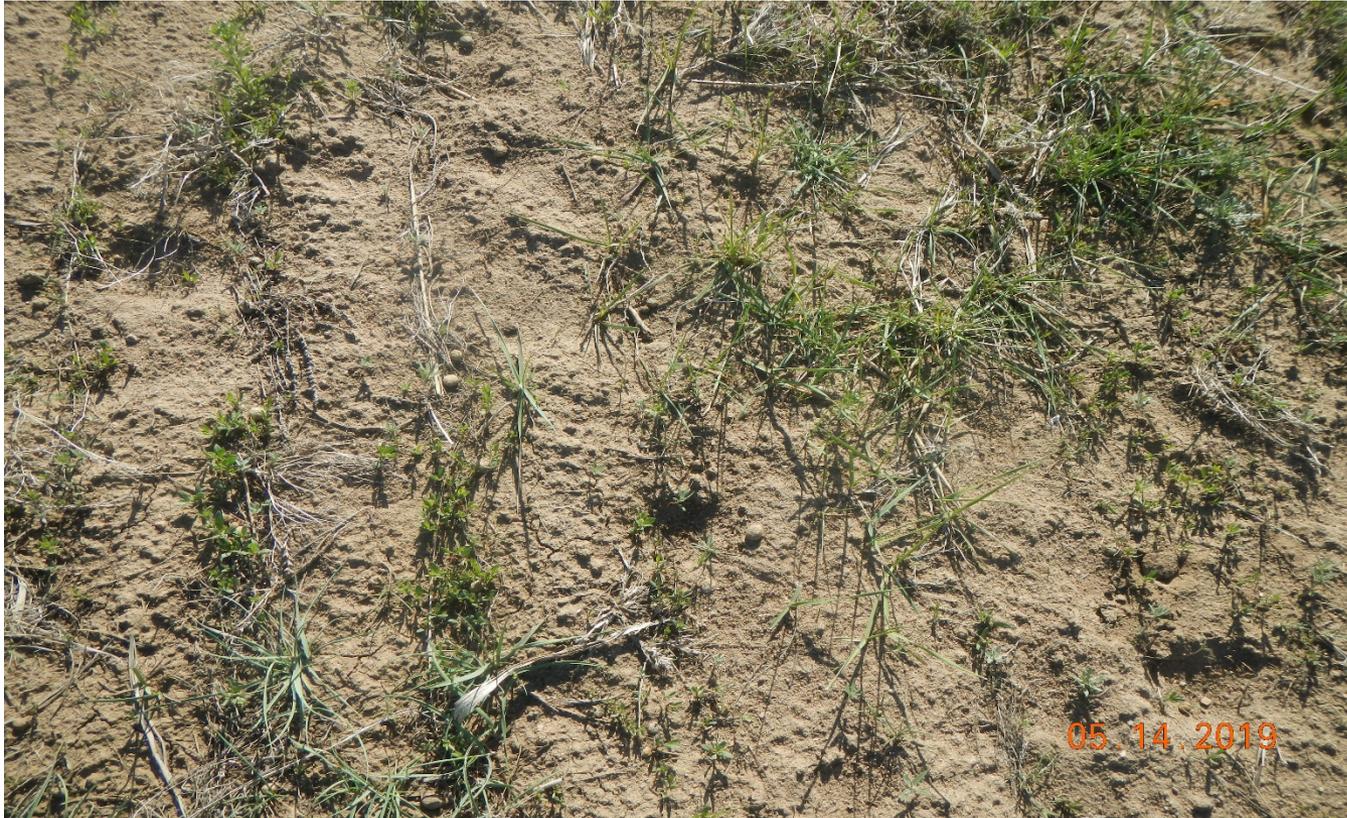
**Photo 15.** There is desirable vegetation germinating in the seeded area. There is also undesirable vegetation establishing that will need to be controlled. This photo depicts compliance of the corrective action, however seeded areas need to be monitored for successful revegetation.
