Inspection Photos
Location Name: Ester #1
API: 05-067-06232

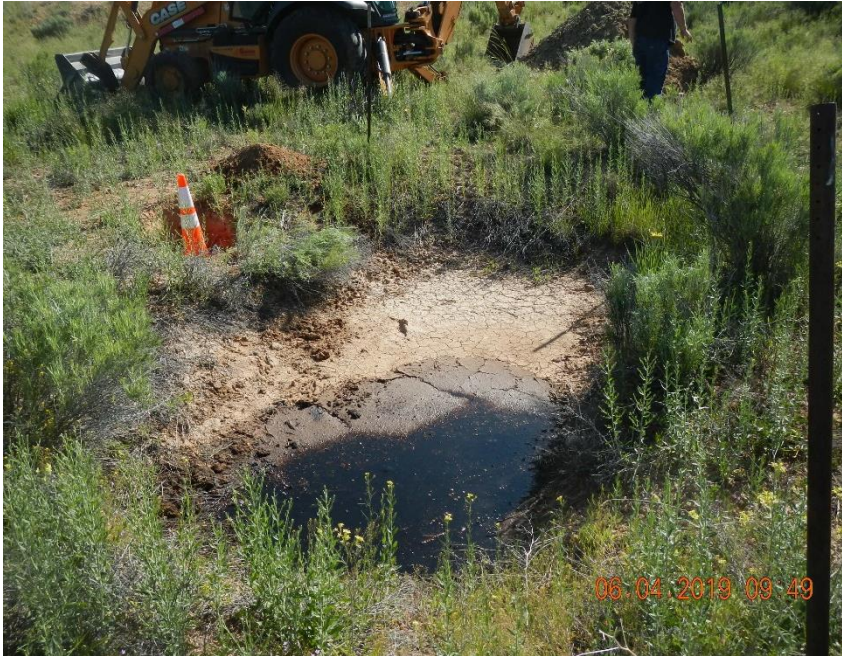
Pit Facility ID #119826 with stained soil and puddle of oil.

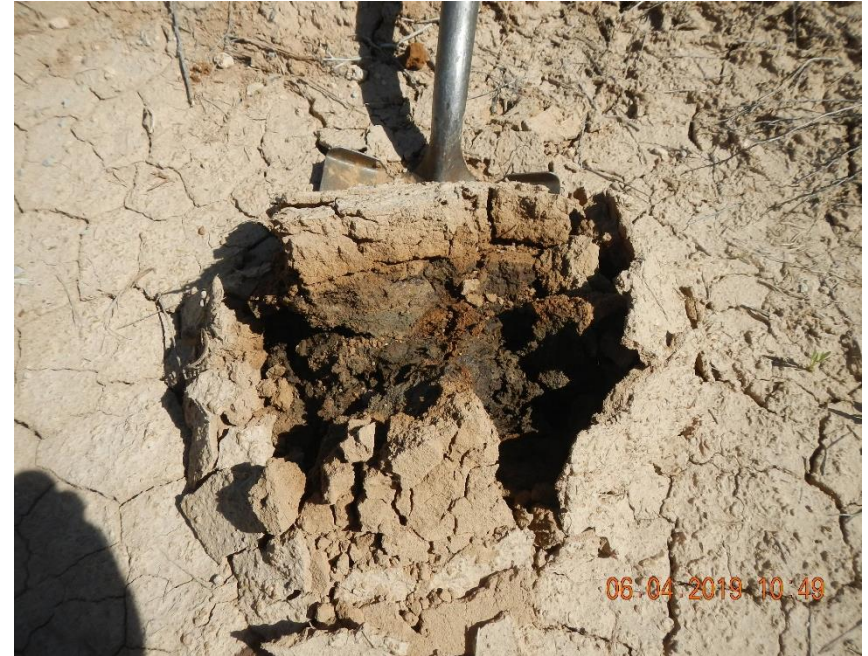
Impacted material below the surface of dry portion of pit.

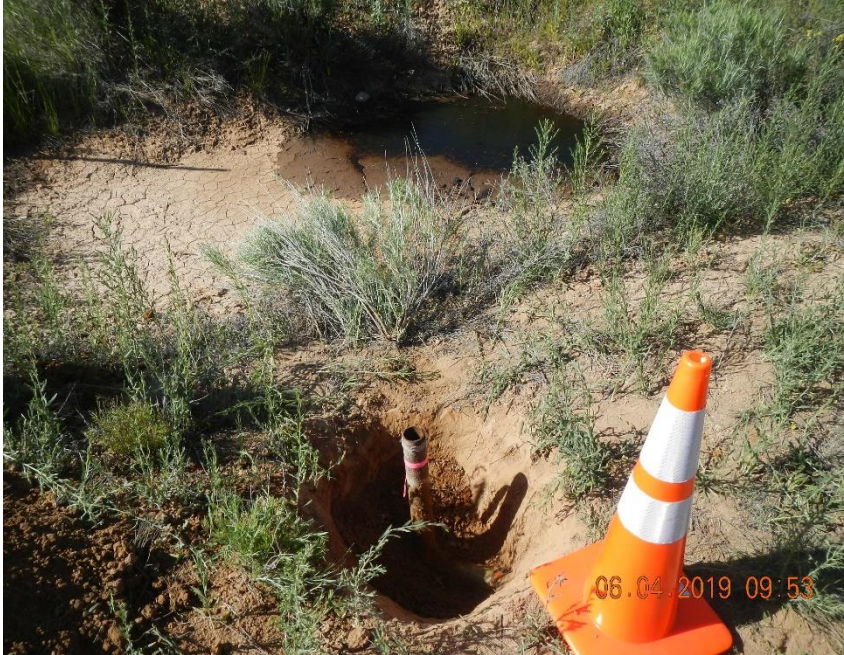
Proximity of stand pipe in relation to pit area.

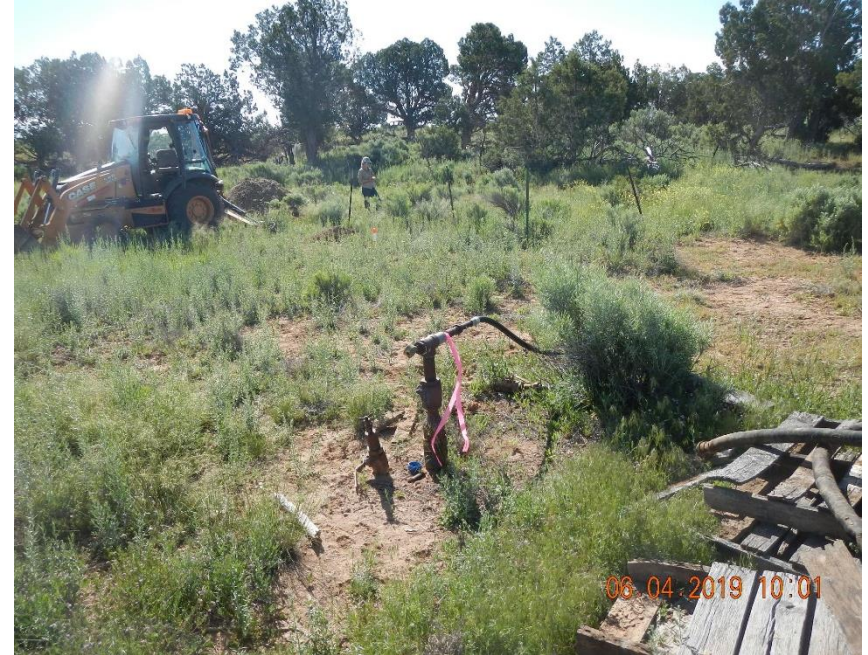
Ester #1 wellhead with Pit Facility ID #119826 in the background.

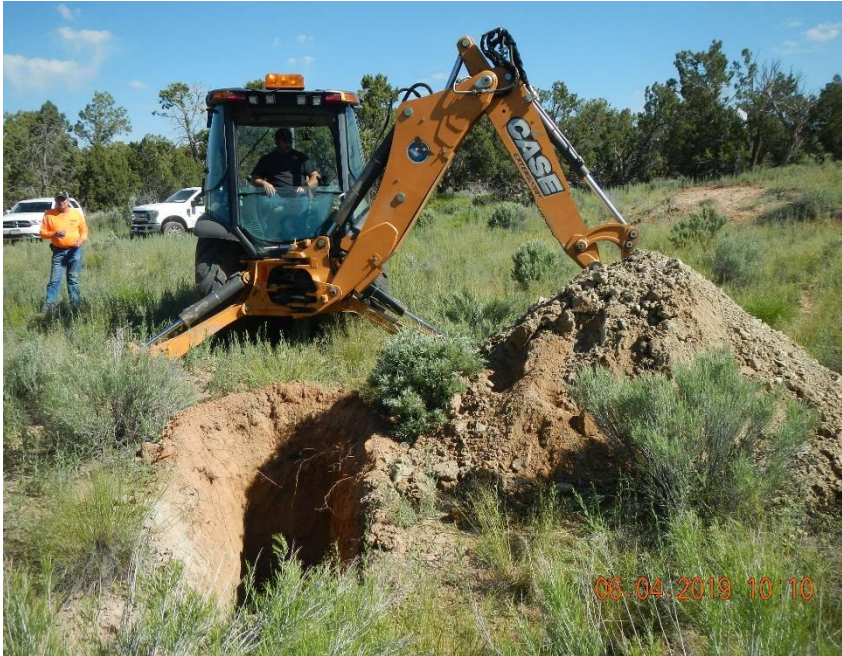
First test trench was dug on northeast side of pit area.

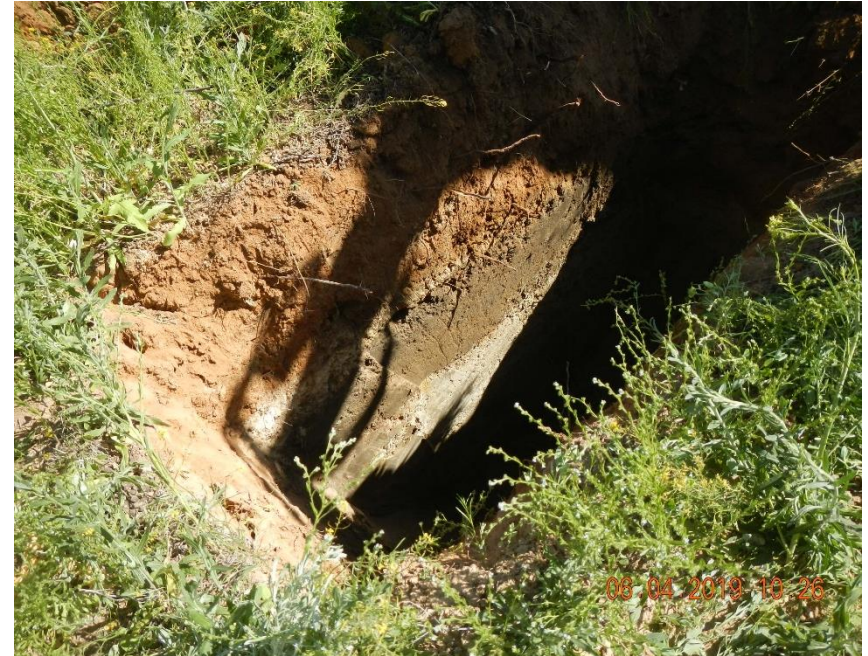
Trench along southeast side of pit contained stained soil.

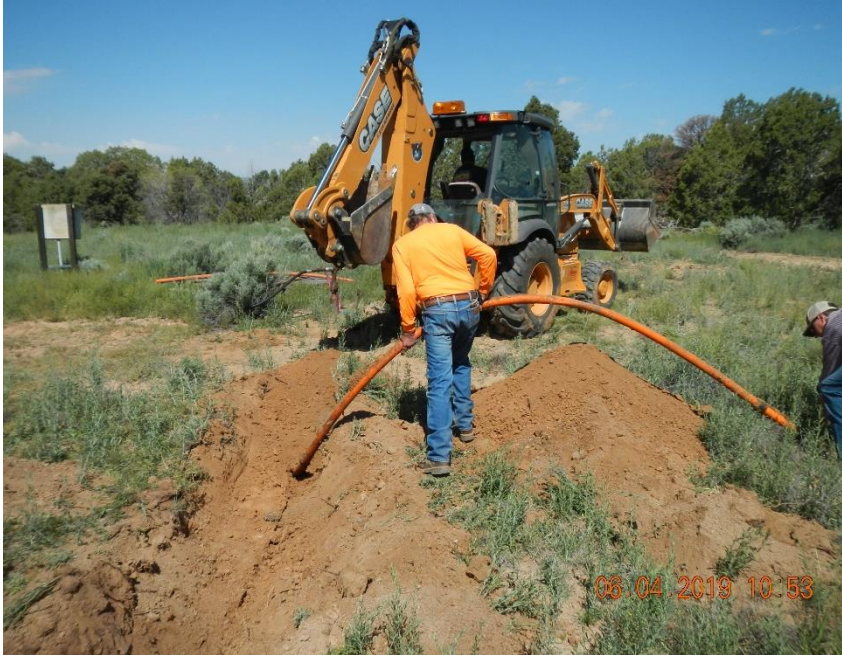
Moving poly pipe from wellhead connected to stand pipe.

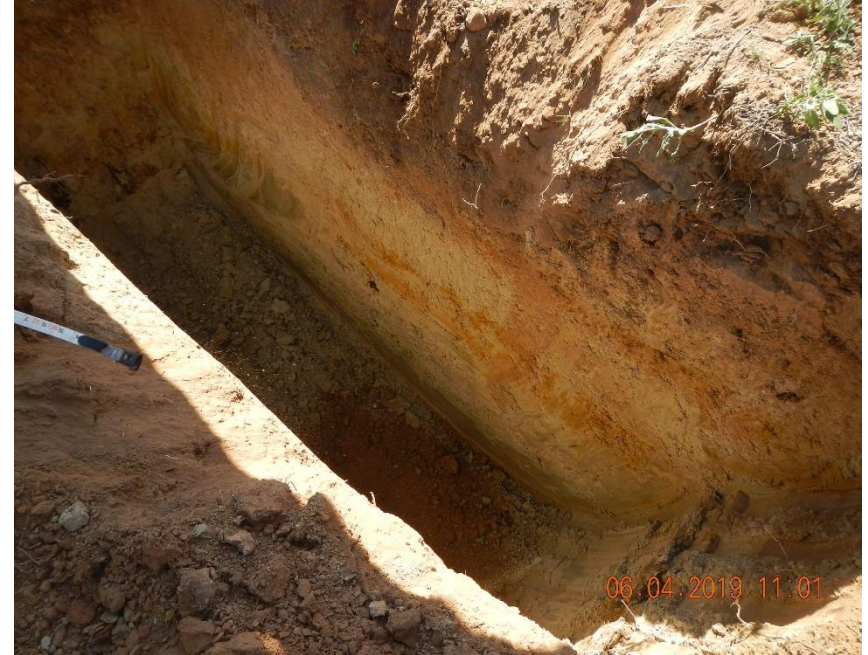
Trench along northwest side with no visual impacts.

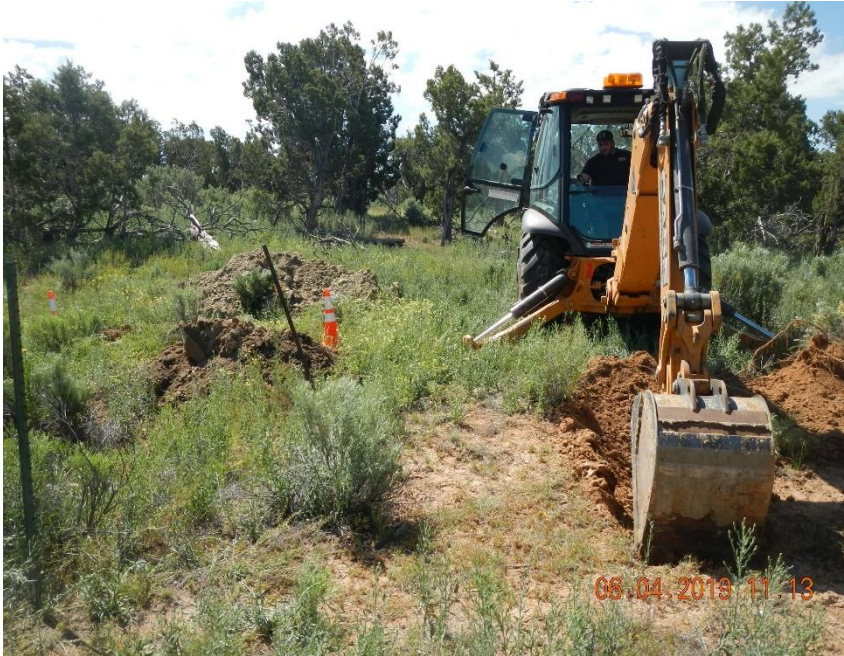
Excavating test trench along southwest side of pit.

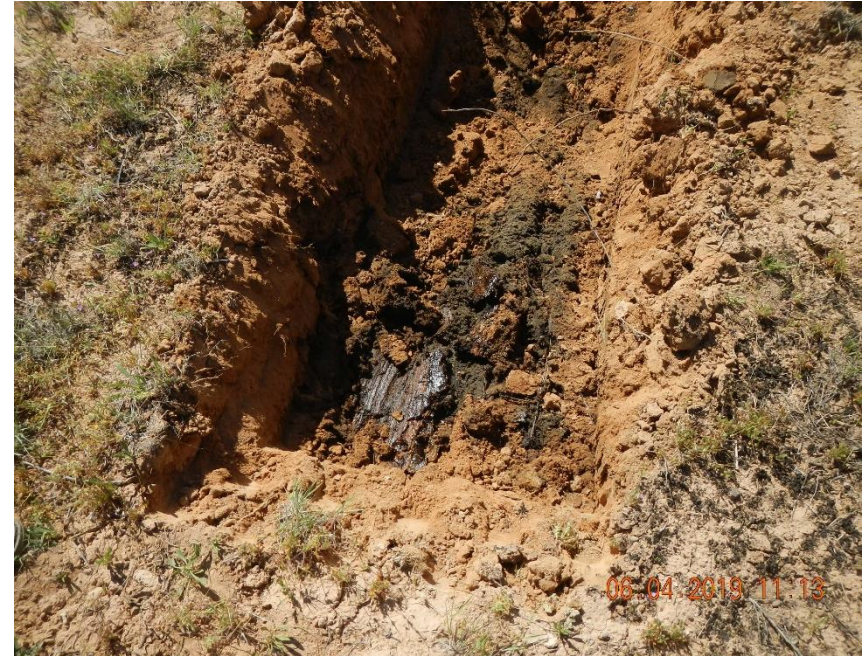
Impacted material in trench #4, down gradient of pit.

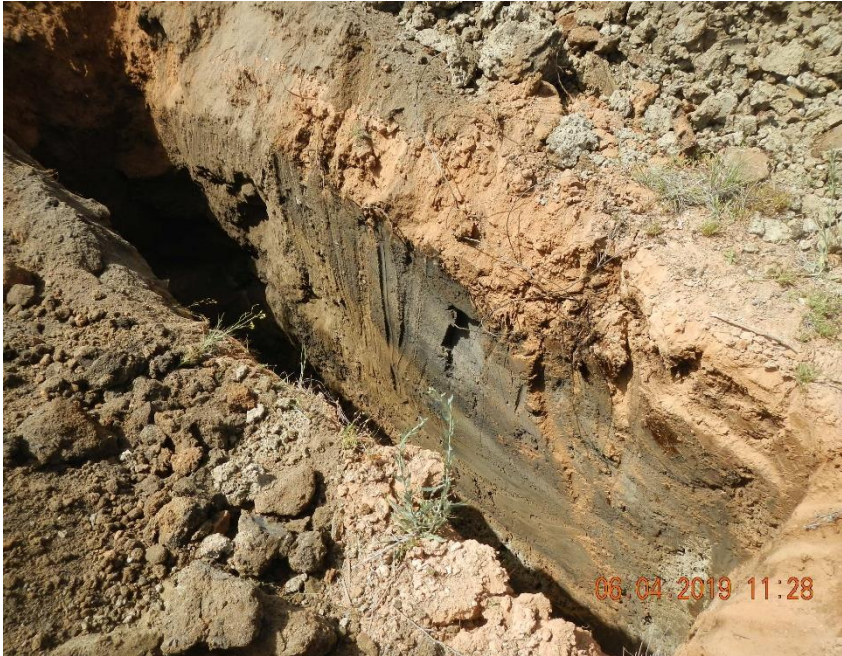
Visual impacts in trench #5 approximately 15' southwest of trench #4.

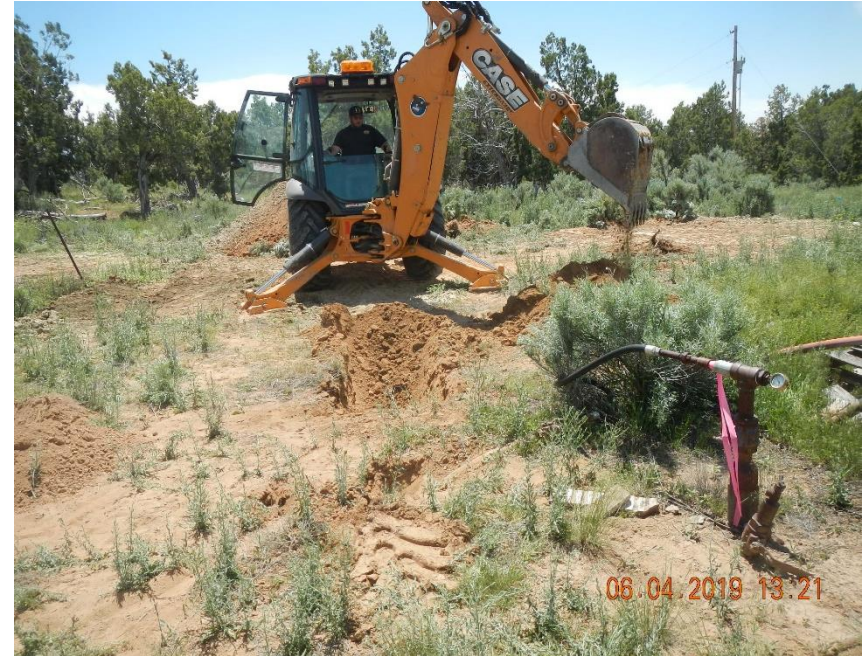
Beginning seventh test trench approximately 10' southeast of wellhead.

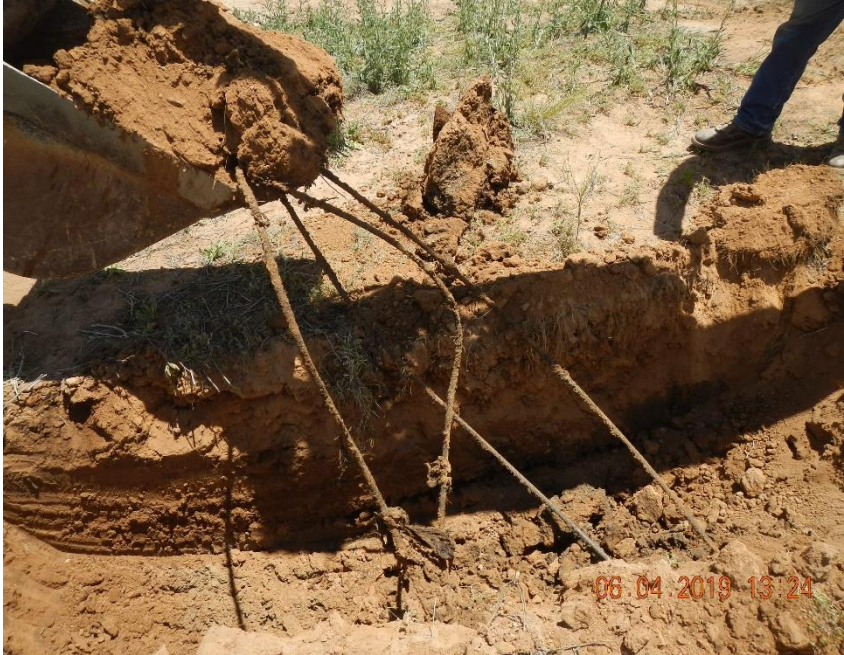
Wire rope and other debris found buried in trench #7.

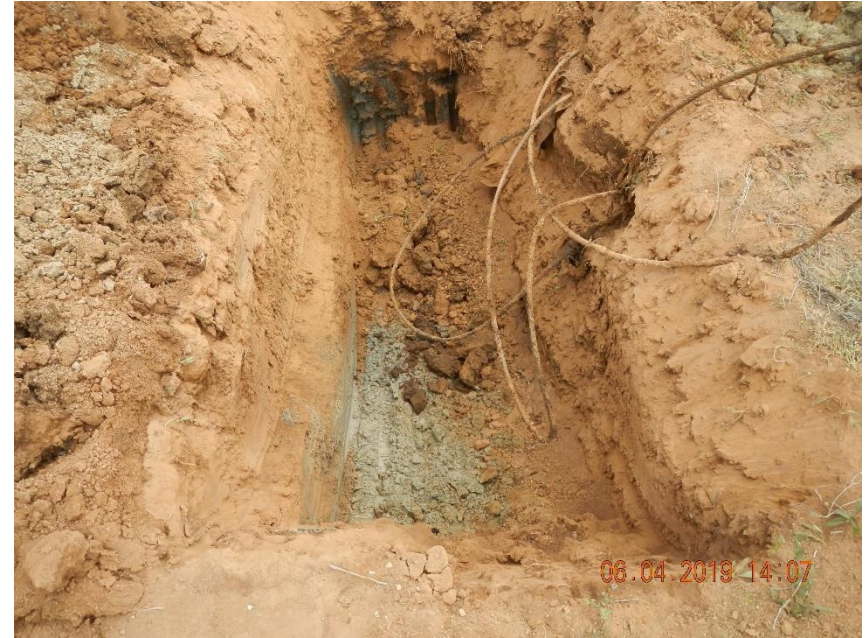
Grayish blue material with strong hydrocarbon odor discovered at depth.

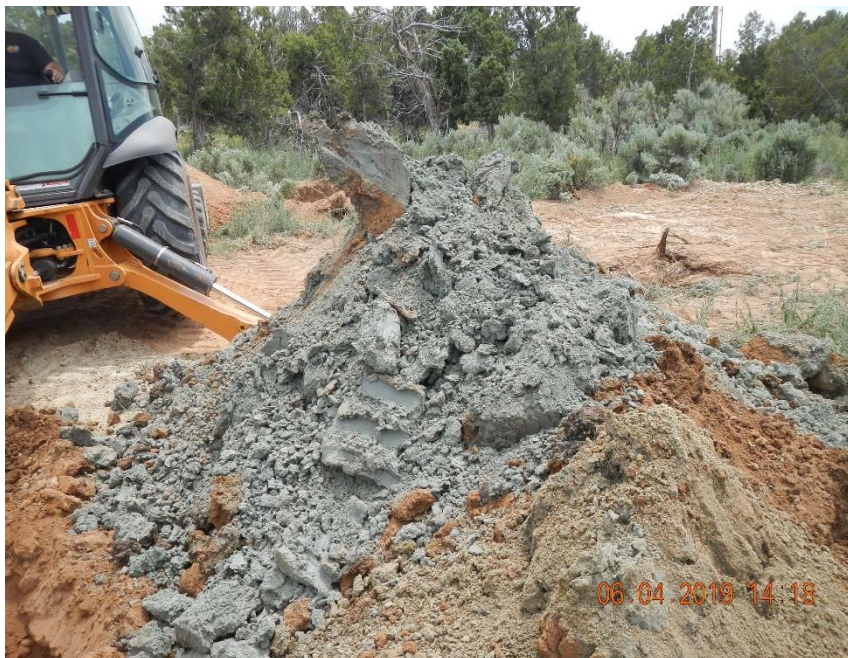
Stock pile of material removed from trench #7.

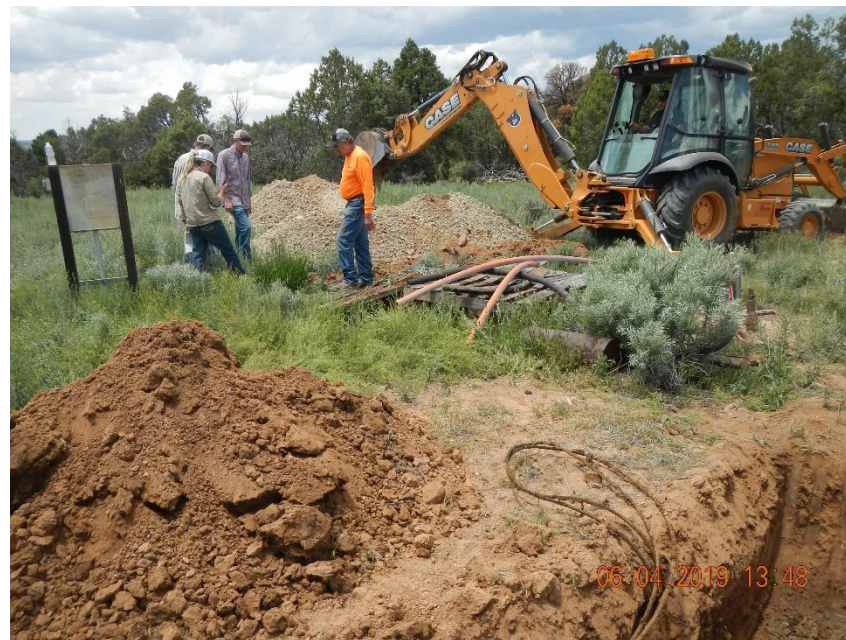
Additional test trenches dug to the west and southwest of the wellhead did not have visual impacts.
