Inspection Photos
Location Name: BAA BAA 34-1 & TR
API#: 05-071-08502 & 08710
INSP. #: 695100841

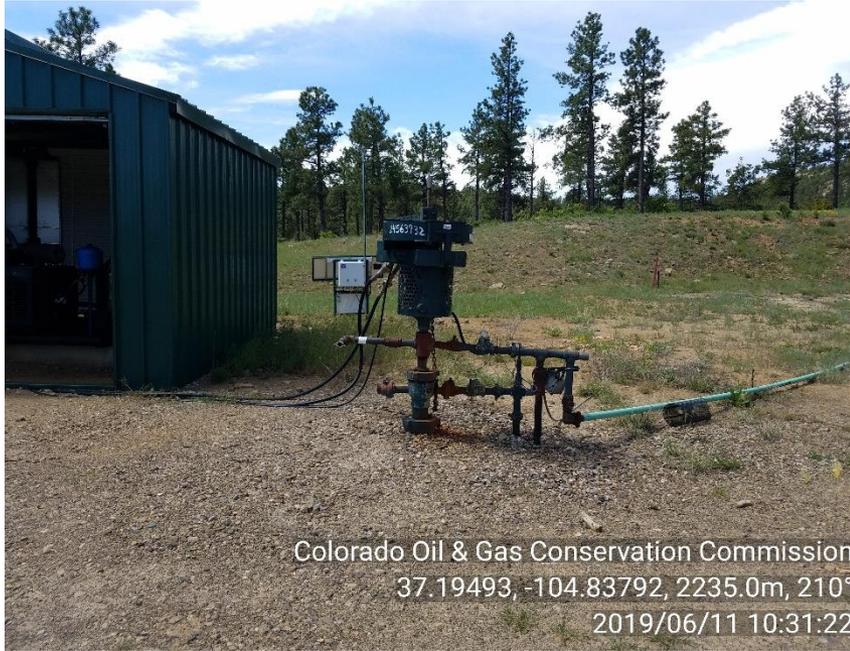
PHOTO 1: ORIGINAL WELLHEAD

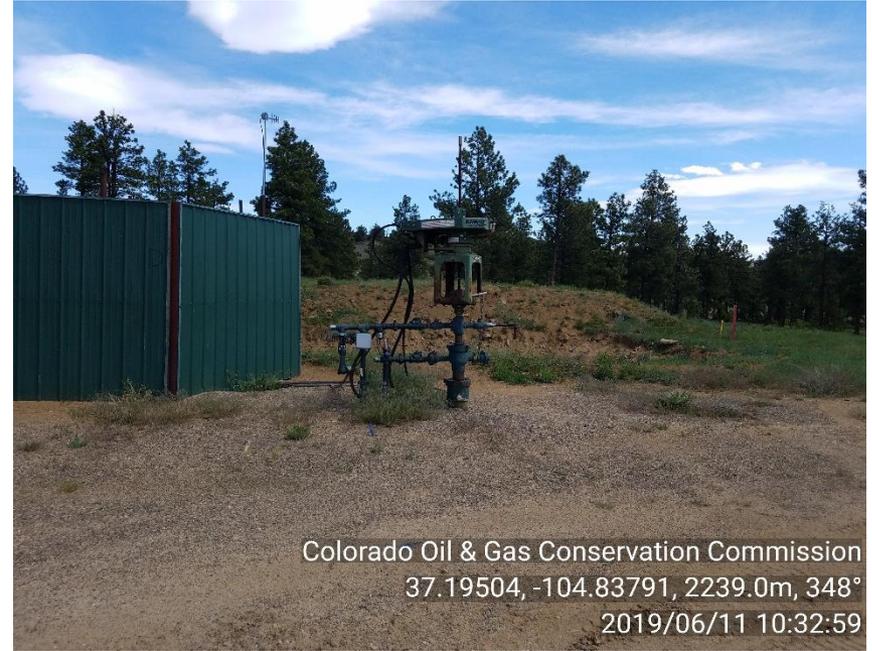
PHOTO 2: TR WELLHEAD

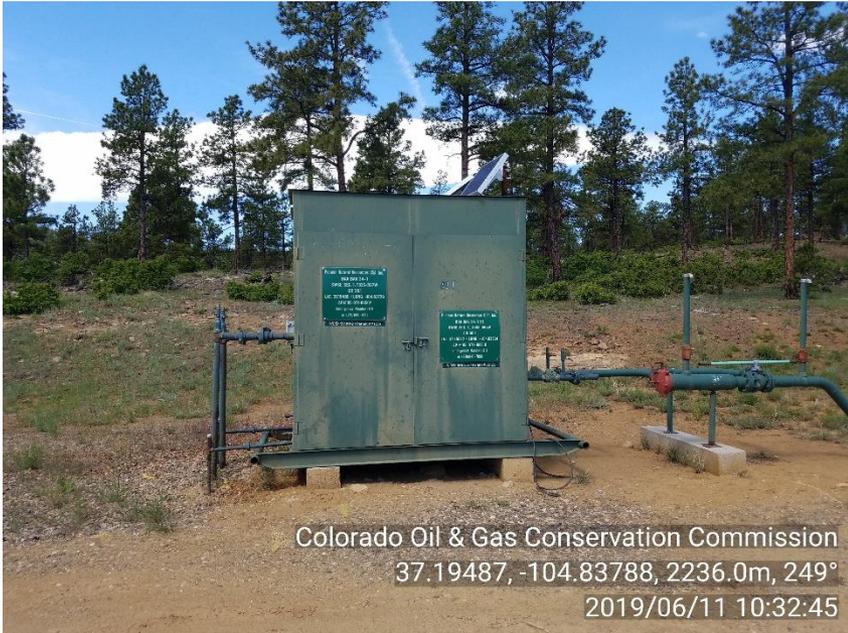
PHOTO 3: WELL SIGNS

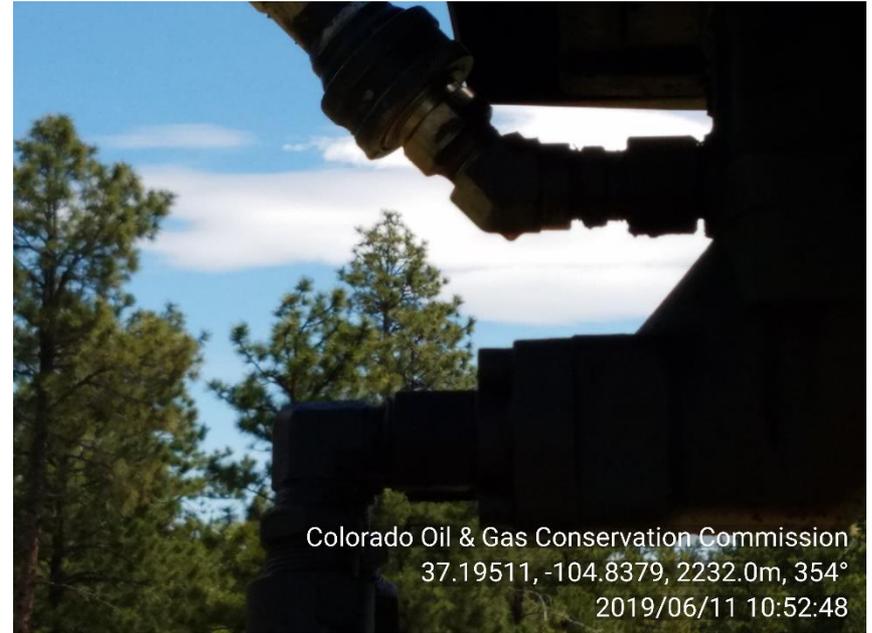
PHOTO 4: HYDRAULIC FITTING ON WELLHEAD IS DRIPPING FLUID. SHADOWS ARE MAKING DRIP HARD TO SEE. ARROW IS POINTING OUT A DRIP THAT IS FORMING ON FITTING. Increase frequency of maintenance and self inspection schedule of equipment to prevent impacting surface materials and mixing of wastes with precipitation" CA DATE 7/11/19.

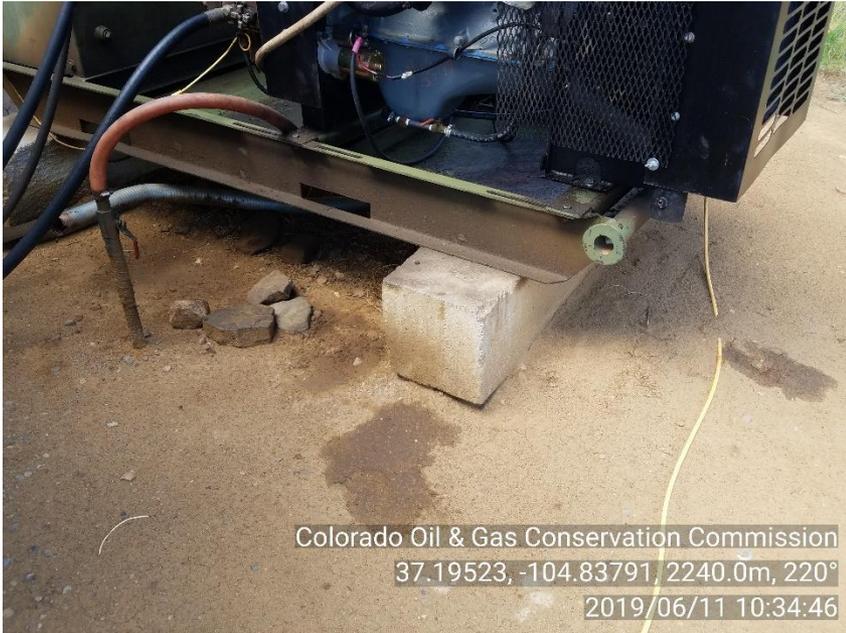
PHOTO 5: 3 AREAS OF IMPACTED SOIL NEAR TR ENGINE SKID. ENGINE SKED ON THE NORTH SIDE OF LOCATION AS THE WELLHEADS ARE NOT MARKED. Remove and dispose impacted material in approved manner, service and maintain equipment and self inspect to prevent recurrence of conditions per 1002.f(2) and 907. CA DATE 7/11/19.

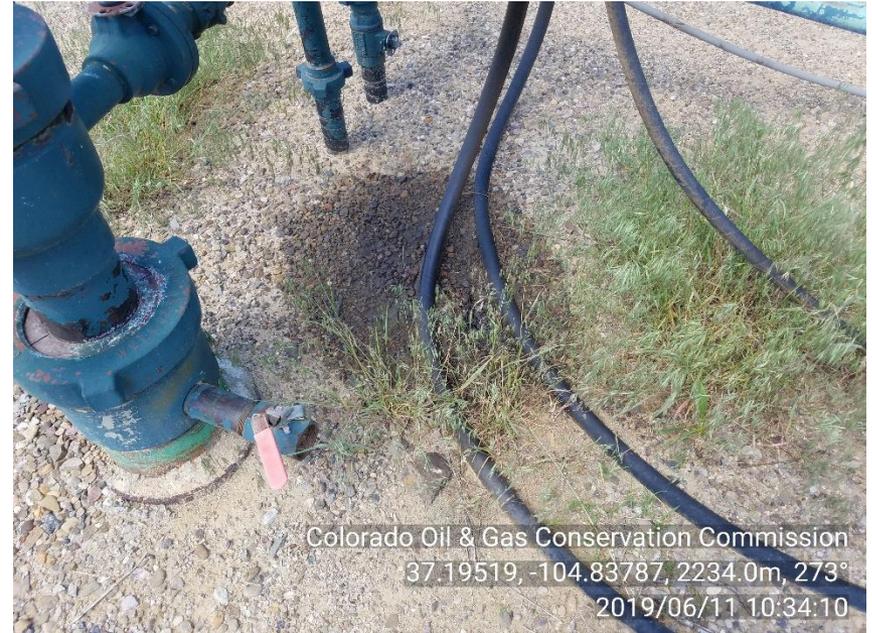
PHOTO 6: 2' AREA OF IMPACTED SOIL NEAR TR WELLHEAD. WELLHEAD ON THE NORTH SIDE OF LOCATION AS THE WELLHEADS ARE NOT MARKED. Remove and dispose impacted material in approved manner, service and maintain equipment and self inspect to prevent recurrence of conditions per 1002.f(2) and 907. CA DATE 7/11/19.
