Inspection Photos

API: 05-055-06035

Operator: OXY USA INC

Inspection Date: 6/11/2019

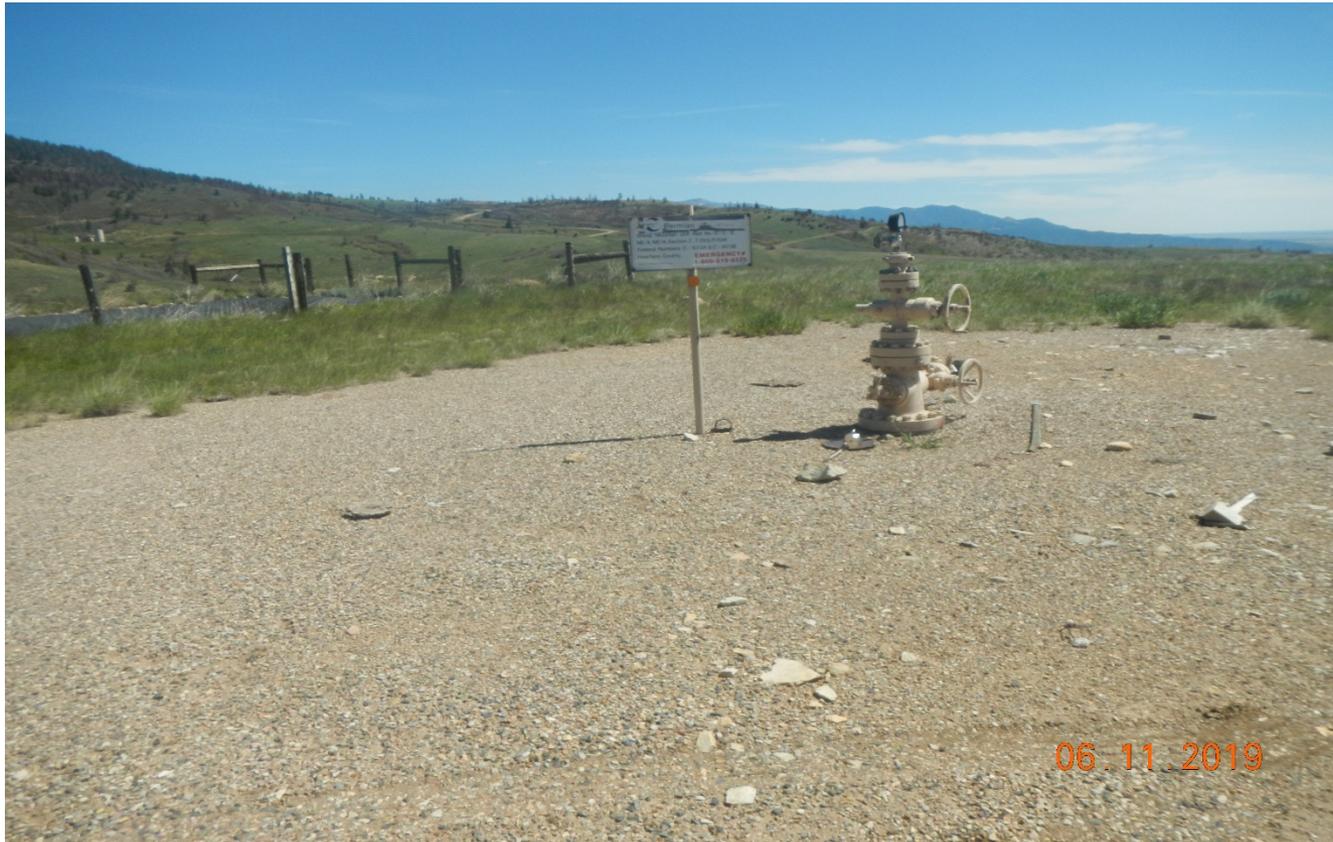
Photo 1. The operator name on well sign is not legible.

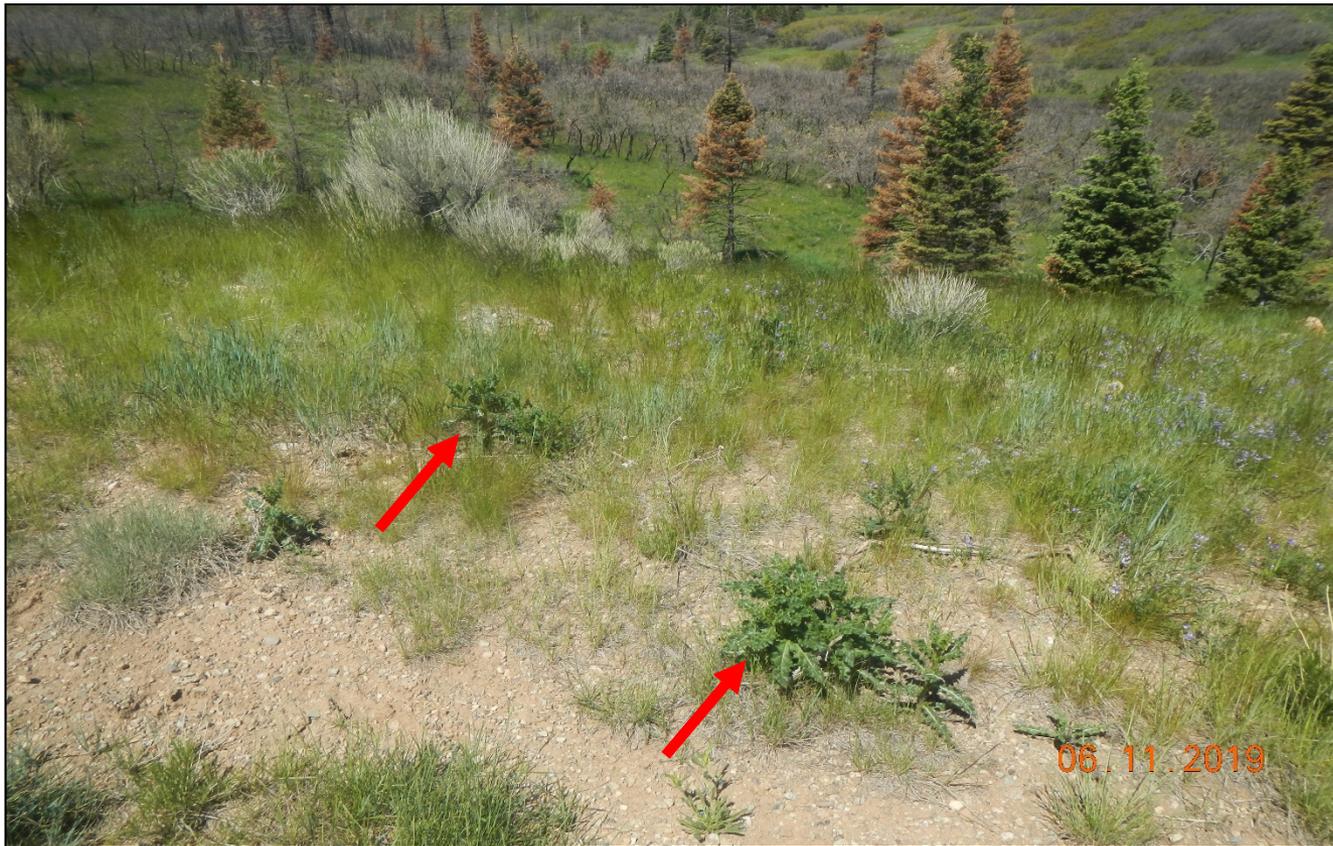
Photo 2. Facing west along the access road toward the wellsite. There are numerous noxious weeds (Canada thistle) in this area.

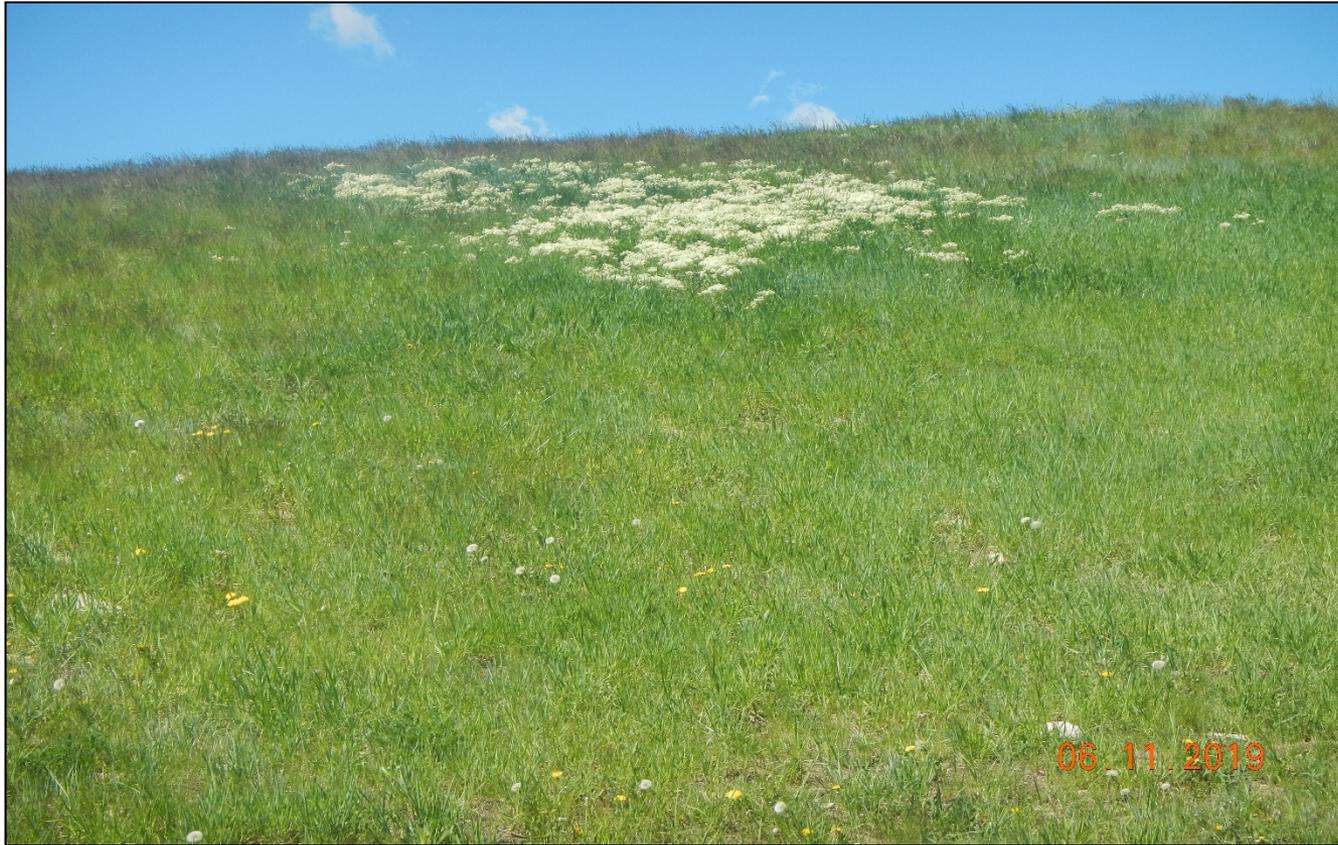
Photo 3. Facing southwest near the well site. There is a area of noxious weeds (Hoary crest) in this area.

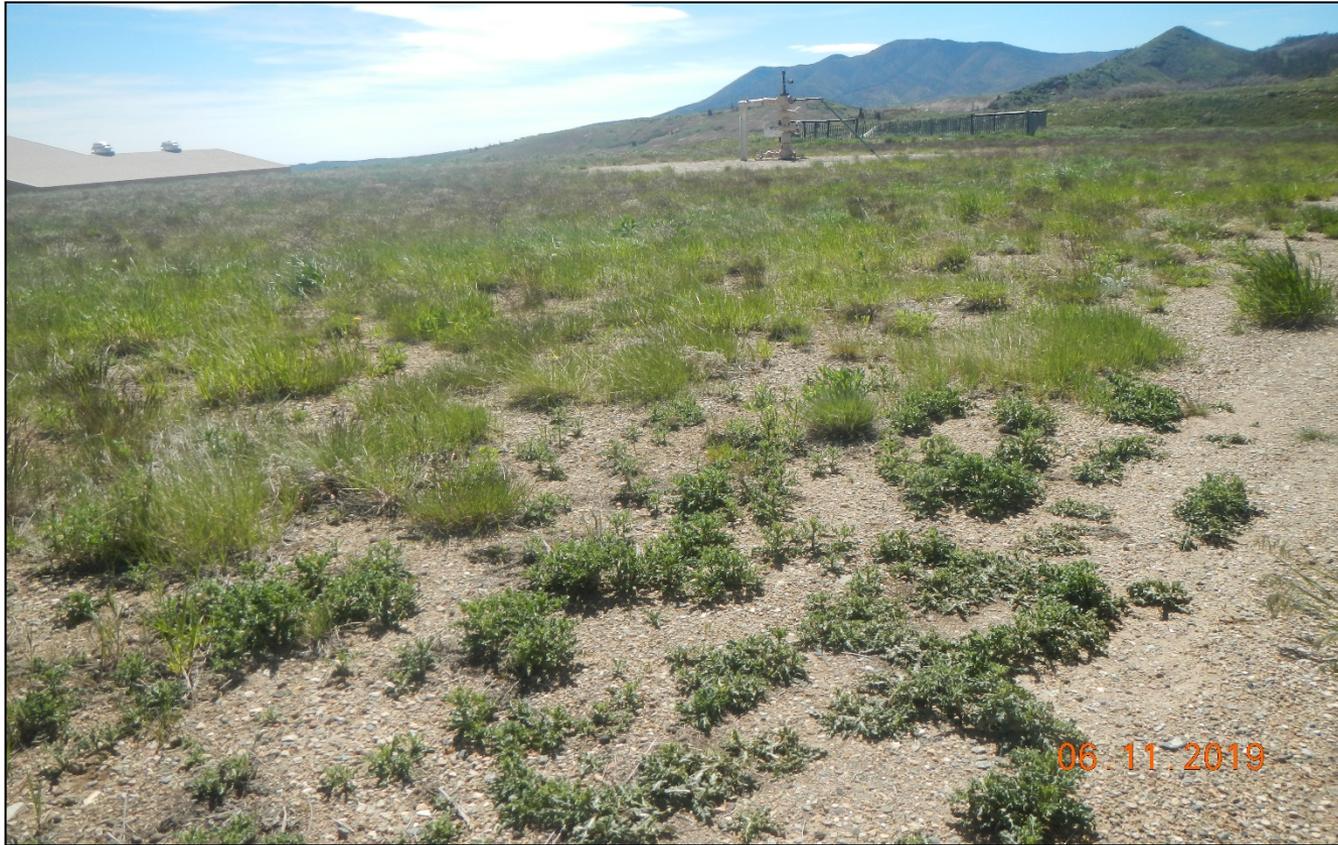
Photo 4. Facing southeast between the two well sites. There are numerous noxious weeds (Canada thistle) in this area.

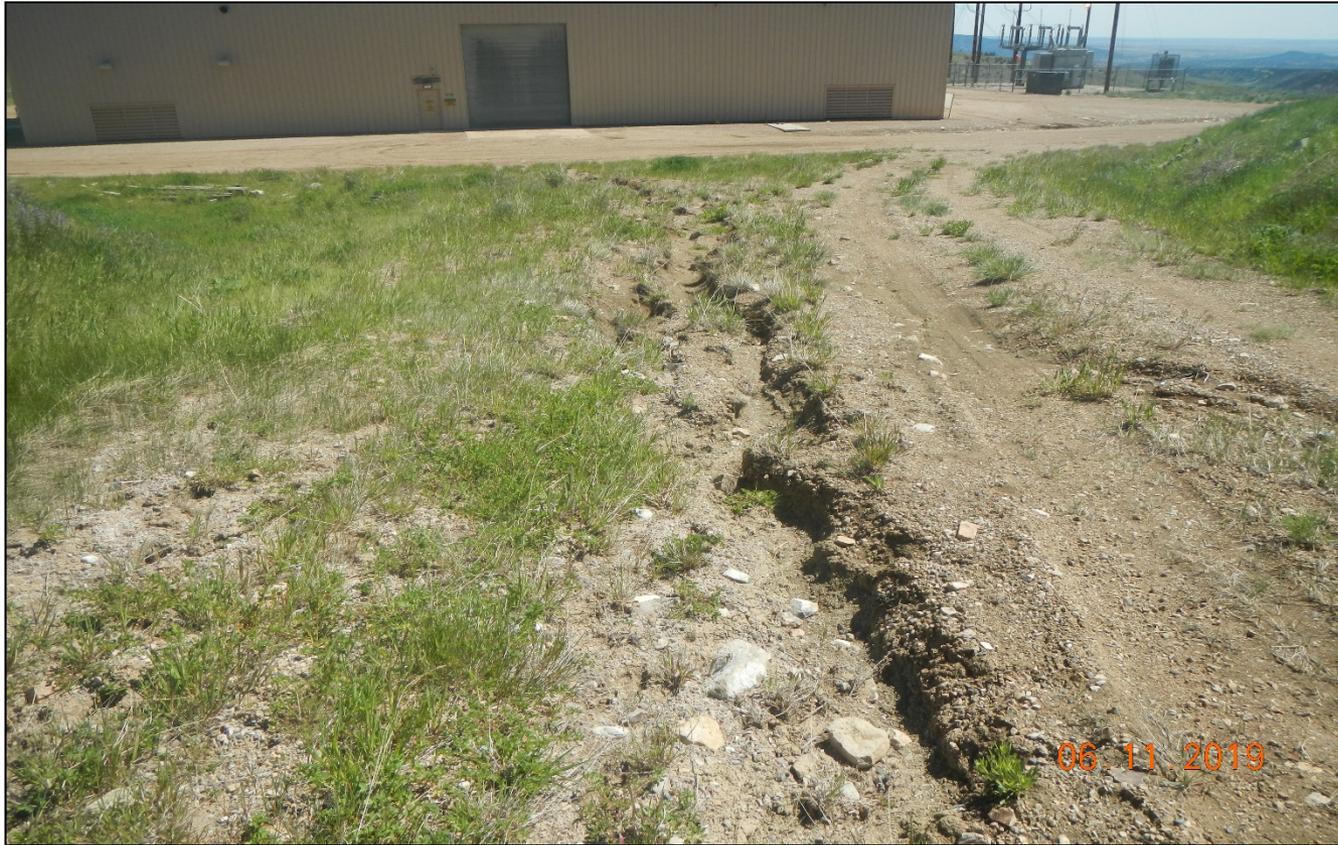
Photo 5. Facing down the access road. There is an erosion channel that has developed.
