# Inspection Photos

API: 05-055-06037

Operator: OXY USA INC

Inspection Date: 6/11/2019

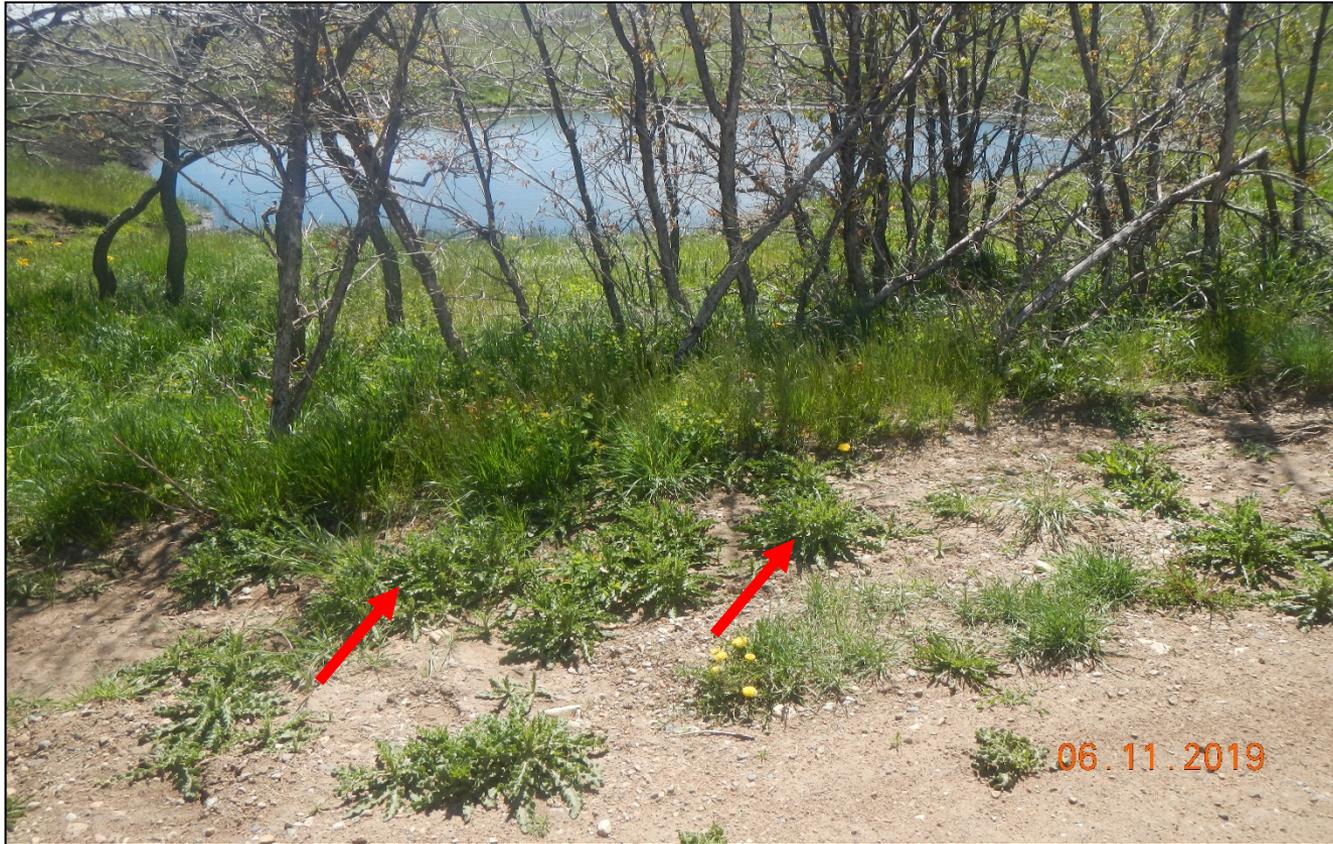
**Photo 1.** Facing northeast along the main access road. There are numerous noxious weeds (Canada thistle) along the road.

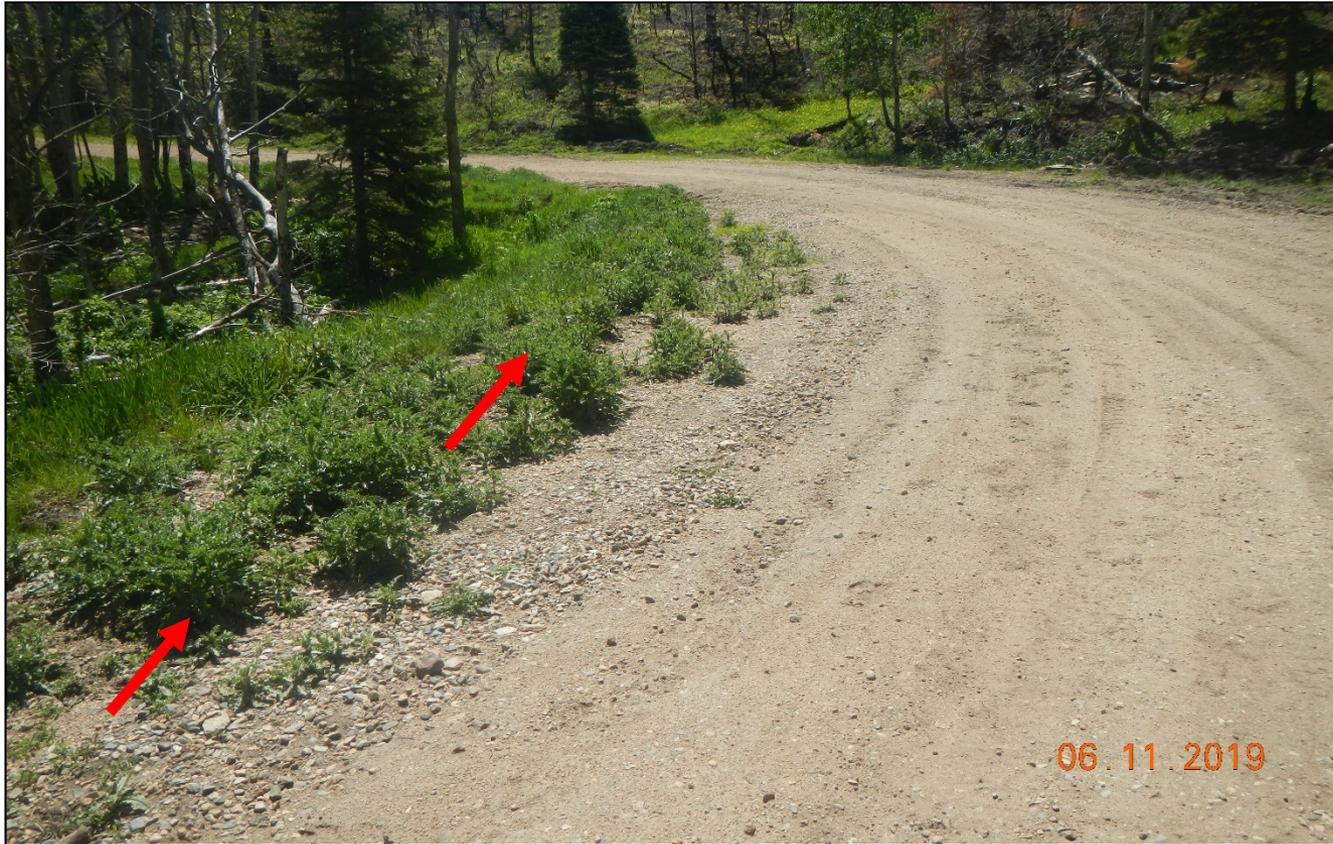
**Photo 2.** Facing southeast along the main access road. There are numerous noxious weeds (Canada thistle) along the road.

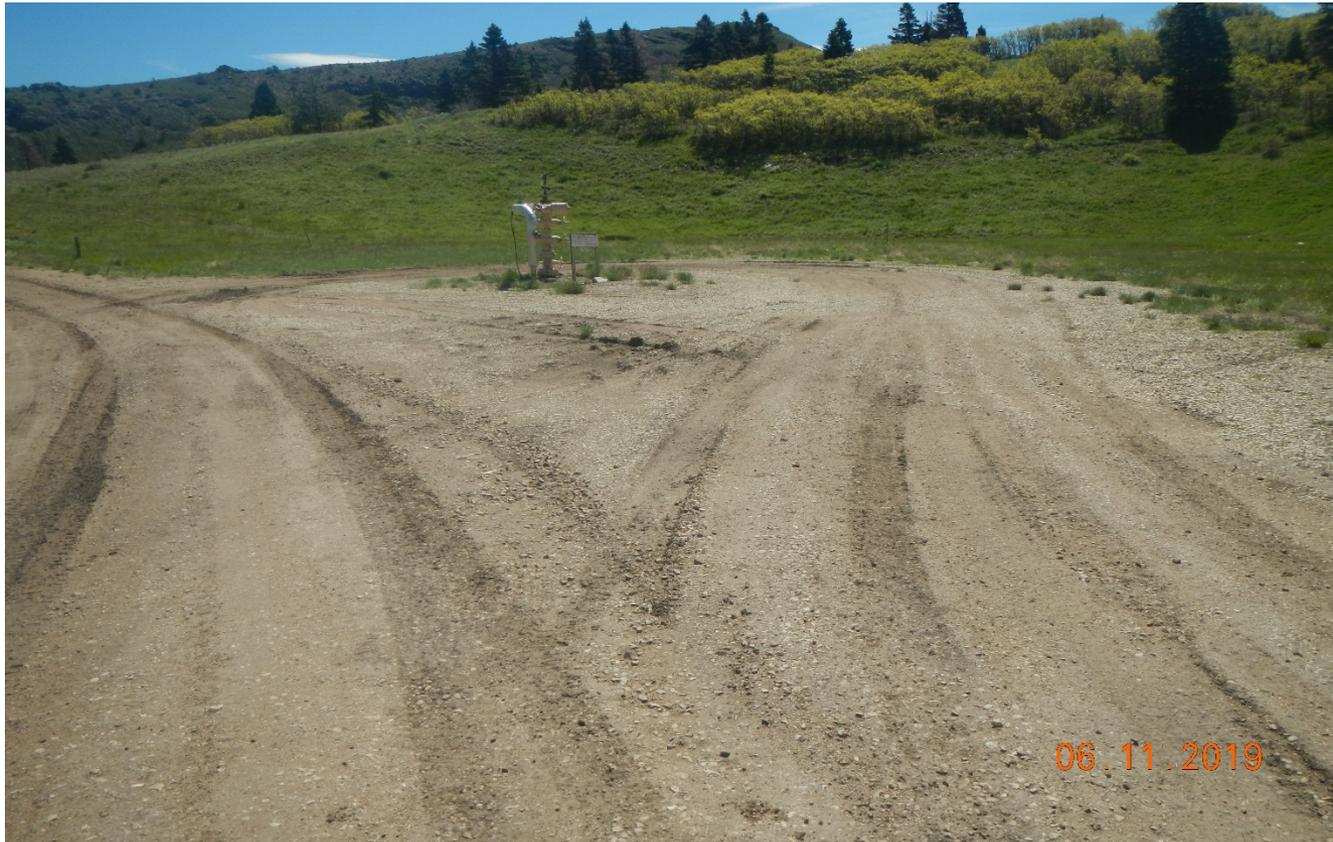
**Photo 3.** Facing east toward the location.

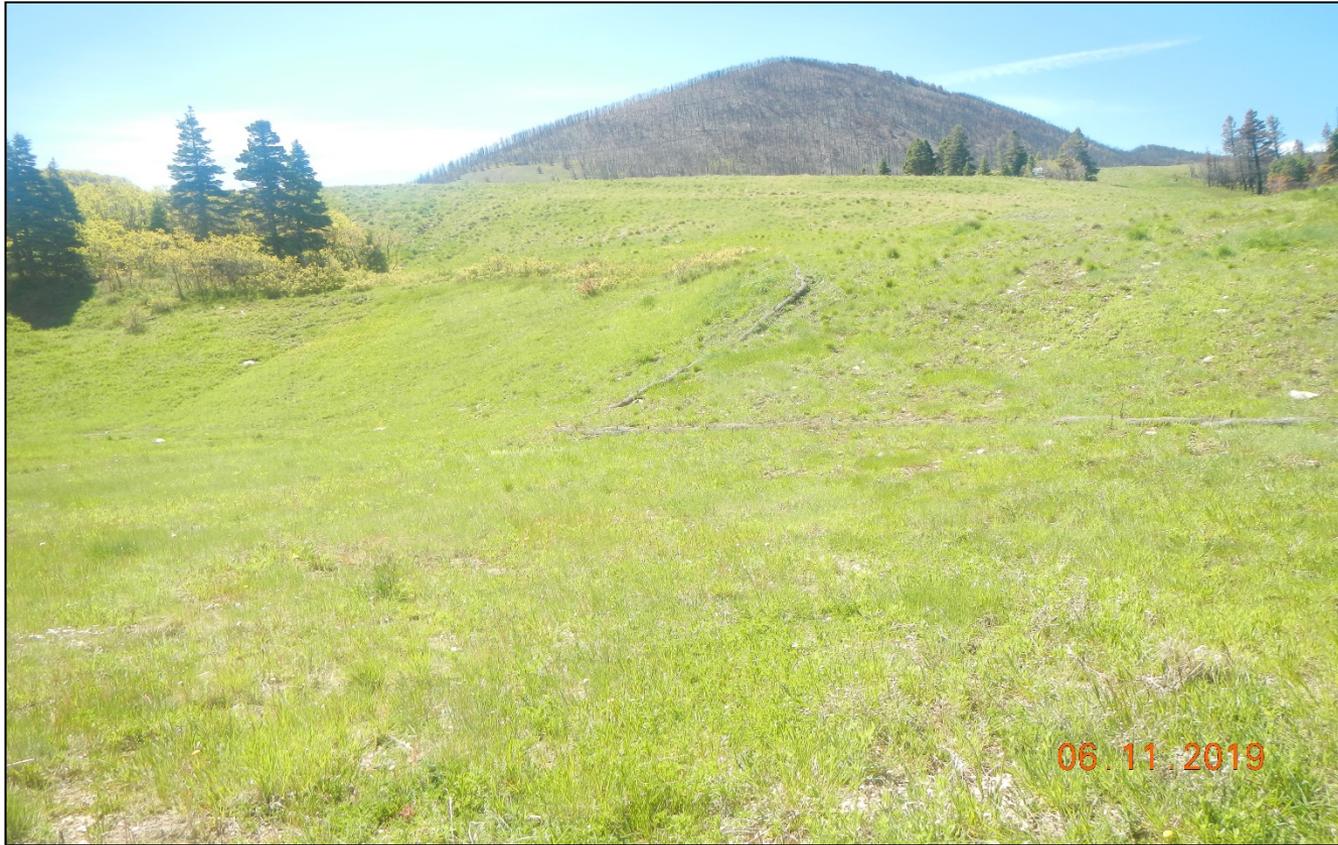
**Photo 4.** Facing south toward the interim reclamation area. Vegetation is well established.

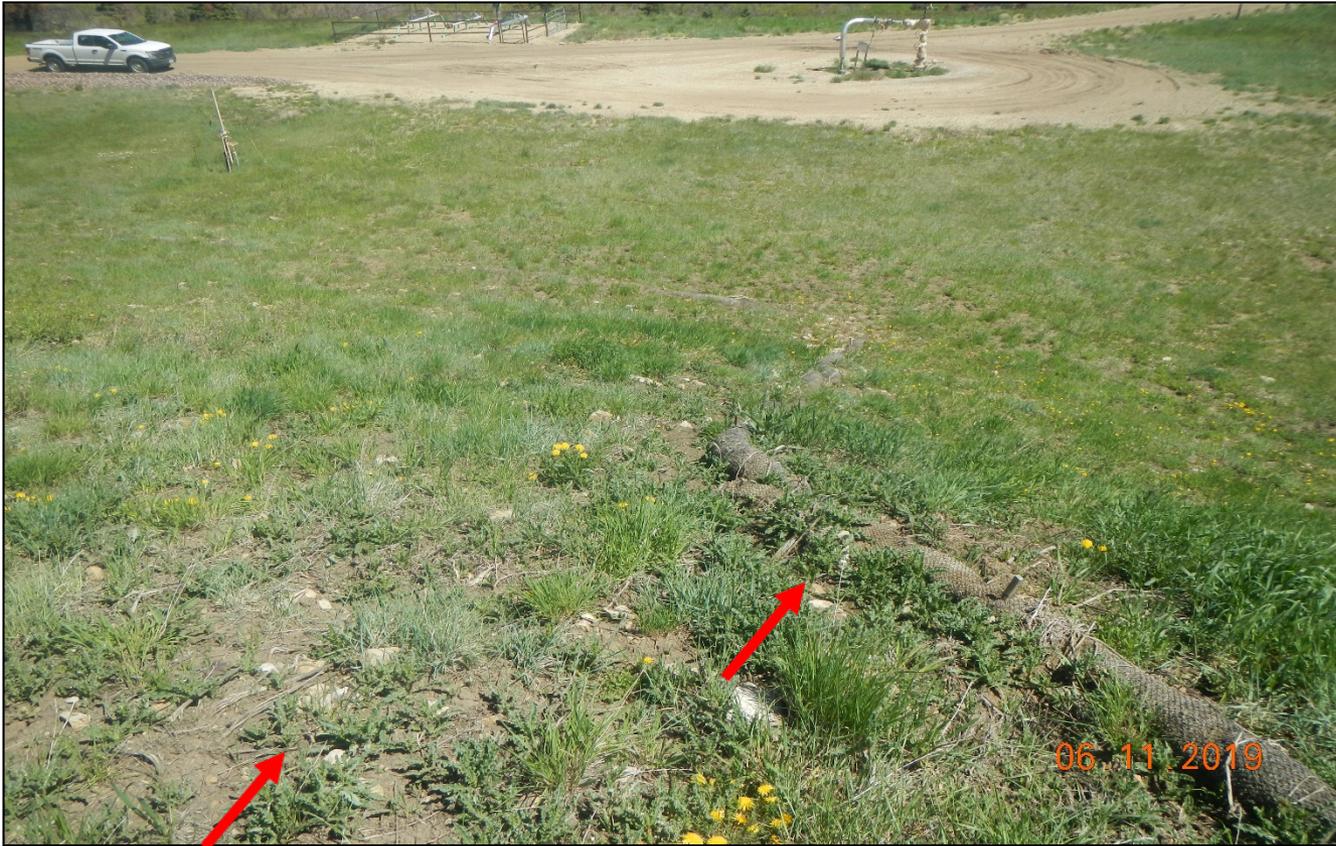
**Photo 5.** Facing north along the hill side at the location. There are numerous noxious weeds (Canada thistle) in this area.
