Pit Status Evaluation Form

Pit Name: STERKEL 1	Facility ID: 114326
Current Status: Unknown	Status Date: 9/23/1999
Current Operator: J M RESOURCES INC / 44155	
Updated Operator: BAYSWATER EXPLORATION & PRODUCTION LLC	
Form 15 Pit Permit Doc #: NA	Permit Date: NA
Related Facilities: API # 05-001-07315 (Facility ID 201911), Location 319926

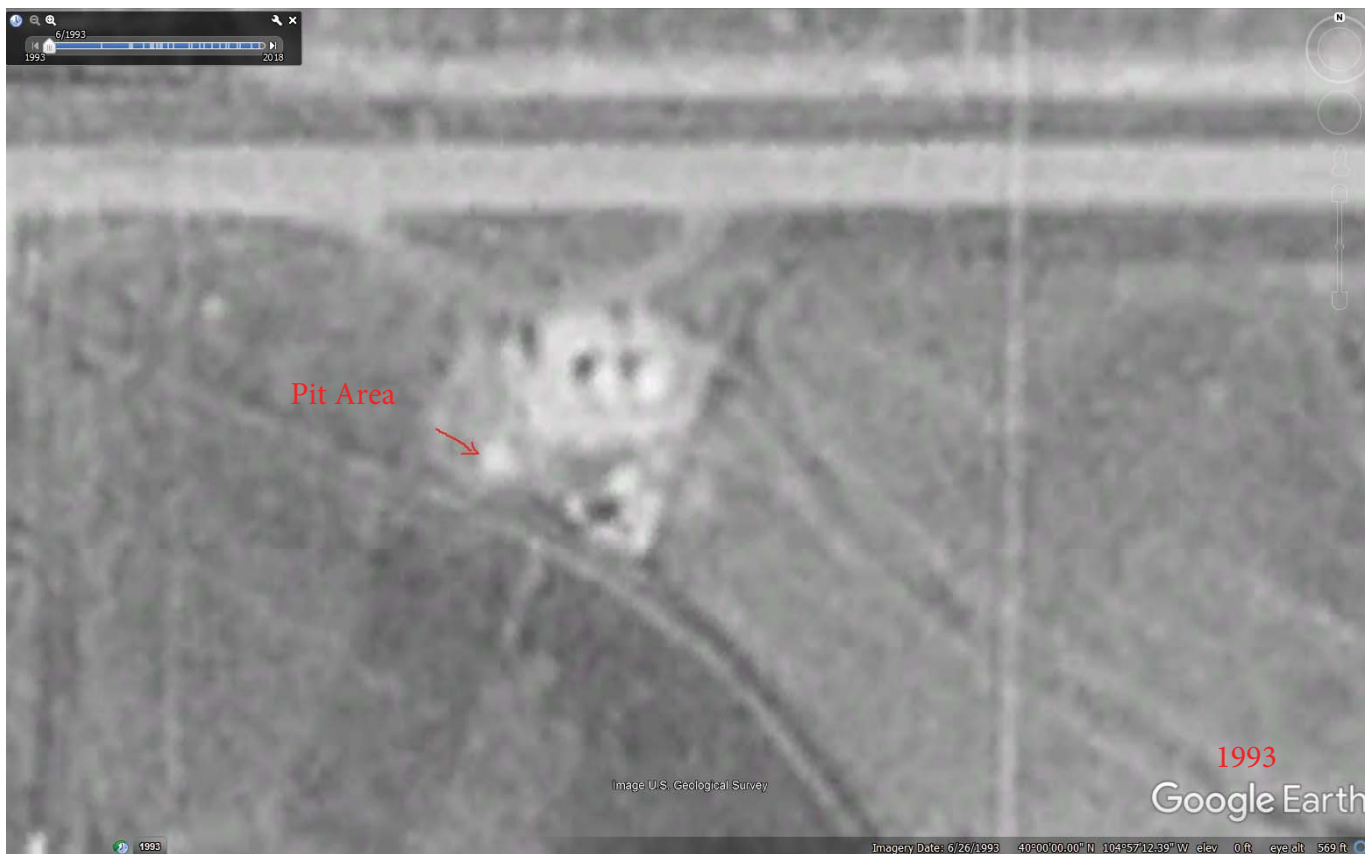
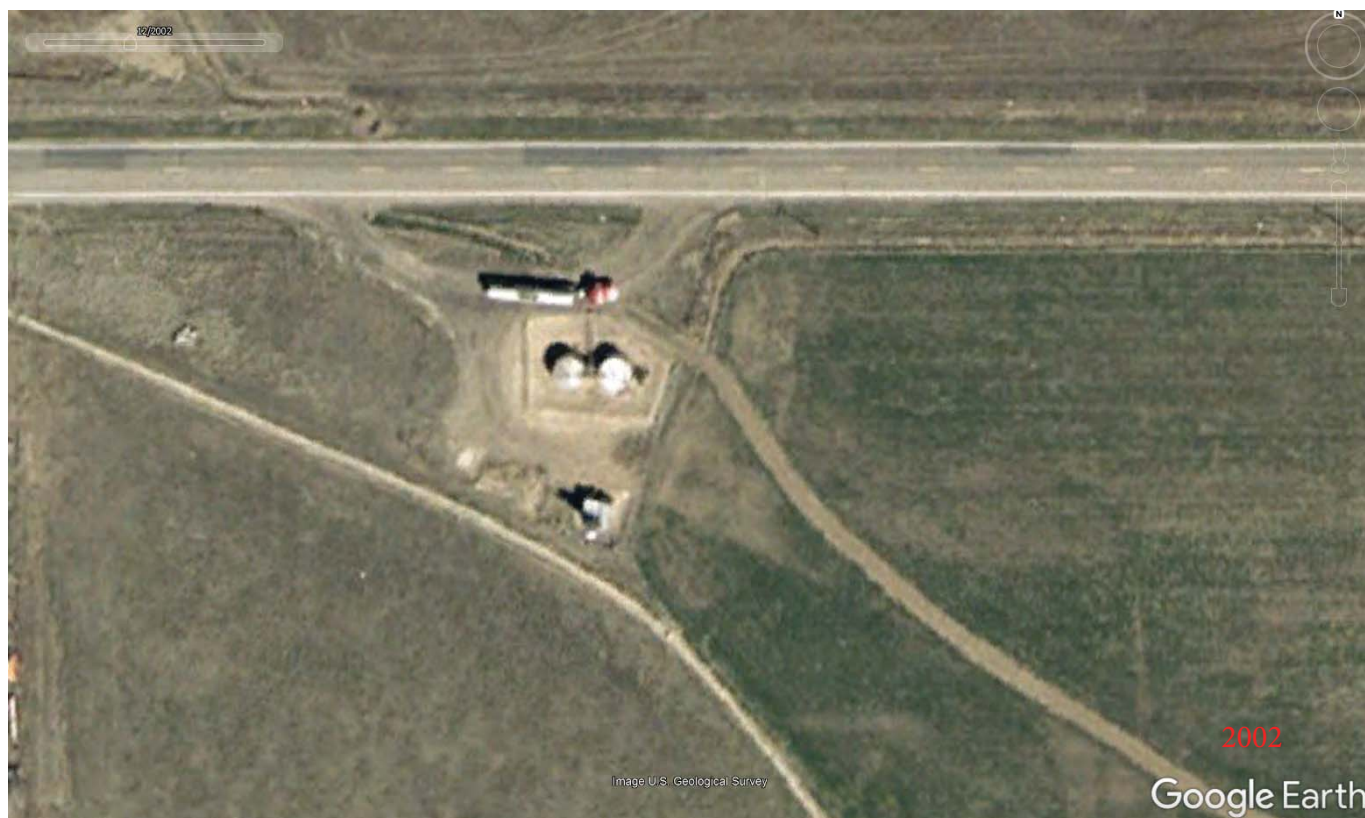
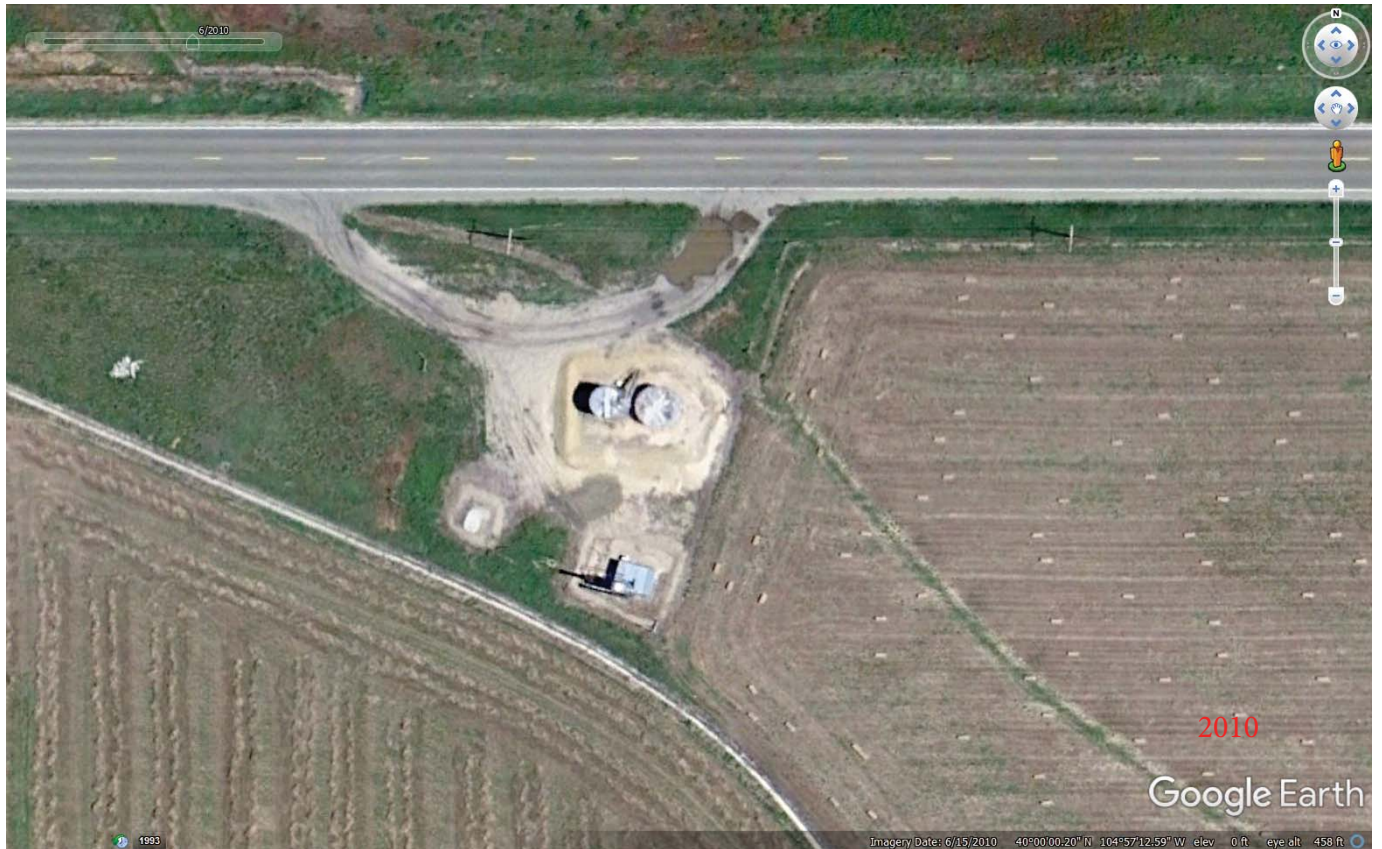
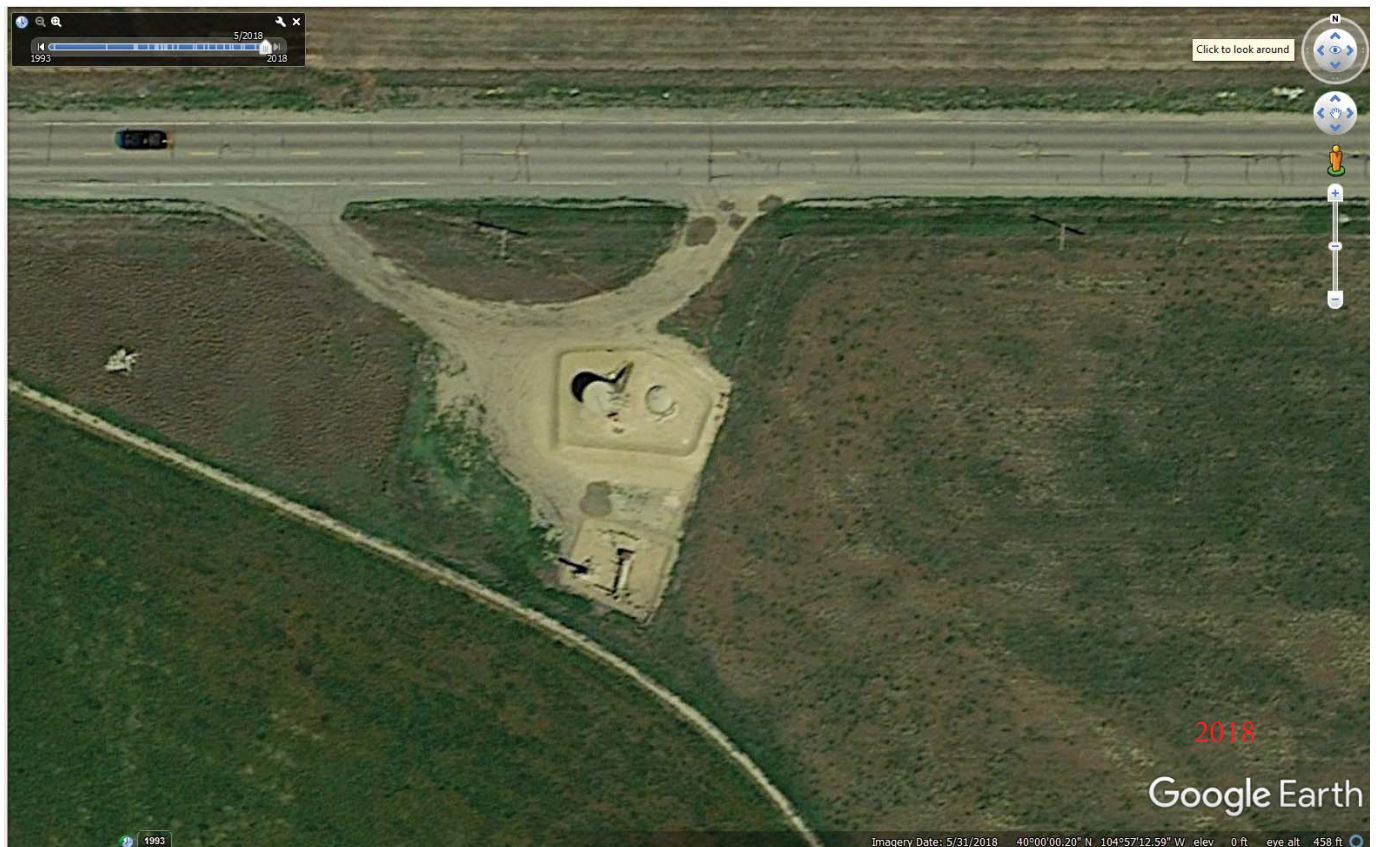
Based on records review and aerial photos, the produced water pit was replaced by a concrete vault in the same location. The vault was removed, and pit/vault impacts were remediated under project #7390, closed 7/23/2015. Pit status has been changed to closed.

Produced water vault removed under remediation project #7390, closed 7/23/2015
