Inspection Photos

ID: 441082

Operator: **DOVER ATWOOD CORPORATION**

Inspection Date: 6/14/2019

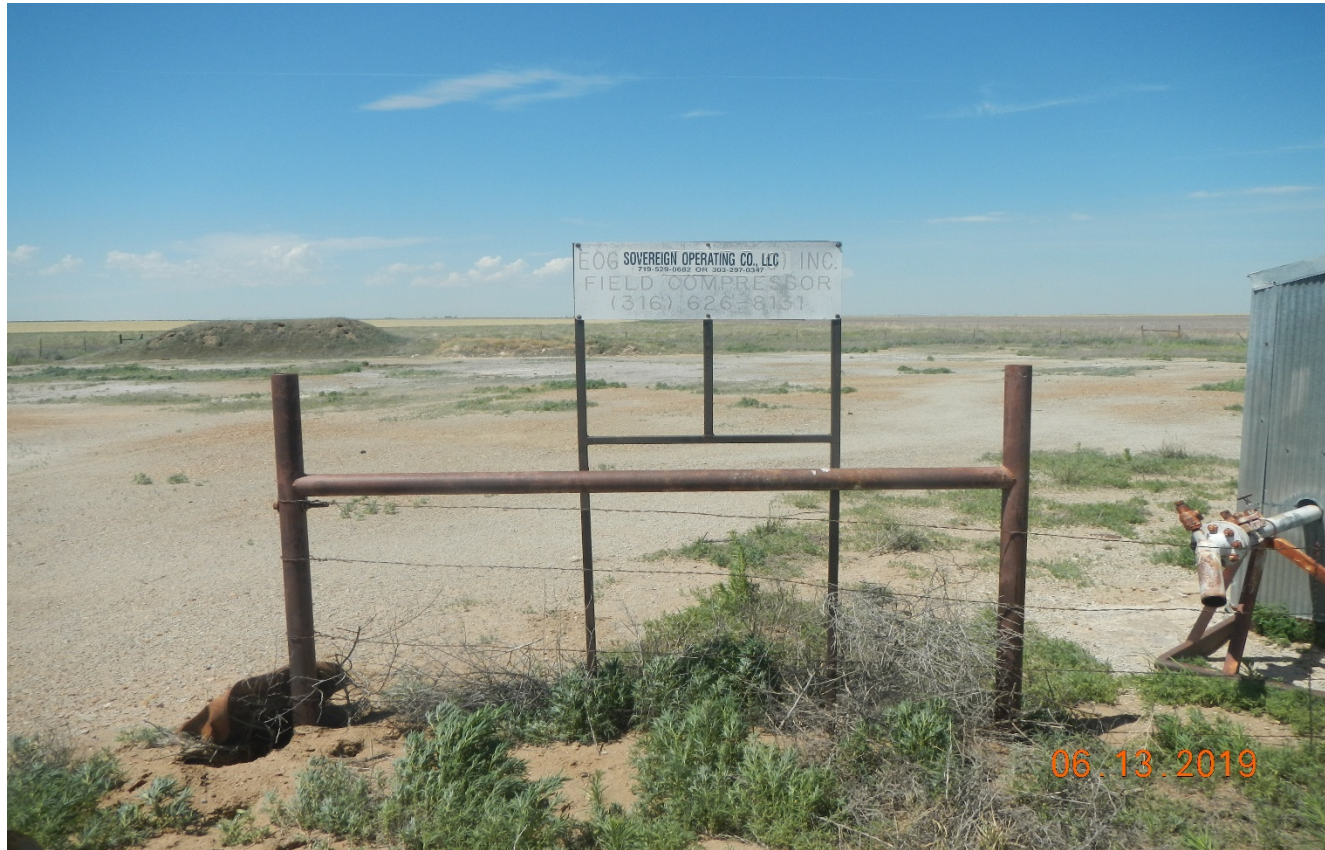
Photo 1. Facing toward location sign which indicates incorrect operator name and emergency contact. Missing information.

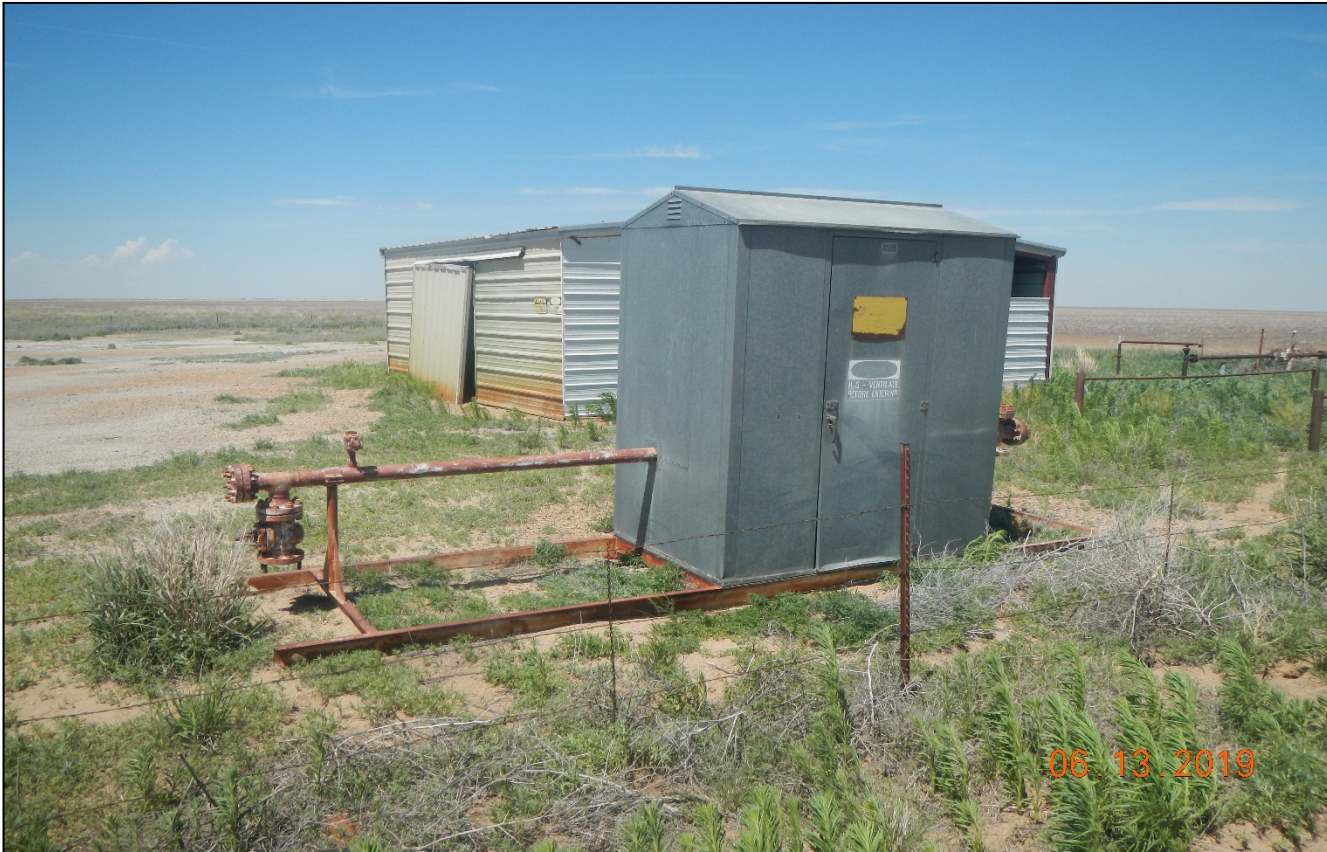
Photo 2. Unused GMR shed stored onsite has not been removed per previous inspection #[678300126](#) .

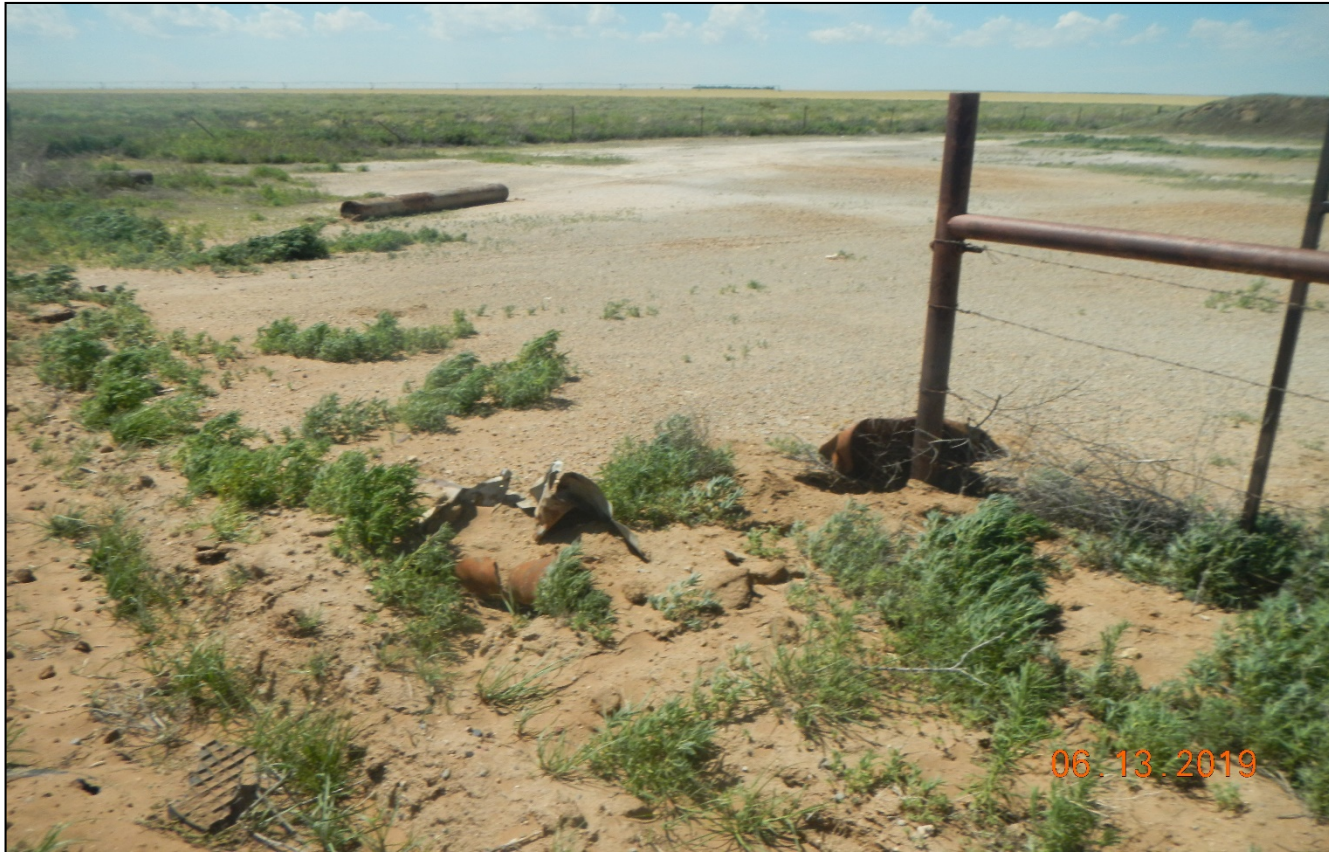
Photo 3. The fence around the location is in disrepair. There is various jagged scrap metal and pipe laying at the entrance of the location.

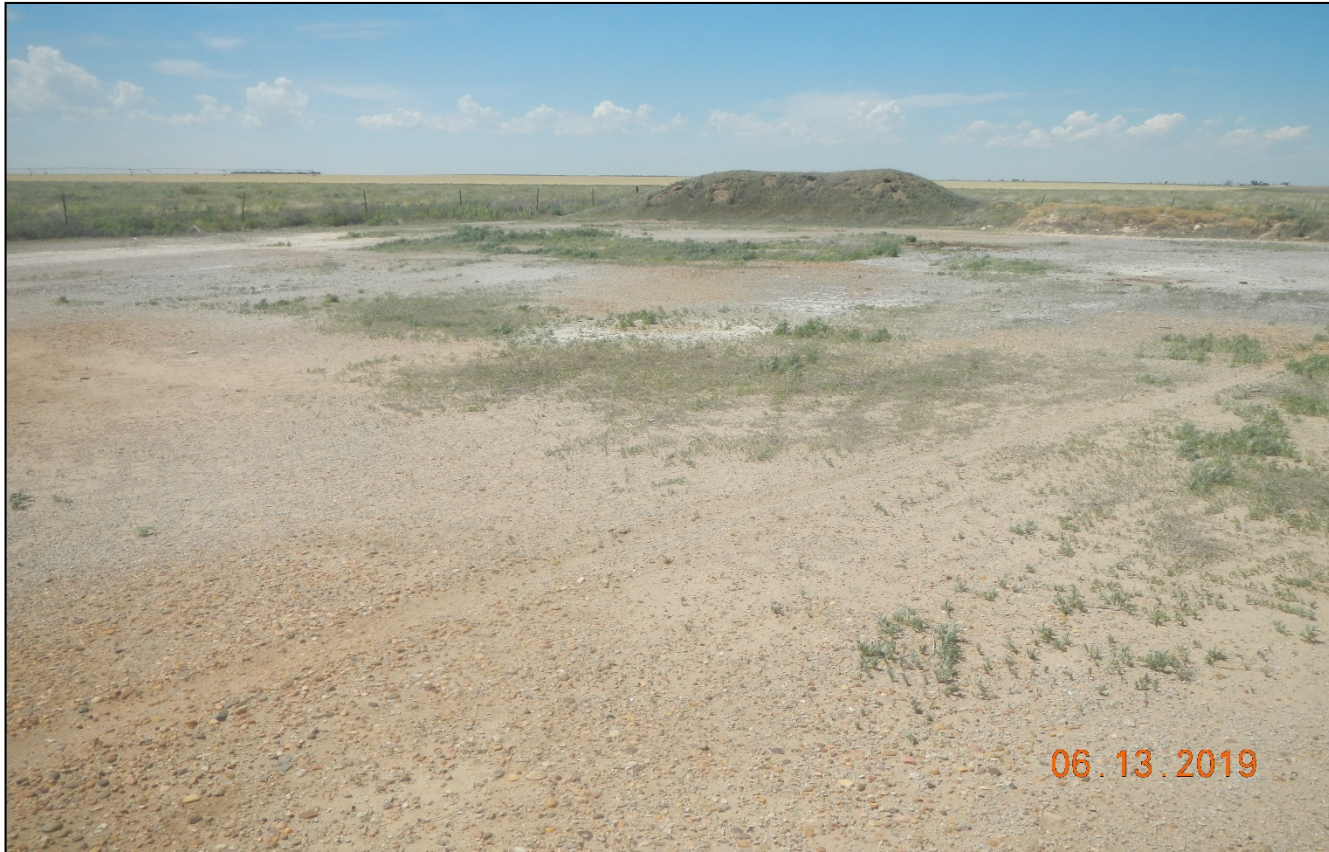
Photo 4. Facing northwest at the location. Soil pile is full of weeds. Unused areas are not reclaimed.

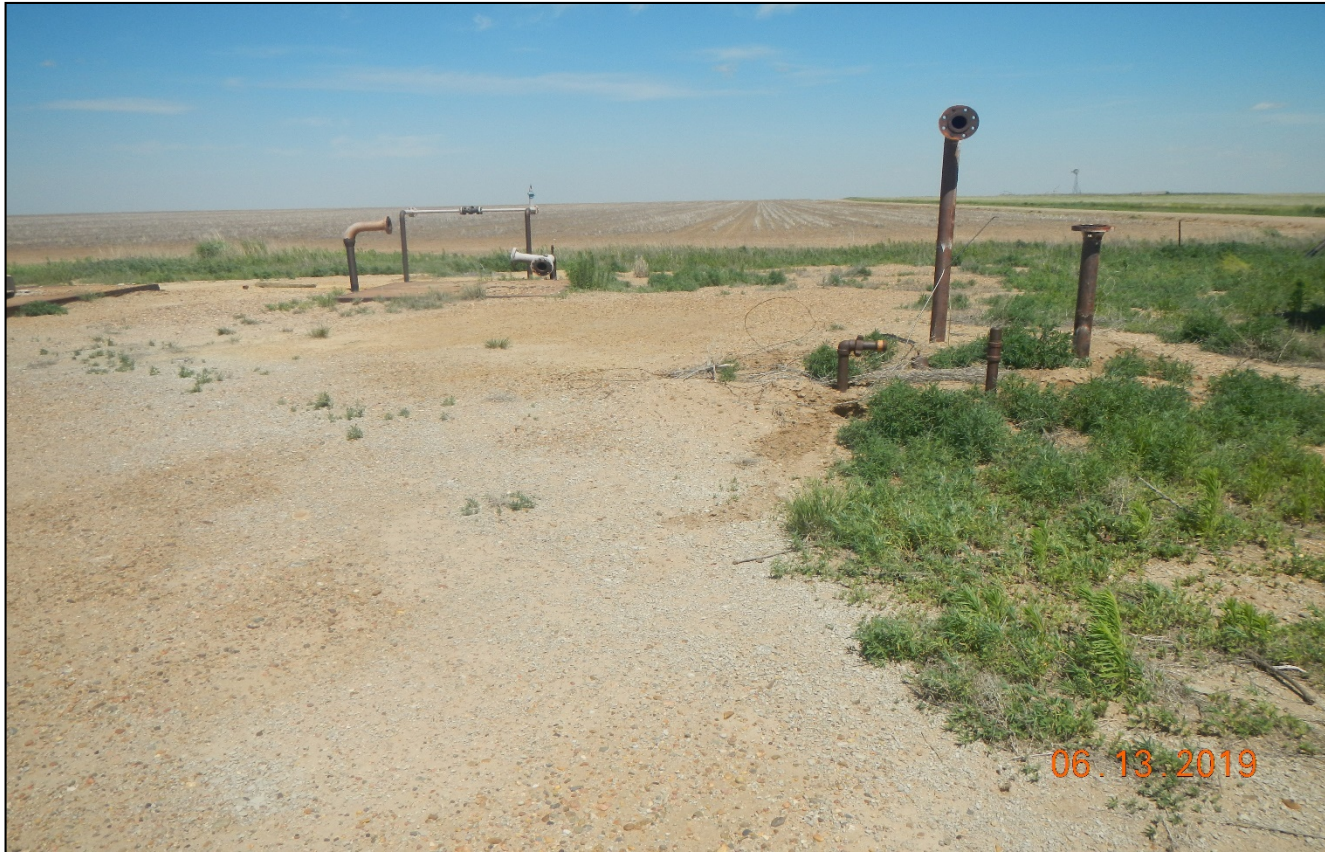
Photo 6. There is numerous abandoned pipe risers at the east side of the location.

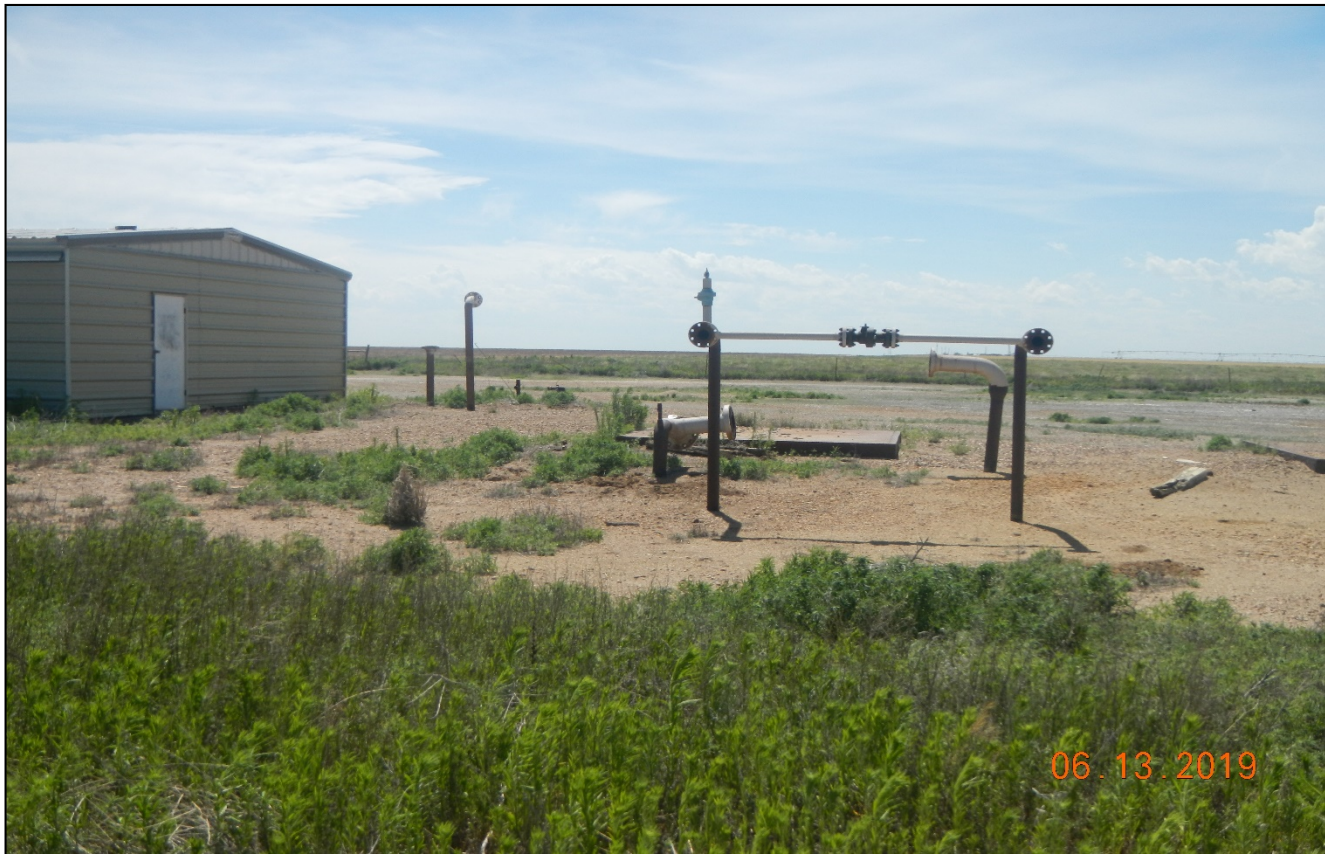
Photo 8. There is numerous abandoned pipe risers at the east side of the location.
