# Inspection Photos

API: 05-061-06076

Operator: CHEMCO INC

Inspection Date: 6/21/2019

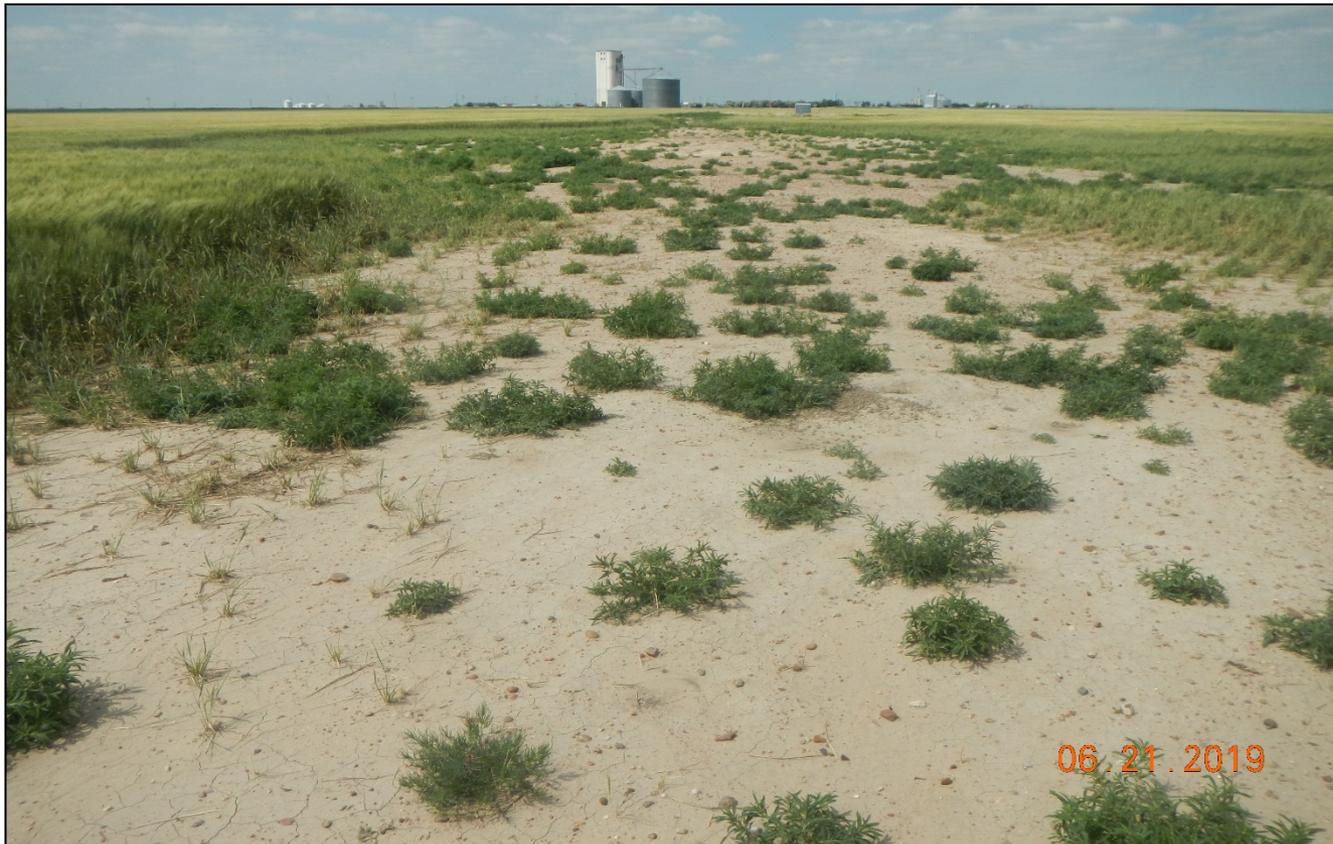
**Photo 1.** Facing southwest along the former access road. Crop is not establishing.

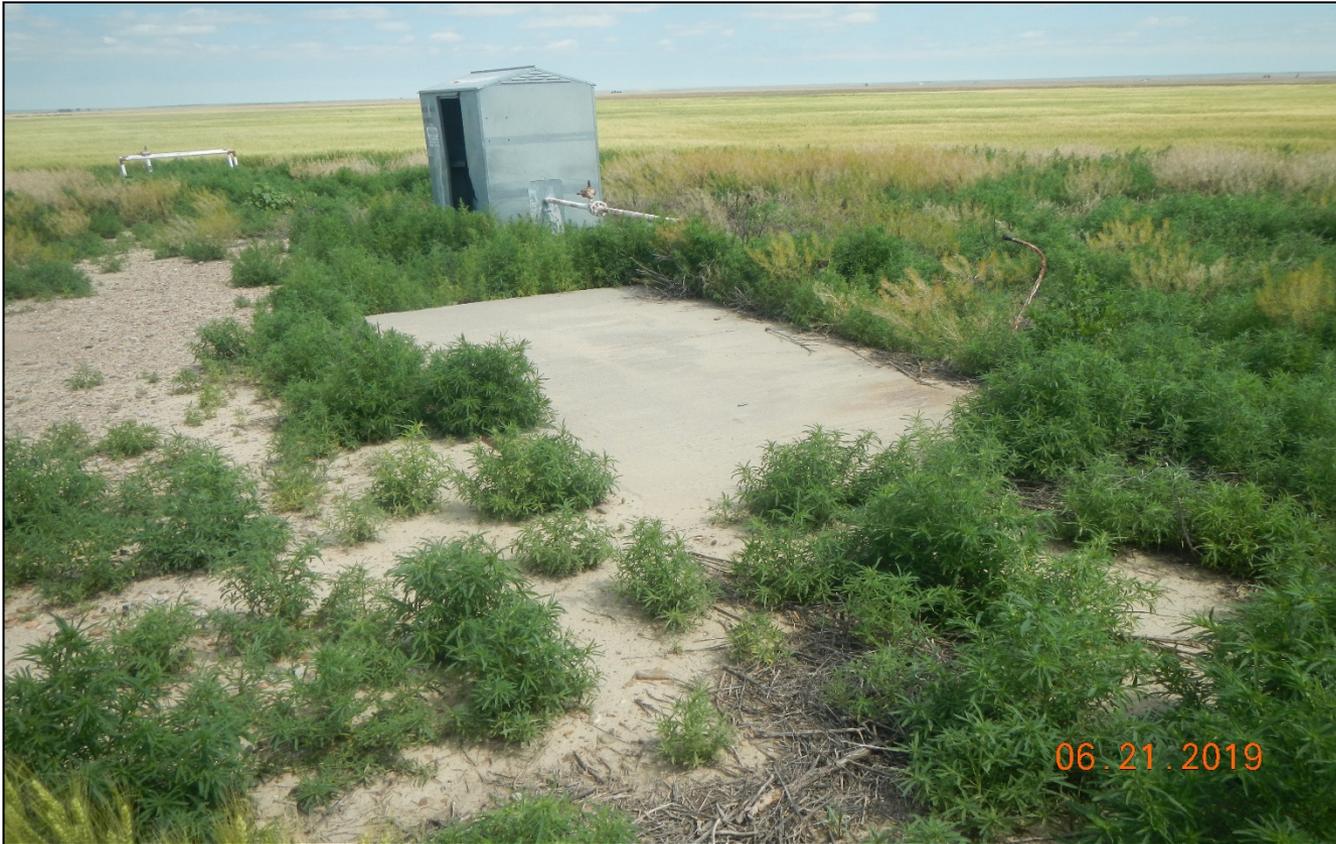
**Photo 2.** There is a cement pad and pipe risers and shed that remain just north of the well site.

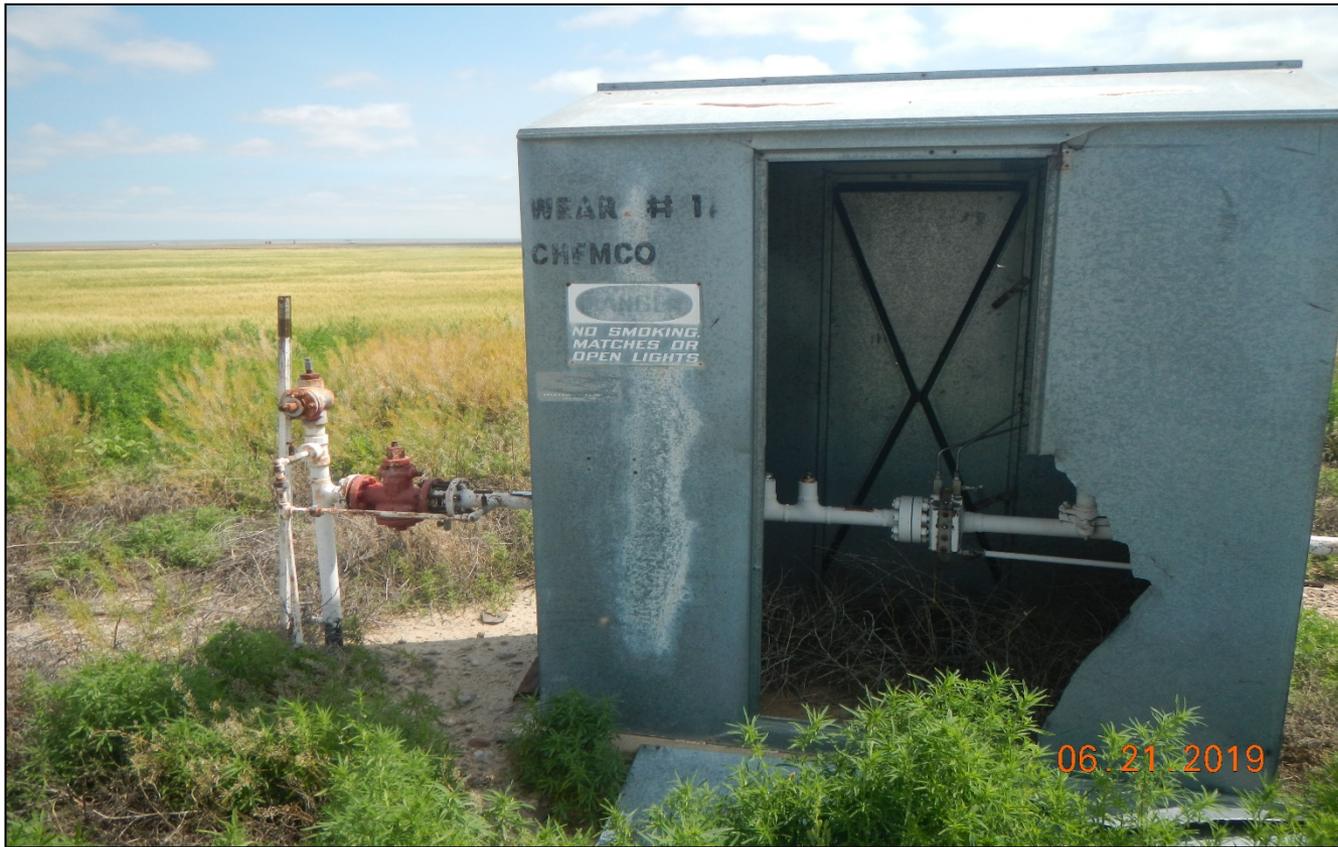
**Photo 3.** View of the abandoned shed and pipe risers.

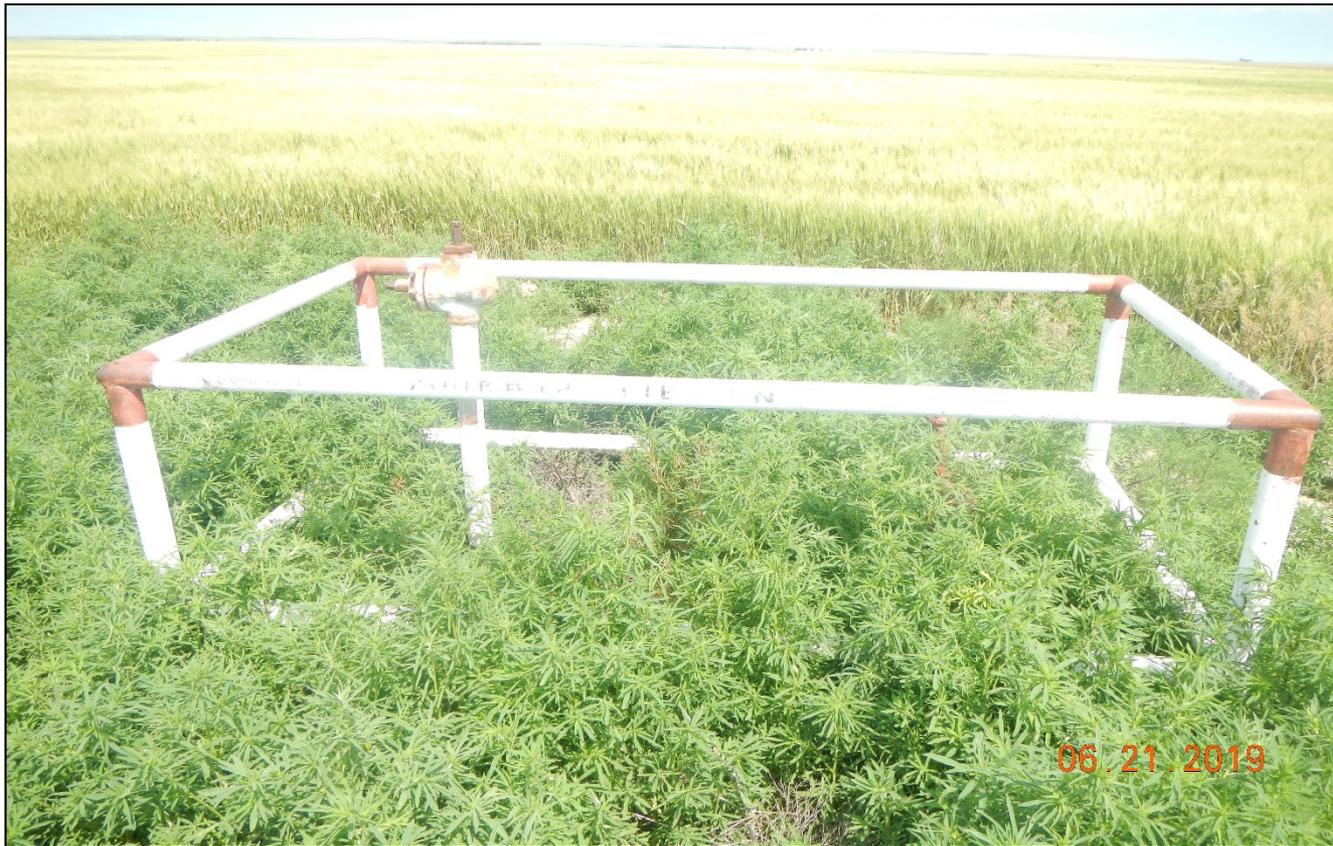
**Photo 4.** Abandoned pipe riser near the well site.

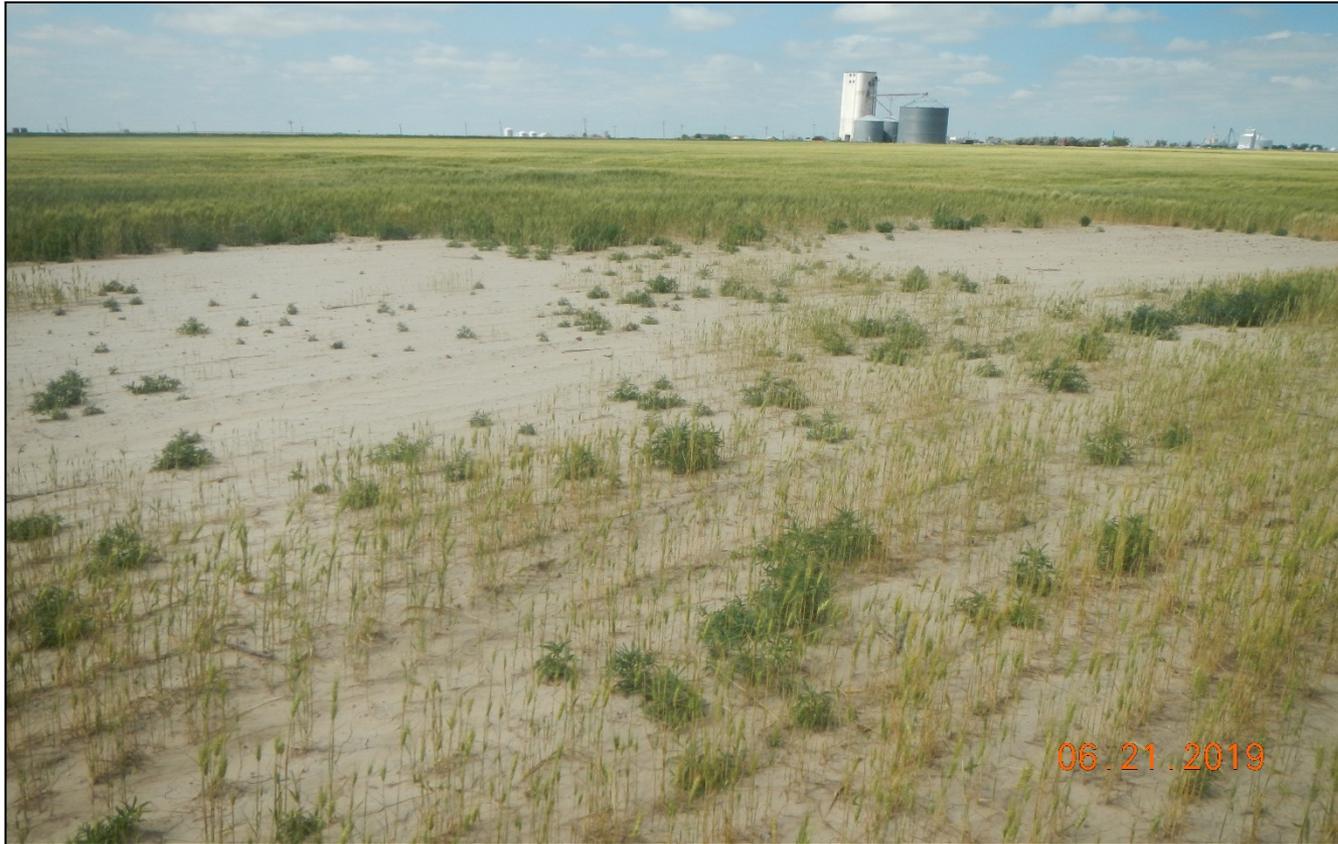
**Photo 5.** Crop is not establishing near the well site.

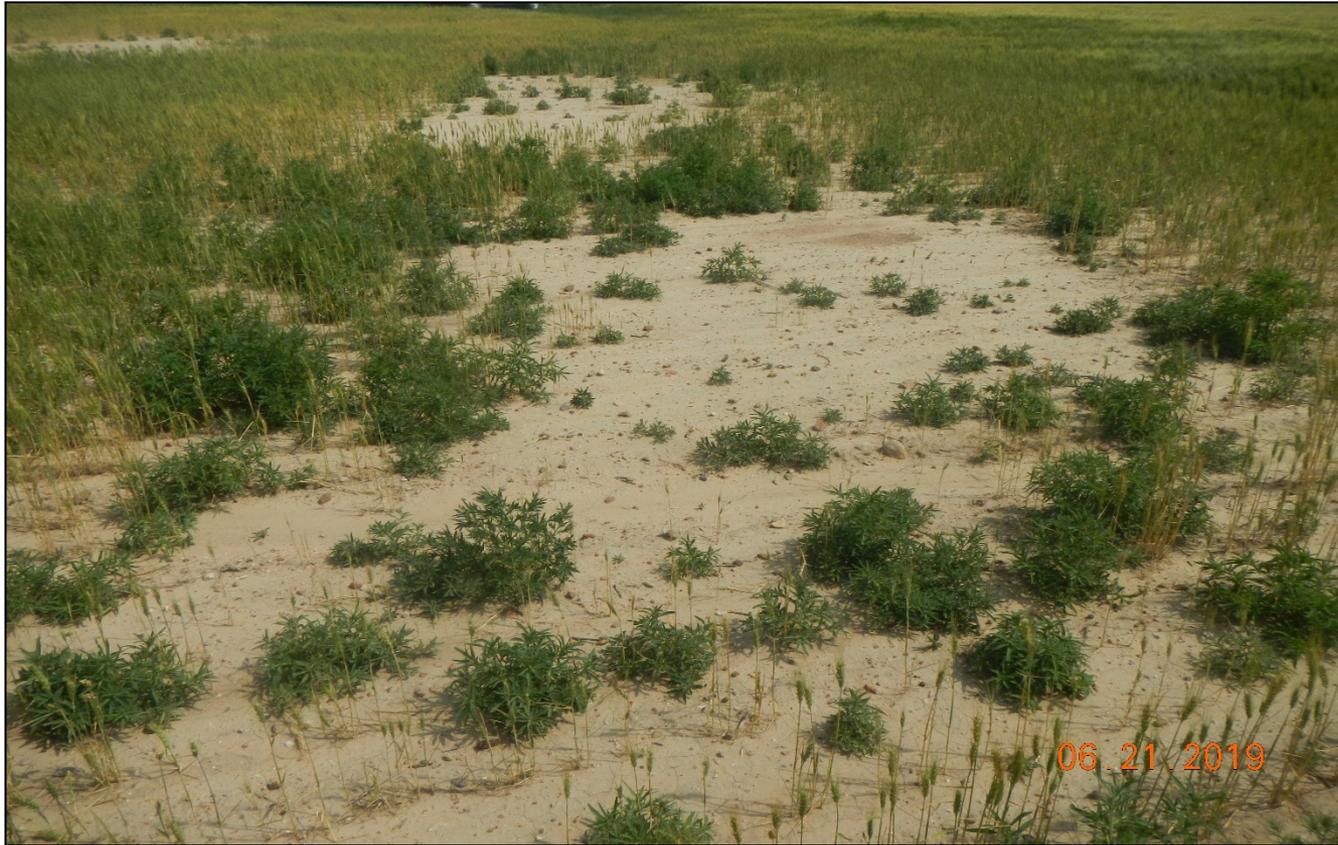
**Photo 6.** Facing north at the well site. Crop is not growing.
