Inspection Photos
Location Name: Peppler Fee Com 12-18
API: 05-081-06857

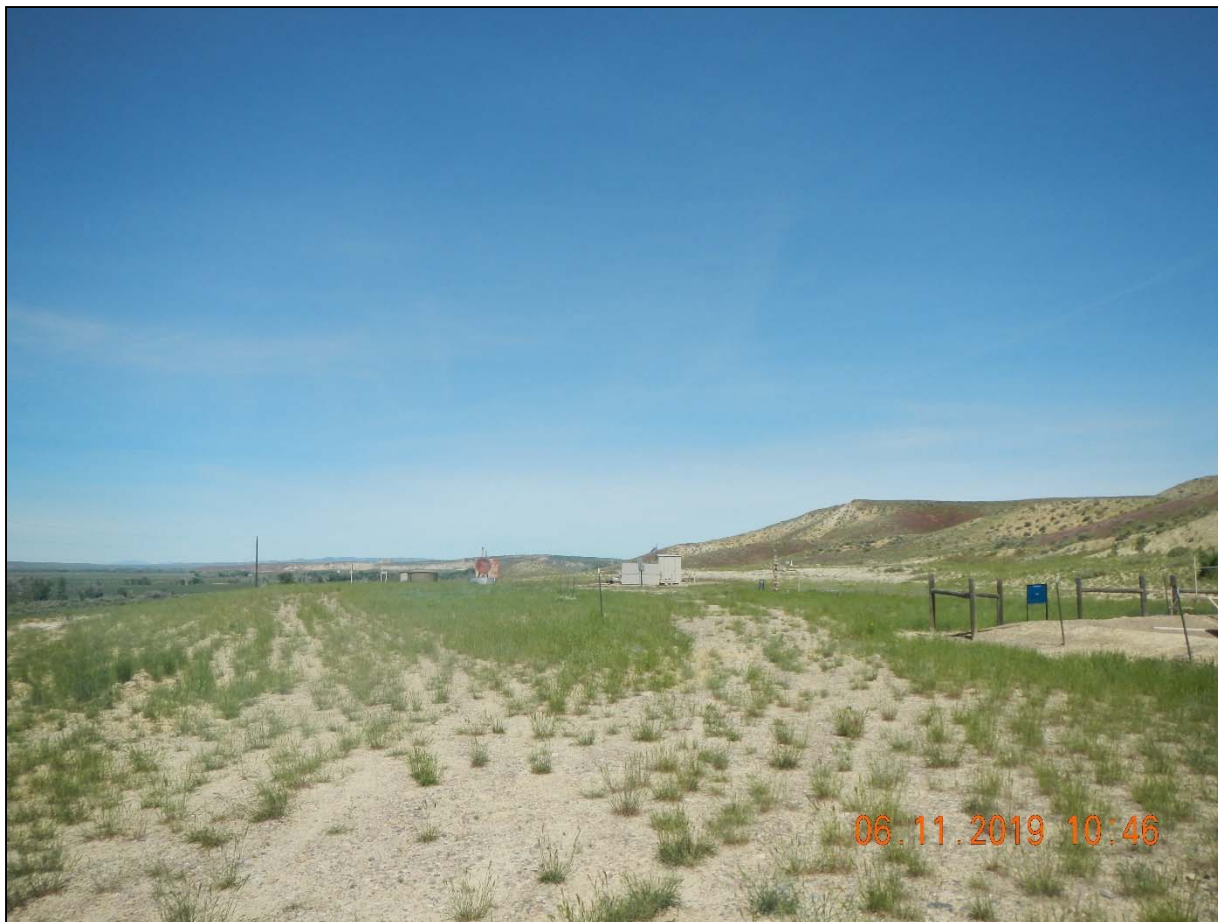
Photo 1. Overview of location taken at entrance facing northwest.

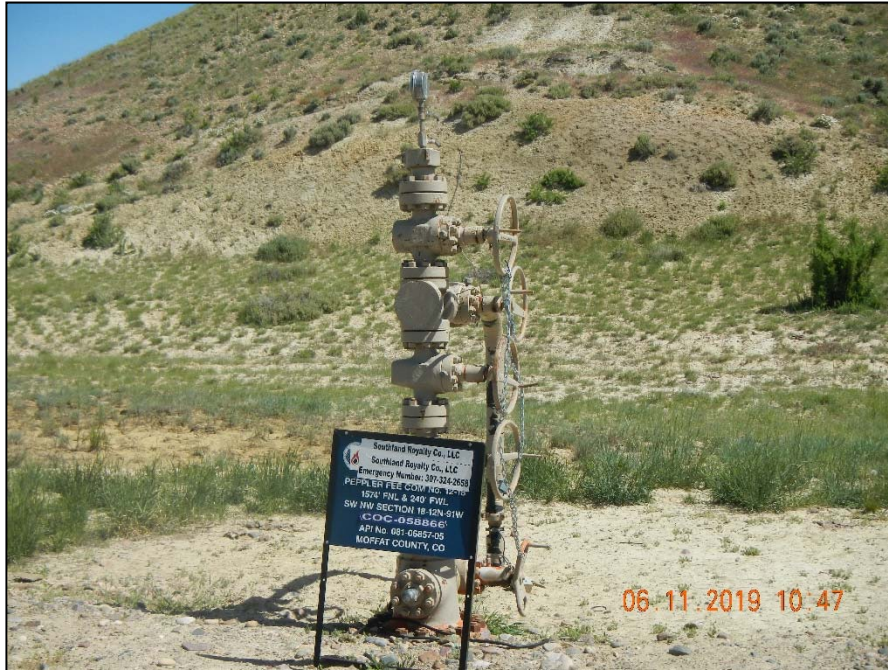
Photo 2. Wellhead LOTO.

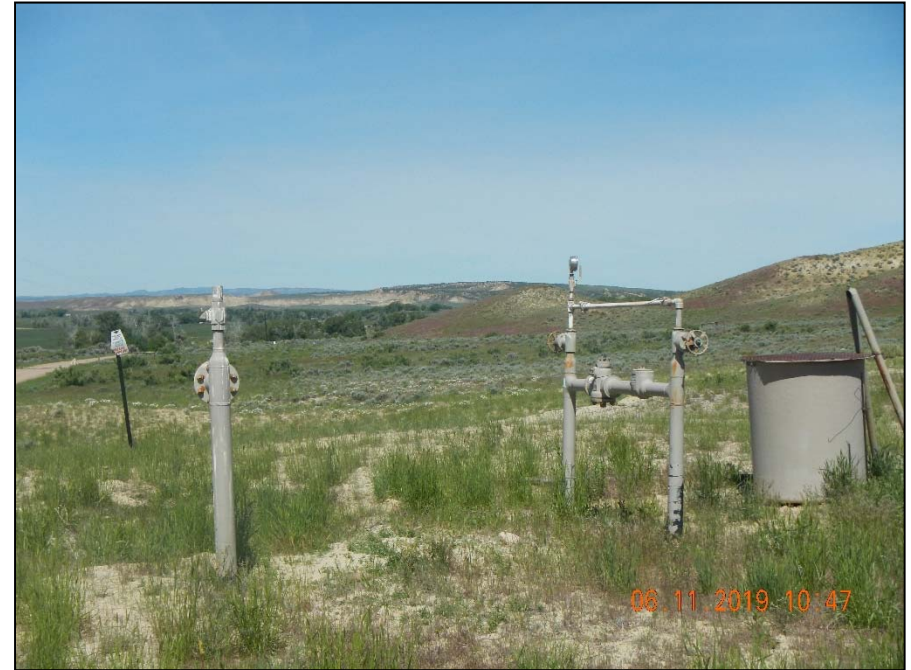
Photo 3. Unmarked risers.

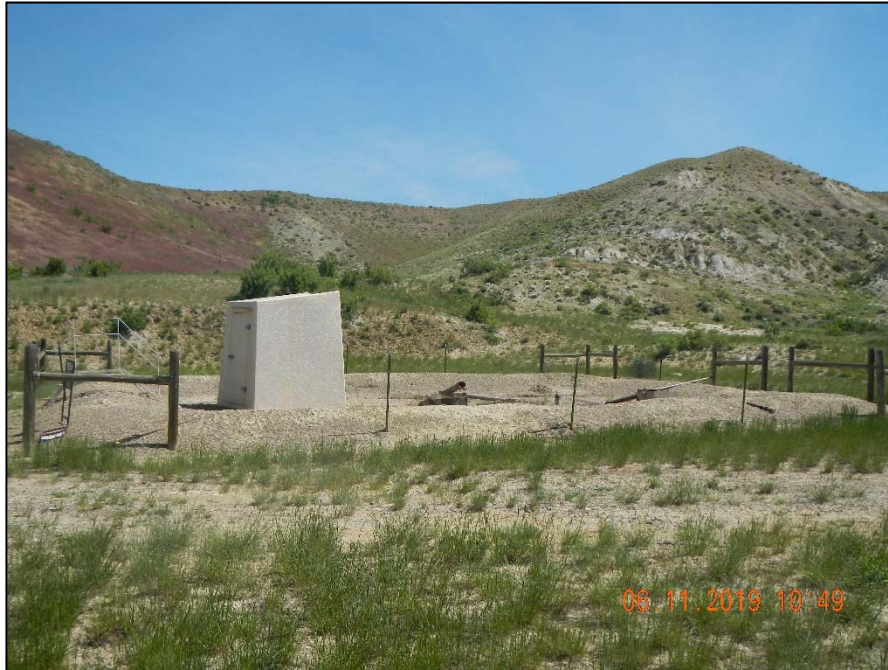
Photo 4. Debris in tank battery.

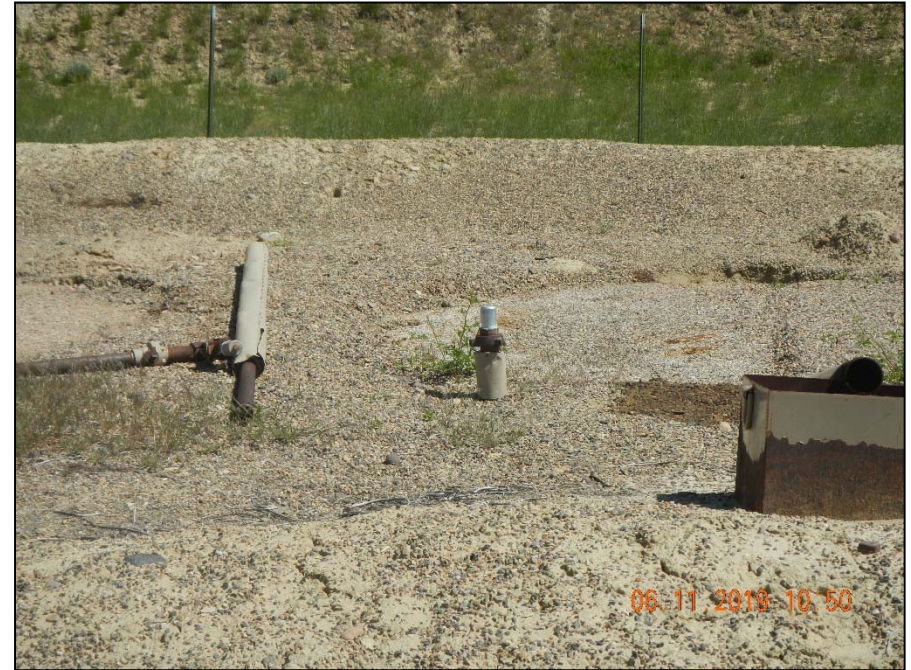
Photo 5. Unmarked riser and stained soil in tank battery.
