Inspection Photos

Location Name: Pit 44-2502-691

Facility ID: 296913

Inspection Date: June 13, 2019

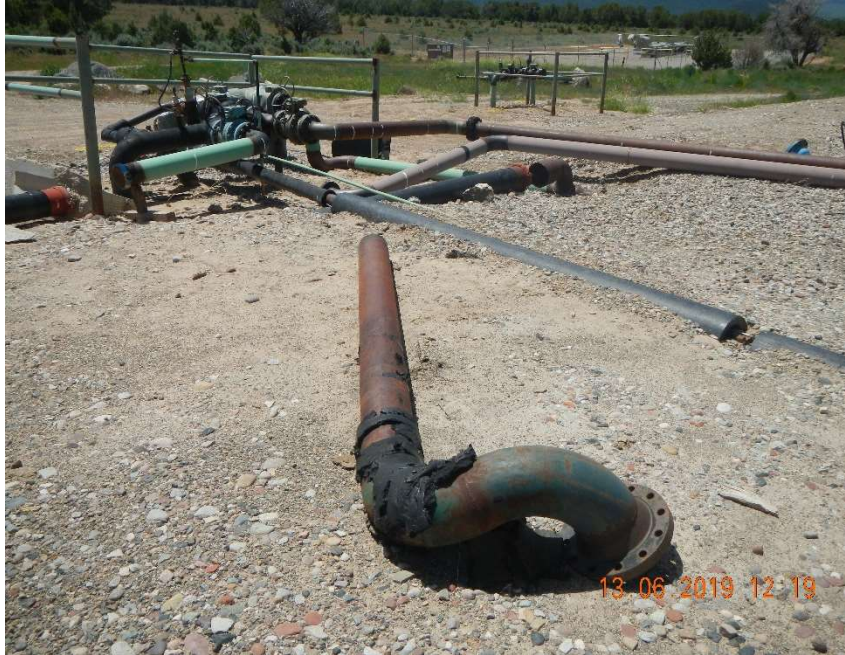
Photo #3 – Unused equipment near the flowline manifold.

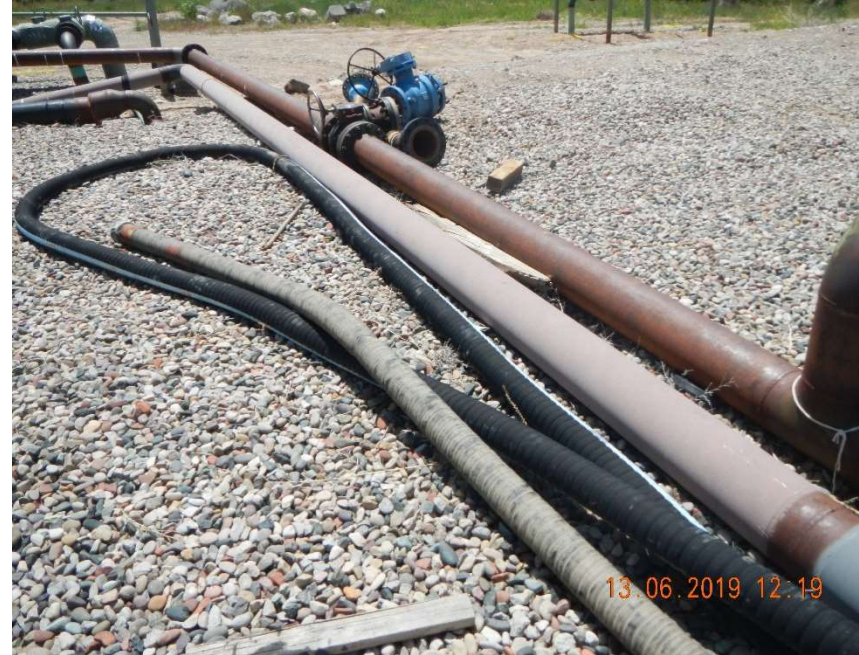
Photo #4 – Unused equipment and debris near flowline manifold.

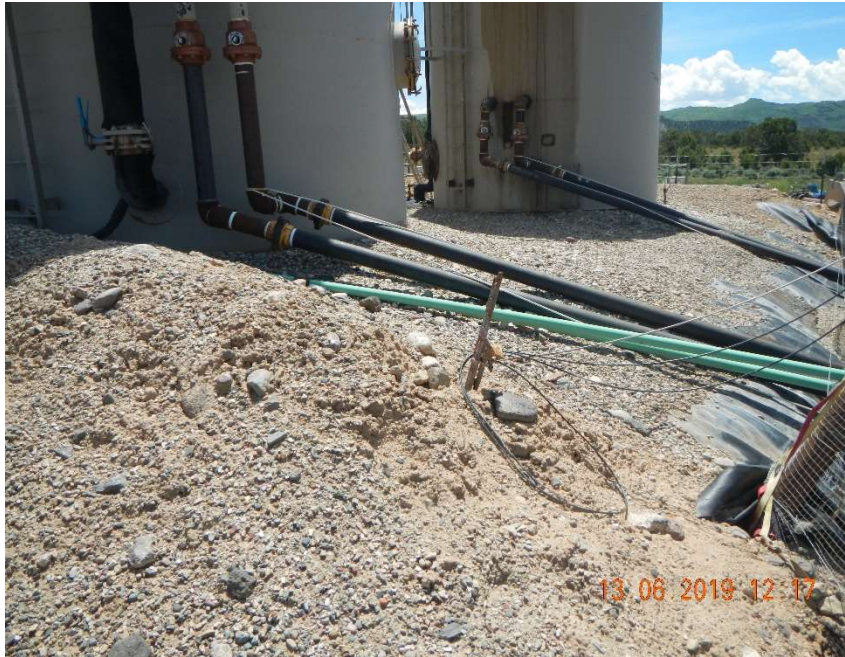
Photo #5 – View of the eroding earthen berm around the tank battery and the stained Steel AST tank.

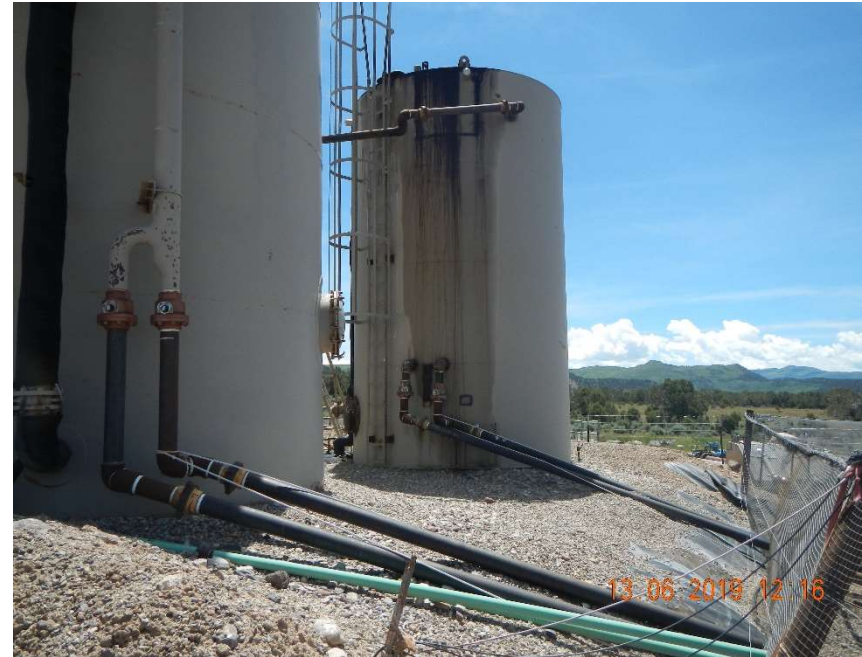
Photo #6 – Steel AST tank with staining.

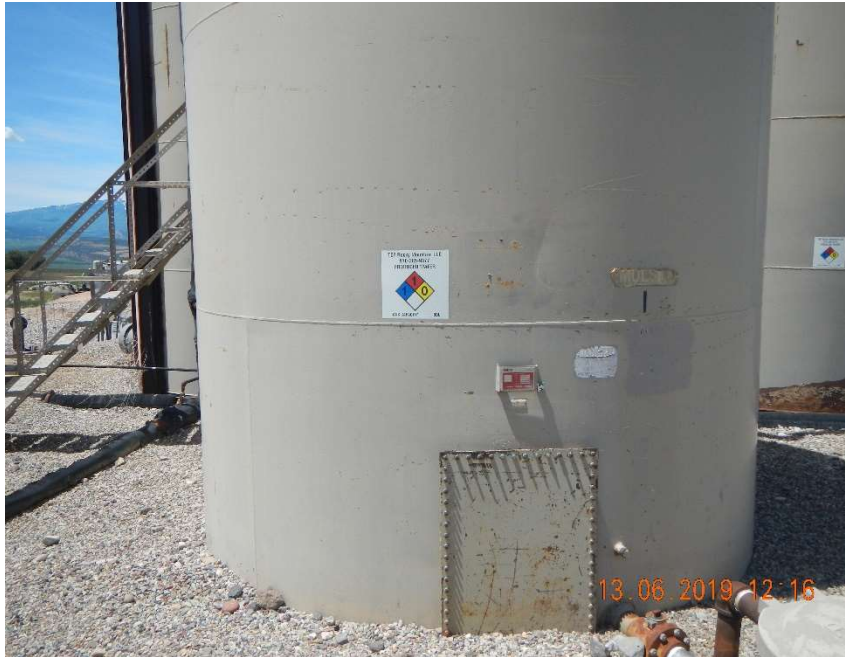
Photo #7 - Steel AST tank lacking tank capacity information.

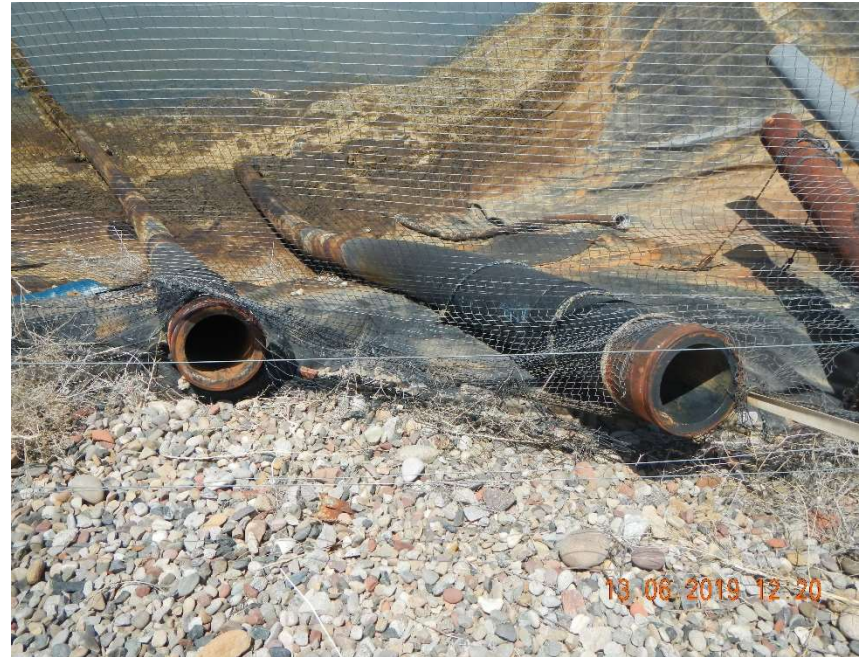
Photo #8 – Uncapped poly pipes leading into the pit.

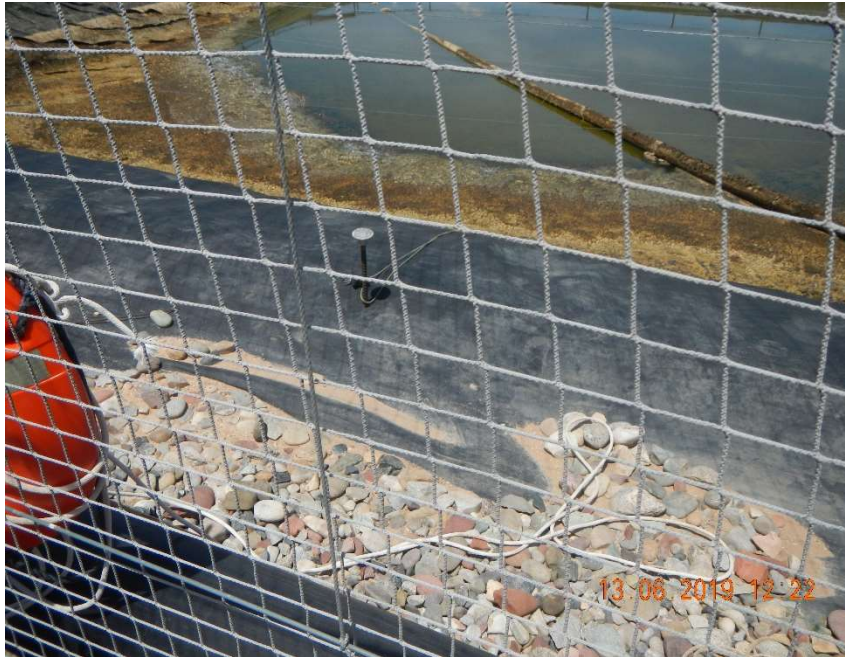
Photo #9 – View of the pit looking north with sediment in the pit bottom and a rebar stake that has been driven through the pit liner. Condensate was also observed within the pit.

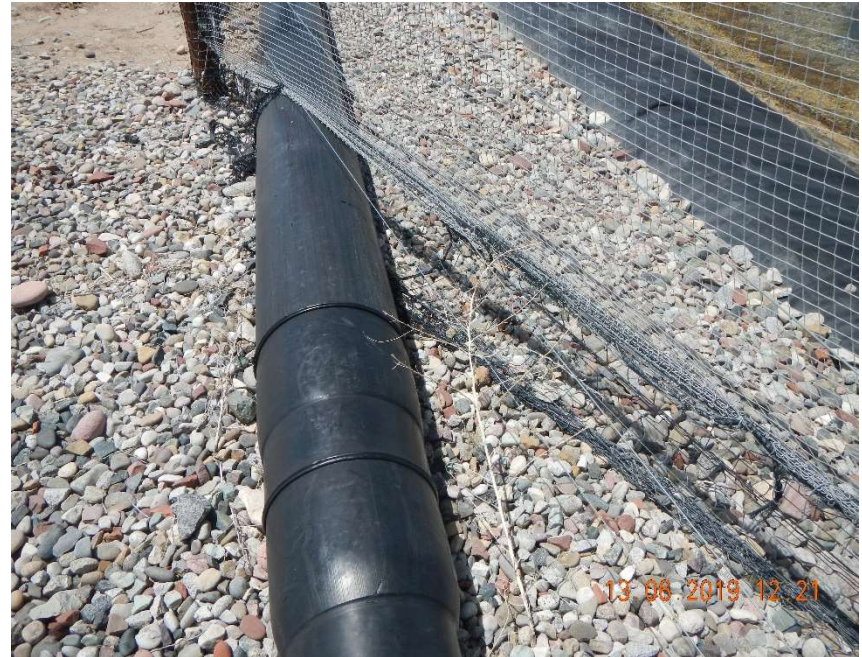
Photo #10 – Gaps (6-8 inches) in netting/fencing at poly pipe penetrations.

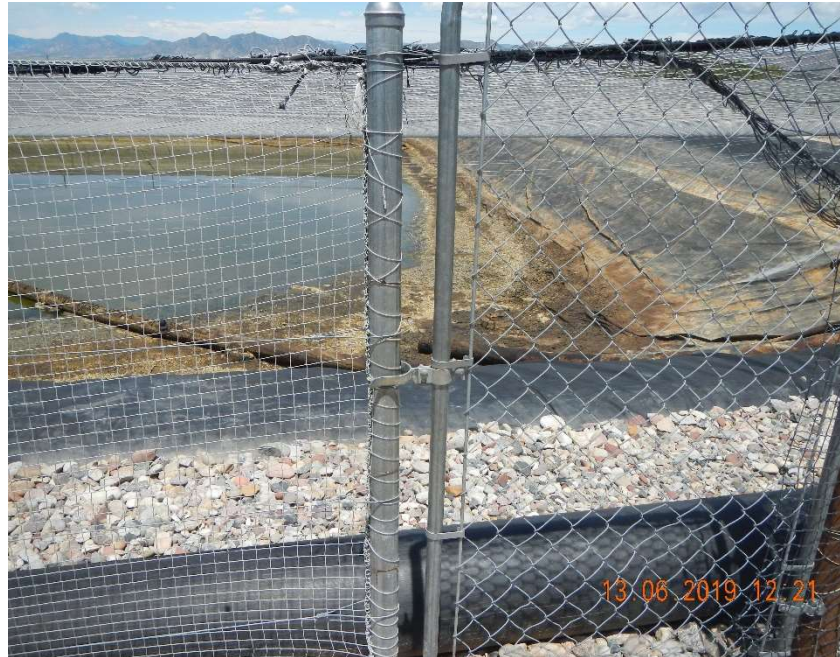
Photo #11 – Uncontrolled access to the pit facility.
