# Final Reclamation Inspection

Operator: NOBLE ENERGY INC - #100322

Location ID: 305716

Inspection Photos  
Location Name: GERKIN #33-21  
Location ID: 305716

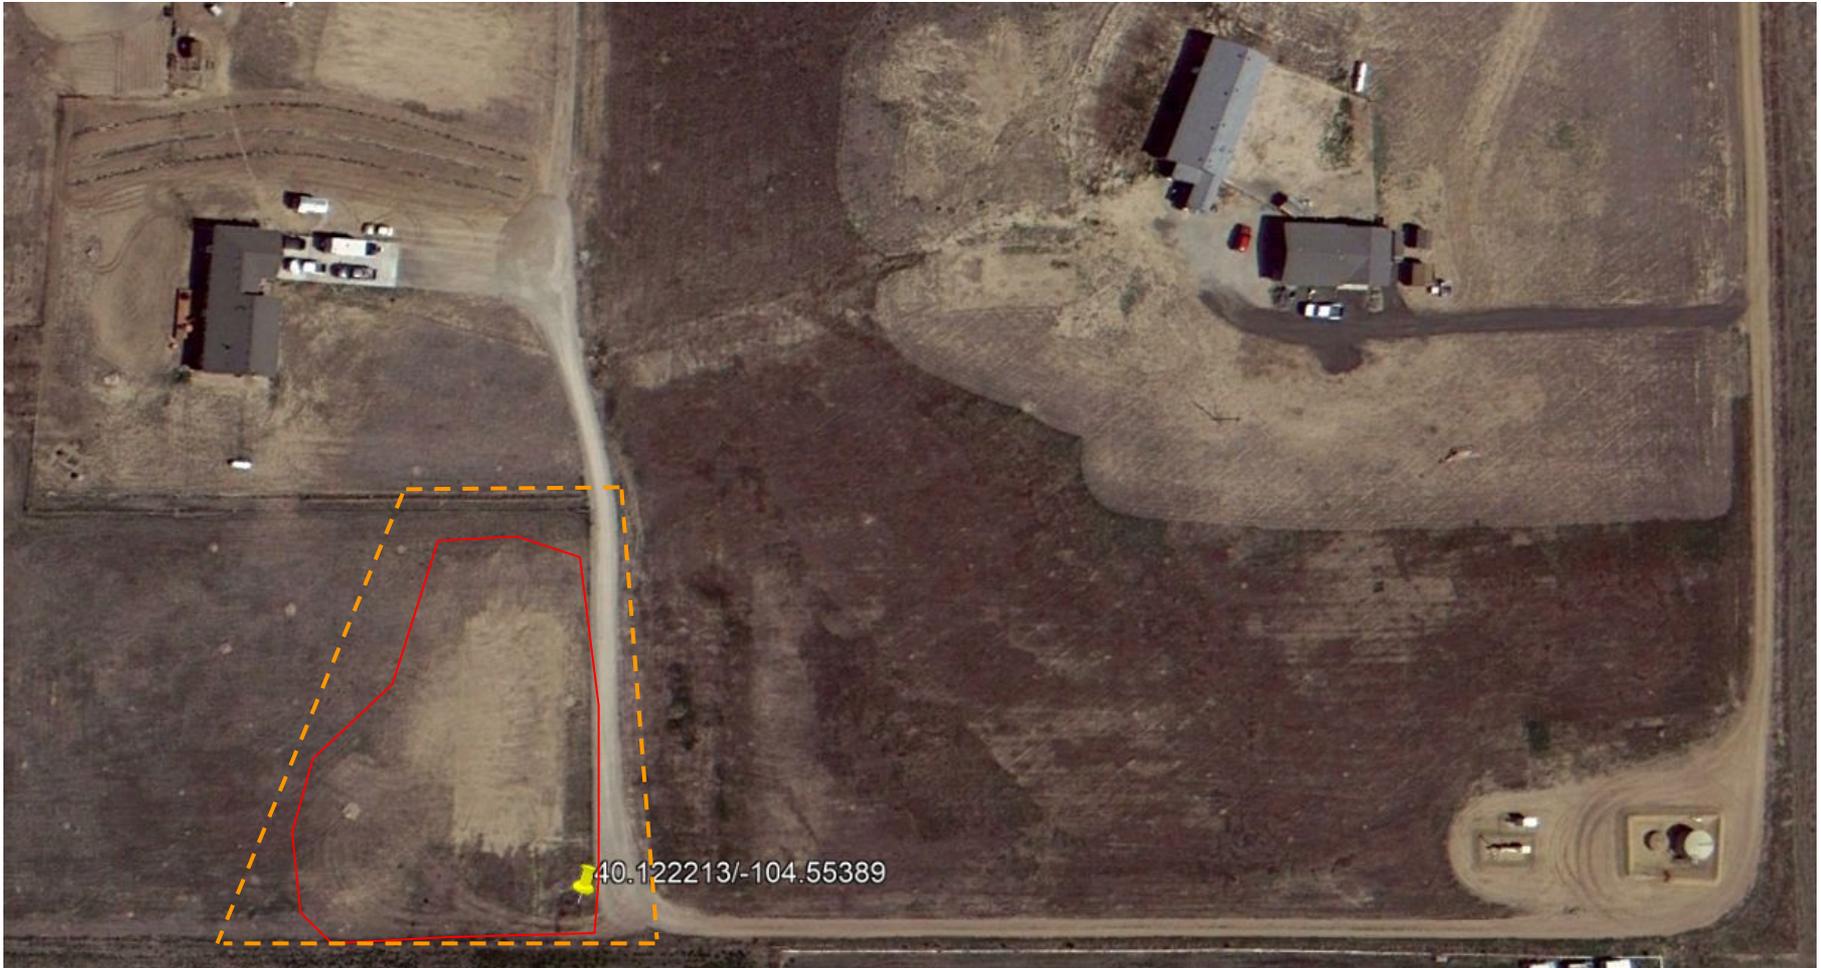
Google earth aerial imagery taken on 5/4/2011 during active operations to help illustrate the complainant issues. The yellow pin identifies the wellbore location and all of the complainant issues are everything within the orange-dashed line. To summarize the complainant issues, there was a disturbance within the red-circled polygon that has not been properly contoured and does not meet vegetation standards, not all of the gravel was properly removed from an access road, it doesn't appear the Operator has performed final reclamation activities at the well location and the Operator failed to put the fence back and gates along the property line.

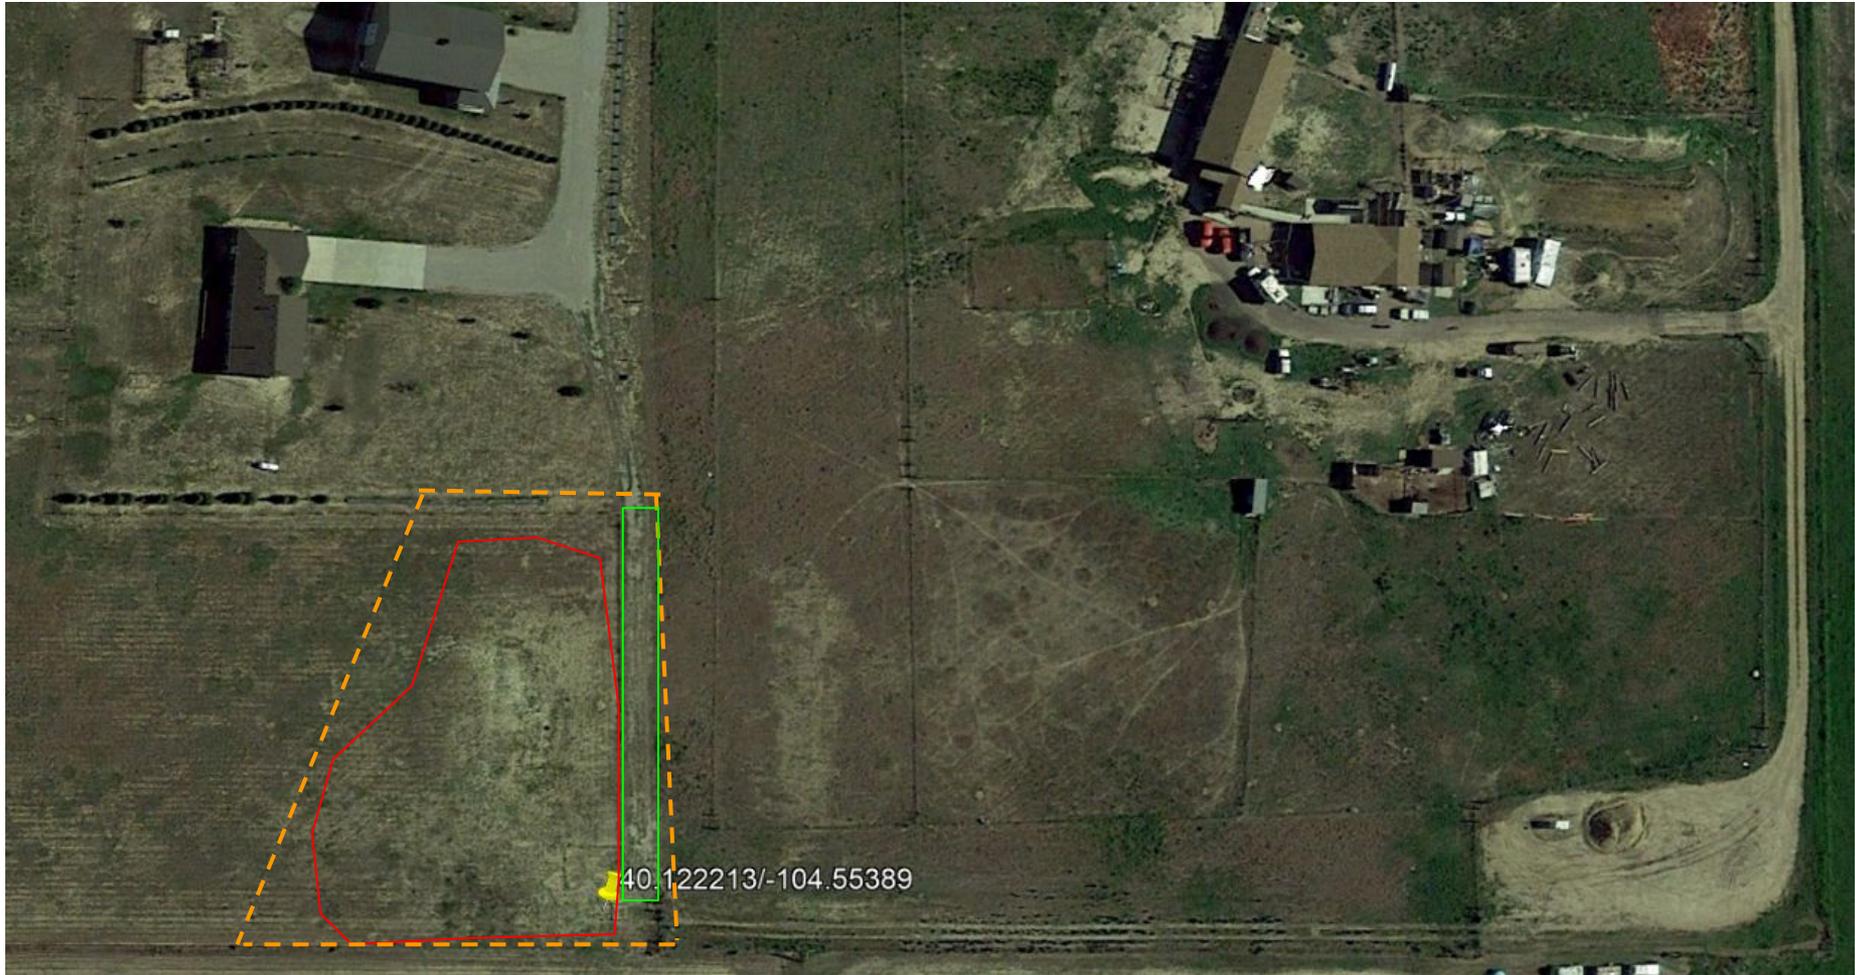
Google earth aerial imagery taken on 5/31/2018, approximately one month after plugging operations. See the previous page that summarizes the complainant issues. It appears the Operator has only performed final reclamation along the access road highlighted in green; however, the Operator has failed to control and manage a List B Colorado Noxious weed, Canada thistle, a List C Noxious weed, Field bindweed, and undesirable weedy annuals (Kochia and Russian thistle).

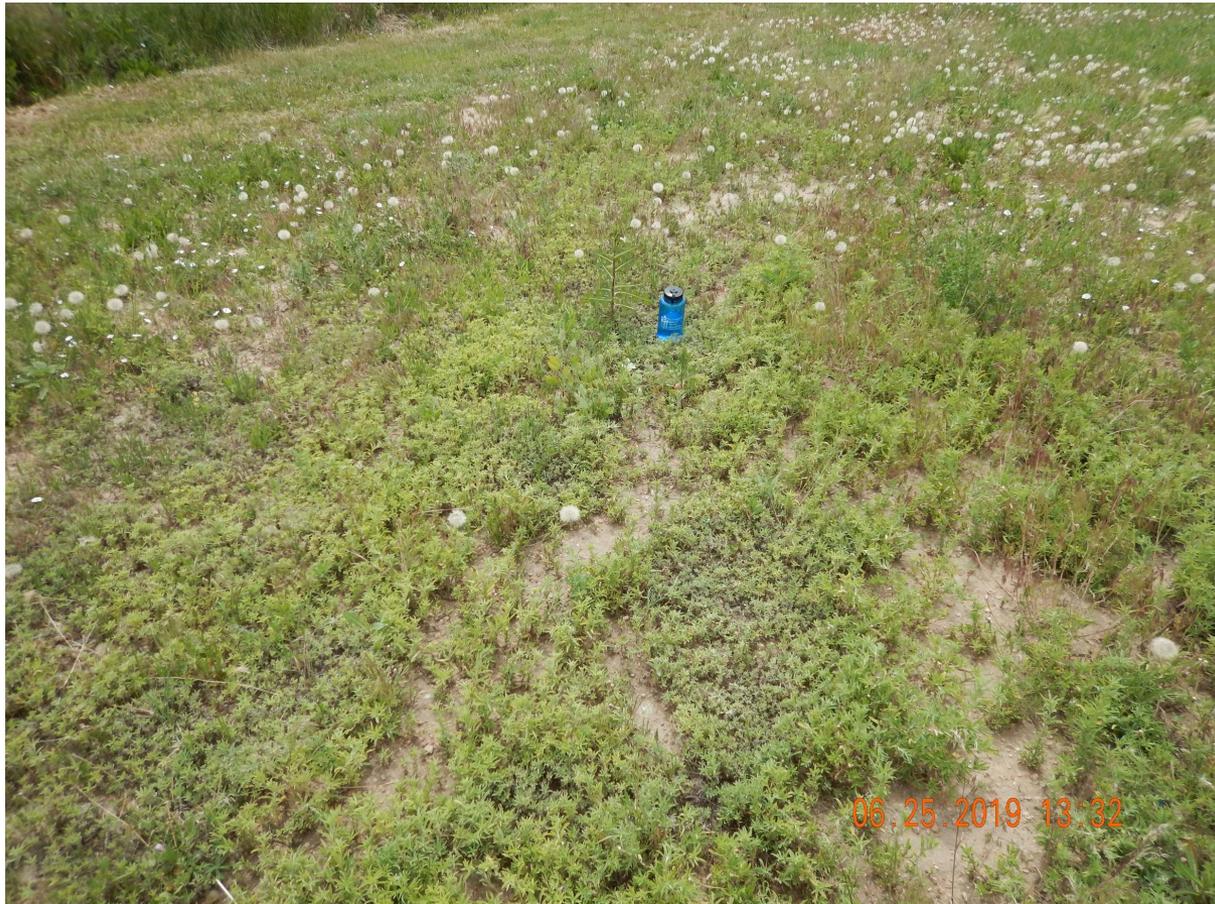
**Photo 1.** Photo taken from the well location, facing West. Photo illustrates the Operator failed to perform final reclamation activities at the well location, as there is no evidence of reclamation and only undesirable, weedy annual vegetation (Kochia).

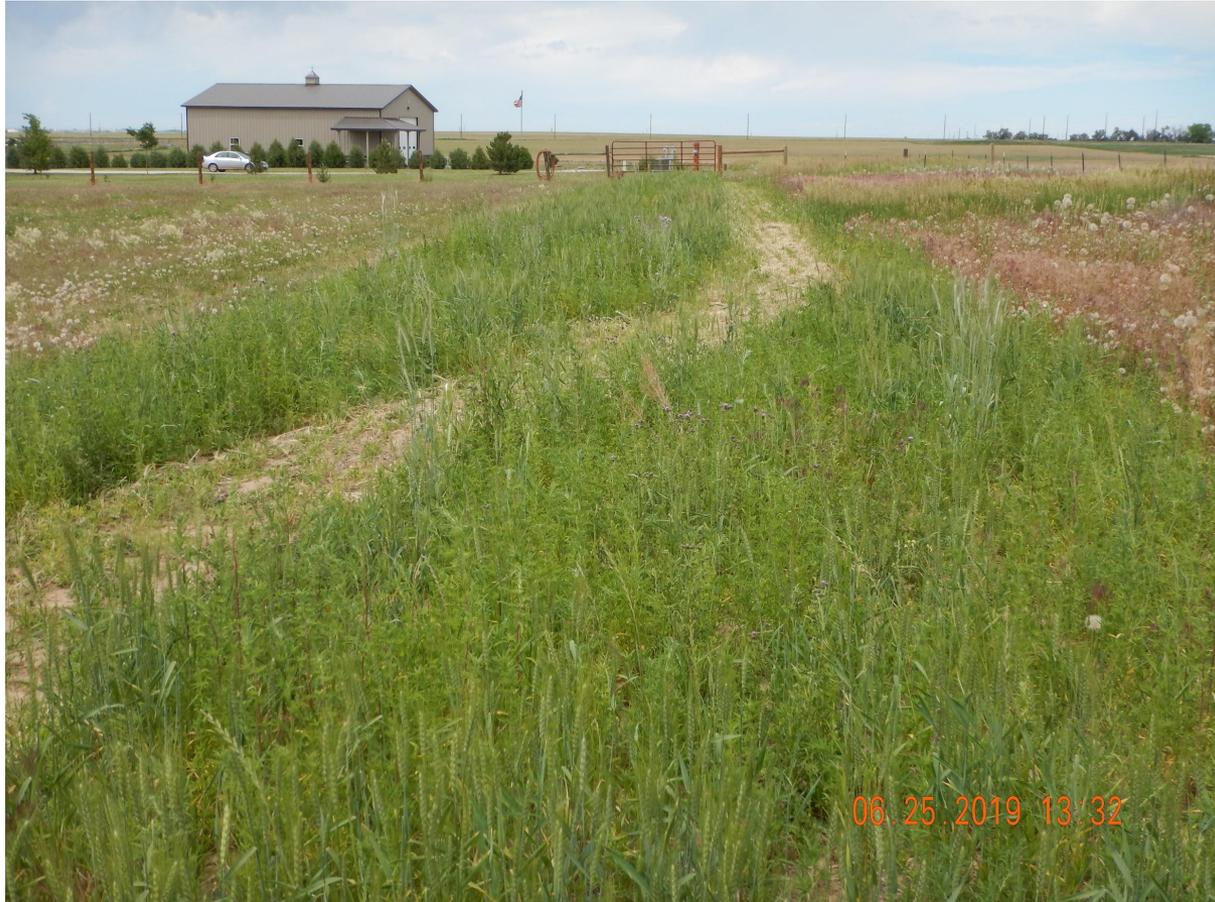
**Photo 2.** Photo taken from the well location, facing North. It appears the Operator has only performed final reclamation along the former access road but has failed to control and manage noxious weeds, undesirable weeds (Kochia) and remove gravel along the former fence line.

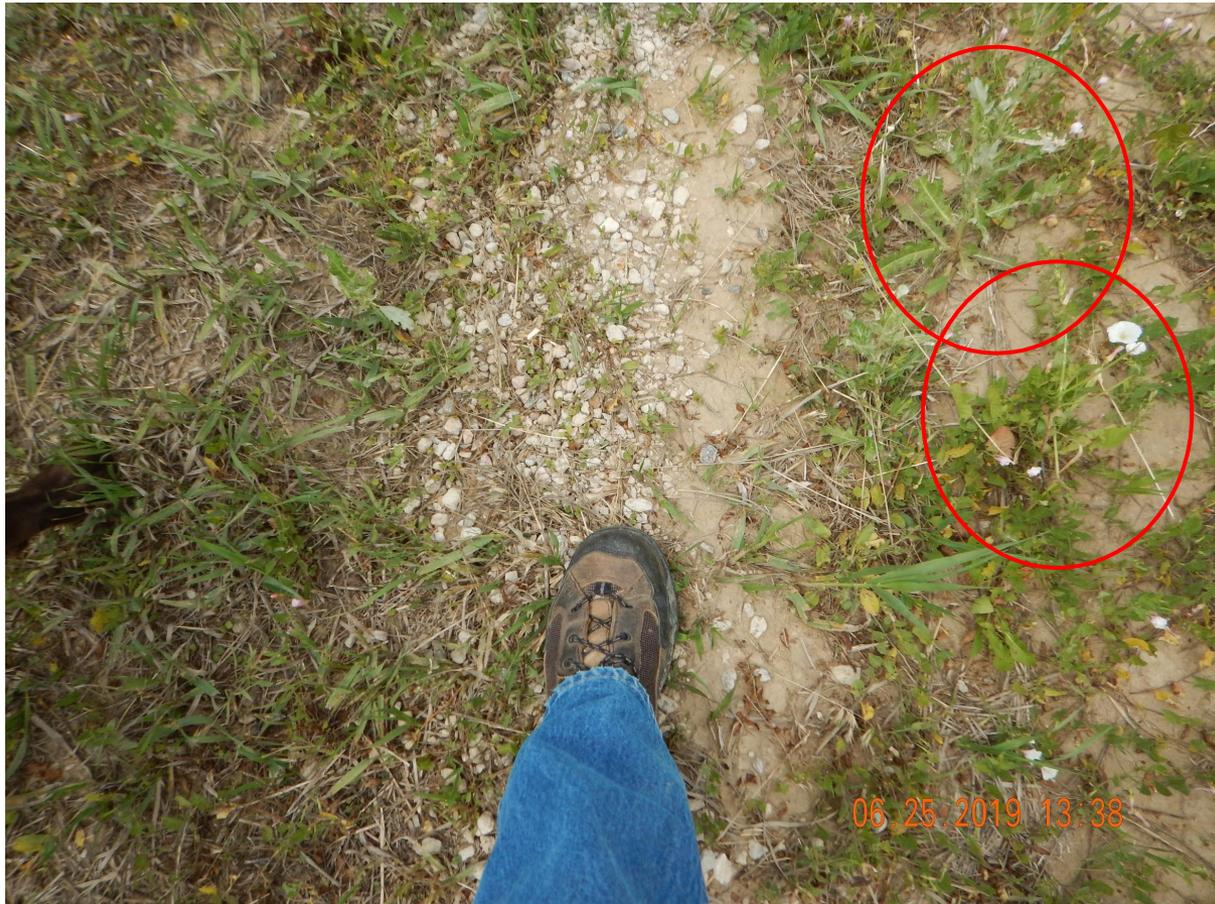
**Photo 3.** Photo taken from a portion of the former fence line where the Operator has failed to remove all gravel. The two red circles illustrate the presence of Canada thistle and Field bindweed.

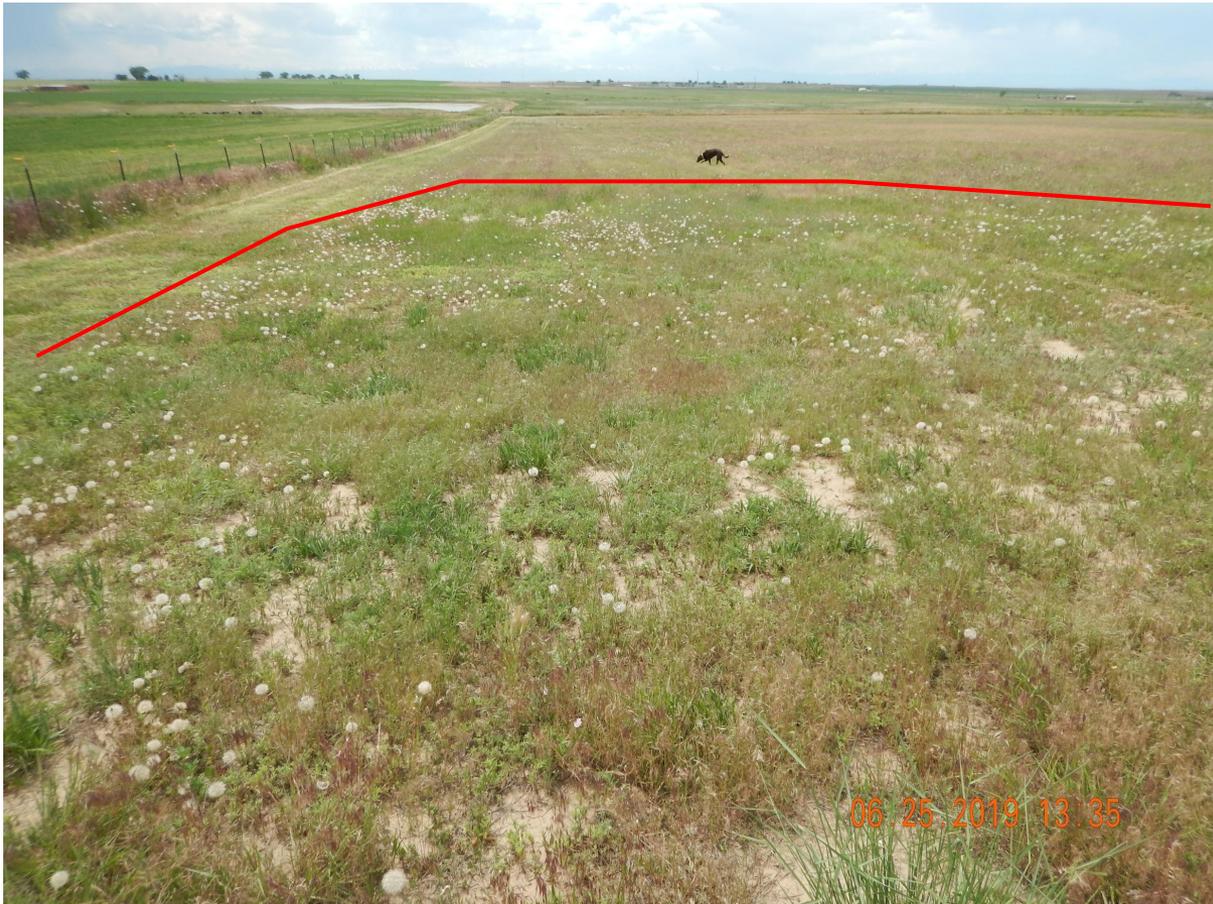
**Photo 4.** Photo taken from the well location, facing West. Everything below the red line has not been properly contoured to match the surrounding landscape.

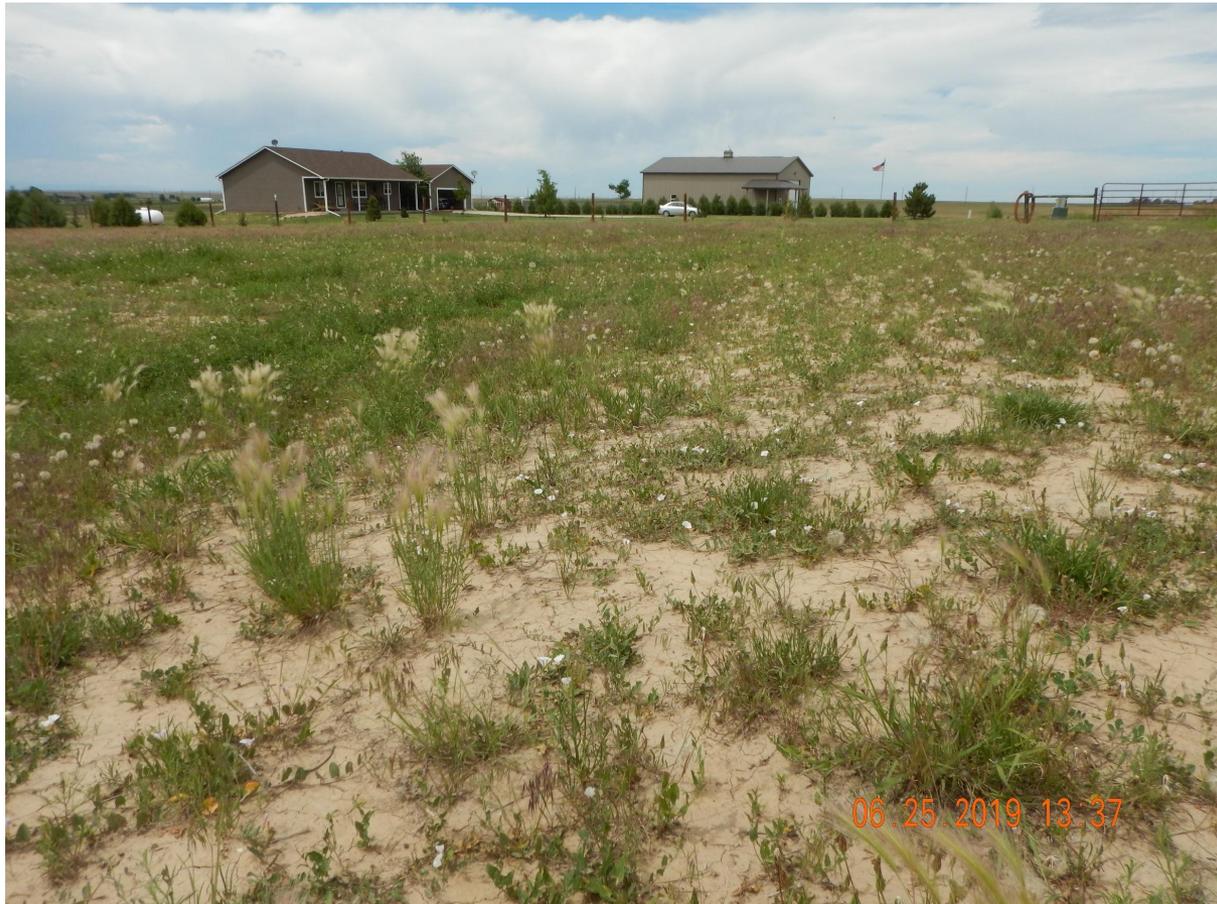
**Photo 5.** Photo taken from the disturbance area west of the well location, facing North. Photo illustrates the disturbance area has not been properly contoured to match the surrounding landscape.
