Inspection Photos

Location Name: SOUTH SHALE RIDGE-68S98W /7NWSE

Location ID: 323851

Inspection Date: June 11, 2019

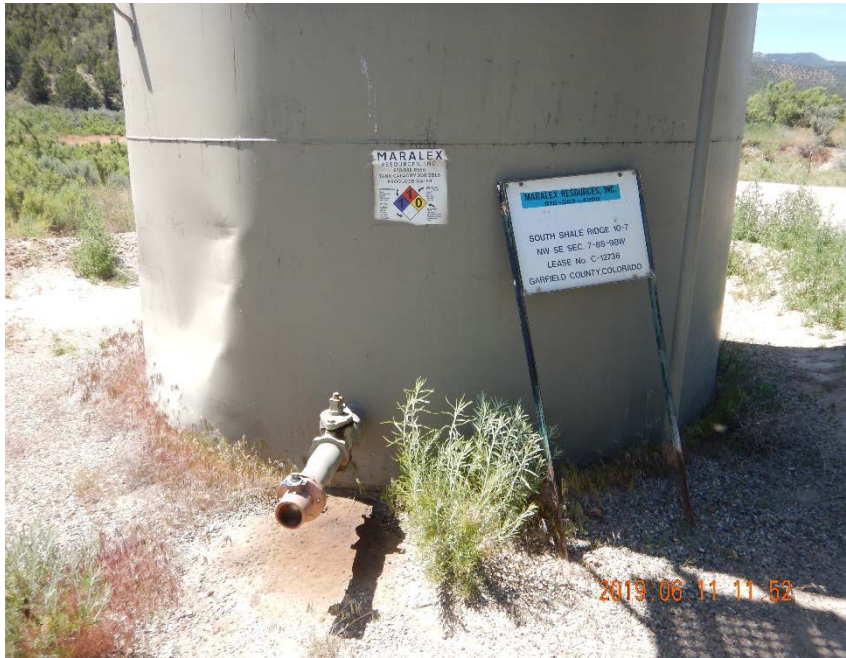
Photo #1 – Facility sign located at tank battery. Note accumulation of oil-stained soil beneath truck loadout and uncontrolled weeds in bermed area.

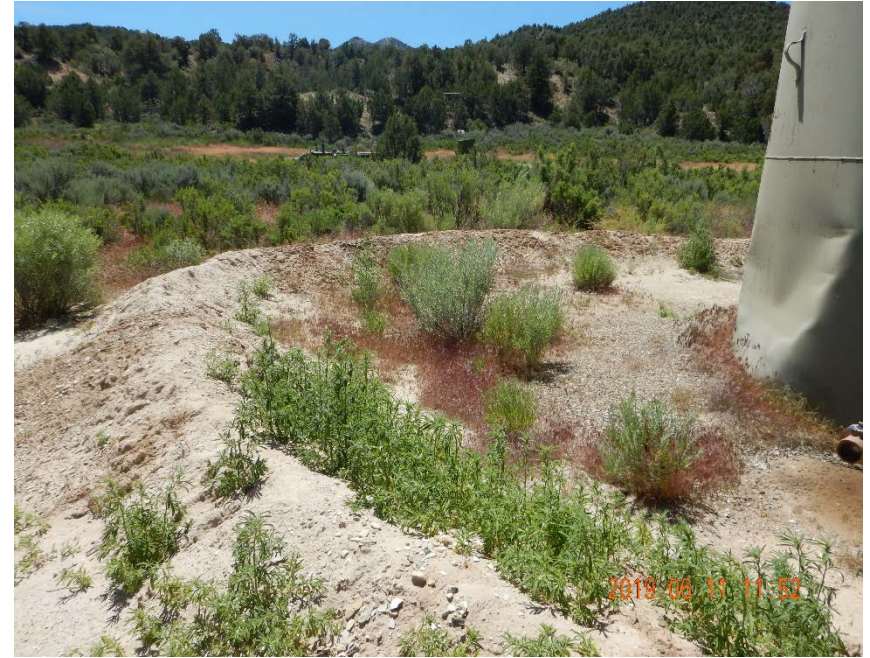
Photo #2 – Uncontrolled weeds and eroded berms at tank battery.

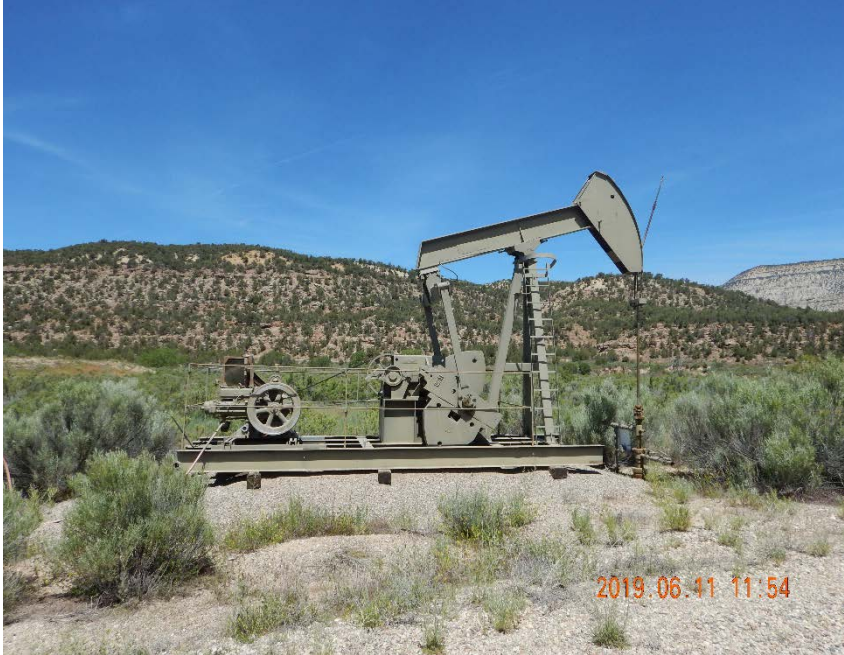
Photo #3 – Pump jack and wellhead are located northwest of tank battery, across lease road.

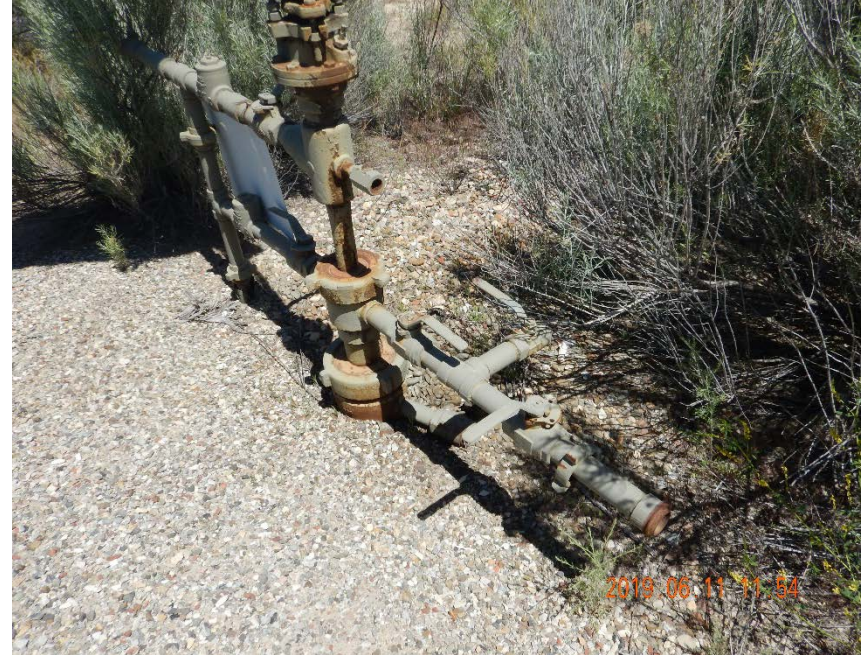
Photo #4 – View of wellhead from south.

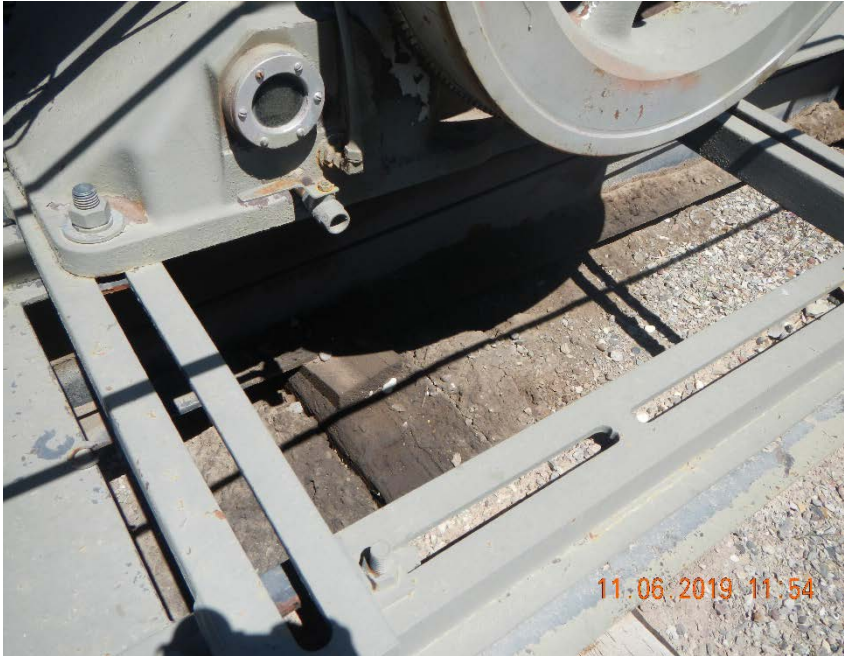
Photo #5 – Accumulation of oil-stained soil beneath prime mover.

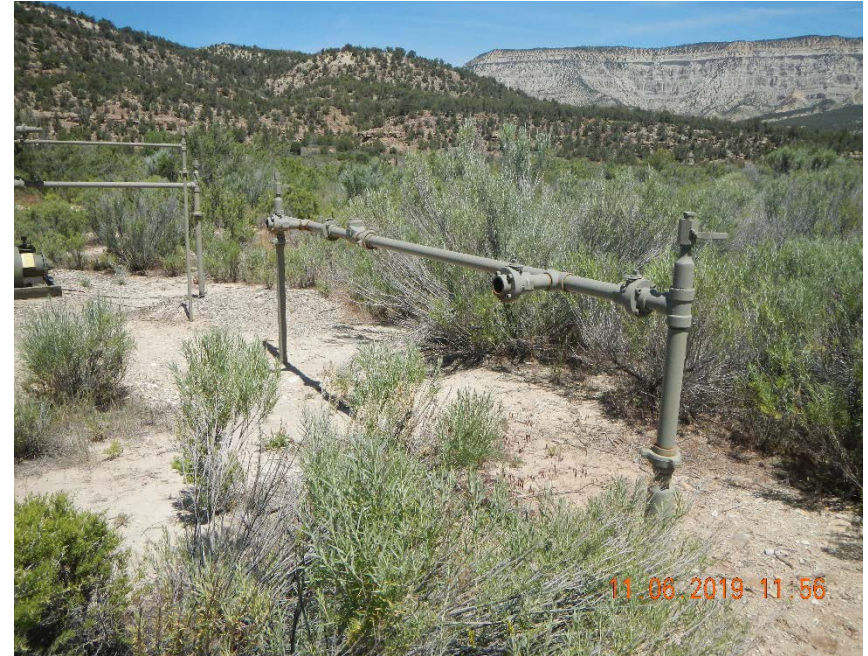
Photo #6 – Uncapped, unmarked flowline manifold west of pump jack. Note uncontrolled weeds in this location.

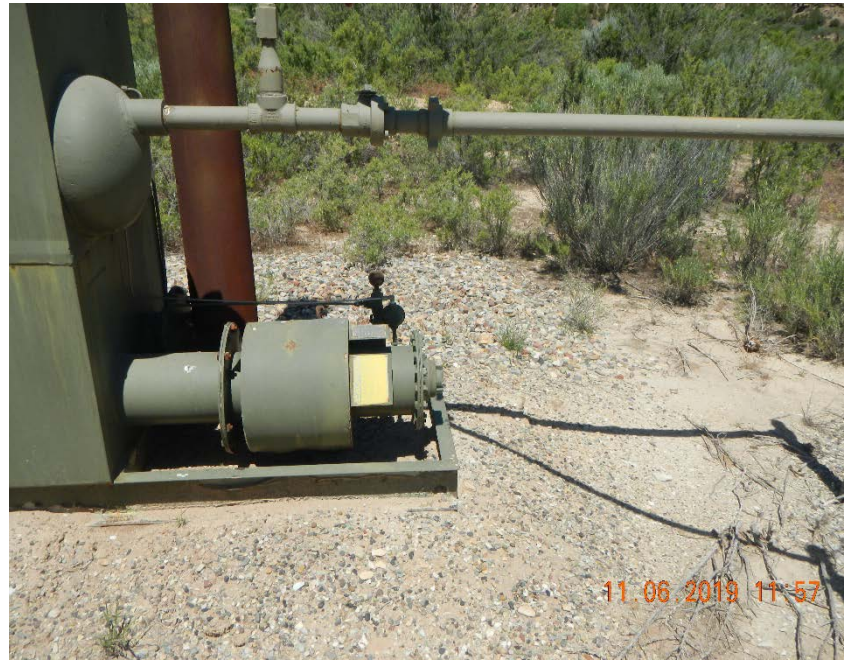
Photo #7 – Uncontrolled weeds near separator.
