Construction and Stormwater Inspection

June 25, 2019

Operator: CRESTONE PEAK RESOURCES OPERATING LLC - #10633

Location ID: 455598

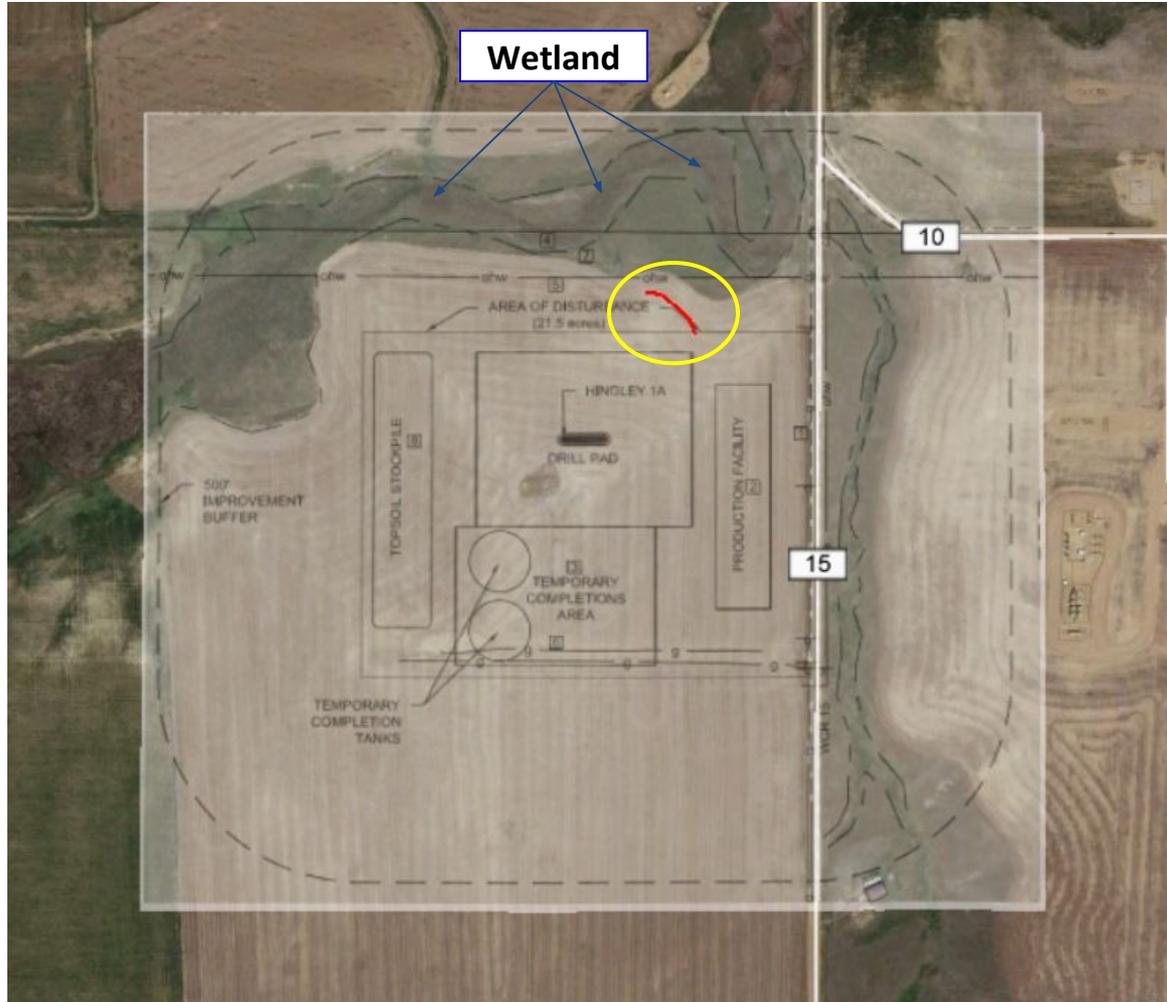
Google Earth aerial imagery taken on 6/9/2017 which has been overlaid with the Operator Location Drawing and field collected data from 6/25/2019 (red line). Aerial imagery illustrates a red line with the approximate path of stormwater erosion that left location during construction operations due to inadequate stormwater BMPs- see Photos 1-5. Note- there were other discharge points along the northern perimeter of the location.

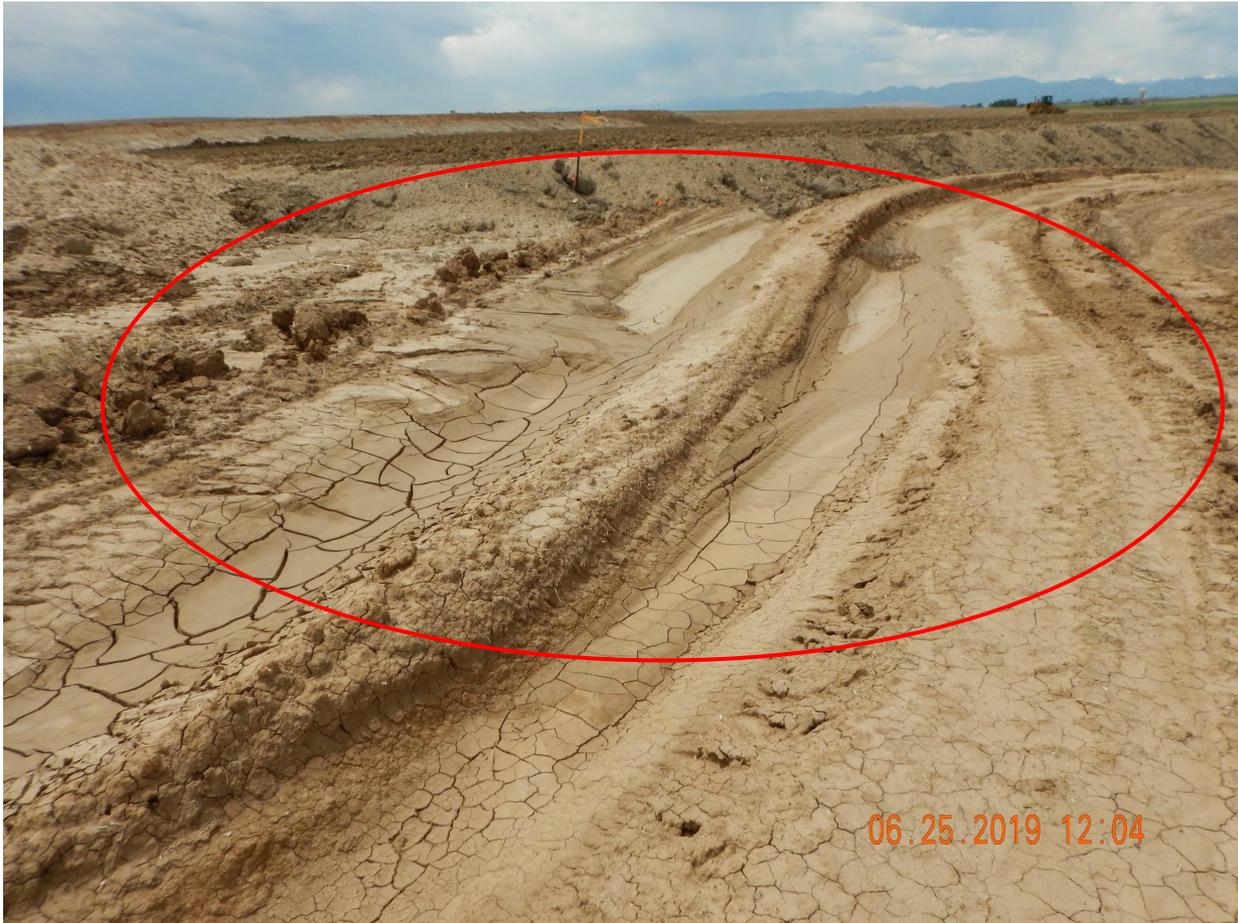
Photo 1. Photo taken from the northeastern location, facing West. Photo illustrates the starting point of the sediment discharge point that was illustrated with the red line in the previous photo. Photo illustrates how both ditches with sediment accumulation.

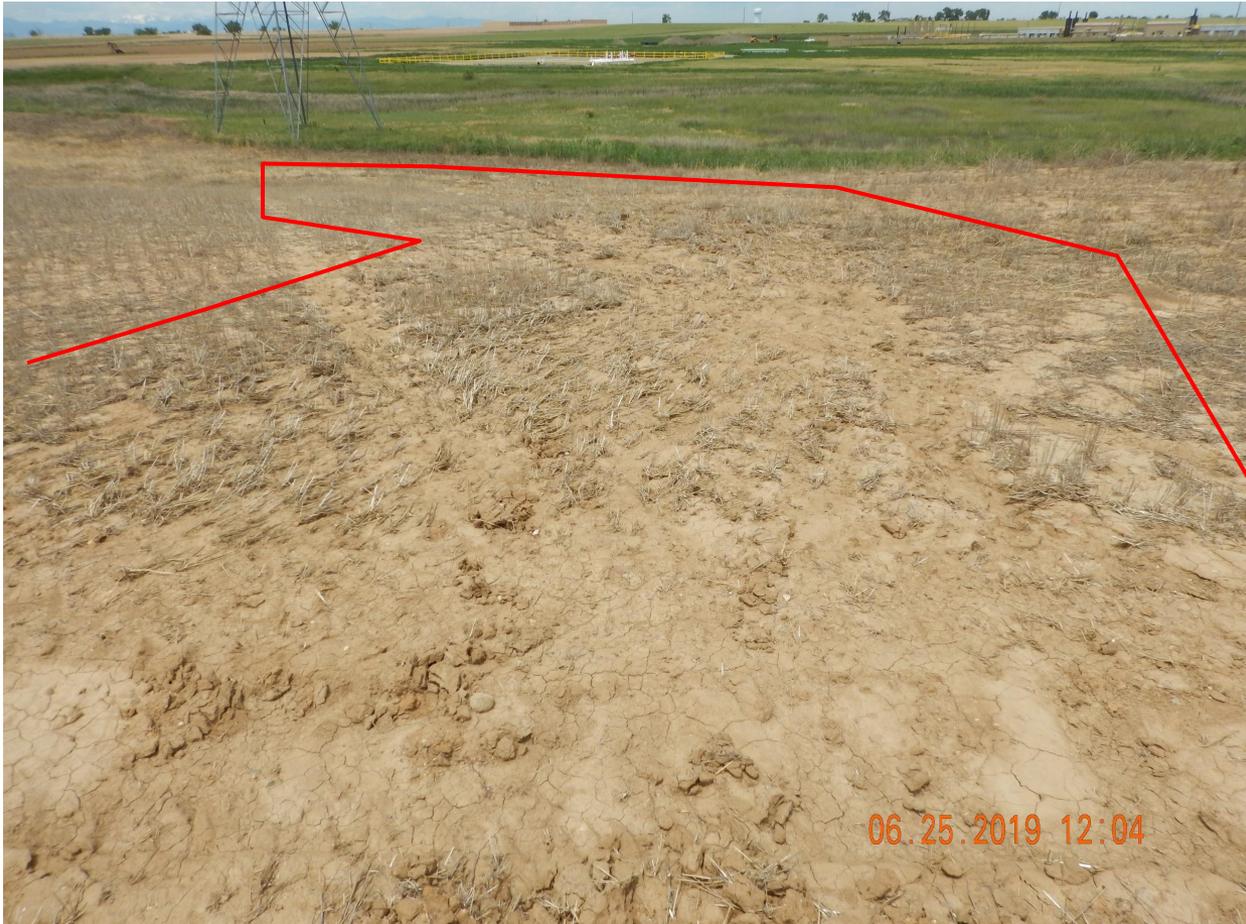
Photo 2. Photo taken from the discharge point along the northeastern perimeter of location, facing North. Photo illustrates wheat stubble that has been laid over due to stormwater erosion discharge from location.

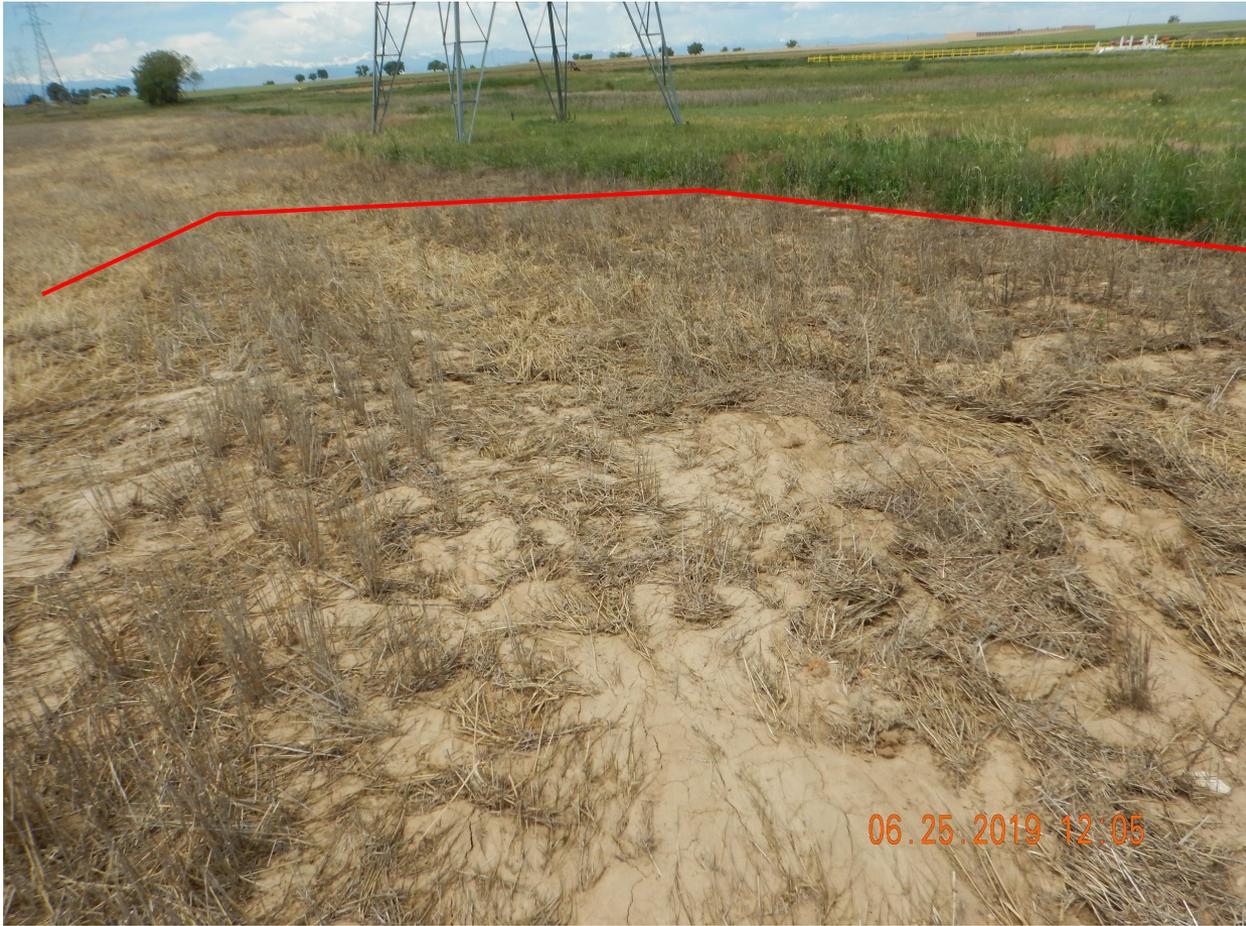
Photo 3. Photo taken from a portion of the northern discharge path, facing West. Photo illustrates sediment accumulation from stormwater erosion discharge from the location.

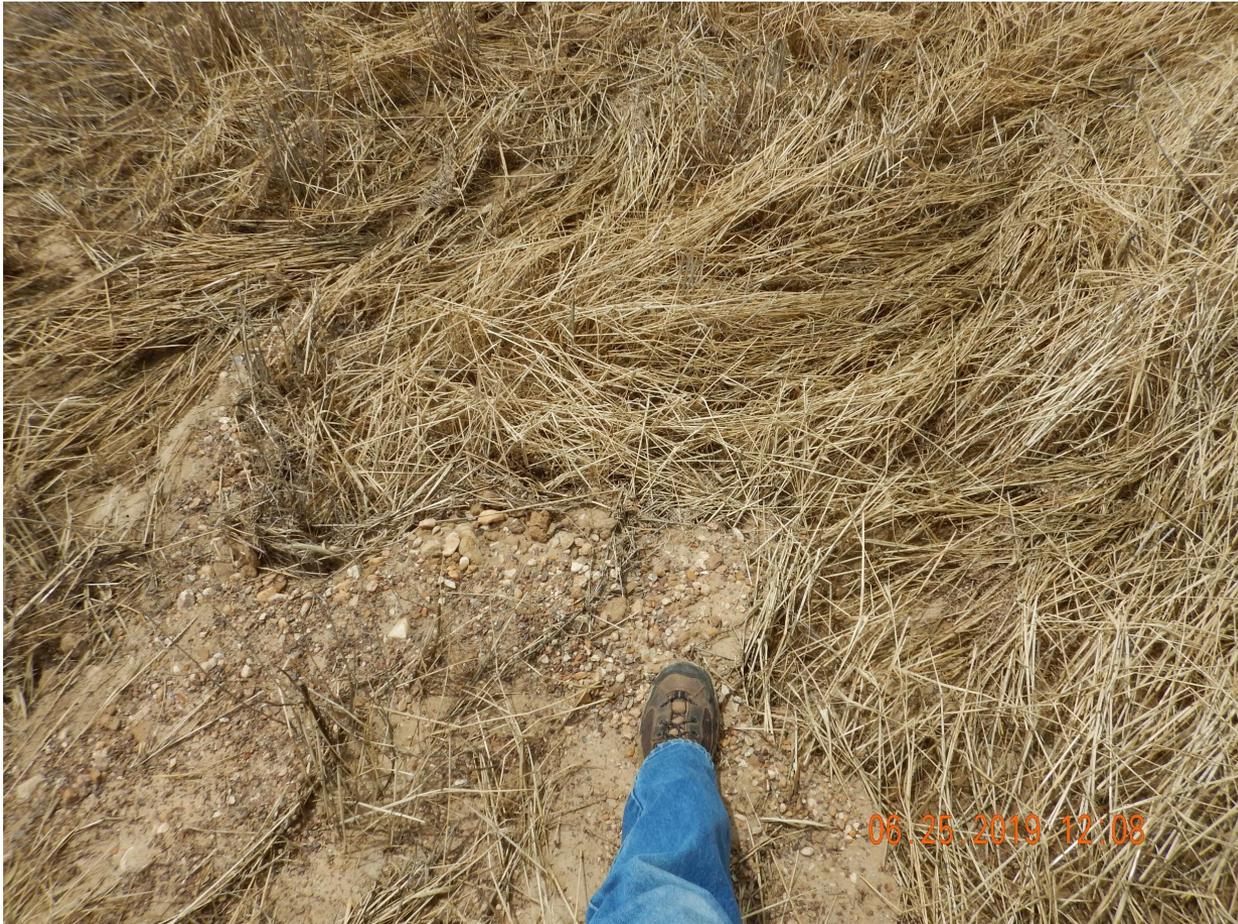
Photo 4. Close up photo taken of the sediment accumulation from stormwater erosion discharge from the location.

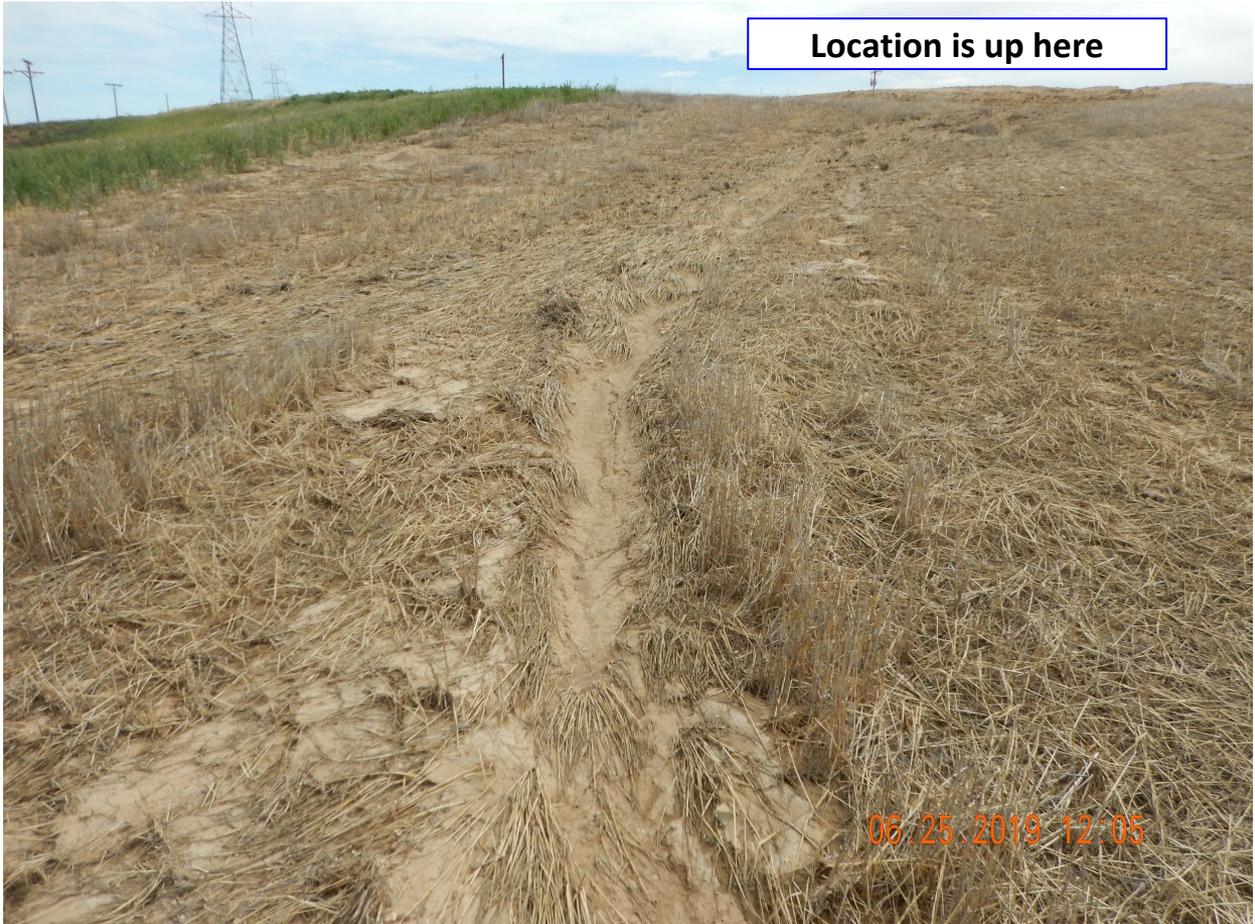
Photo 5. Photo taken from a portion of the northern discharge path, facing South. Photo illustrates the evidence of a portion of the stormwater erosion discharge path that left the location.

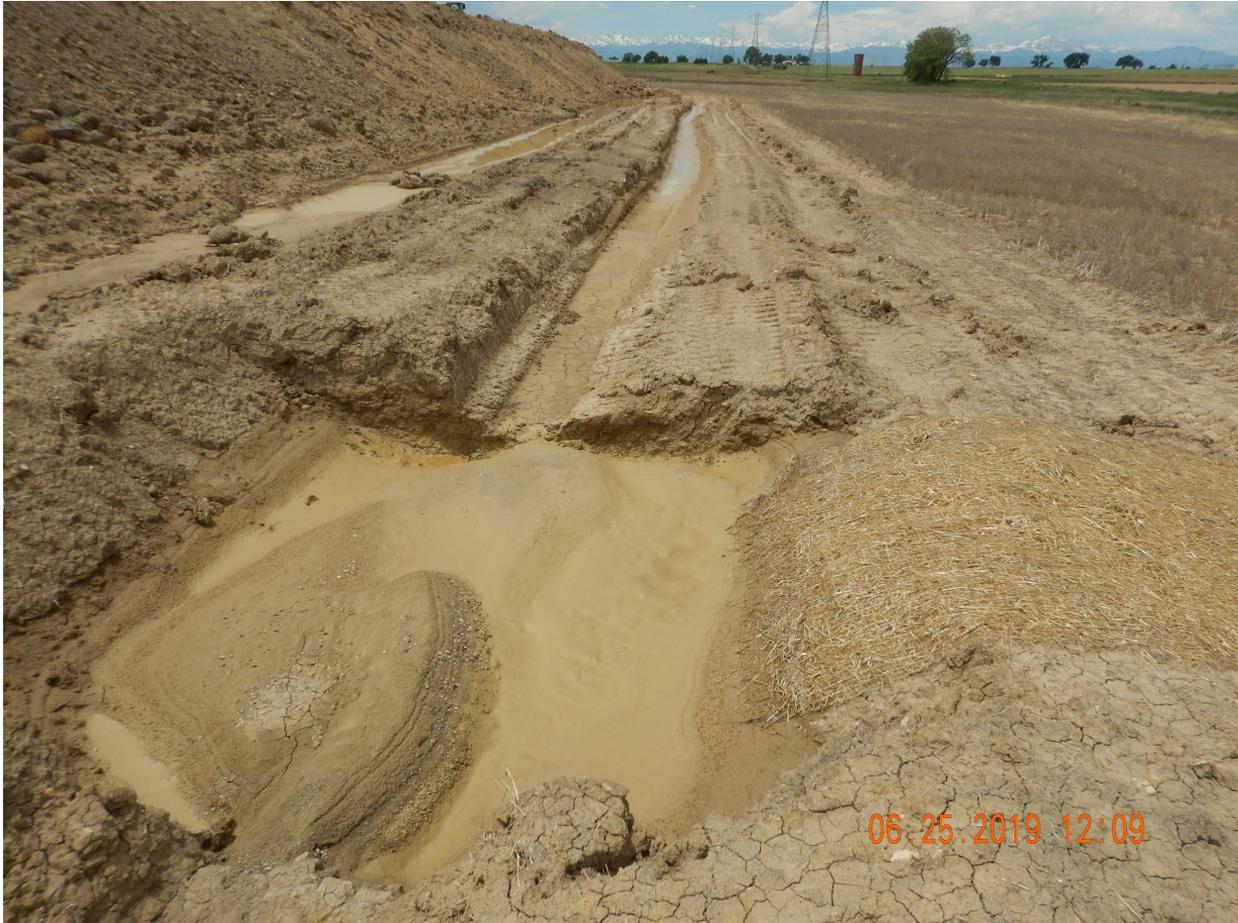
Photo 6. Photo taken from the northern perimeter of location, facing West. Photo illustrates an improperly installed sediment trap. Operator has failed to install the sediment trap per good engineering practices and it doesn't appear to be properly sized as sediment accumulation has almost filled it up. Based off my observations, the Operator installed this sediment trap after sediment had already discharged from location- see Photo 7.

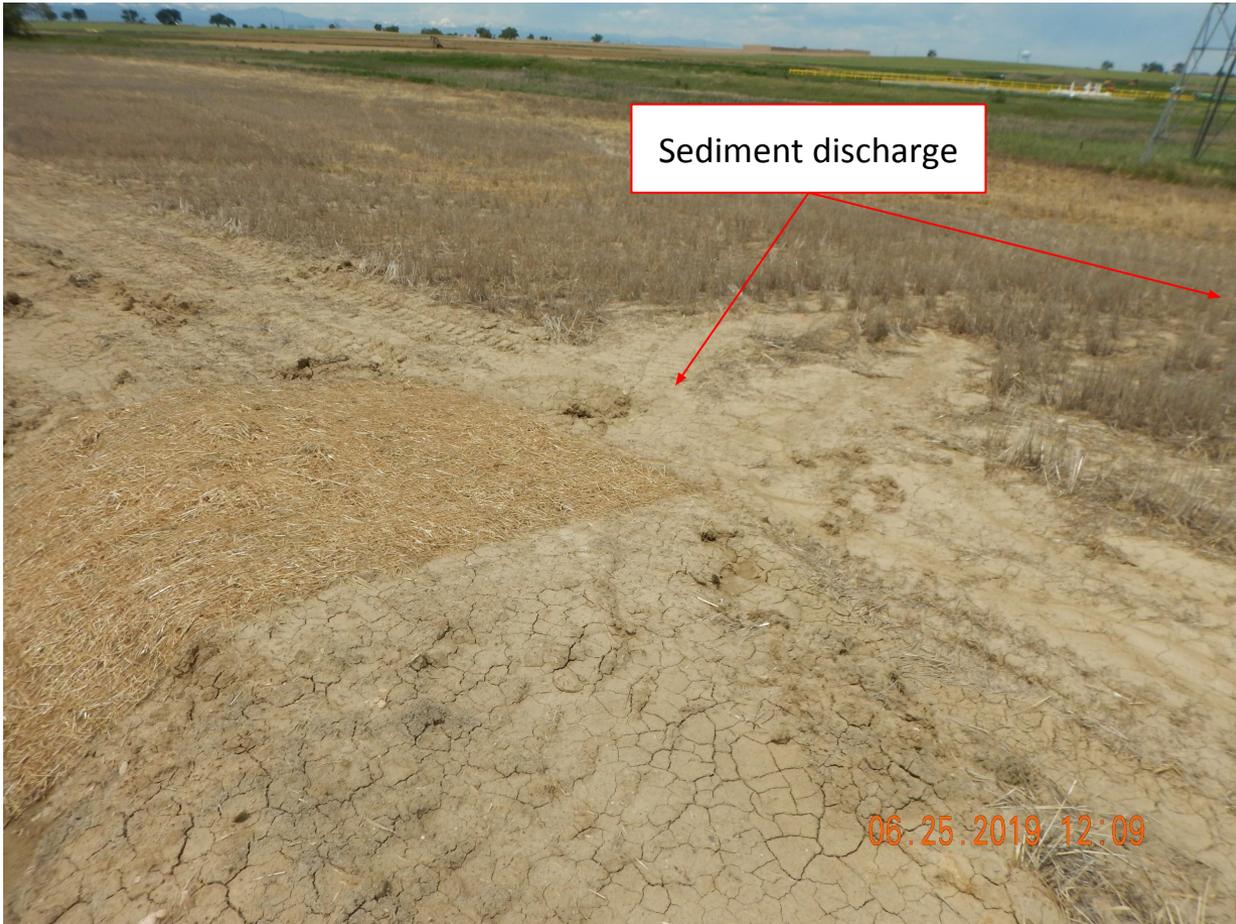
Photo 7. Photo taken from the northern perimeter of location, facing Northwest. Sediment discharge was observed beyond the temporary stabilized outlet (erosion control blanket). There was no observed sediment within the erosion control blanket which would imply it was installed after the discharge event.

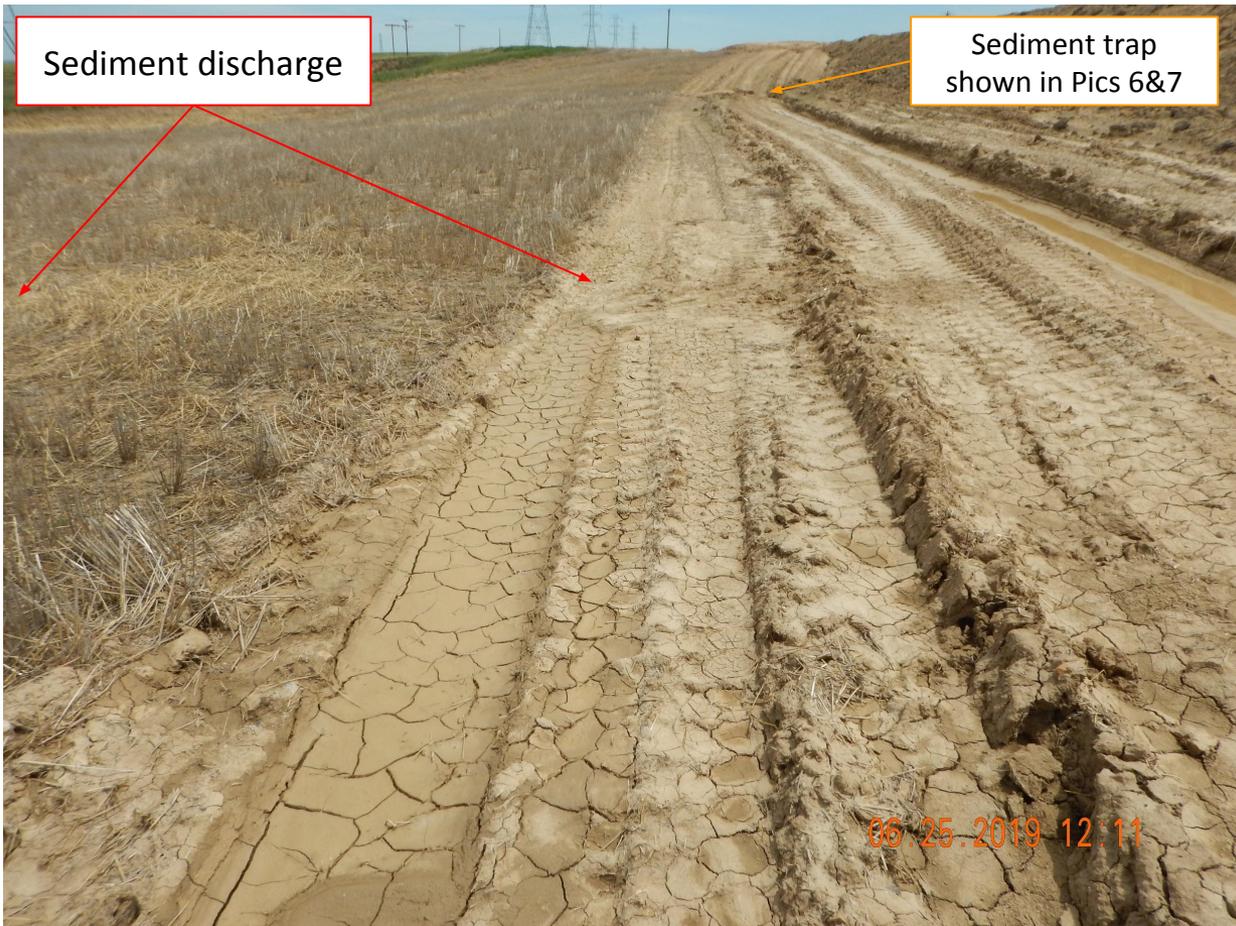
Photo 8. Photo taken from northwestern perimeter of location, facing East. Photo illustrates another point of discharge from location. Also, photo illustrates how the berm BMP has not been properly installed, as unconsolidated material has not been stabilized.

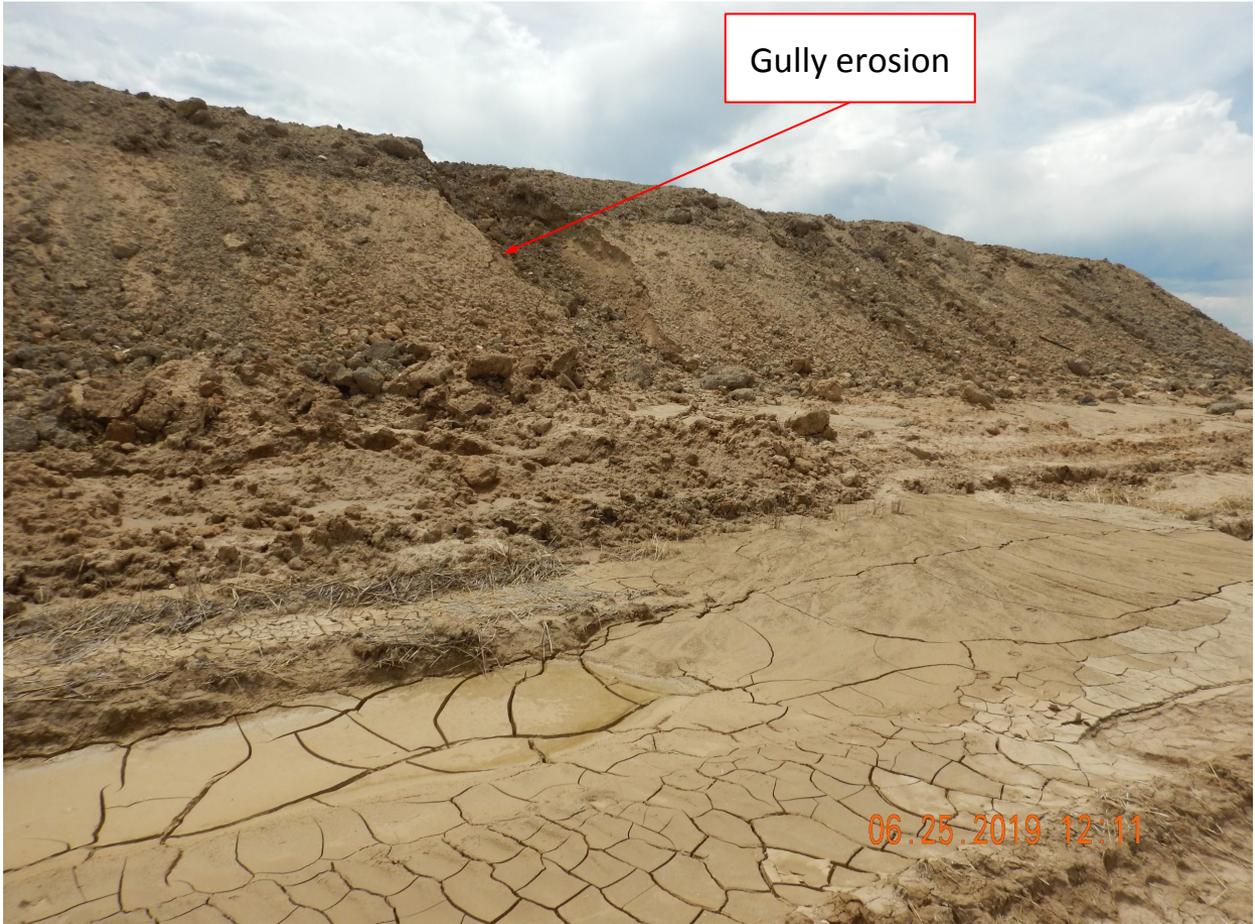
Photo 9. Photo taken from northwestern perimeter of location, facing Southwest. Photo illustrates gully erosion along the fill slope which has filled in the perimeter ditch and berm BMP.

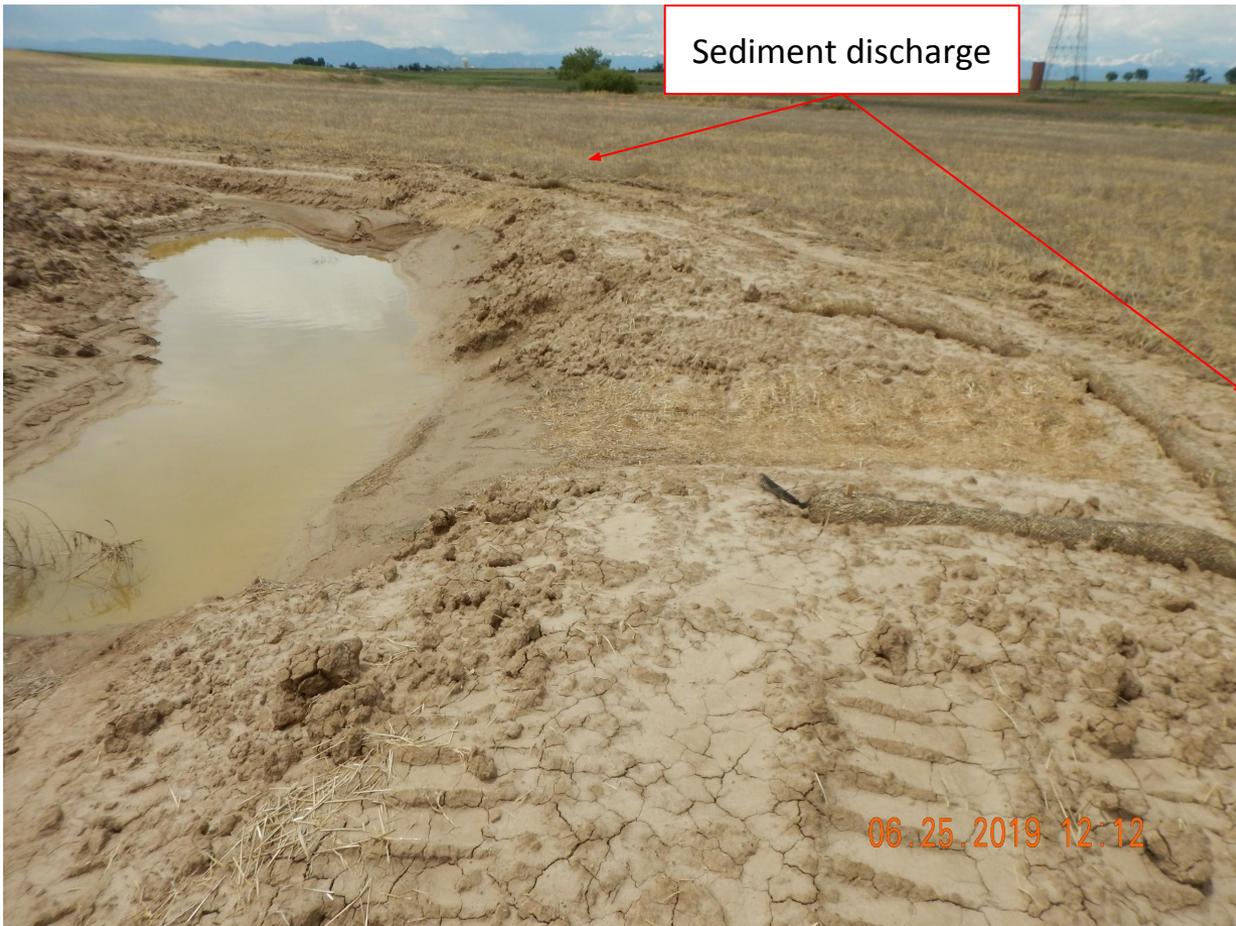
Photo 10. Photo taken from northwestern perimeter of location, facing West. Photo illustrates an improperly installed sediment trap. Operator has failed to install the sediment trap per good engineering practices and it has not been properly sized because sediment discharge was observed beyond the temporarily stabilized outlet (erosion control blanket)- see Photo 11.

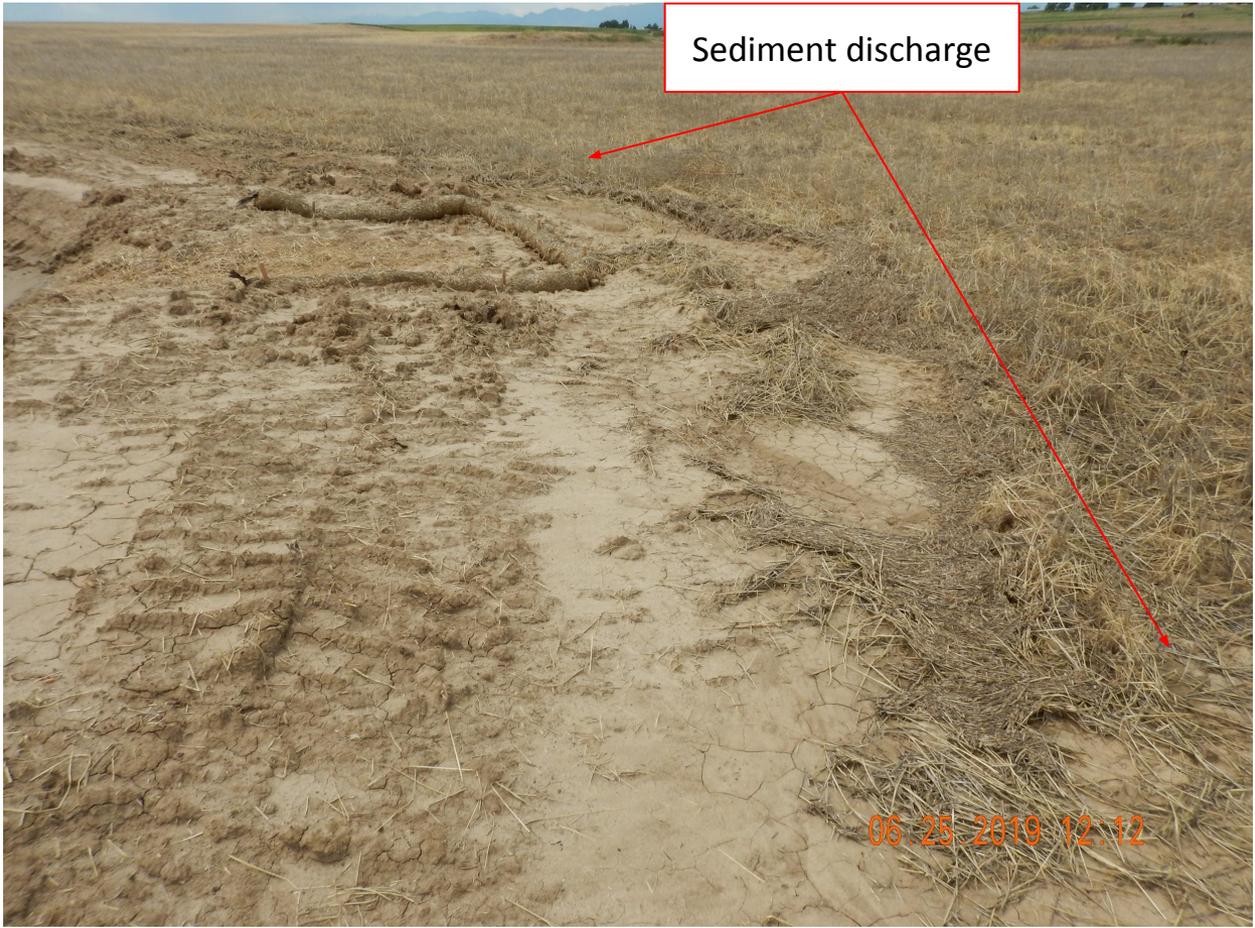
Photo 11. Close up photo taken from northwestern perimeter of location, facing West. Photo illustrates sediment discharge beyond the temporarily stabilized outlet (erosion control blanket).

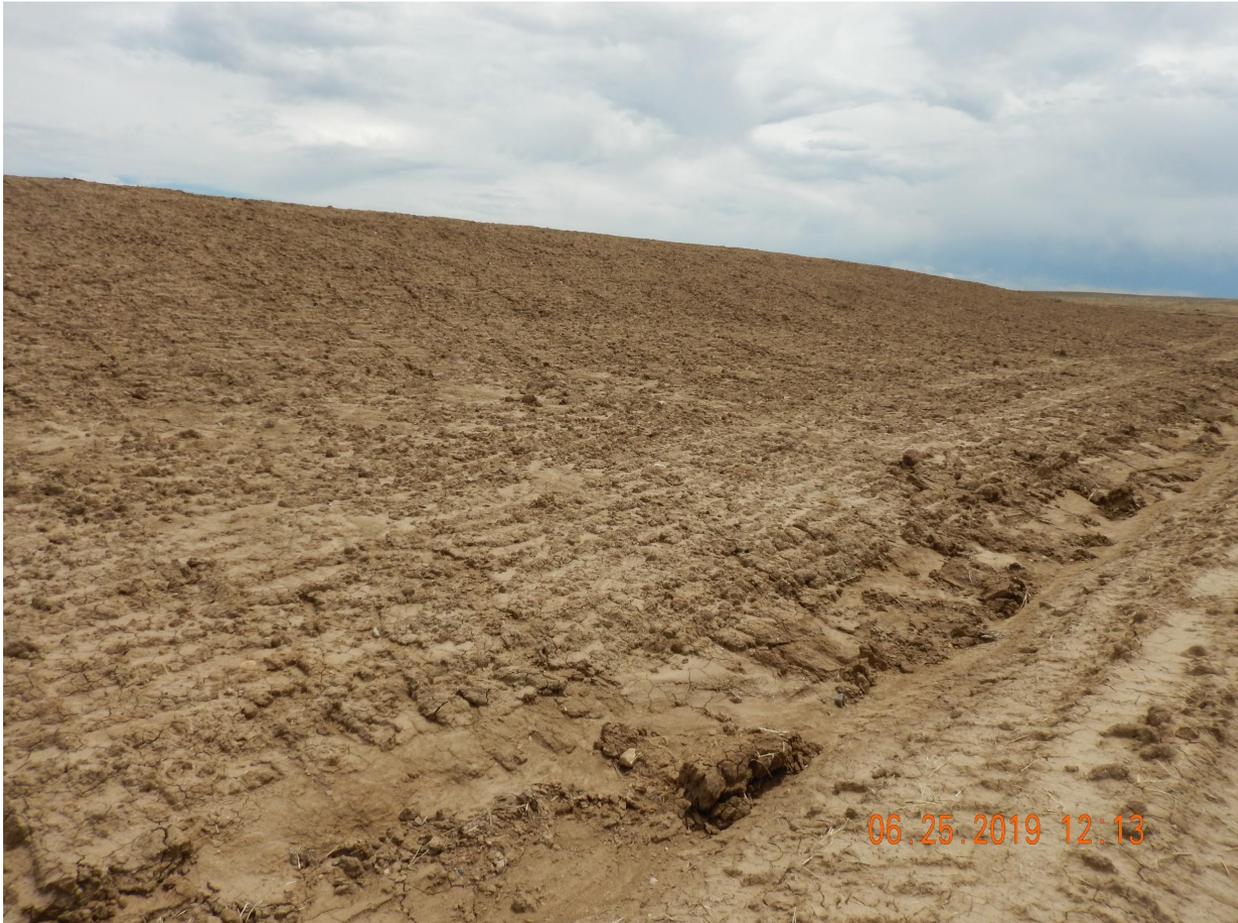
Photo 12. Photo taken from western perimeter of location, facing South. Photo illustrates the topsoil stockpile which has been temporarily stabilized but rill erosion was observed throughout.

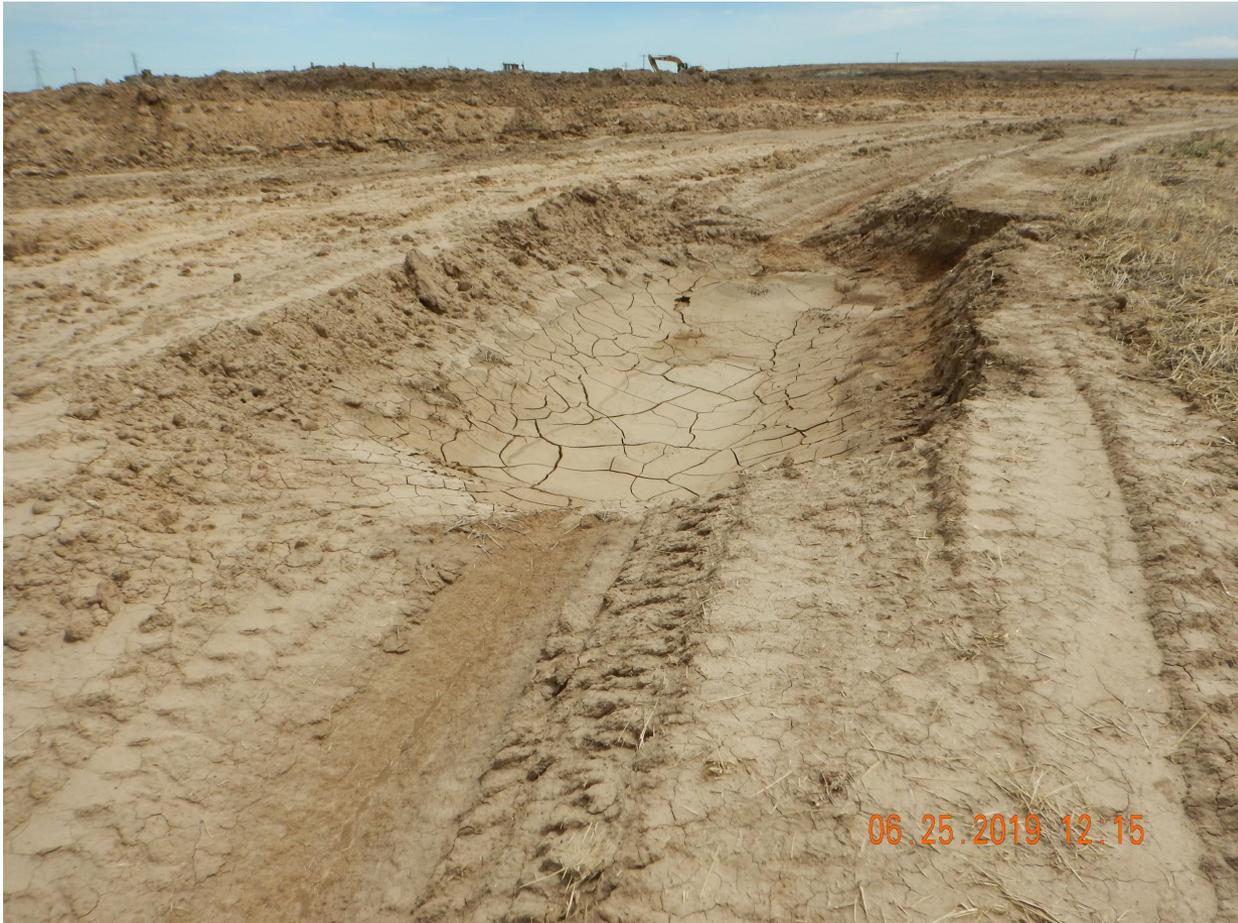
Photo 13. Photo taken from southwestern perimeter of location, facing East. Photo illustrates an improperly installed sediment trap. Operator has failed to install the sediment trap per good engineering practices, as the sediment trap itself appears to be eroding.

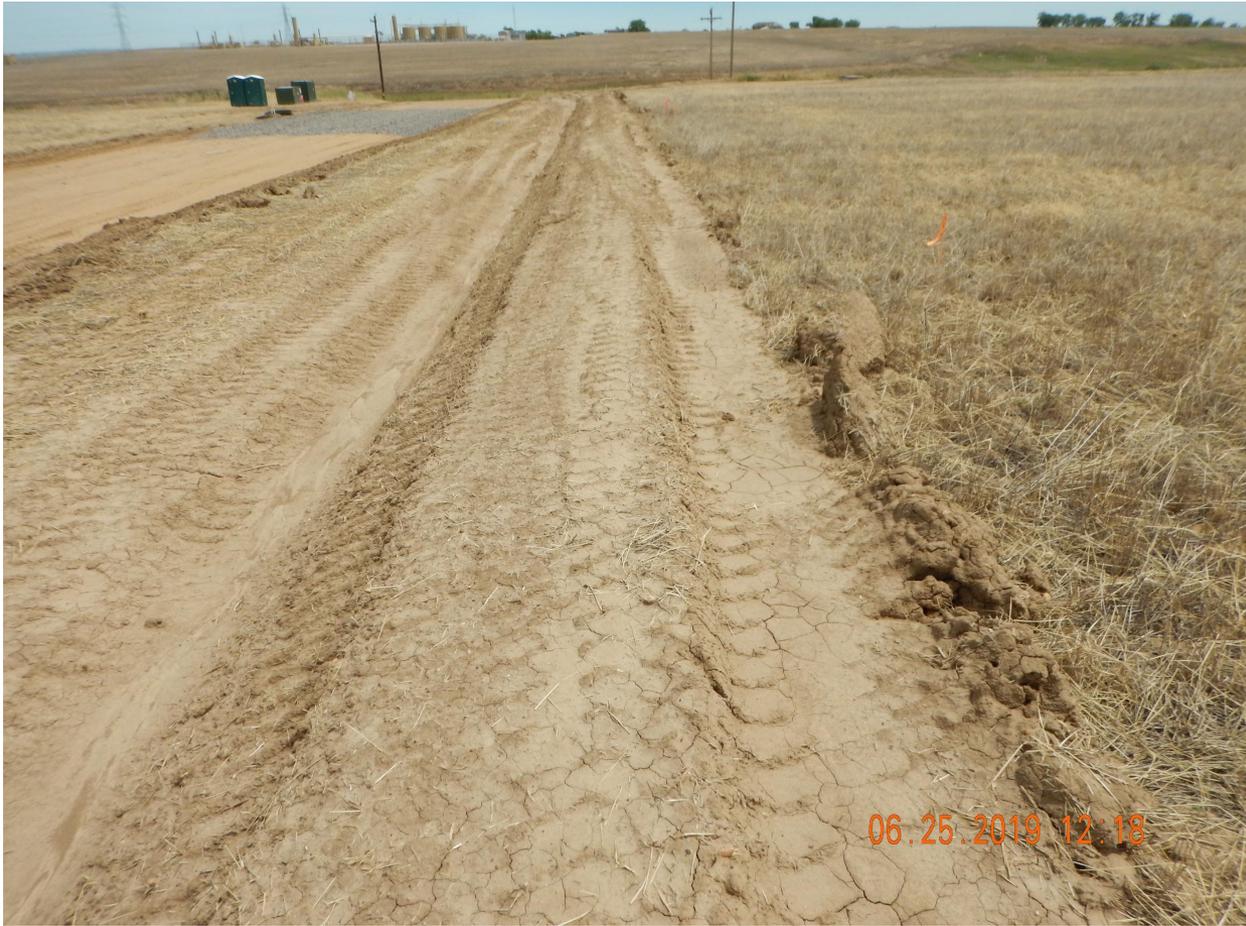
Photo 14. Photo taken from southern perimeter of location, facing East. Photo illustrates an improperly installed berm BMP, as unconsolidated material has not been stabilized.

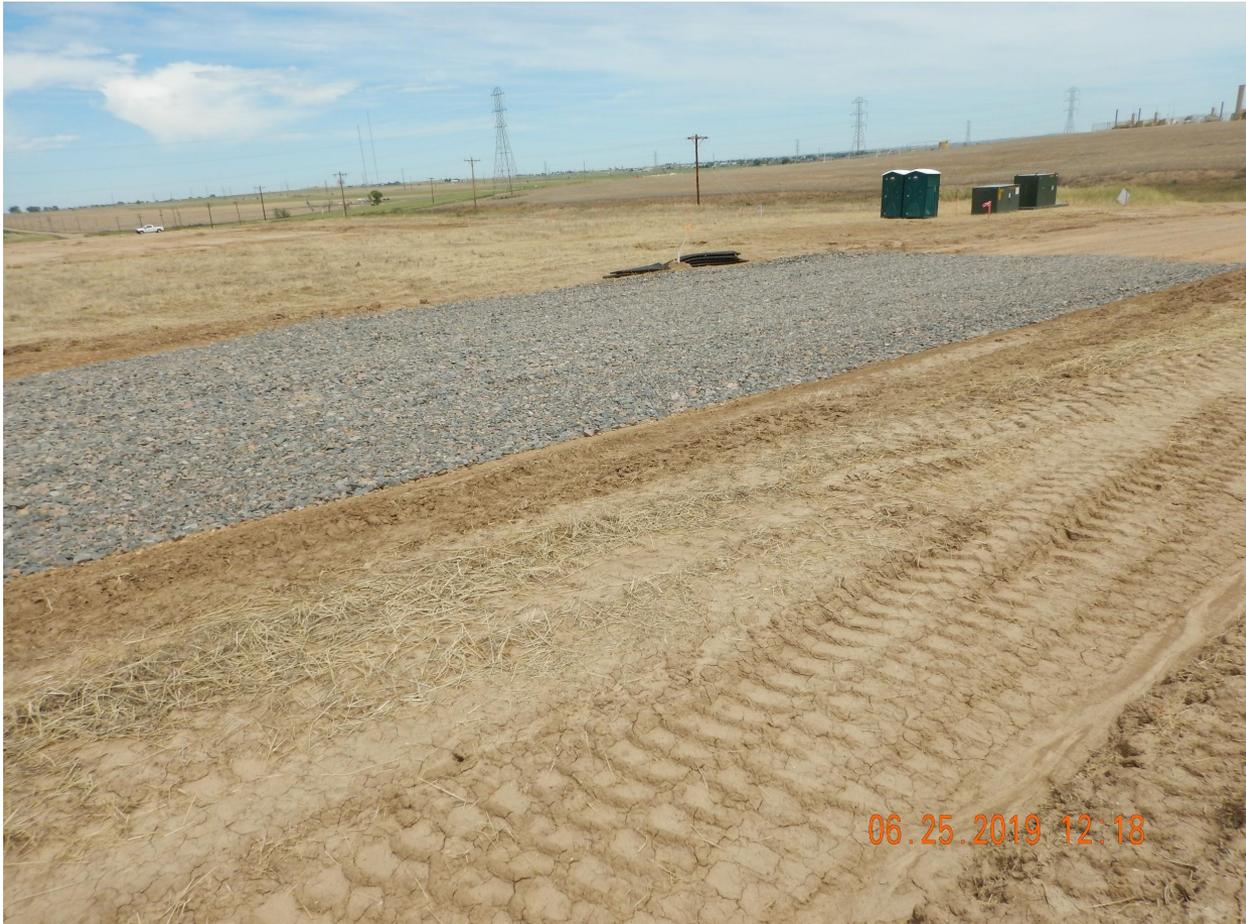
Photo 15. Photo taken from the southern entrance of location, facing Northeast. Operator has installed a vehicle tracking device BMP and it appears to be in proper functioning condition at the time of this inspection.

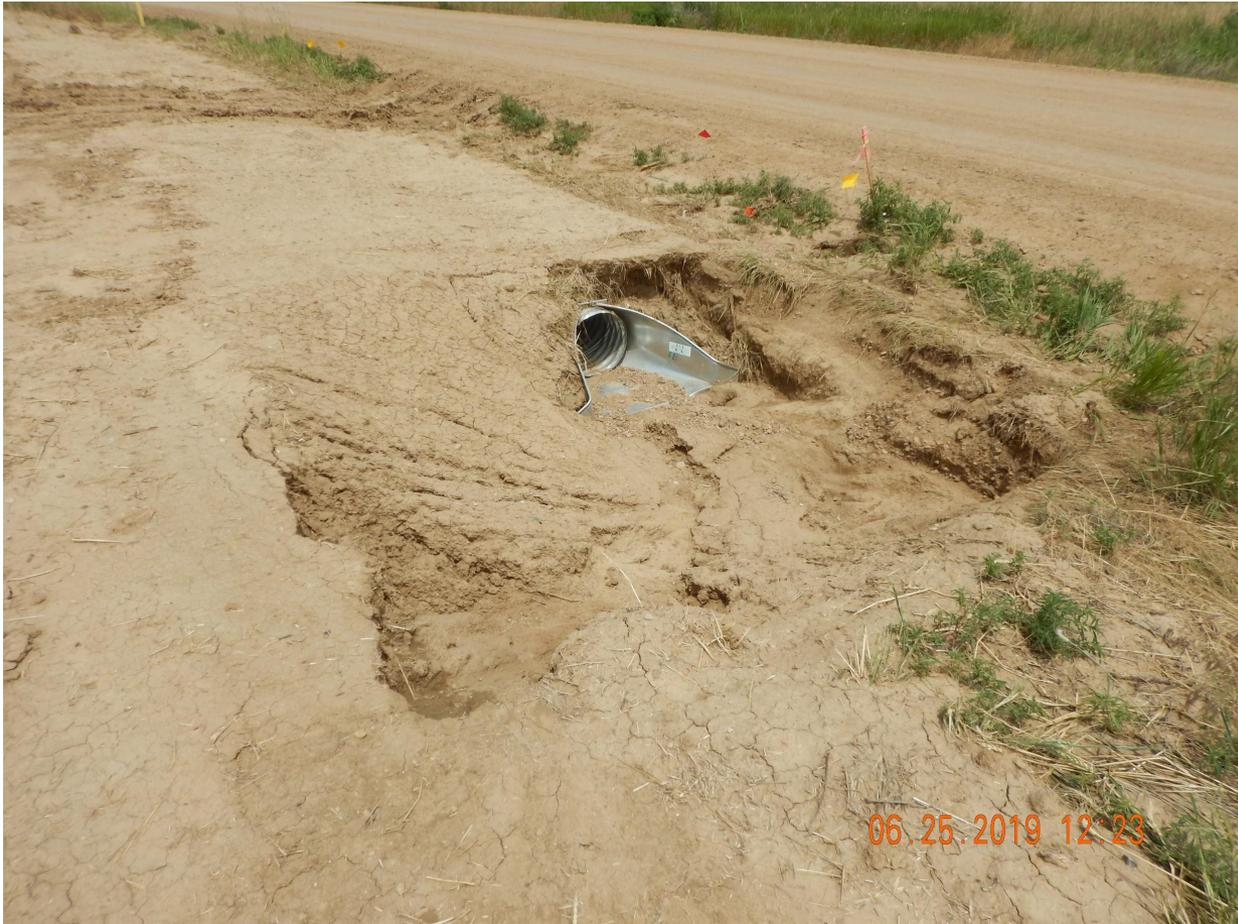
Photo 16. Photo taken from the north entrance of location, facing Northeast. Photo illustrates the Operator has failed to properly install the culvert with inlet protection, as gully erosion is observed at the inlet area.

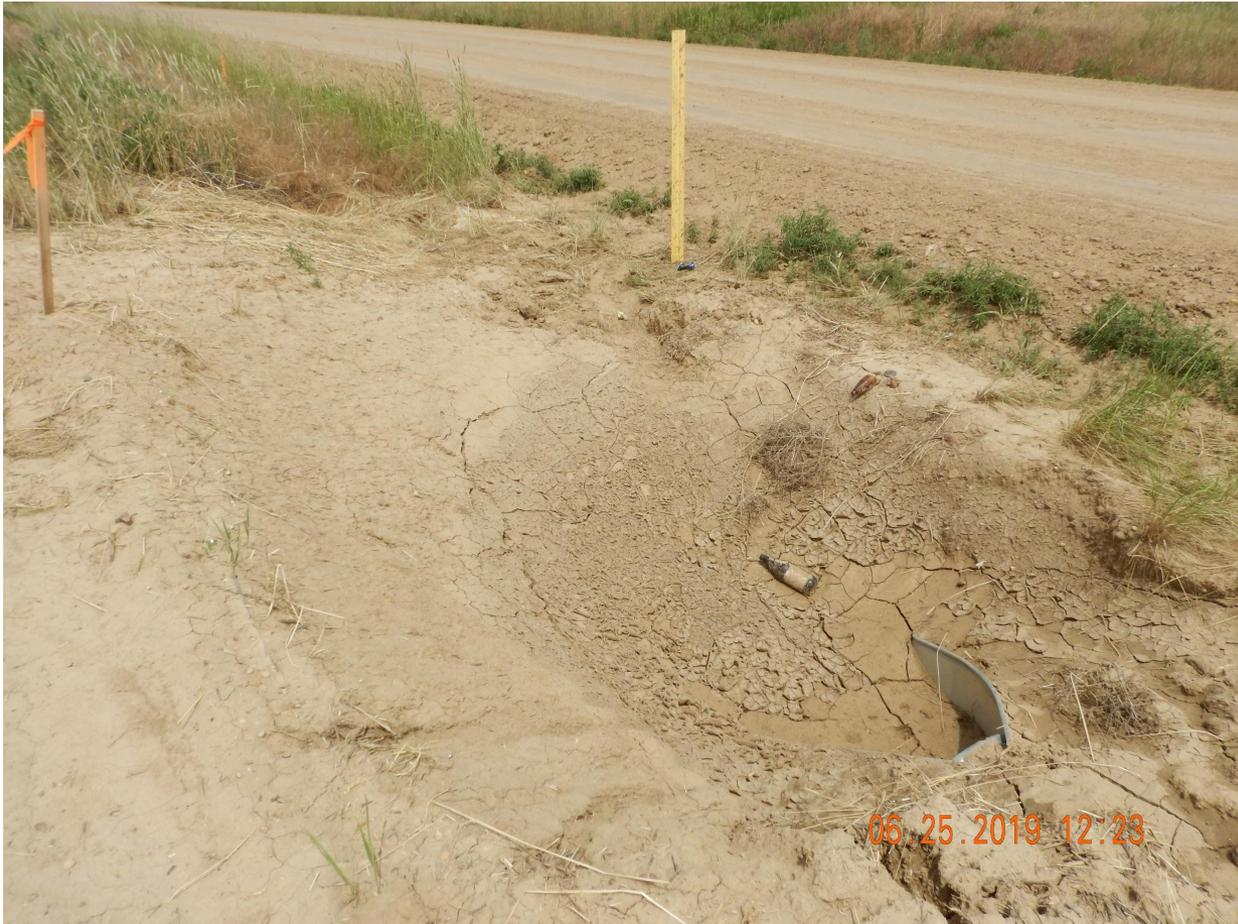
Photo 17. Photo taken from the north entrance of location, facing Northeast. Photo illustrates the Operator has failed to properly install the culvert with outlet protection, as sediment accumulation was observed at the outlet area.
