Inspection Photos

Operator: Gunnison Energy
Location/API #: 051-06103
Date: 6-18-2019

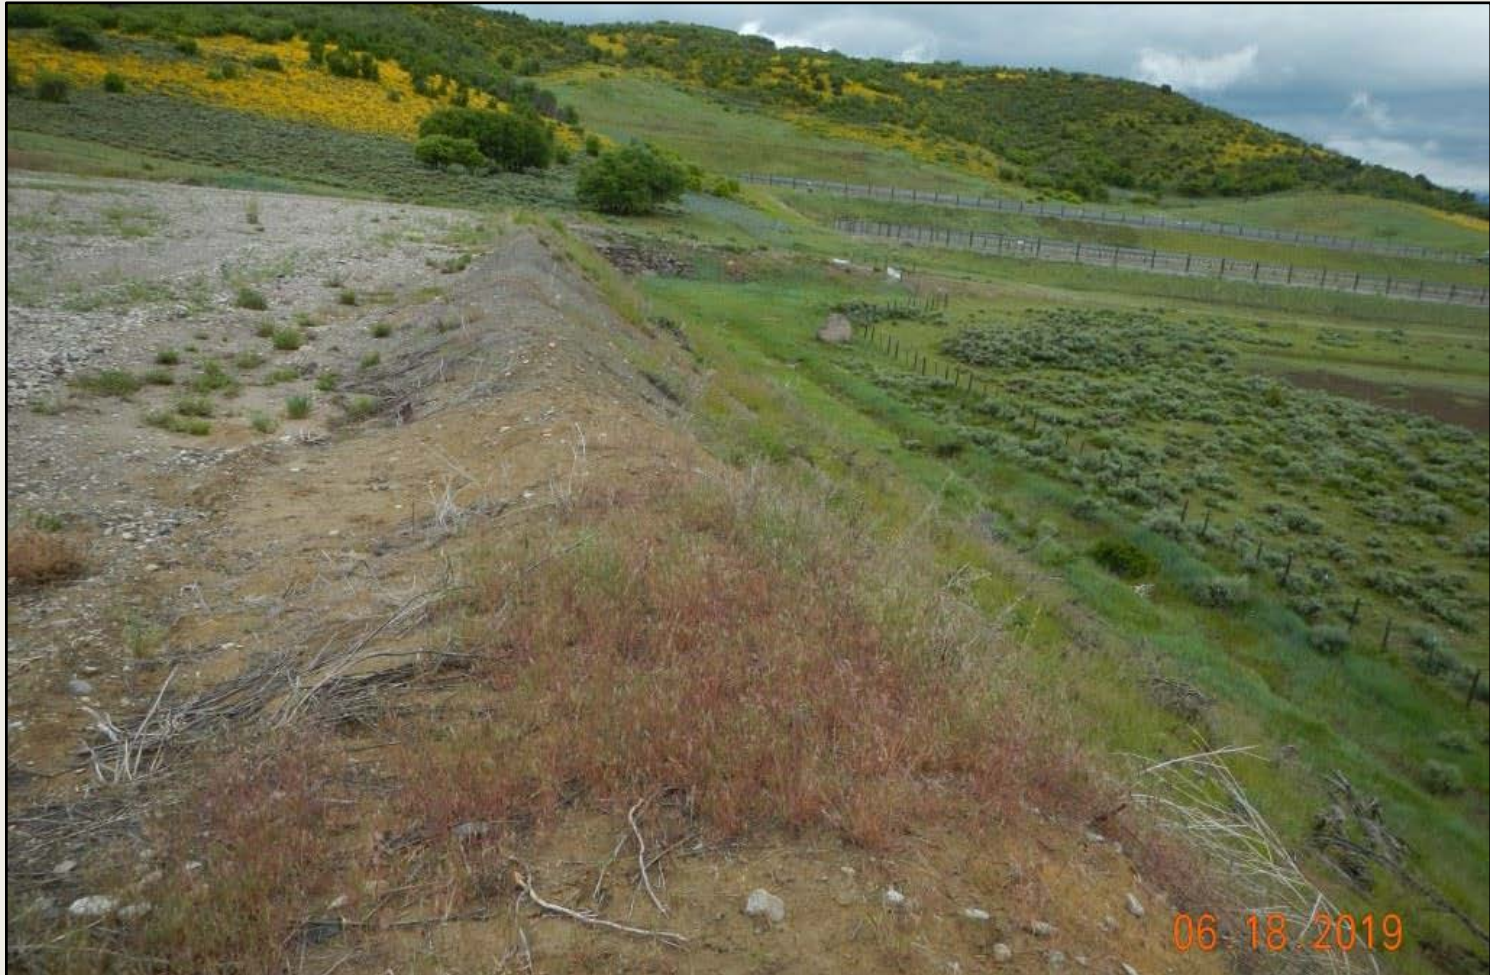
Photo 1. View of the eastern project area from the southeastern corner facing northward. Revegetation is sparse and weedy on steep cut and fill slopes.

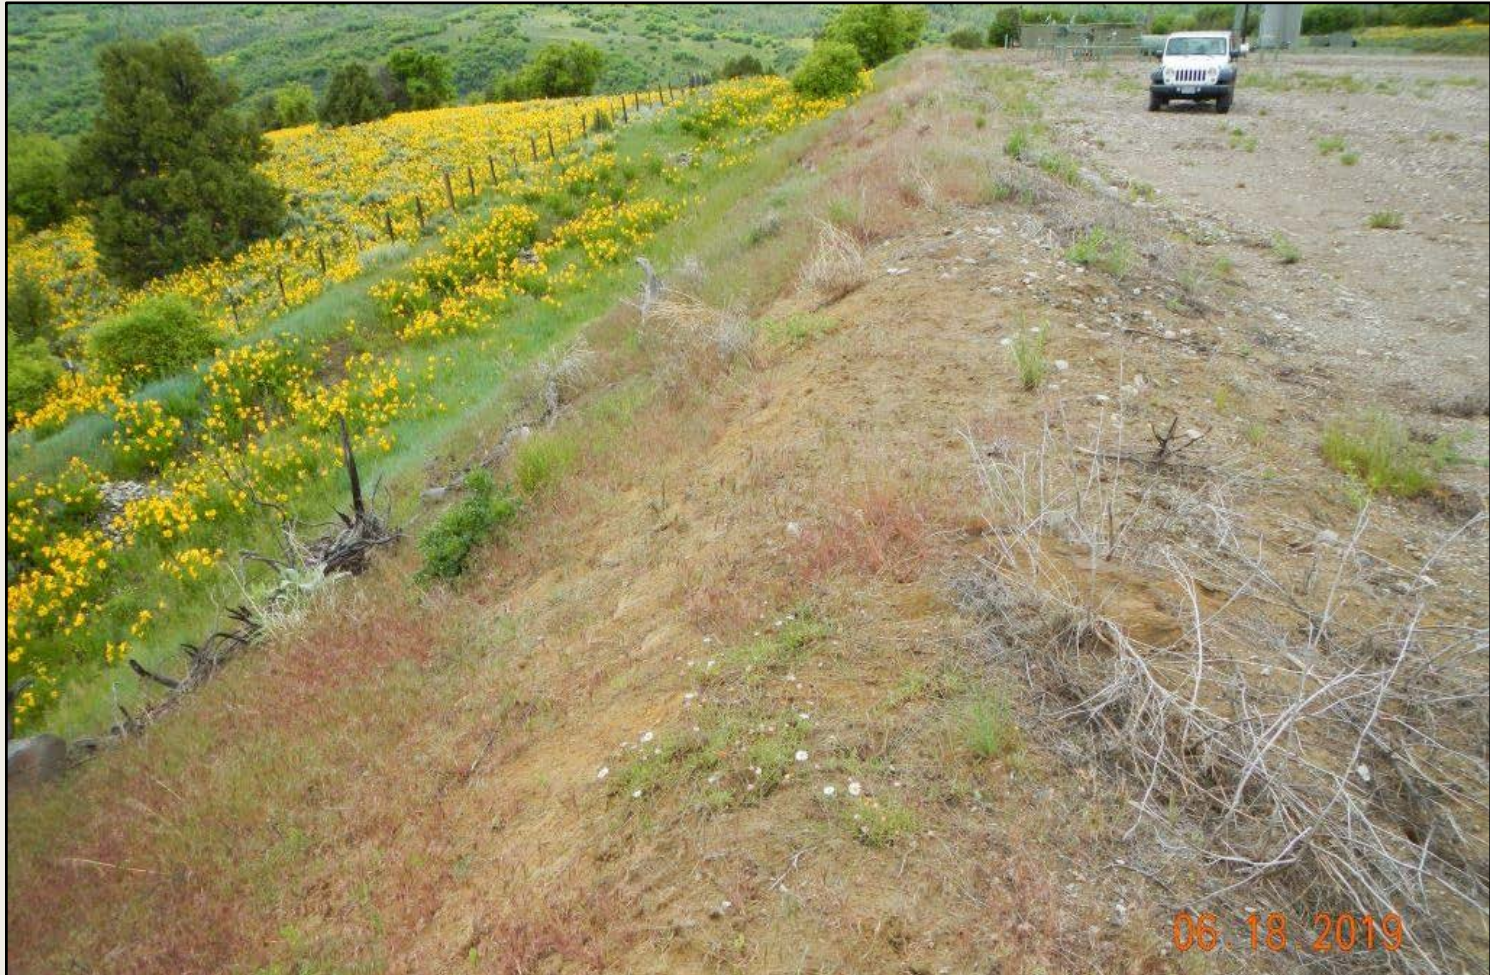
Photo 2. View of the southern project area from the southeastern corner facing westward.
