Inspection Photos

Location #334480

Inspection #: 692401123

Inspection Photos: Fram Mansur Loc#334480

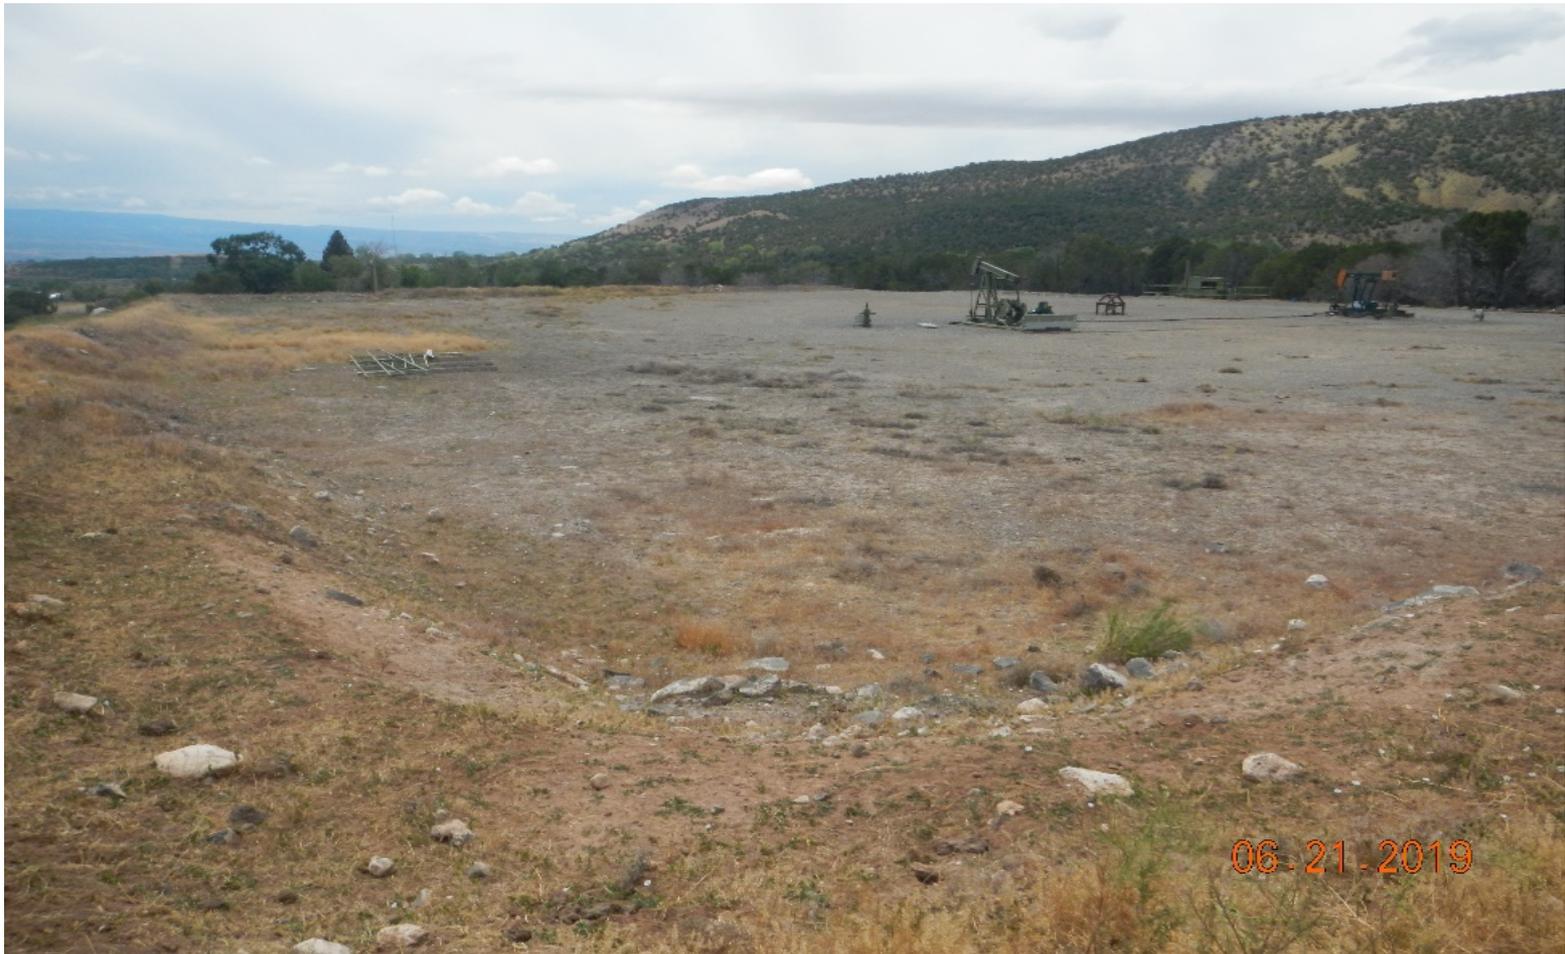
Photo#1:
Overview of Location to West.

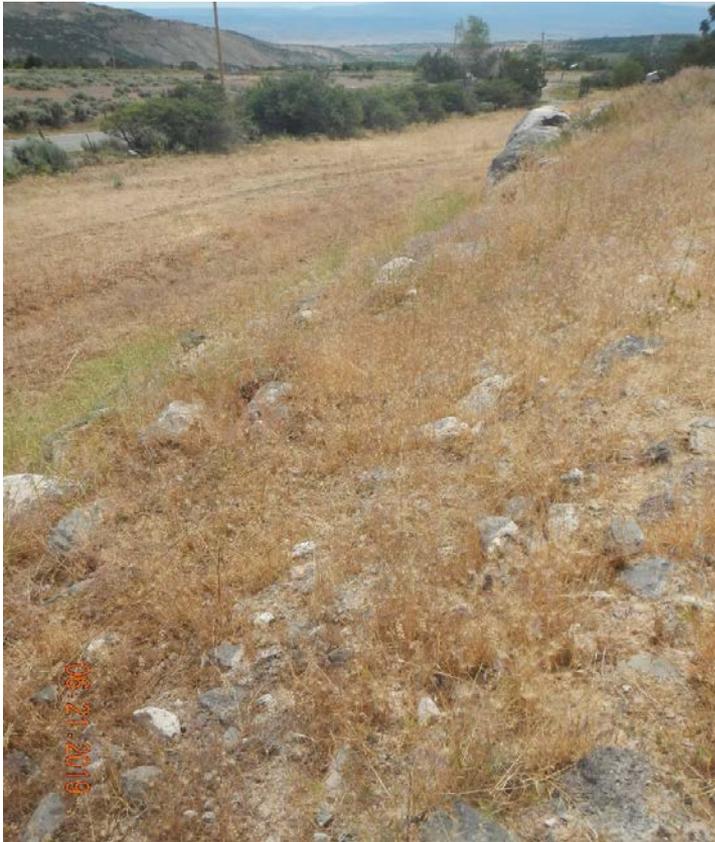
Photo#2:
Existing vegetation is weedy.

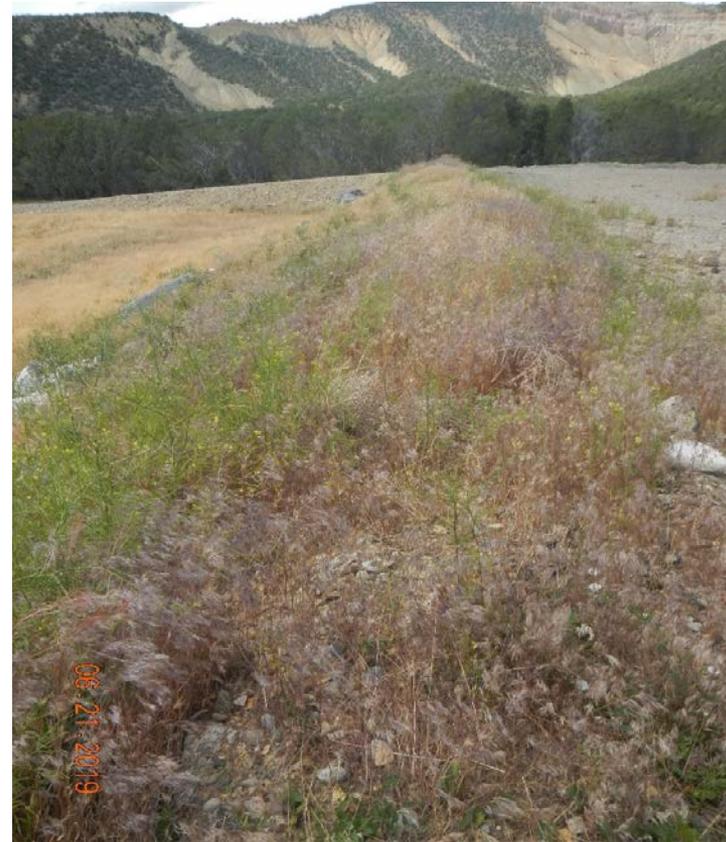
Photo#3:
Existing vegetation is weedy.

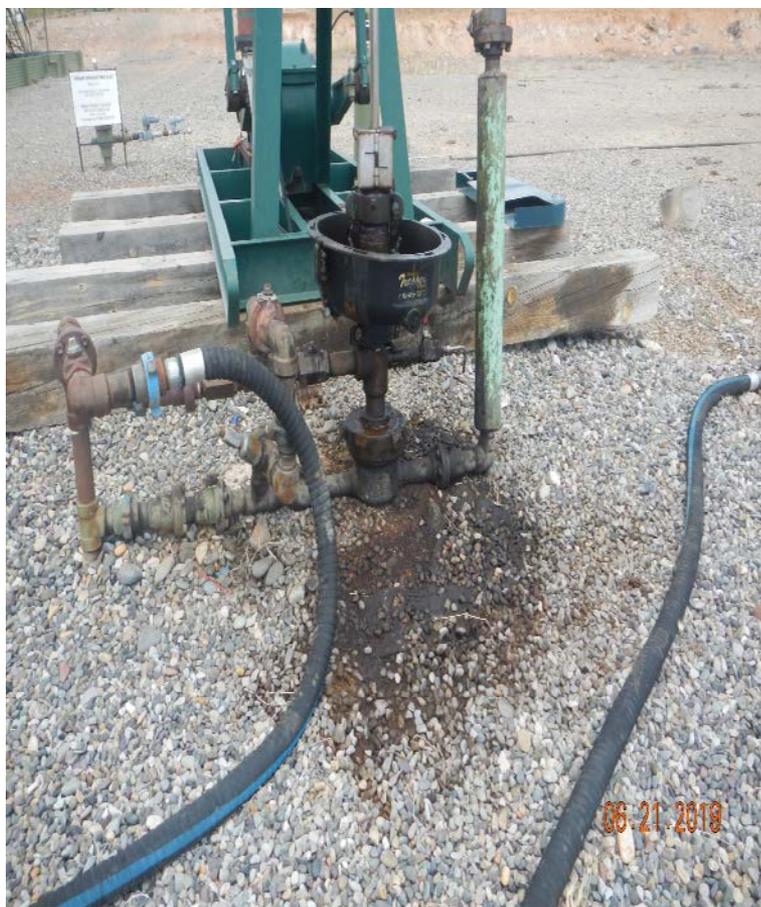
Photo#4:
Stained soil and equipment coated with oily waste.

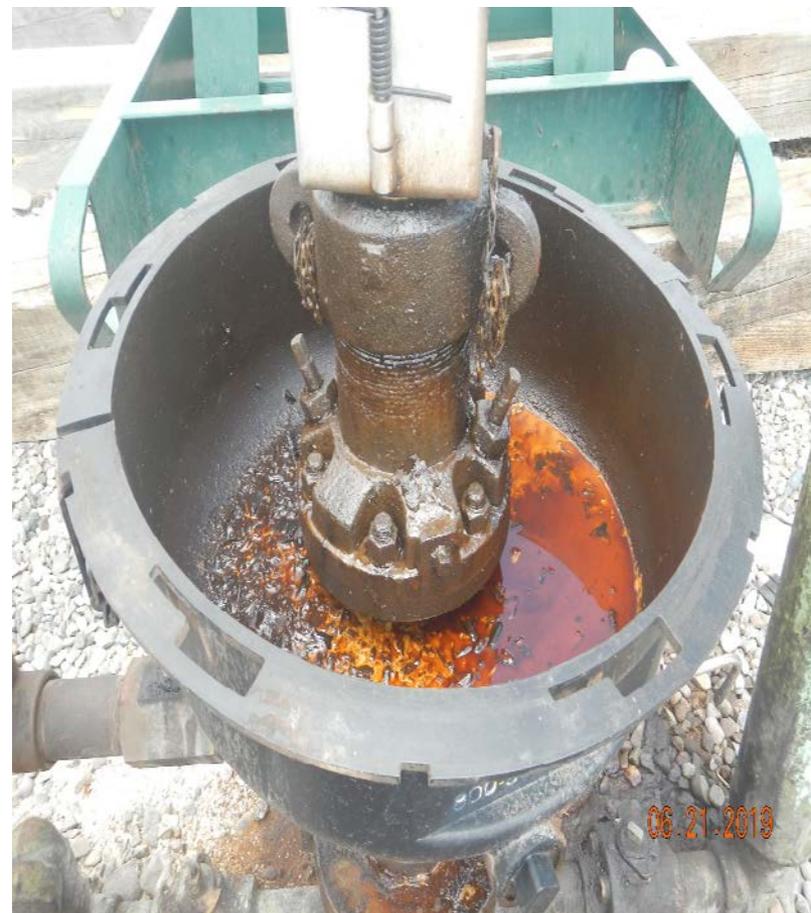
Photo#5:
Stained soil and equipment coated with oily waste.

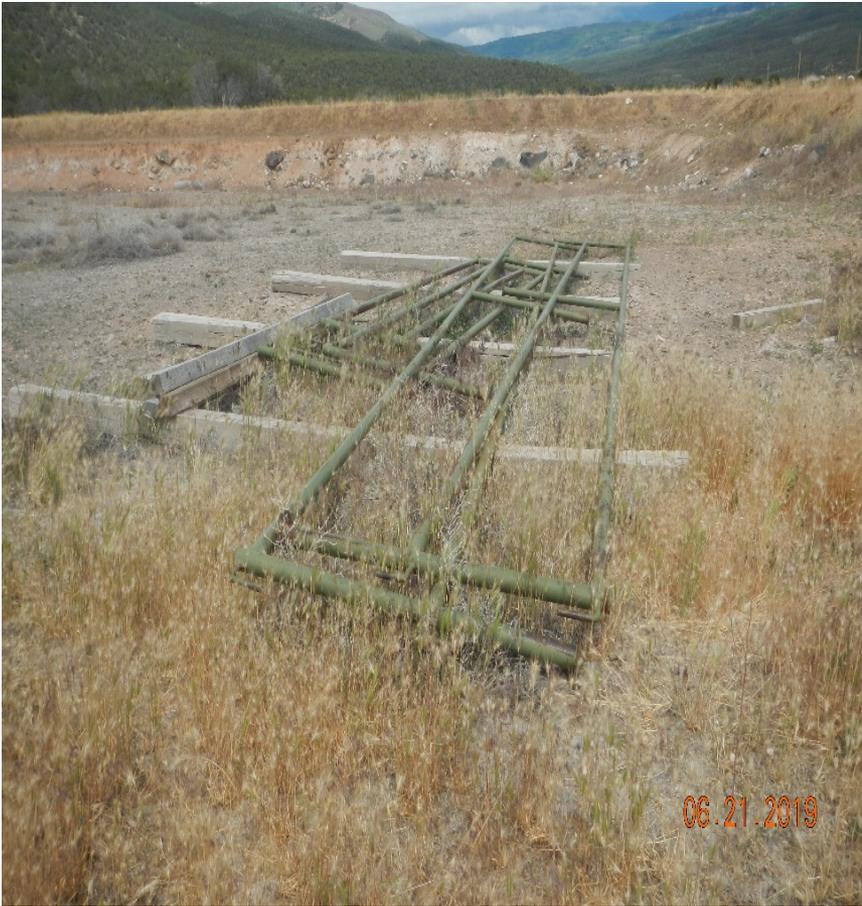
Photo#6:
Unused equipment stored on site.

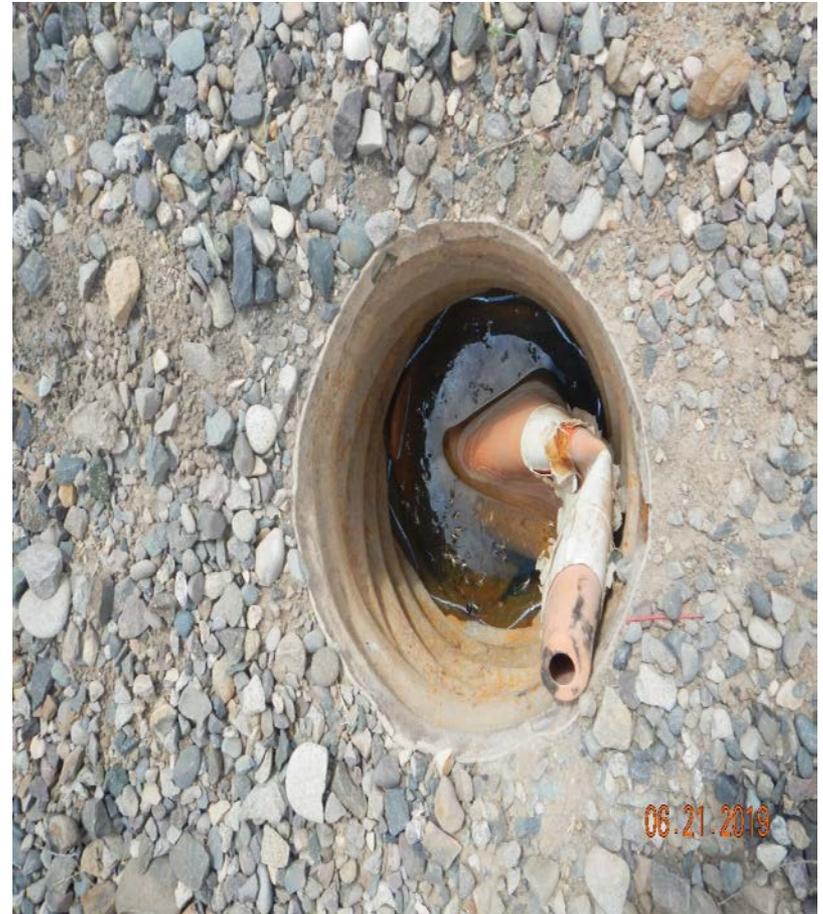
Photo#7:
Open Rat Hole at Well API#077-09473.

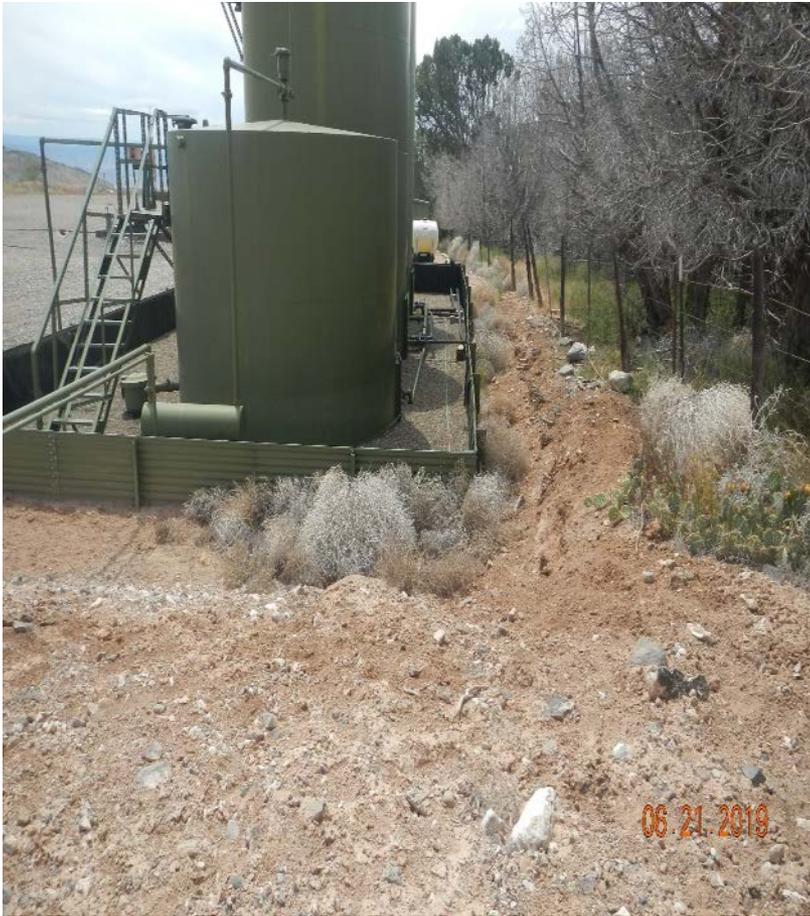
Photo#8:
Weeds that have become Debris have blown in & around equipment.

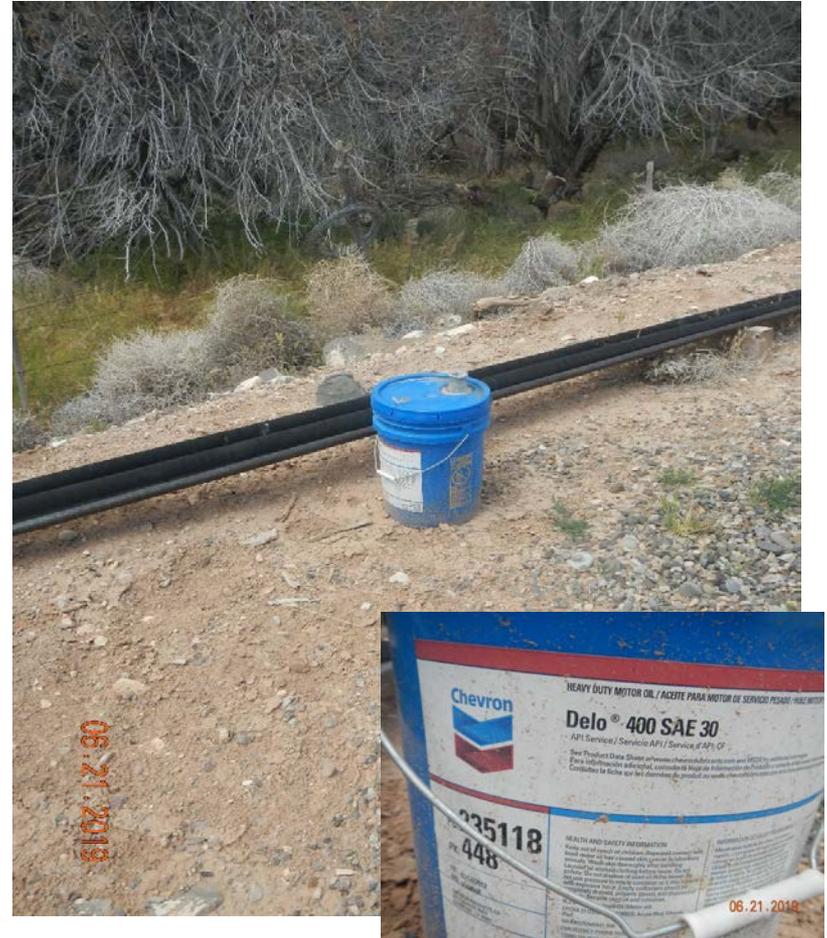
Photo#9:
Non E&P Waste not properly stored.

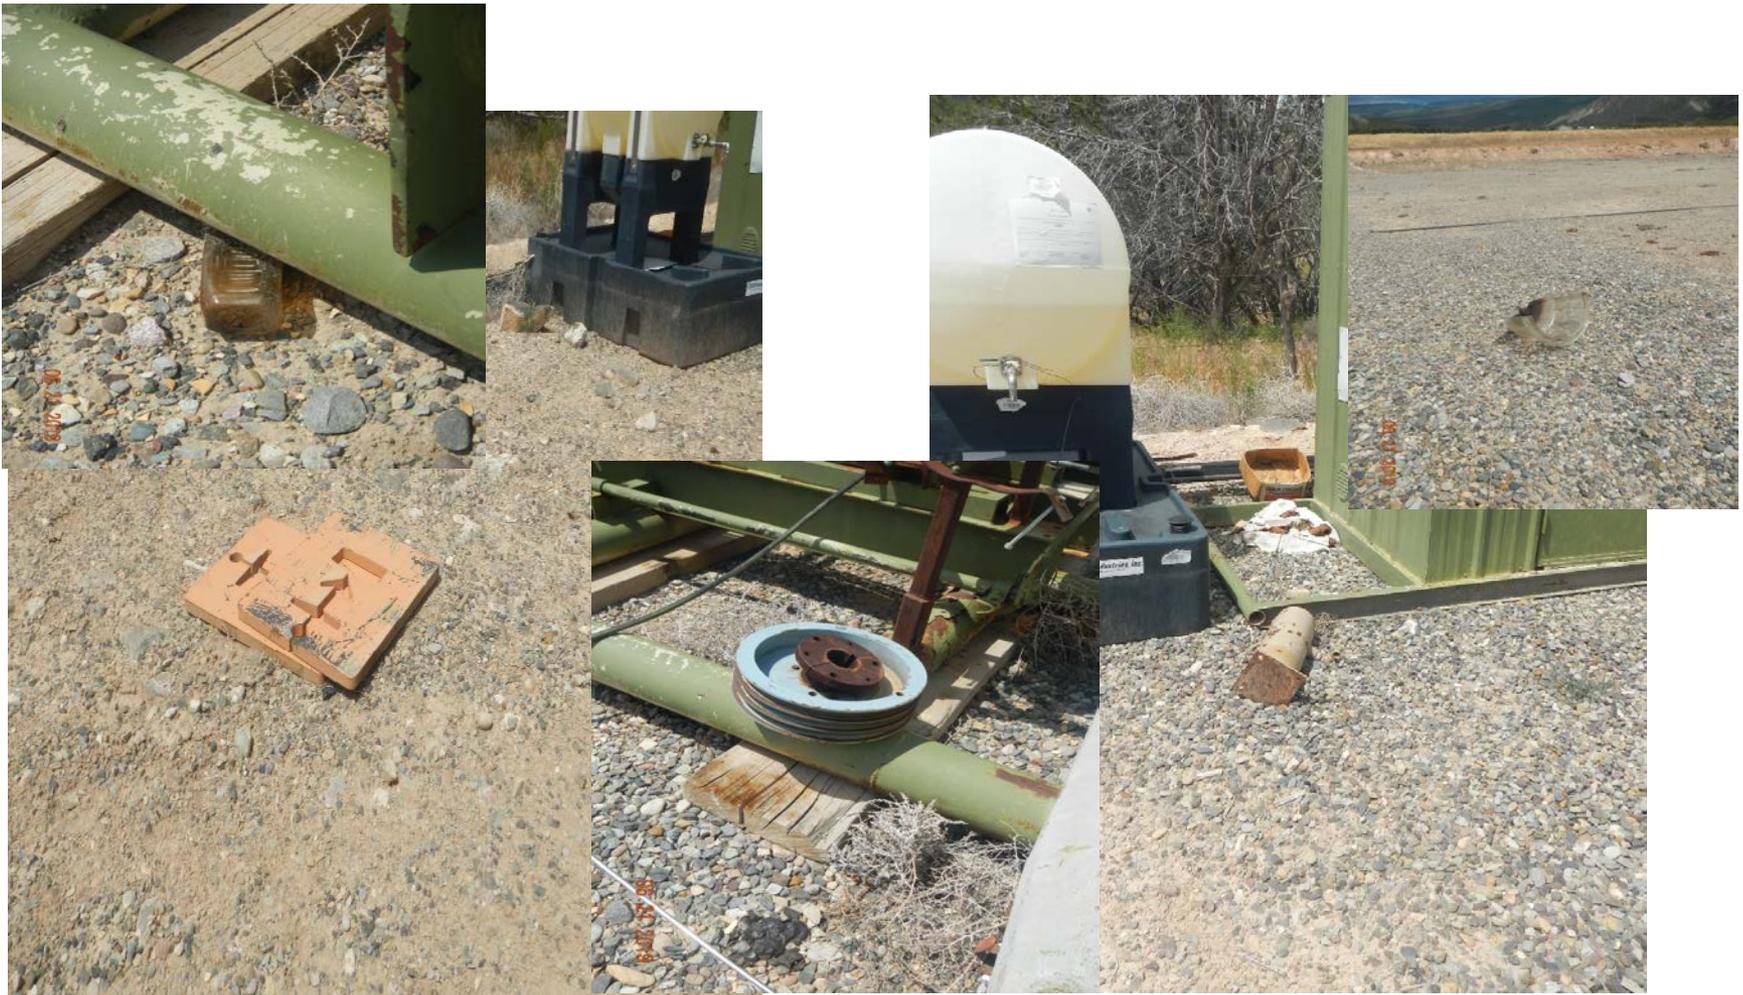
Photo#10:
Various pieces of trash/debris are scattered across
Location.

Photo#11:
Various pieces of trash/debris are scattered across
Location.
