Inspection Photos

Location Name: McDaniel 2-9 Pad & McDaniel 2-9 Spill

Location ID: 334529 & Spill/Release ID: 459854

Inspection Date: June 17, 2019

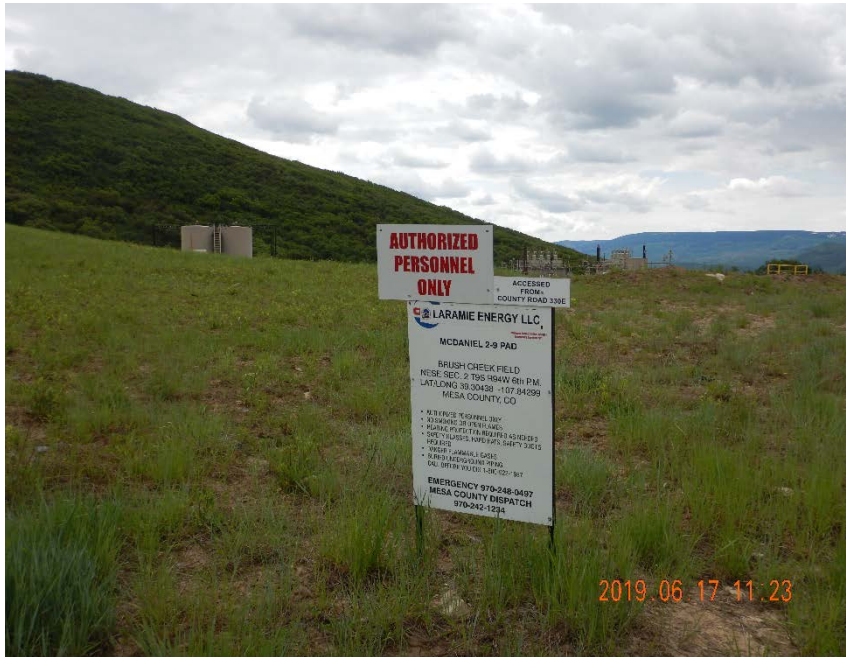
Photo #1 – Sign located on north side of pad.

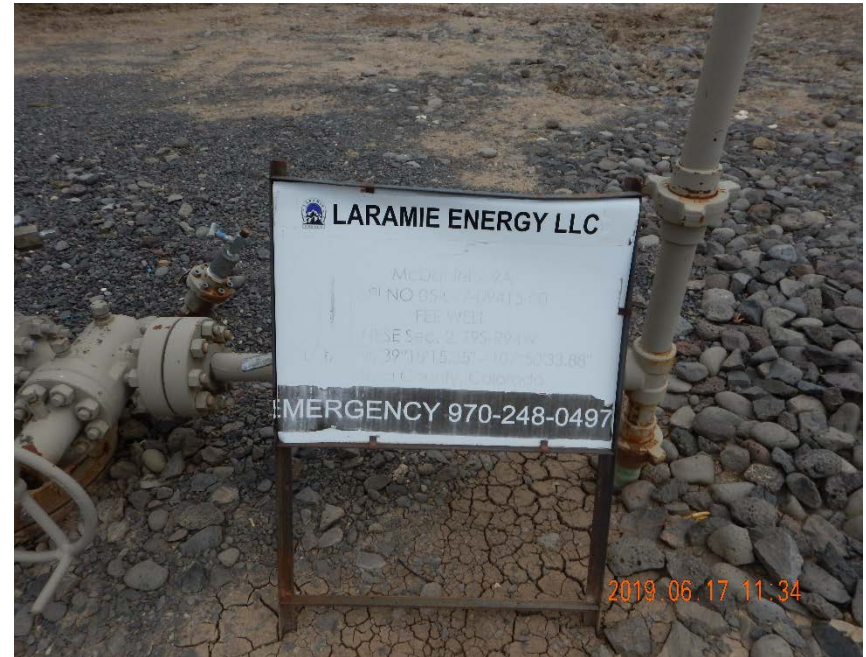
Photo #2 – Faded well sign (McDaniel 2-9A).

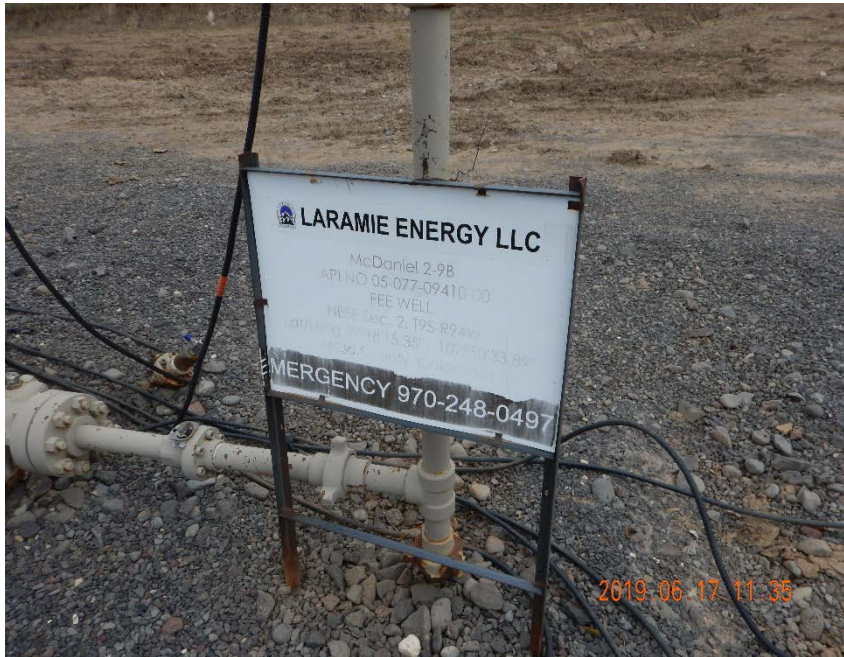
Photo #3 - Faded well sign (McDaniel 2-9B).

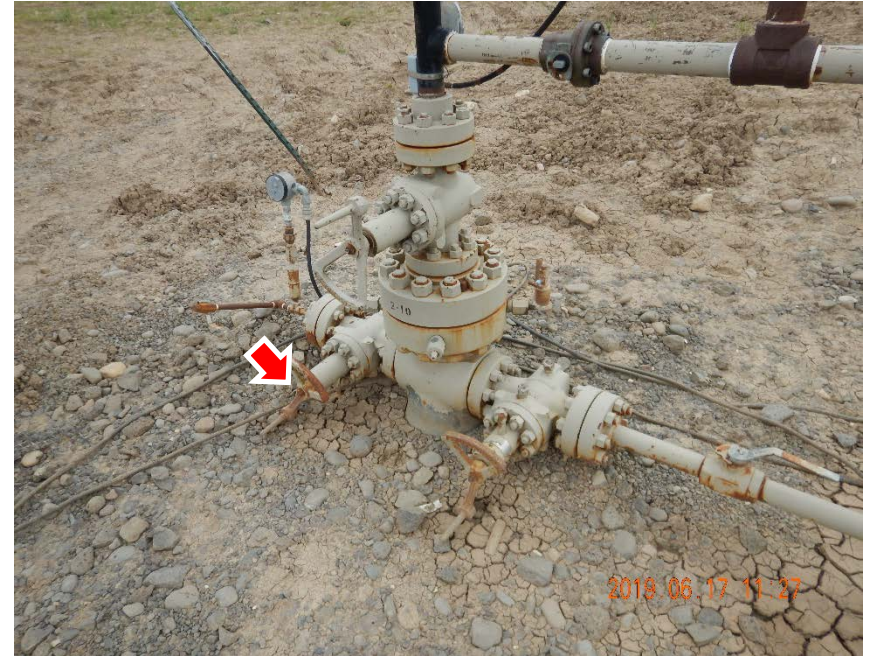
Photo #4 – McDaniel 2-10 wellhead. Note an audible gas leak was observed from this wellhead on inspection date (red arrow depicts approximate leak location). Operator was notified of leak via phone on inspection date.

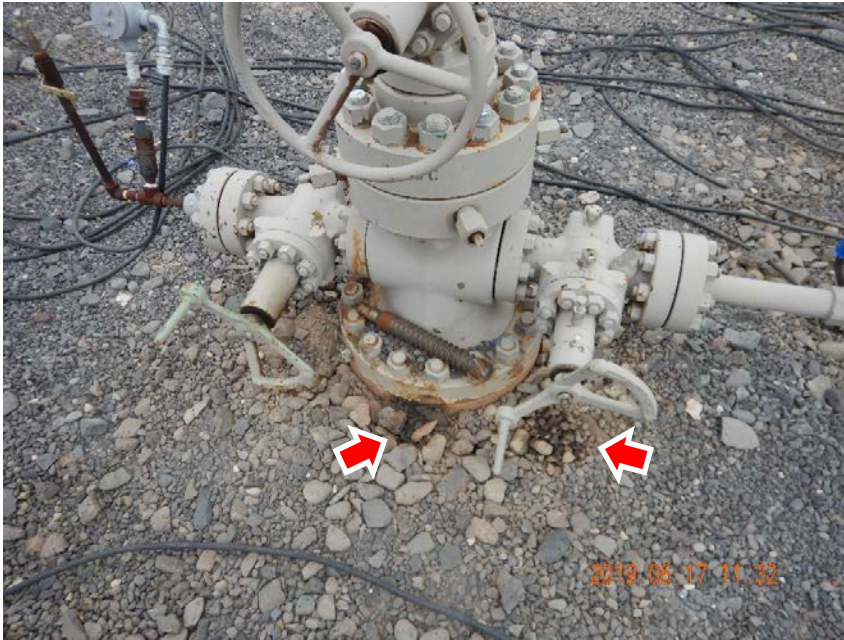
Photo #5 – McDaniel 2-16C wellhead. Note accumulations of oil-stained soil observed at wellhead (red arrows). Well sign was down on inspection date.

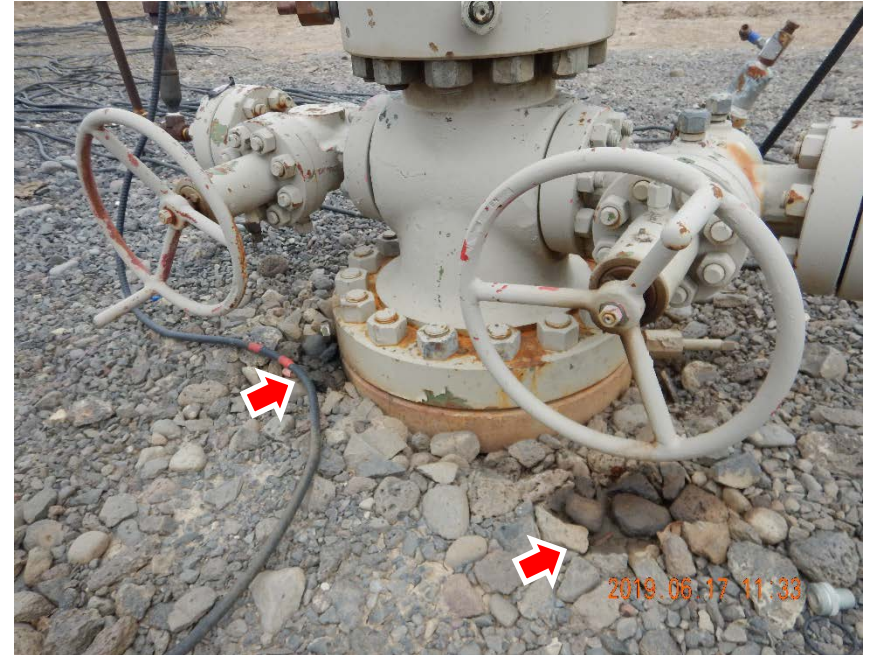
Photo #6 - McDaniel 2-16A wellhead. Note accumulations of oil-stained soil observed at wellhead (red arrows).

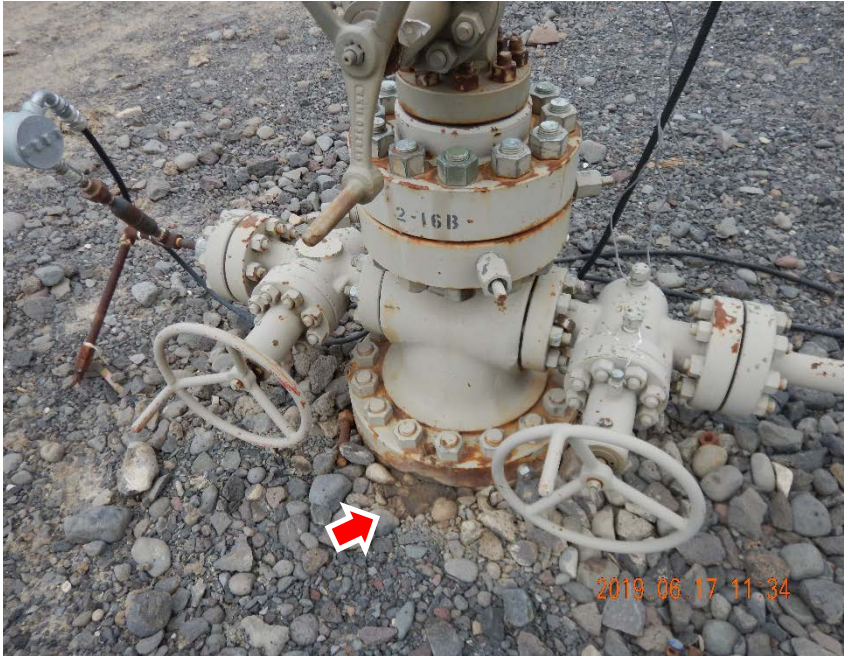
Photo #7 - McDaniel 2-16B wellhead. Note accumulation of oil-stained soil observed at wellhead (red arrow).

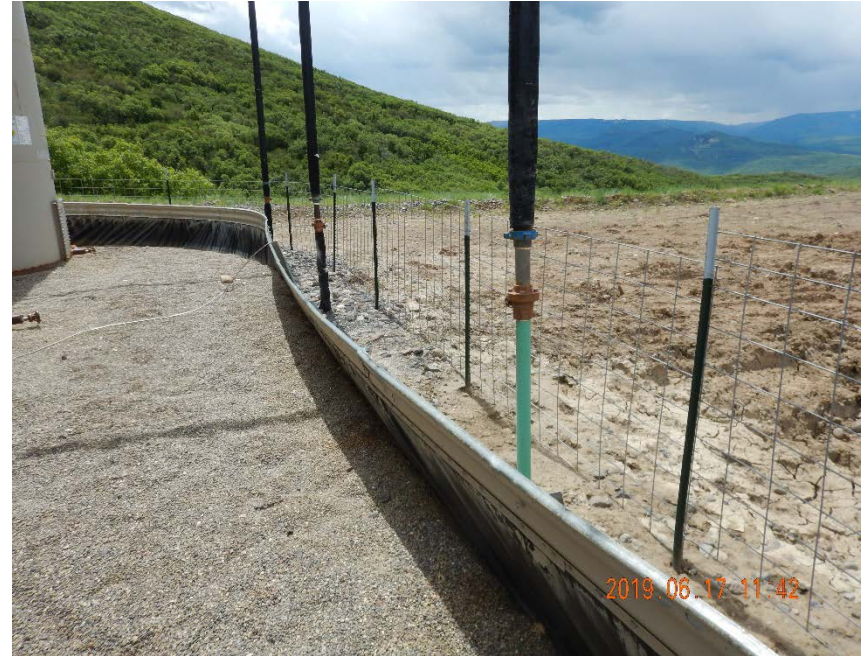
Photo #8 – Bent section of tank battery berm (south side).

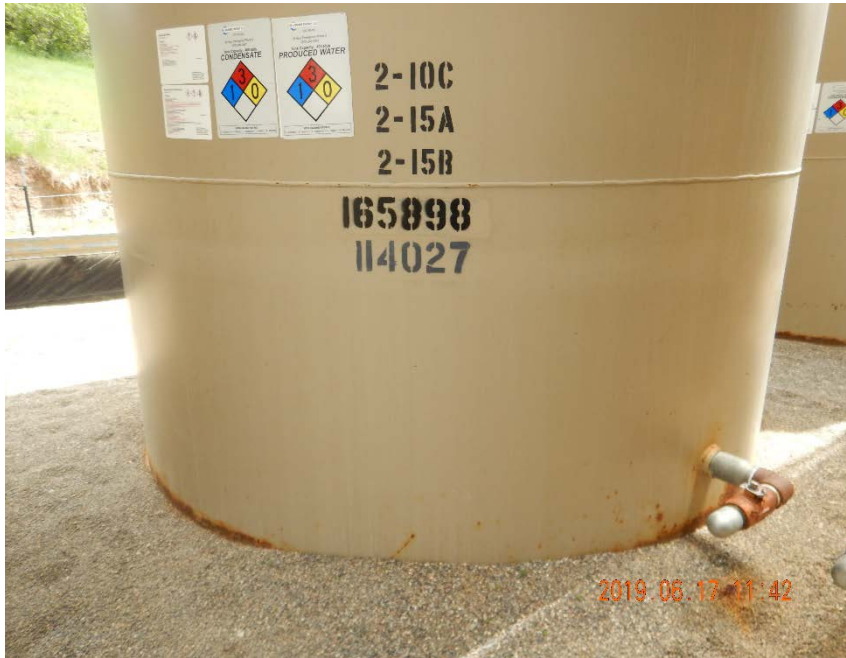
Photo #9 – Tank ID #114027. Accumulation of rust and salt observed beneath bullplug (next photo).

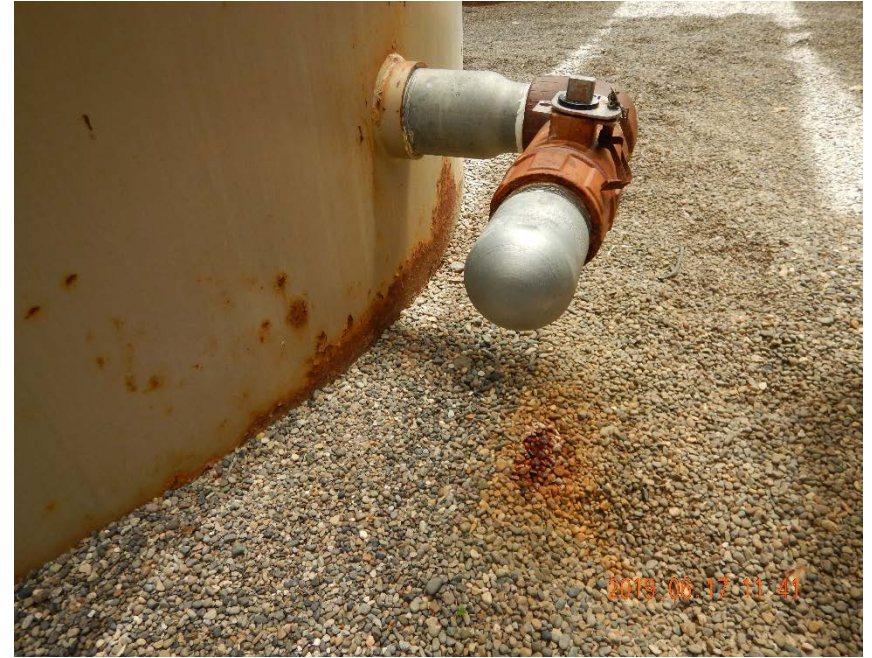
Photo #10 – Accumulation of salt and rust observed beneath bullplug attached to Tank ID #114027.

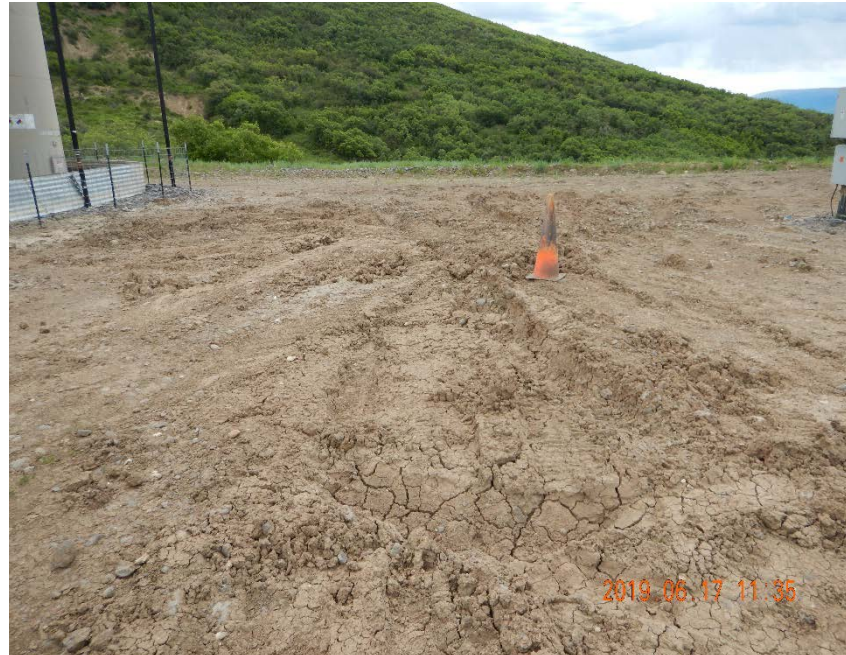
Photo #11 – Rutted area between tank battery and separators.
