# *Inspection Photos*

*Location #312709*

*Operator: Fram*

*Inspection #: 692401128*

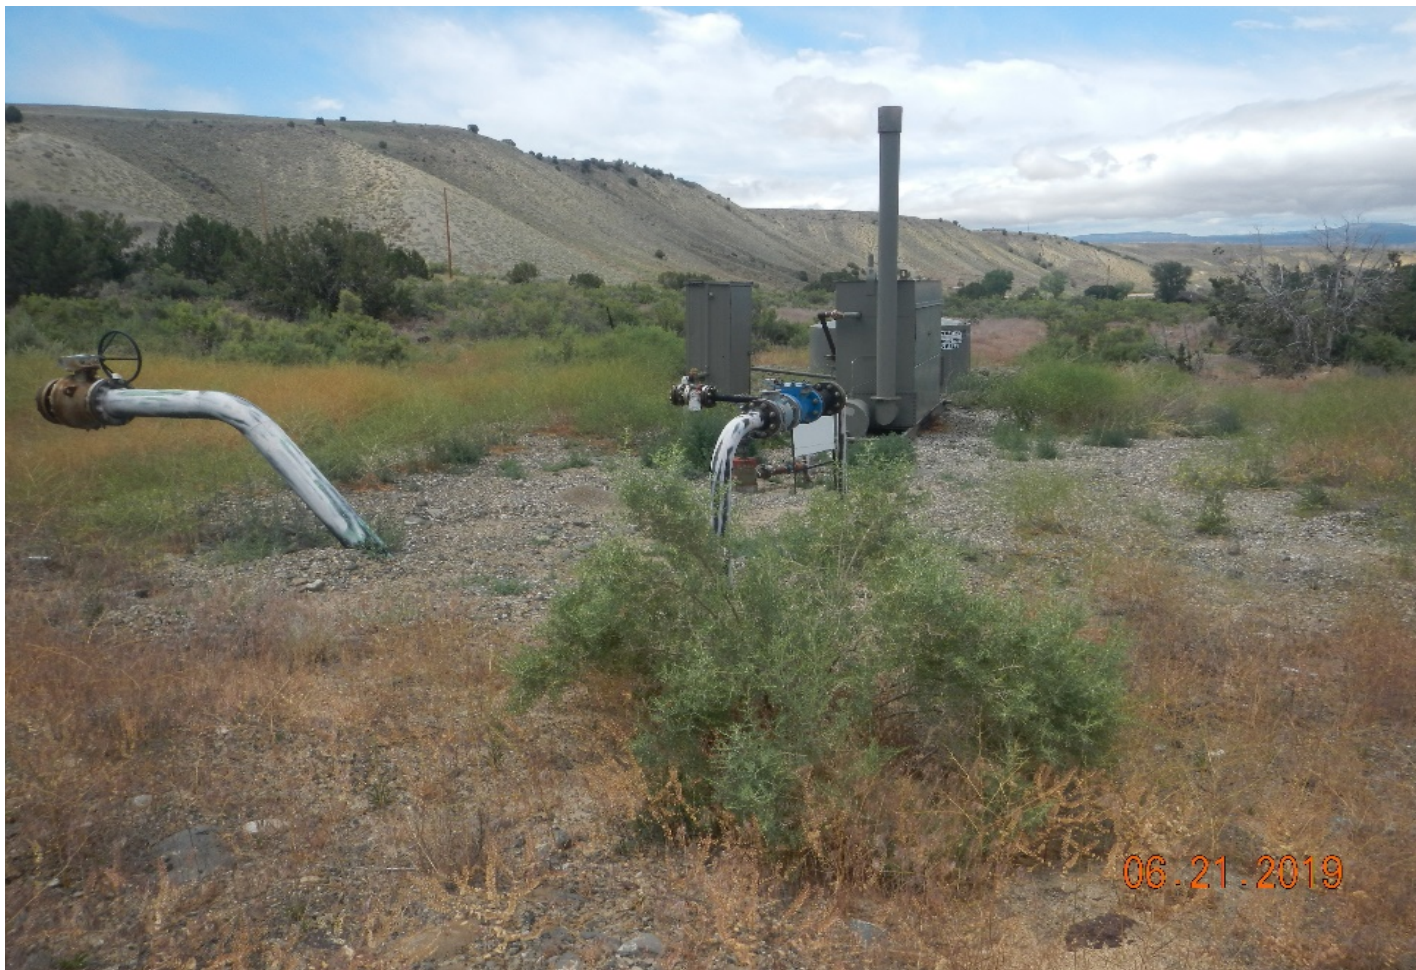
Photo#1:  
Overview of Location to West.

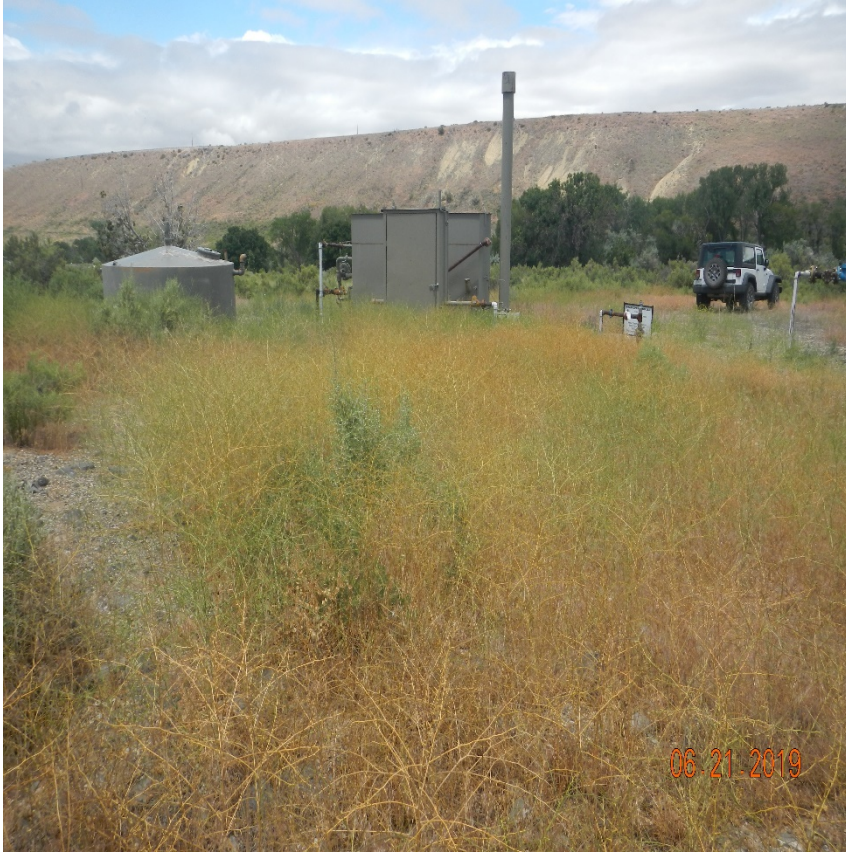
**Photo#2:**

Location is infested with desiccated (dead), as well as new growth, ruderal/debris weeds.

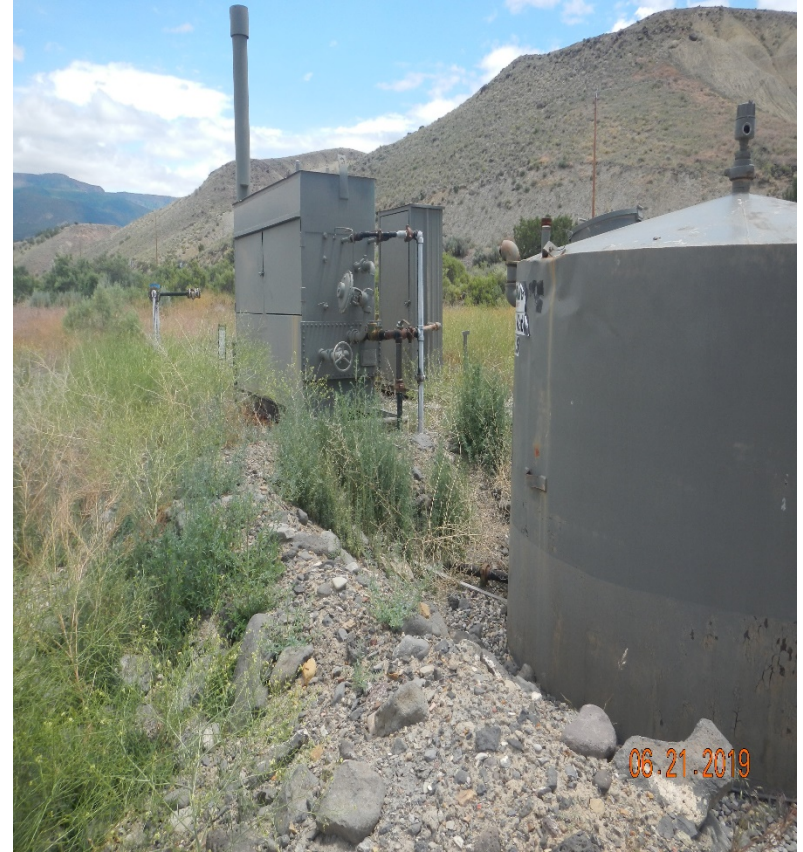
**Photo#3:**

Weeds are growing in and around equipment.

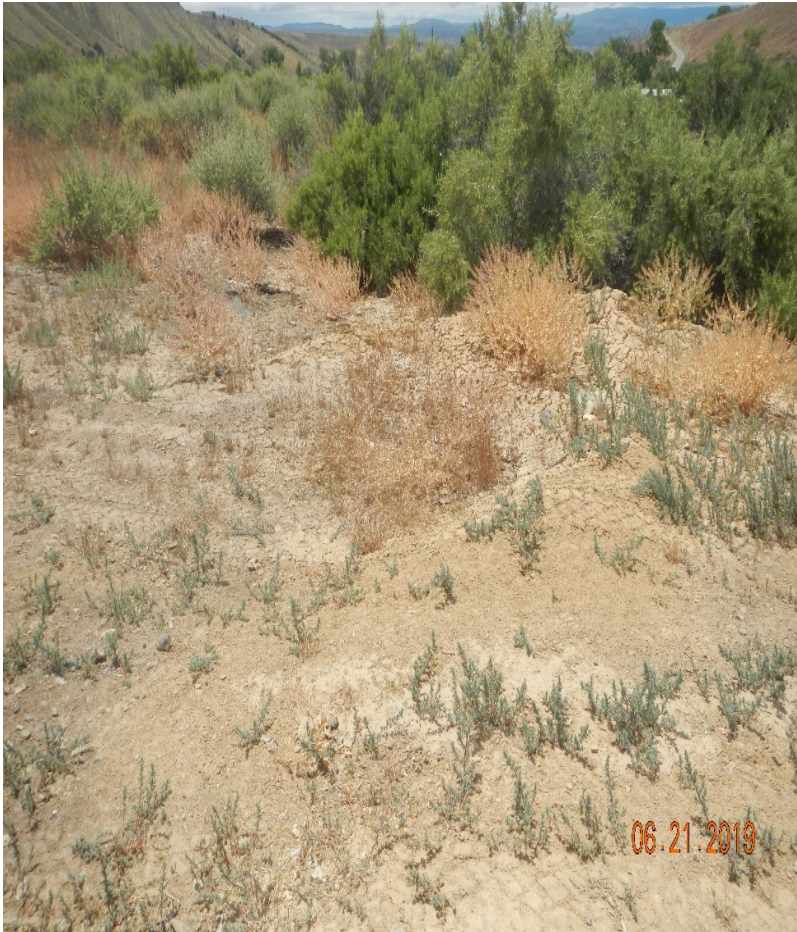
**Photo#4:**  
Access road does not have adequate Stormwater controls.

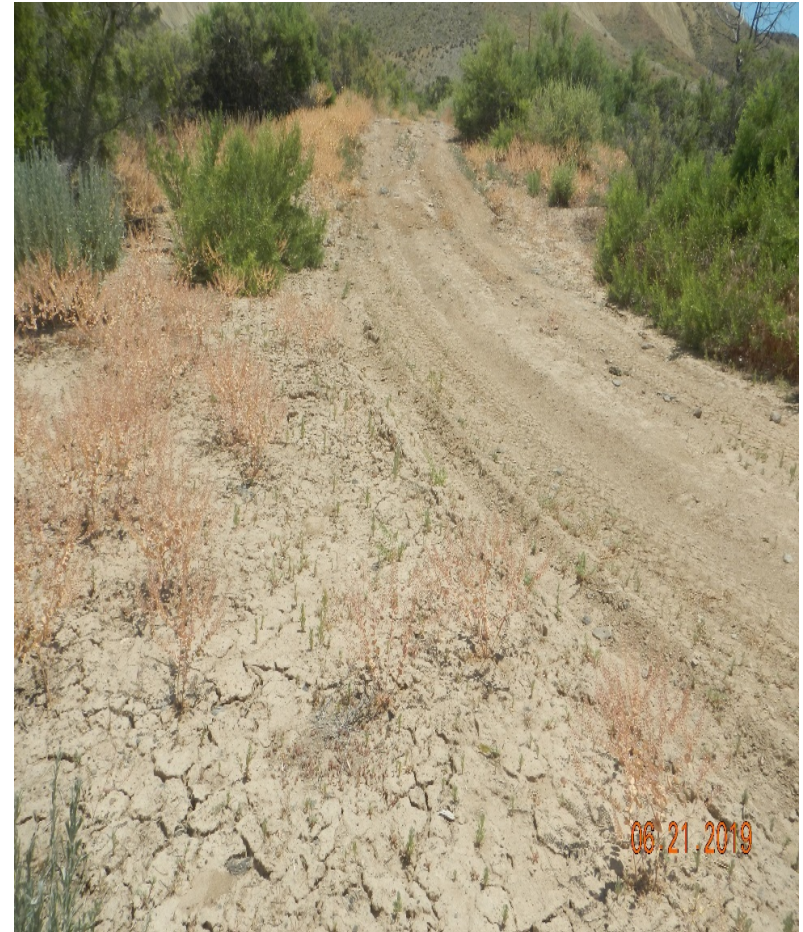
**Photo#5:**  
Access road does not have adequate Stormwater controls.

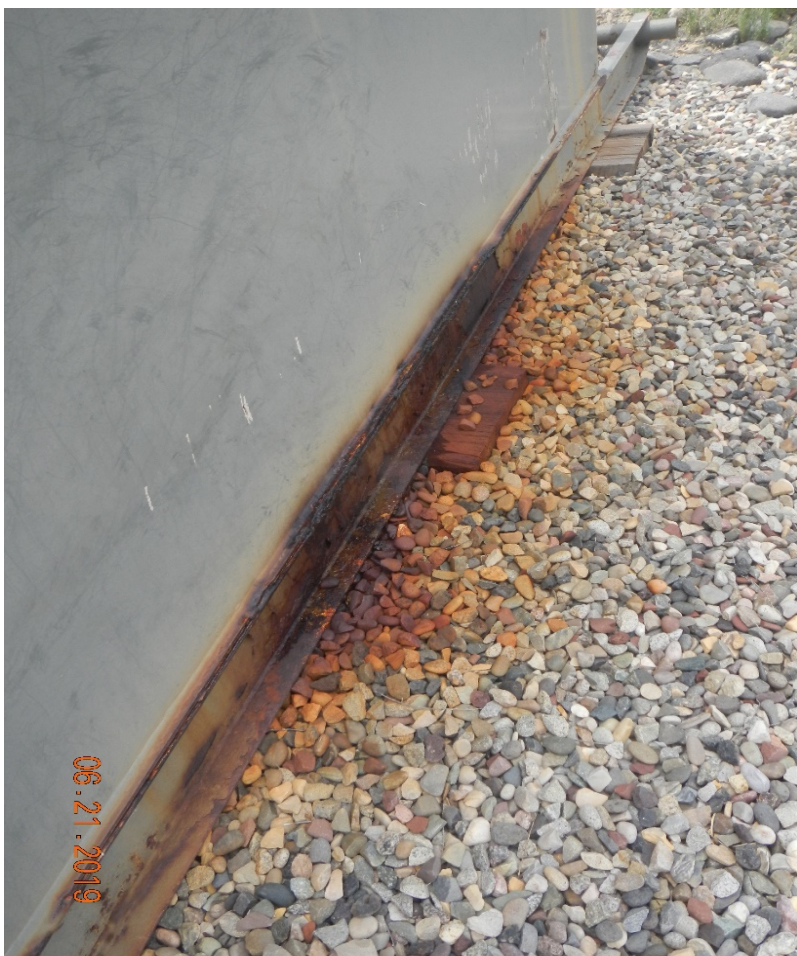
**Photo#4:**  
Repair of leak has failed.

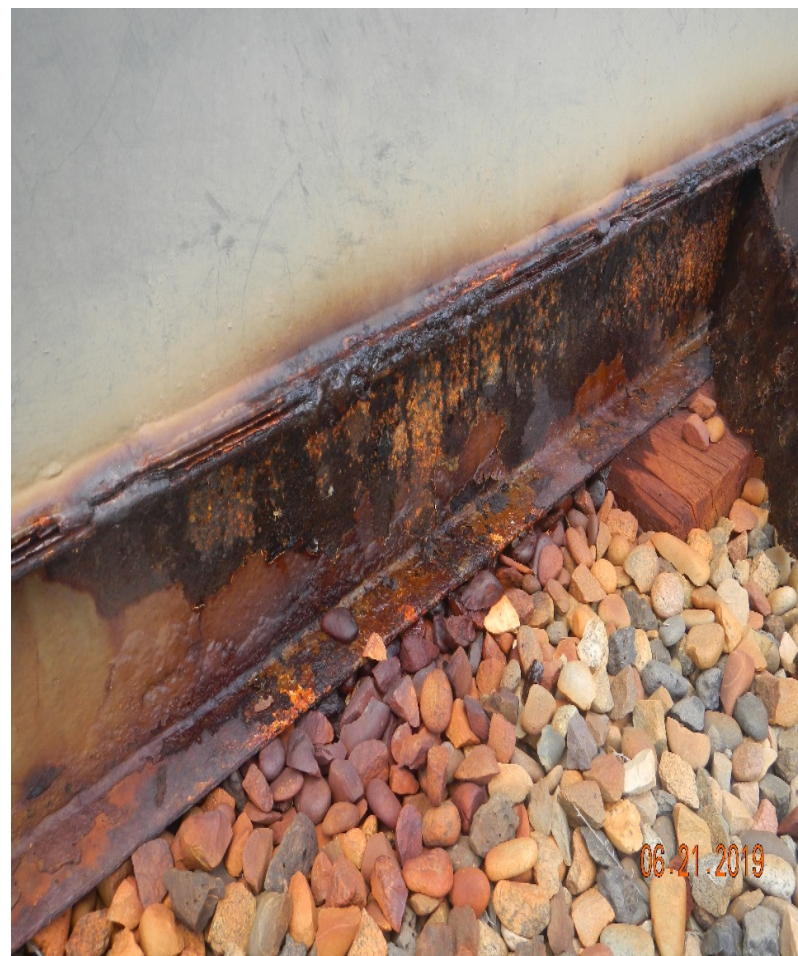
**Photo#5:**  
Repair of leak has failed.
