Inspection Photos

API: 05-071-07414

Operator: TIMBER CREEK OPERATING LLC

Inspection Date: 7/1/2019

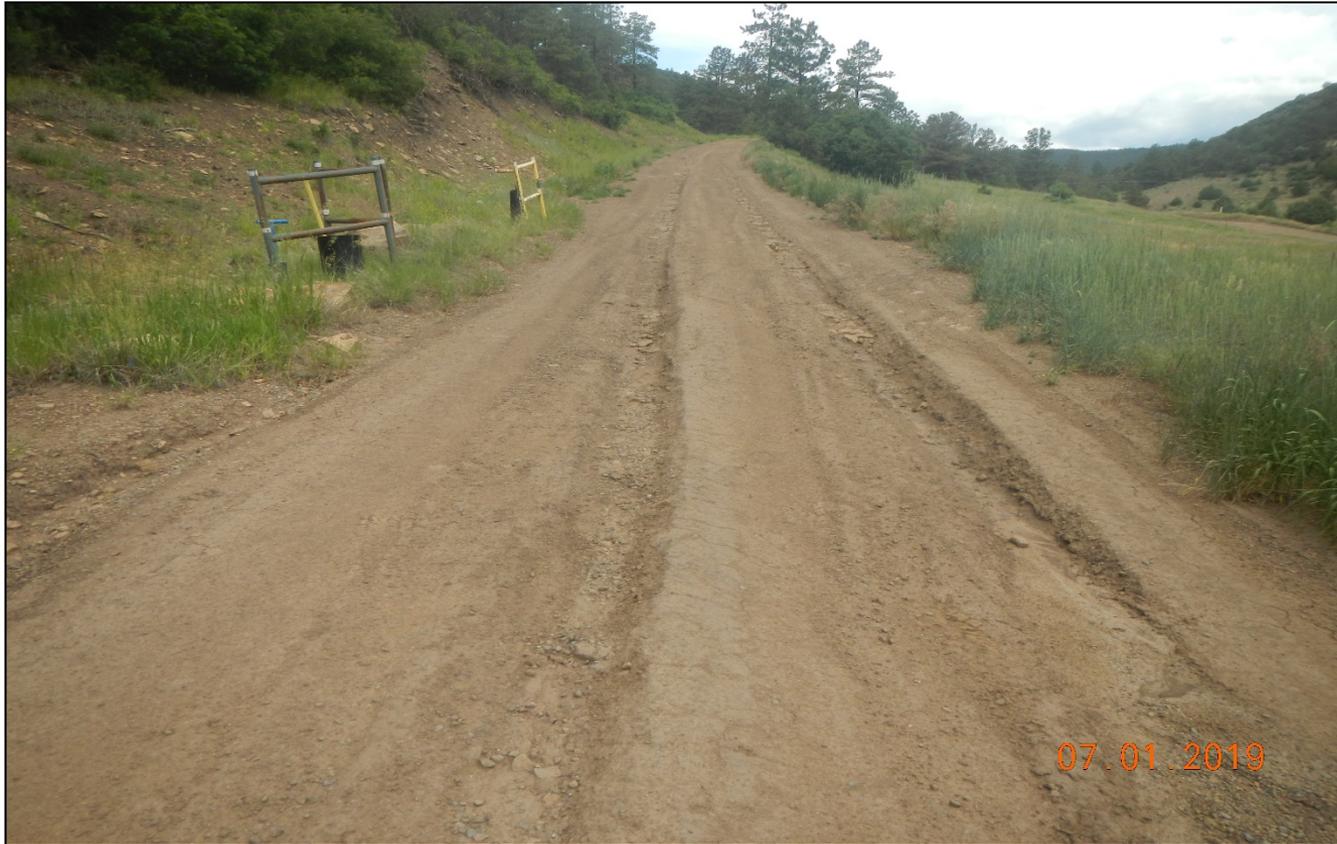
Photo 1. Vehicle ruts remain along the road which is a conveyance for stormwater erosion.

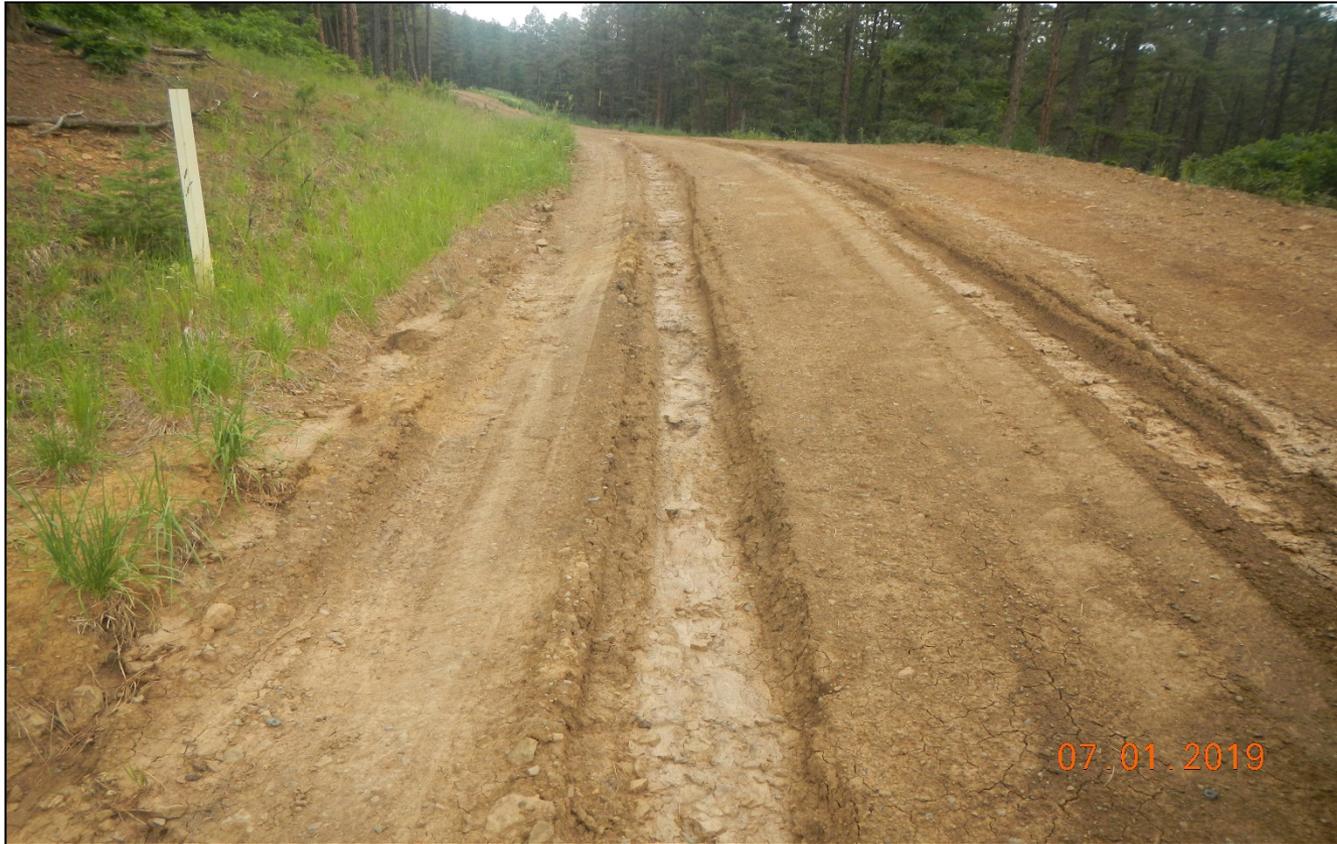
Photo 2. Vehicle ruts remain along the road which is a conveyance for stormwater erosion.

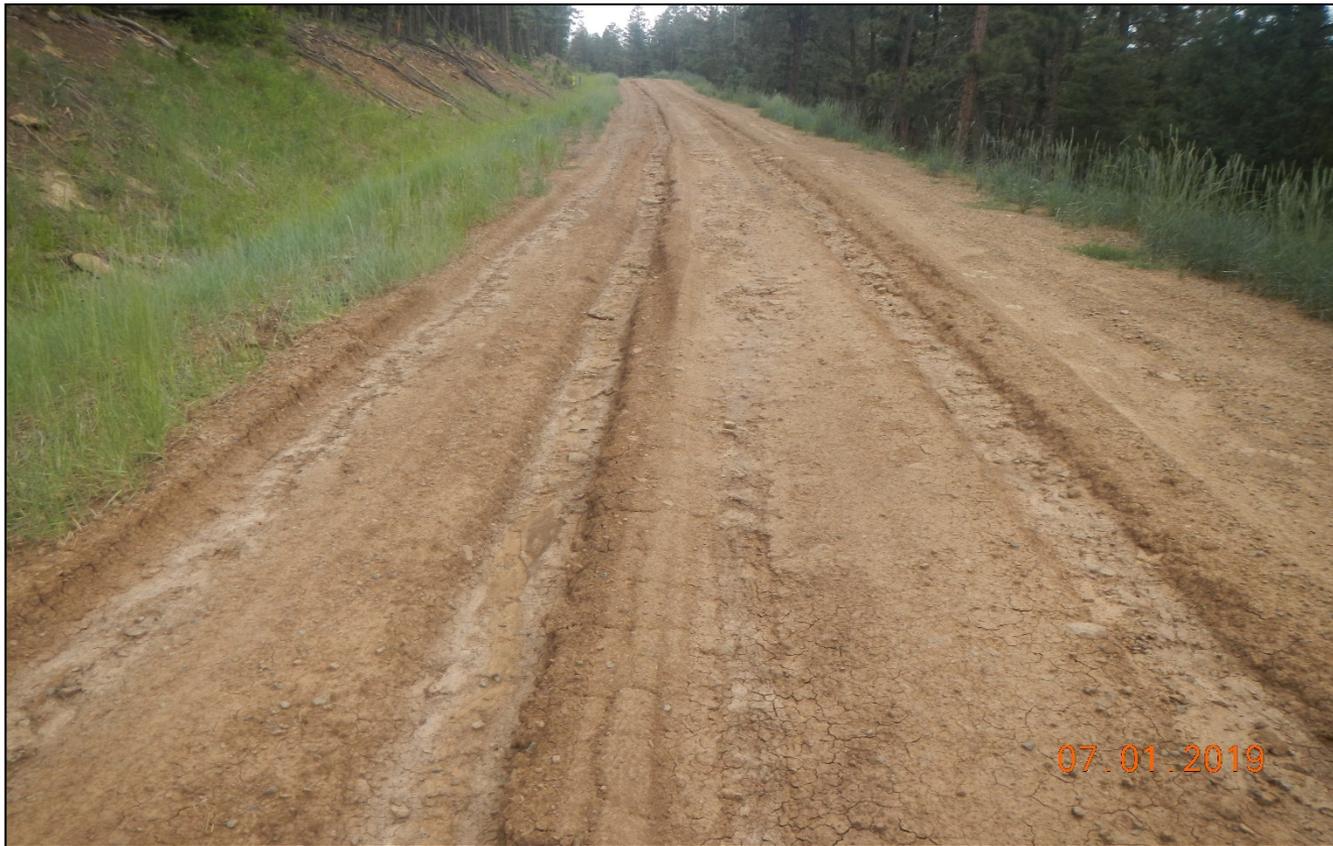
Photo 3. Vehicle ruts remain along the road which is a conveyance for stormwater erosion.

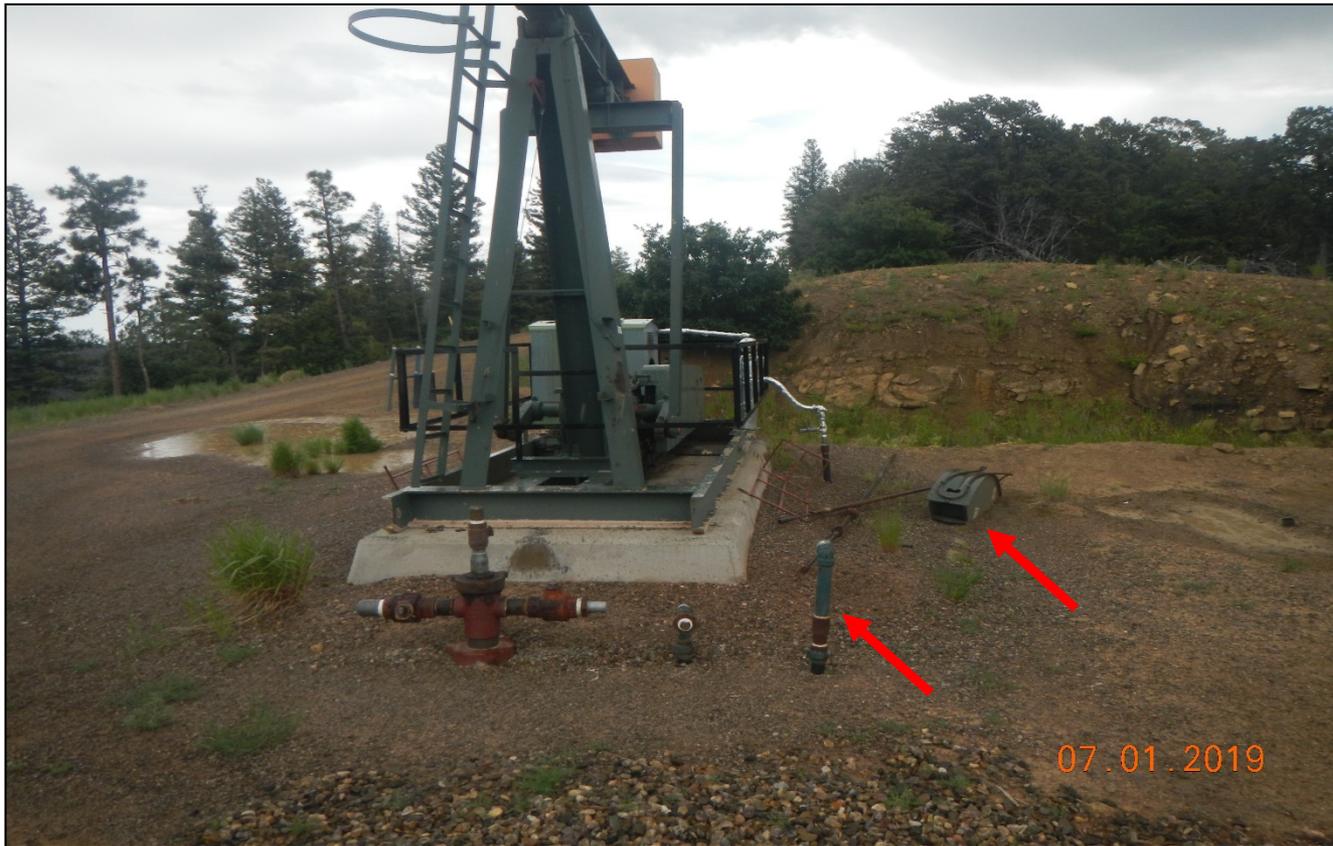
Photo 4. Facing toward pumpjack. Unused equipment remains. Pipe risers with not LO/TO are unused equipment.

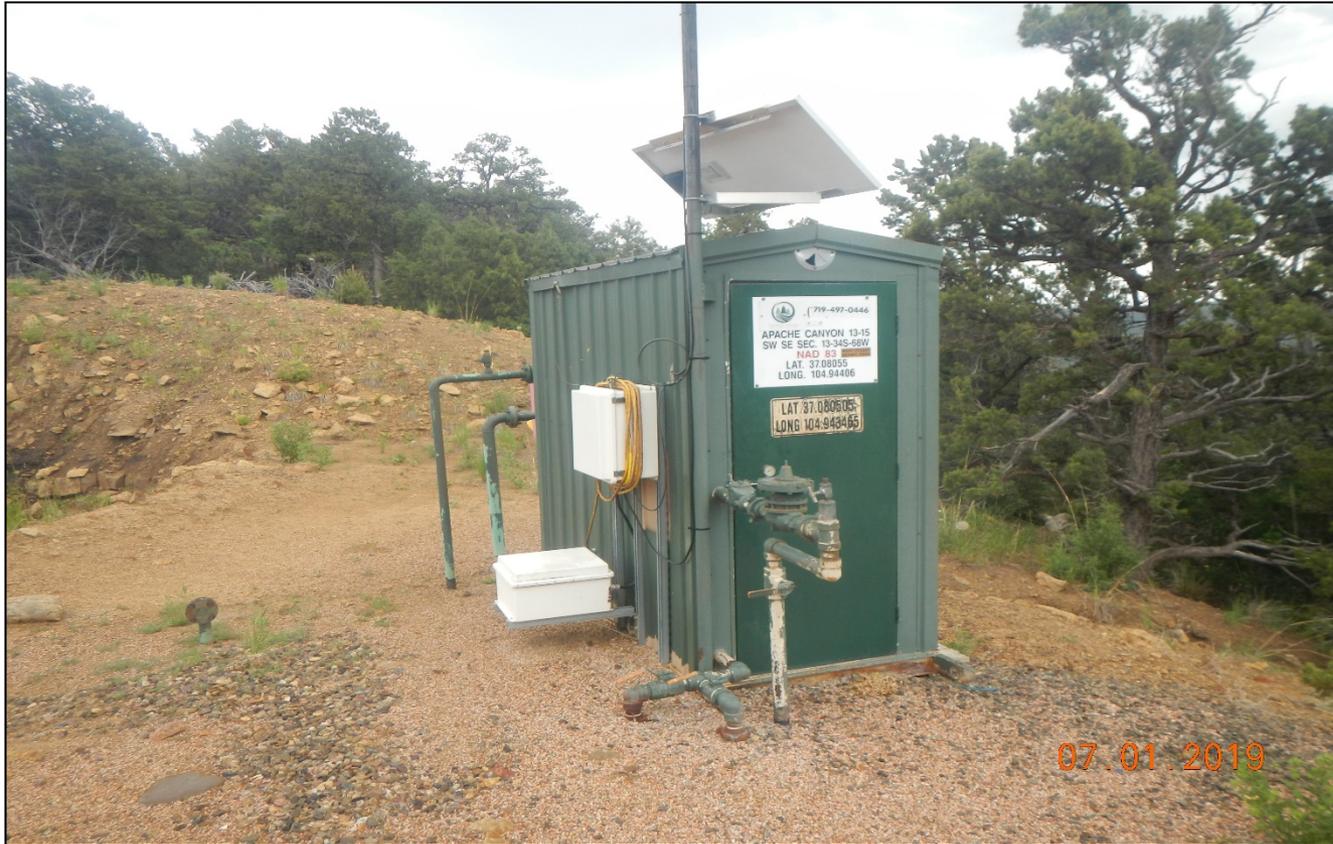
Photo 5. Meter shed has well sign.

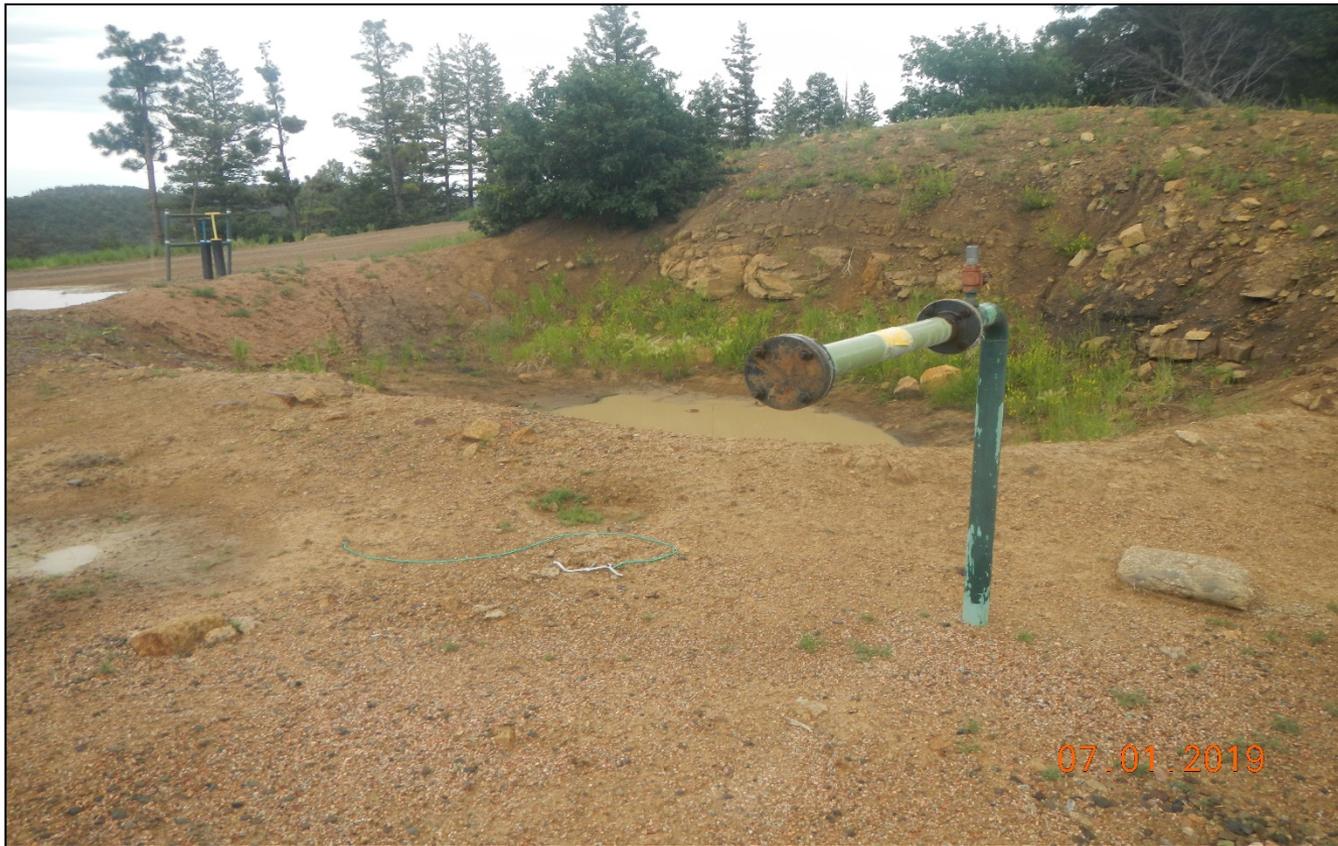
Photo 6. Pipe risers with not LO/TO are unused equipment.
