# Inspection Photos

API: 05-071-07186

Operator: TIMBER CREEK OPERATING LLC

Inspection Date: 7/1/2019

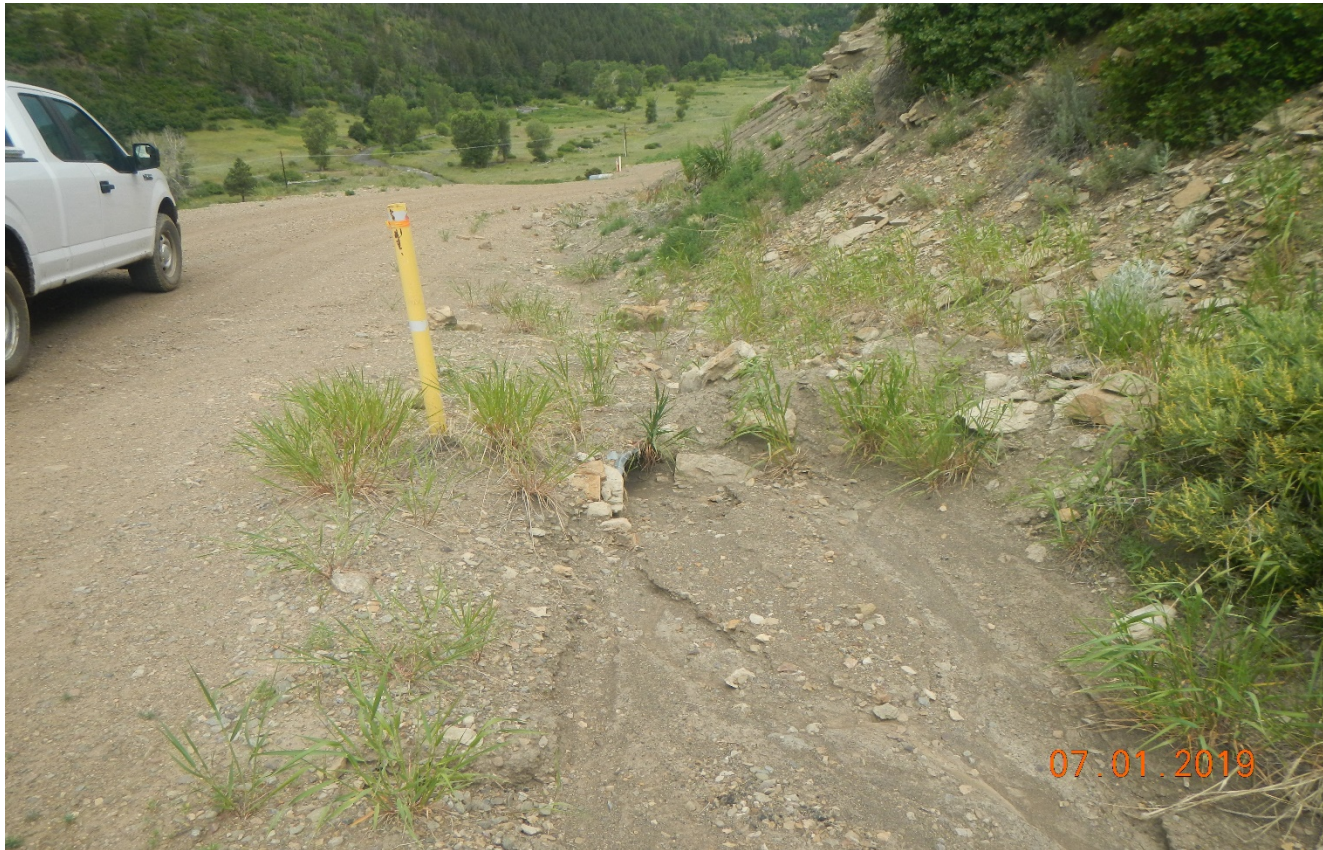
**Photo 1.** The culvert is full of sediment along the access road.

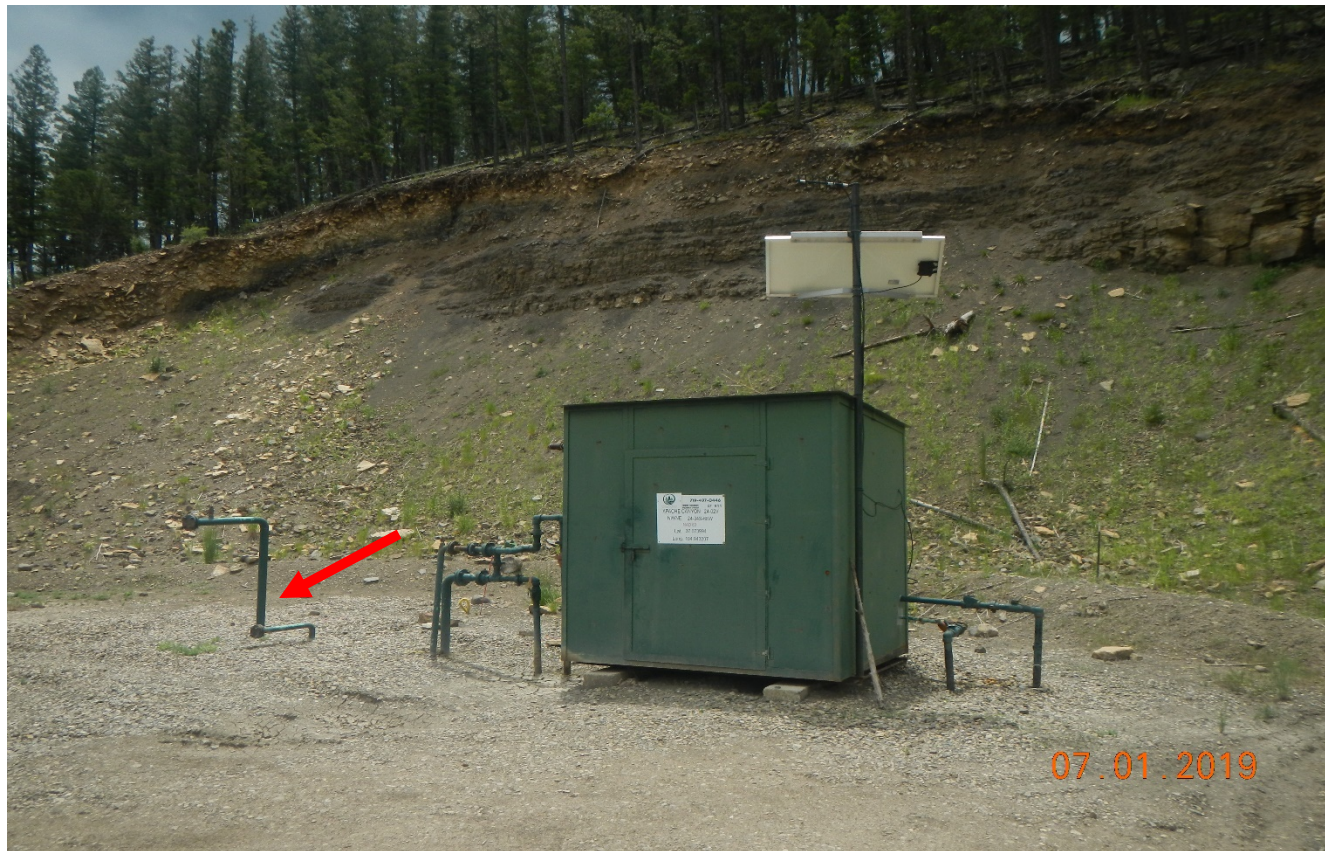
**Photo 2.** Facing toward the location. Unused risers not LO/TO.

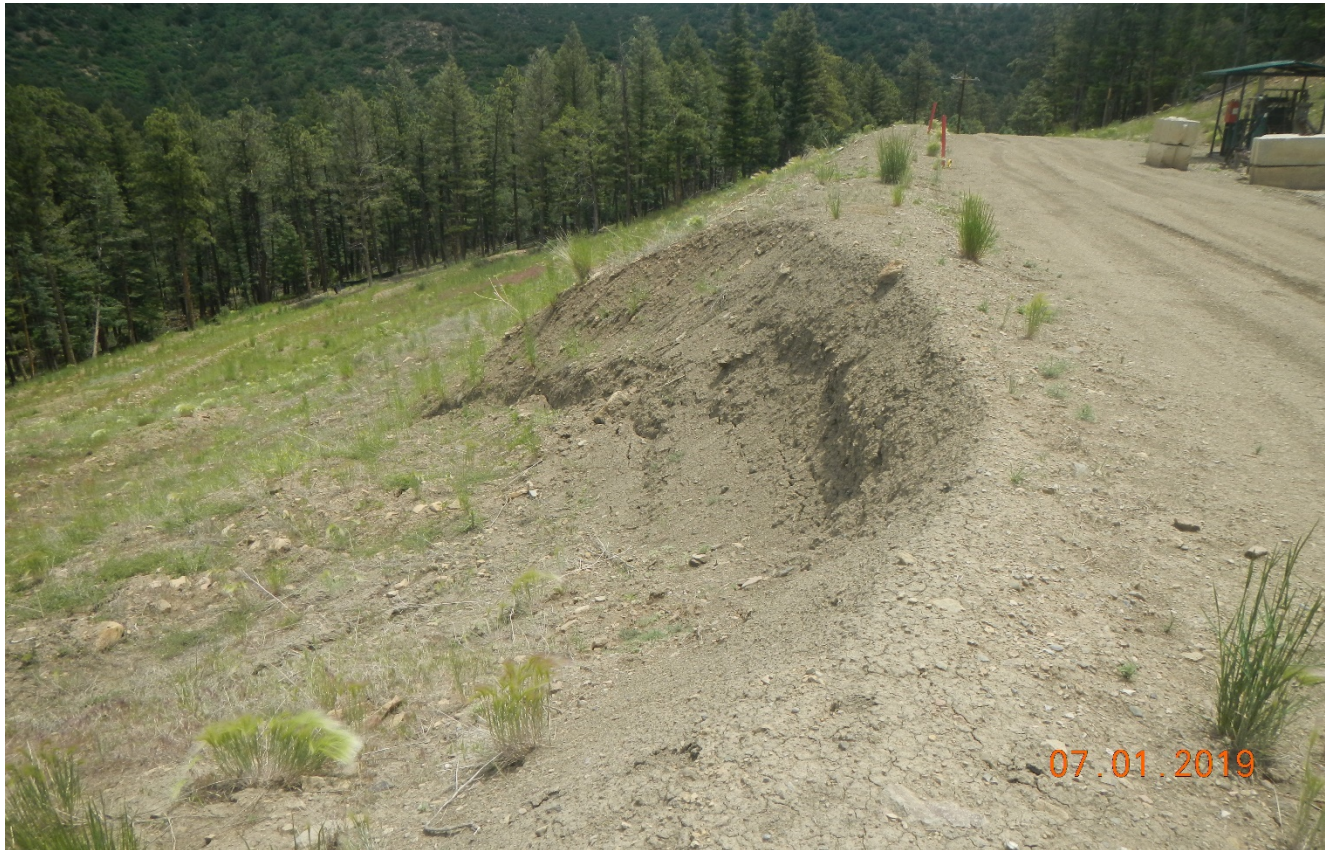
**Photo 3.** There is soil sloughing that occurred at the east side of the location.
