Maralex Resources Inc.  
API # 05-045-09853  
Inspection # 696600237

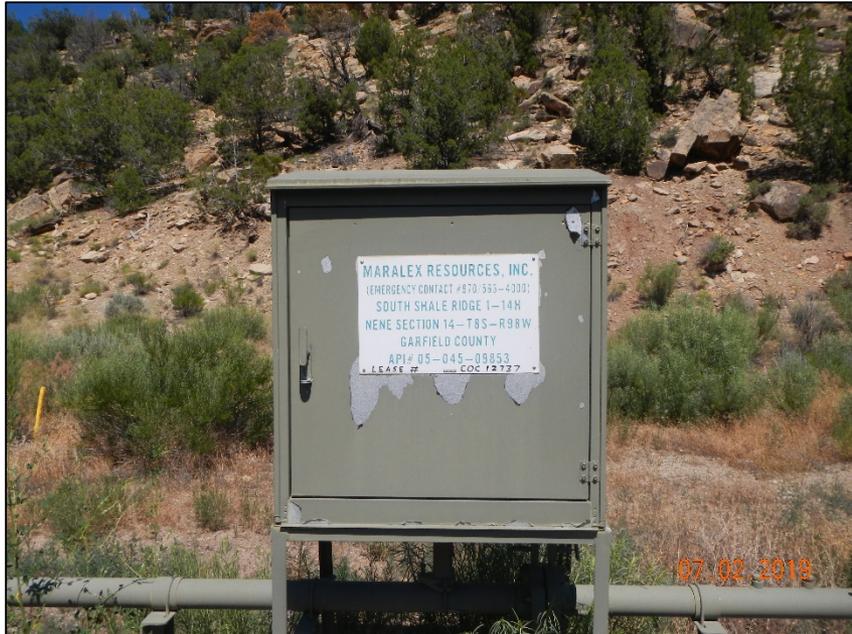
Photo #1 Photo of Tank Battery sign on Meter

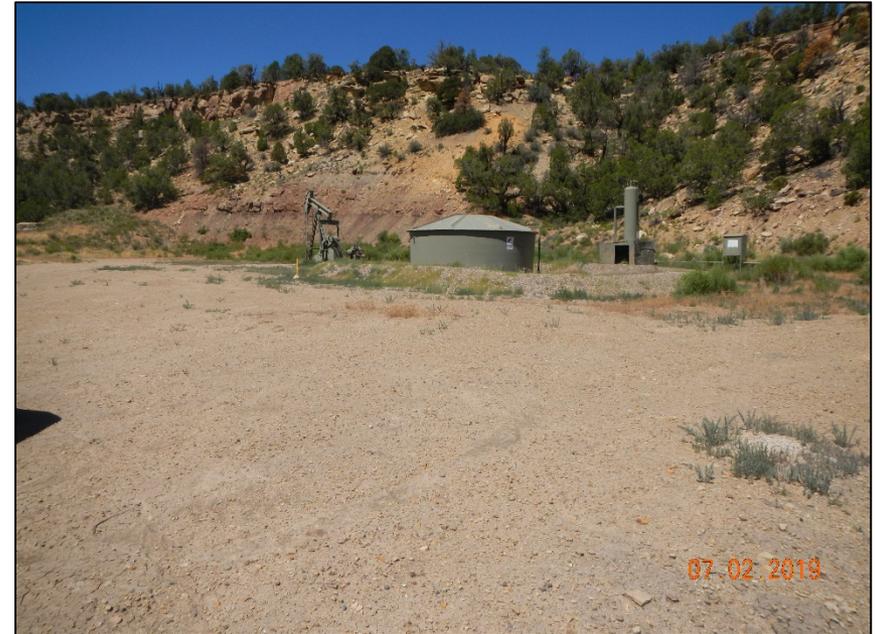
Photo #2 photo from entrance of location

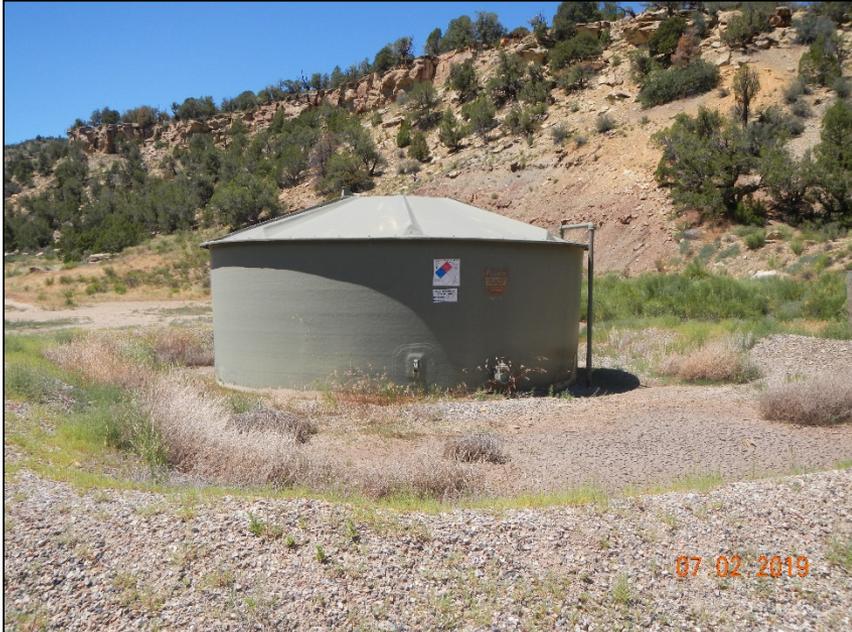
Photo #3 photo of tank battery

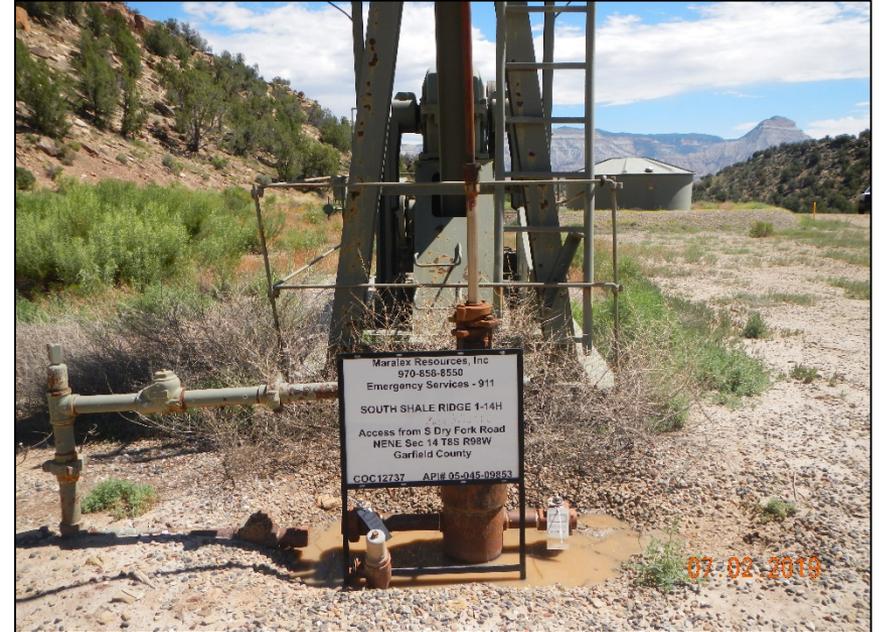
Photo #4 photo of Wellhead

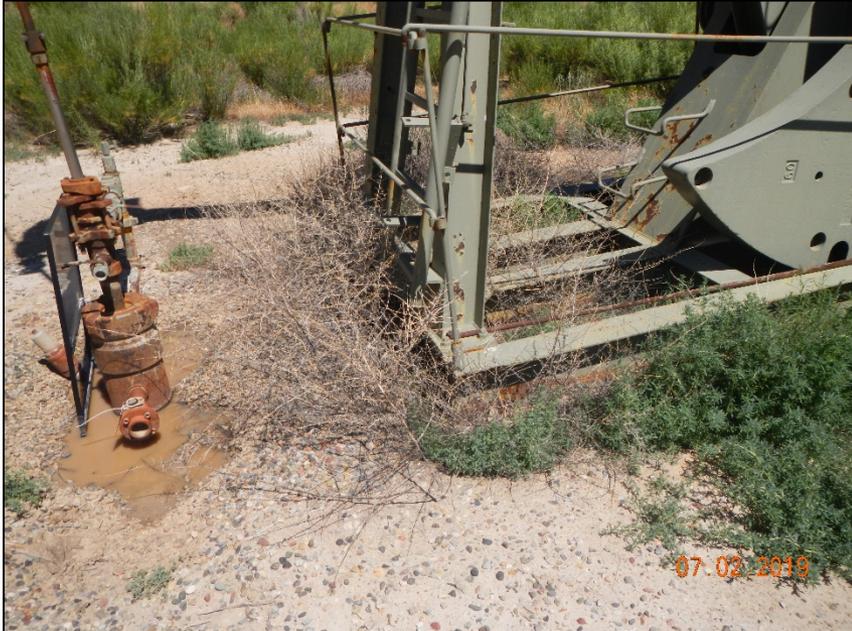
Photo #5 Weeds and Debris on location

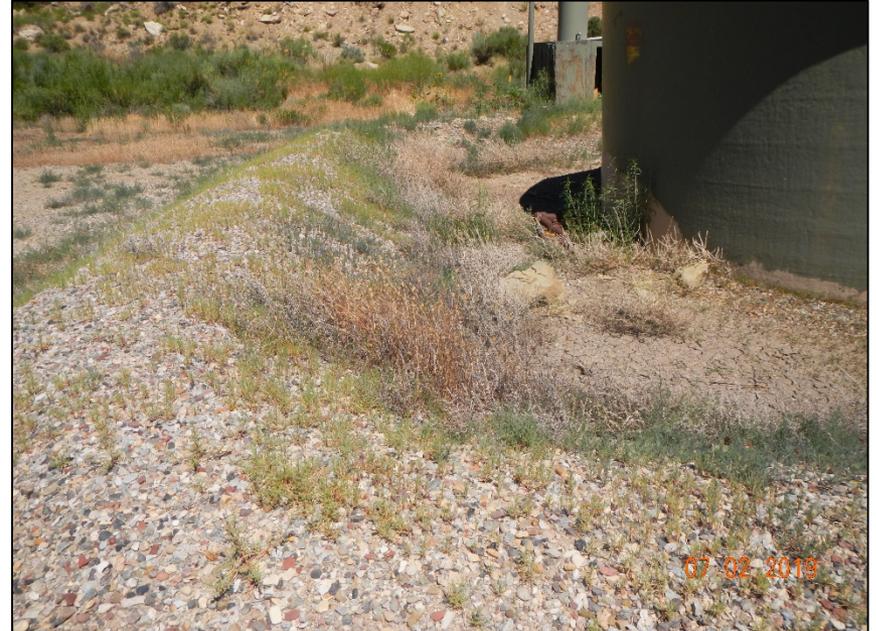
Photo #6 Weeds and Debris on location and in tank battery containment

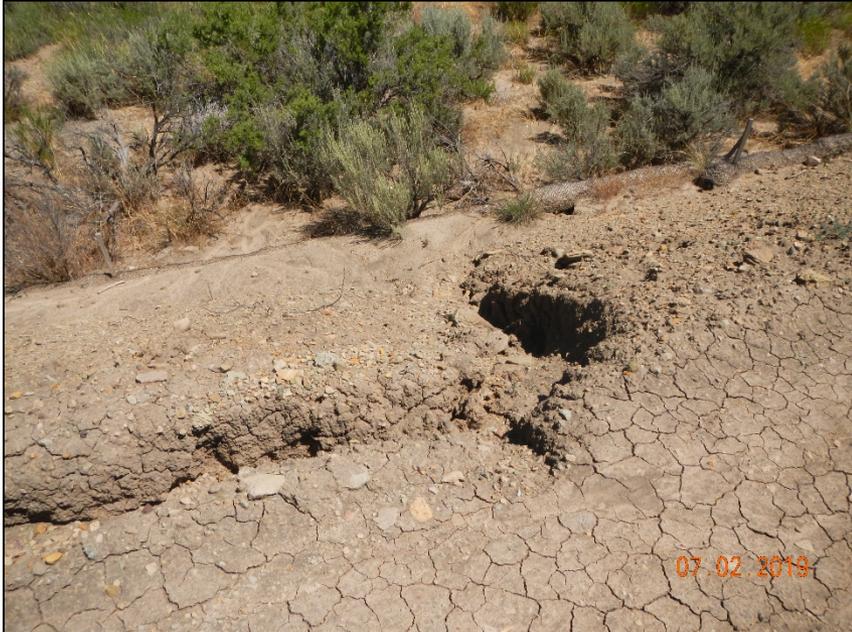
**Photo #7 Storm Water Erosion moving off location on East side of location**

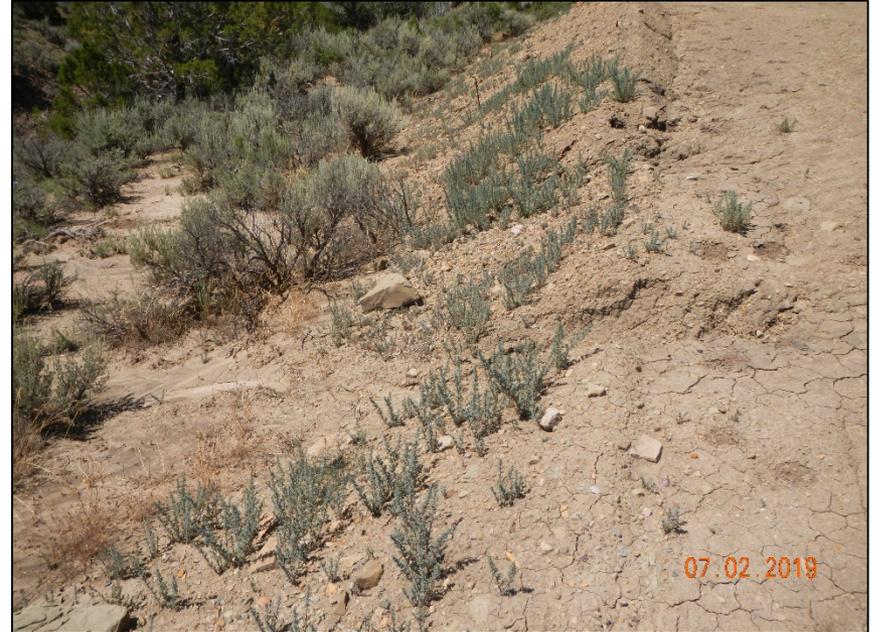
**Photo # 8 Storm Water Erosion moving off location on South East side of location along access road, Waddle needs maintenance.**

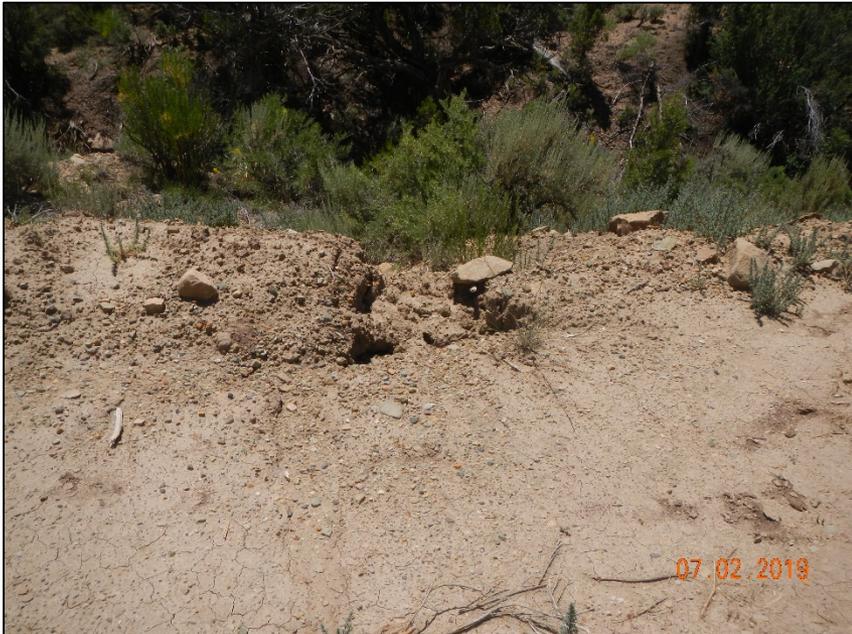
**Photo #9 Storm water erosion moving off location on SE side of entrance.**

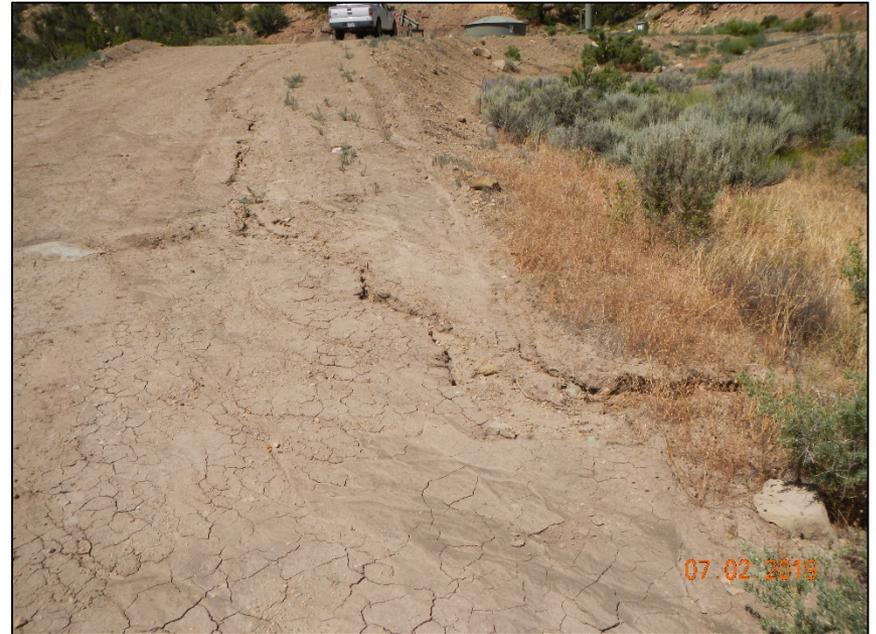
**Photo #10 Storm water erosion moving off location down access road on east entrance.**

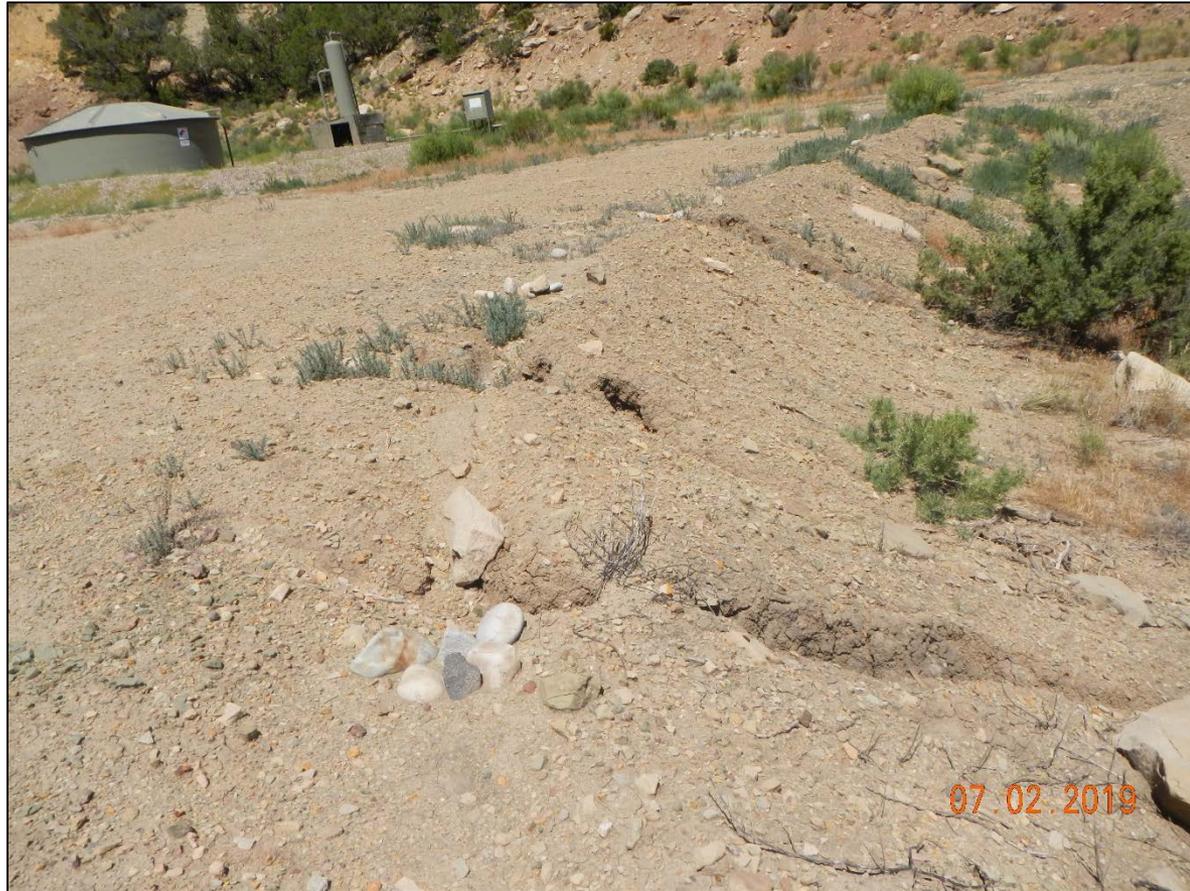
**Photo #11 Storm Water Erosion moving off location on East side of location**
