Inspection Photos
Location Name: Mutual 01-17H
Location ID: 324757

COLORADO
Oil & Gas Conservation
Commission
Department of Natural Resources

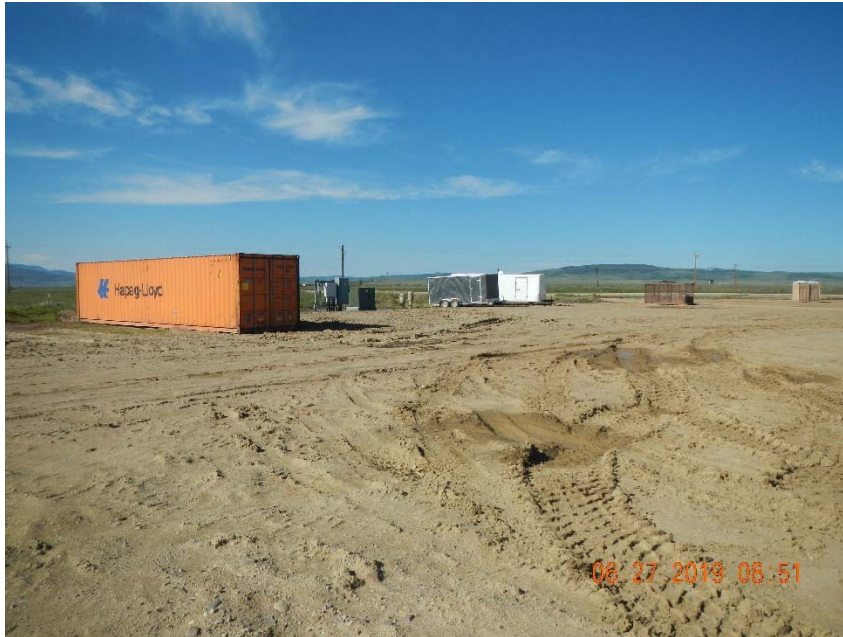
Photo 1. Equipment stored on location. Site degradation.

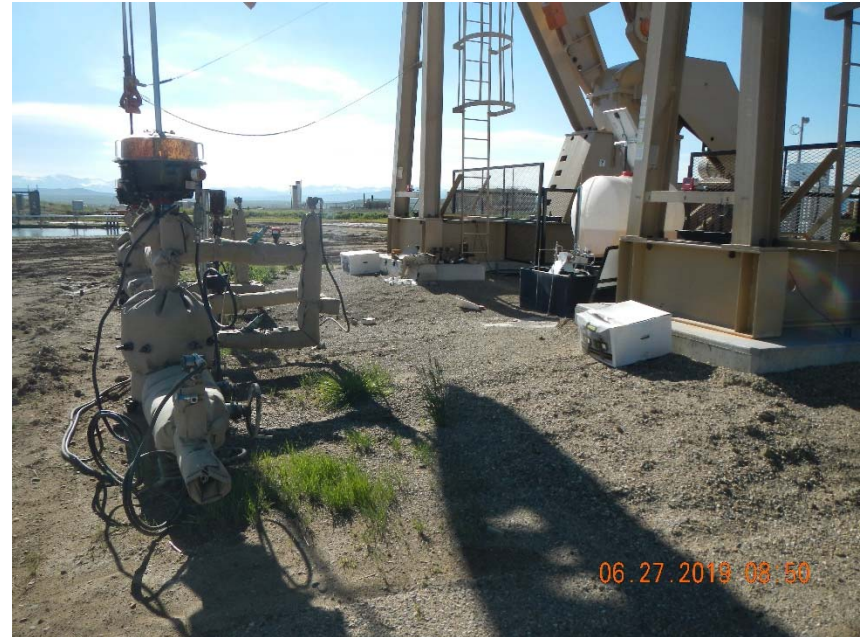
Photo 2. Example of trash on location.

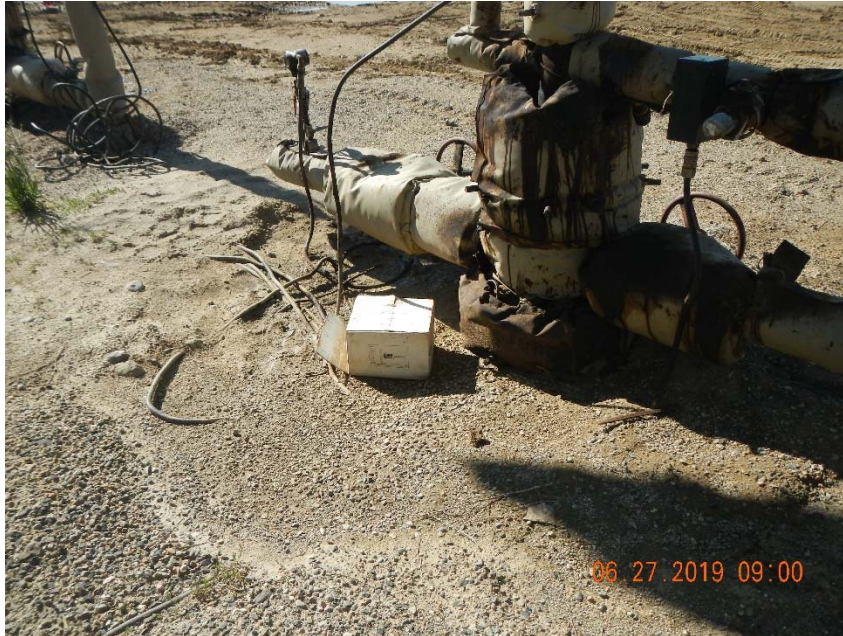
Photo 3. Example of debris on location.

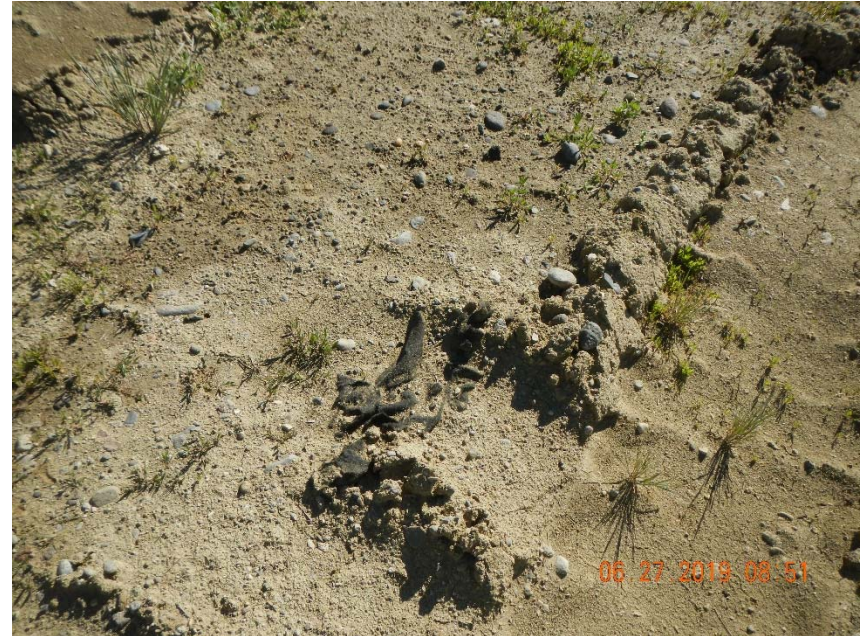
Photo 4. Example of trash on location.

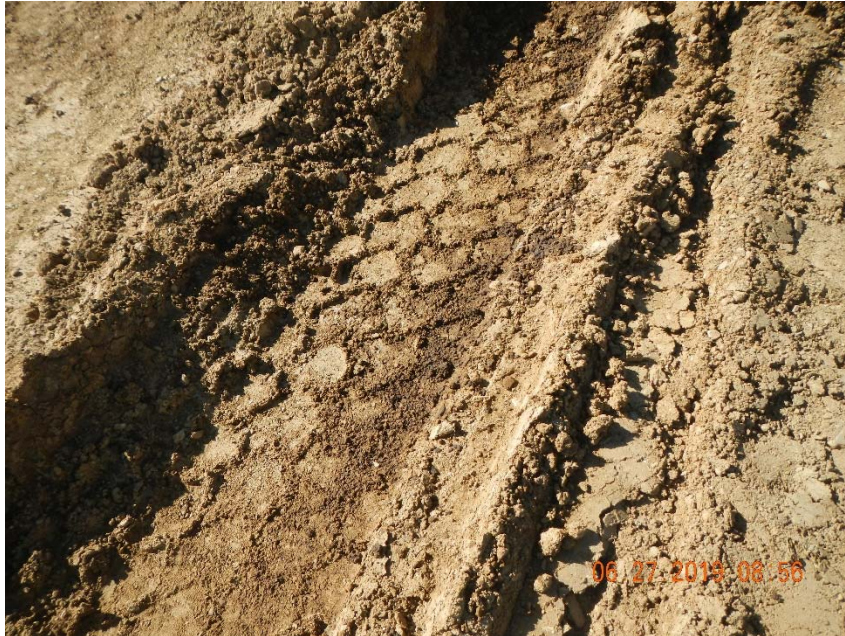
Photo 5. Example of stained soil on location.

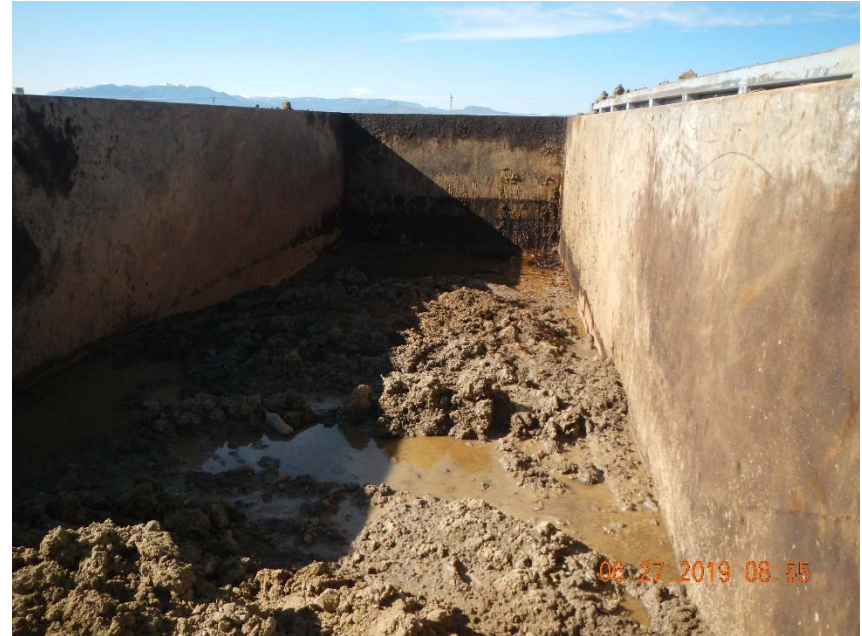
Photo 6. Example of storage of cuttings remediation material.

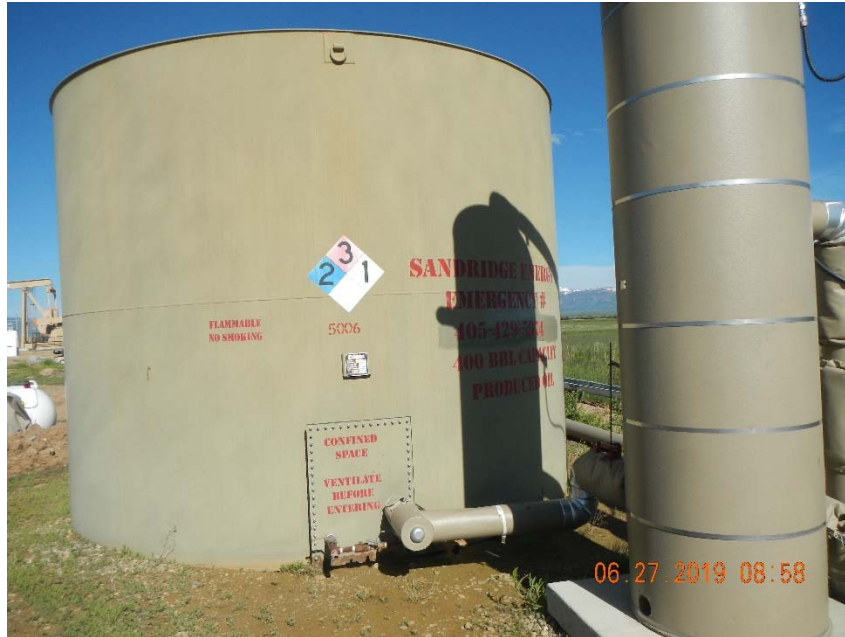
Photo 7. Condensate tank labeled as crude oil. No liner apparent, berm not compacted.

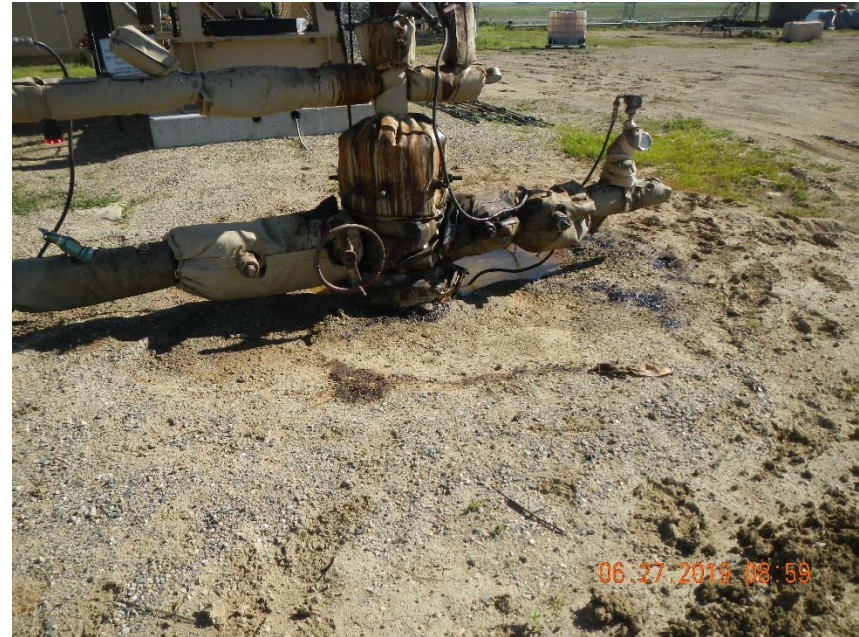
Photo 8. Cellar full of stormwater with free product on top and stained soil around wellhead.

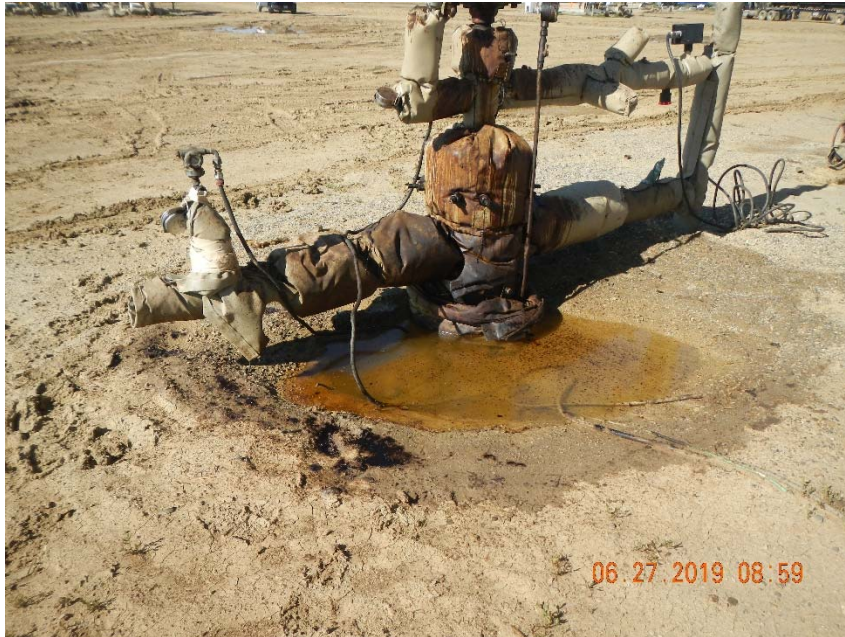
Photo 9. Cellar full of stormwater with free product on top and stained soil around wellhead.

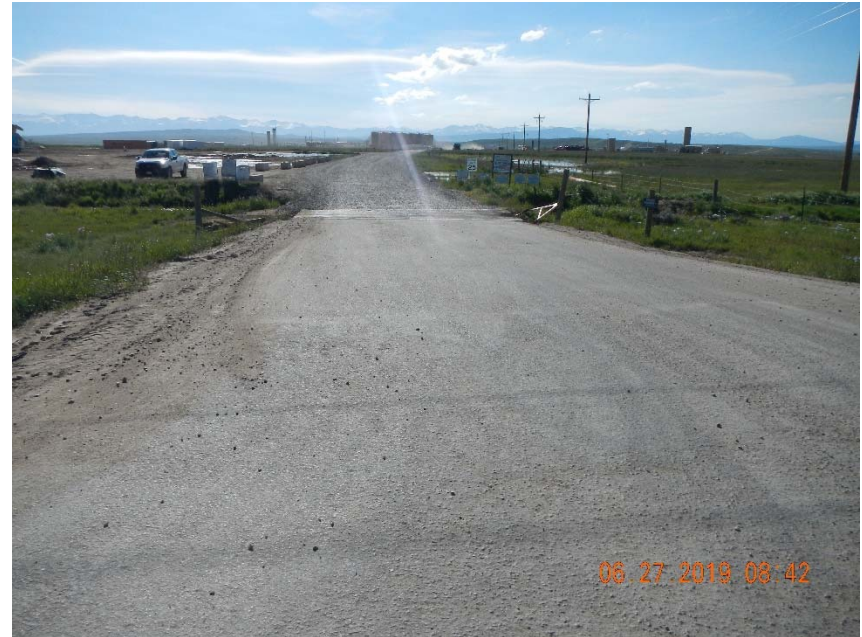
Photo 10. No tracking BMPs apparent at location entrance from highway.

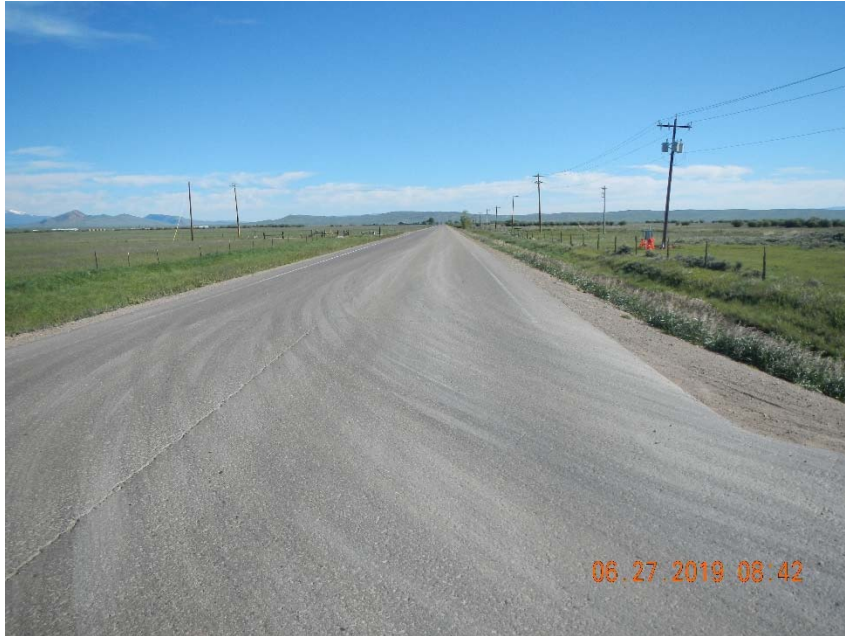
Photo 11. Tracking north onto Colorado Highway 14.

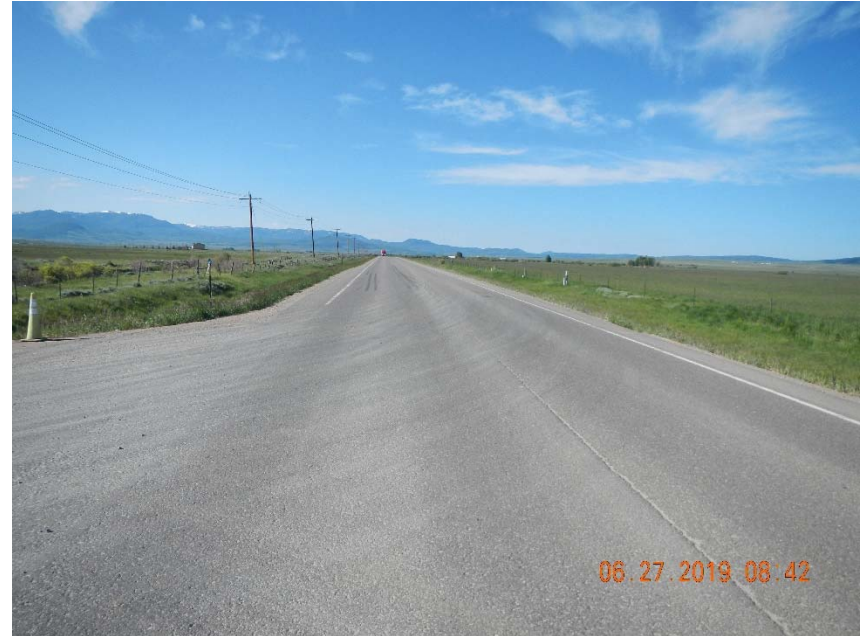
Photo 12. Tracking south onto Colorado Highway 14.
