Inspection Photos
Location Name: Evans 0780 21
Location ID: 438250

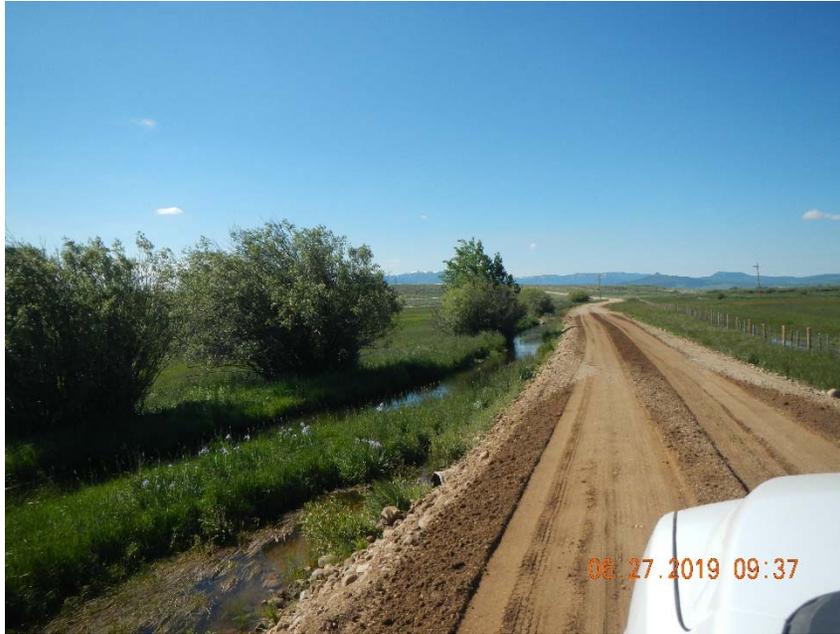
Photo 1. Access road with fresh material and no stormwater BMPs.

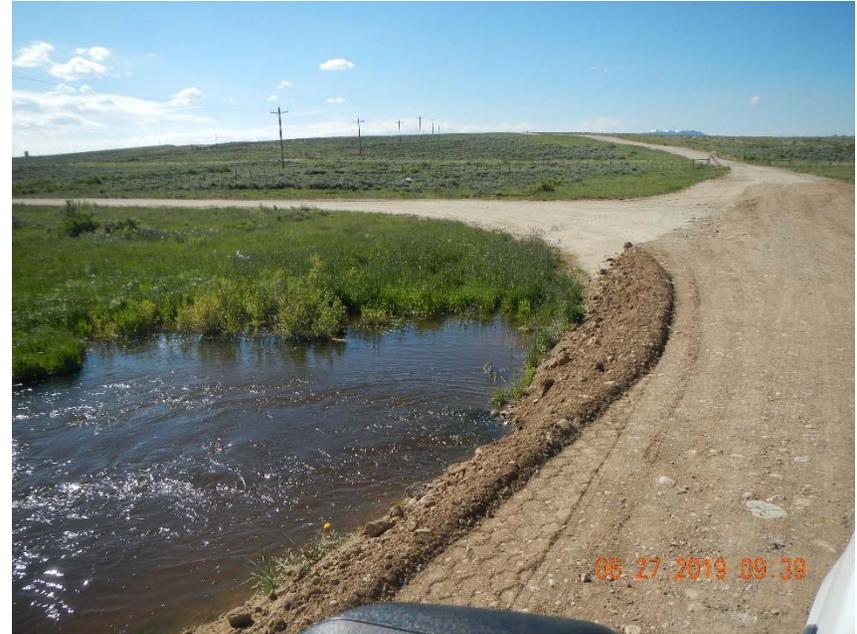
Photo 2. Access road with fresh material and no stormwater BMPs.

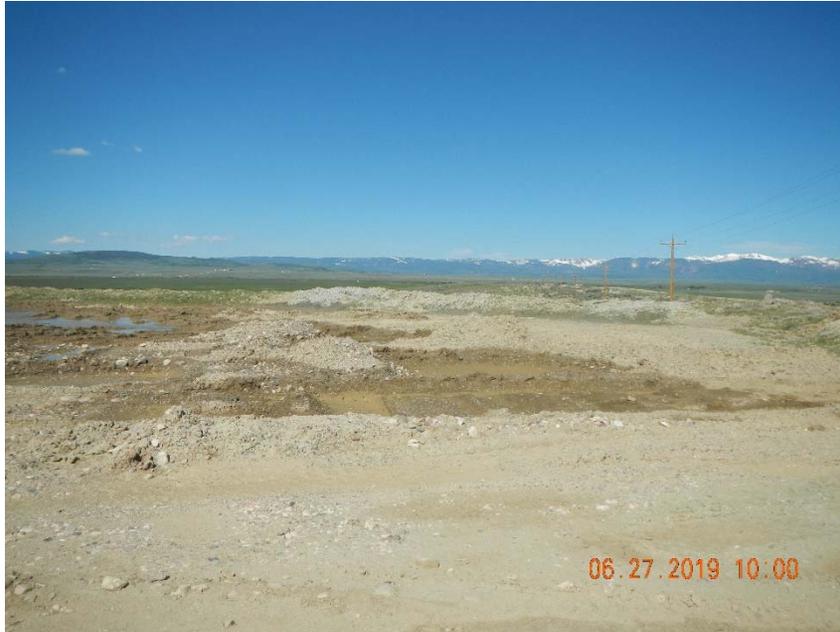
Photo 3. Example of cuttings on location.

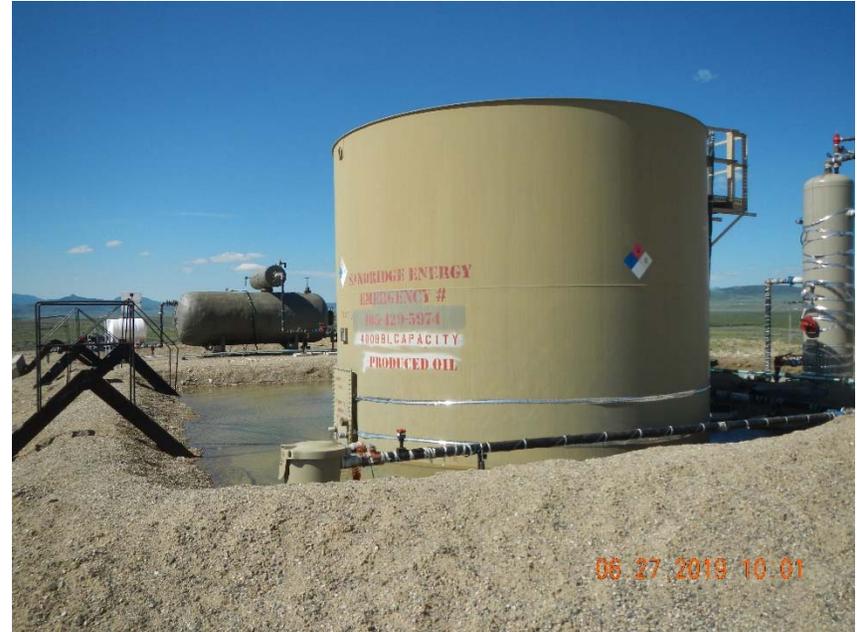
Photo 4. Condensate tank labeled as crude oil.

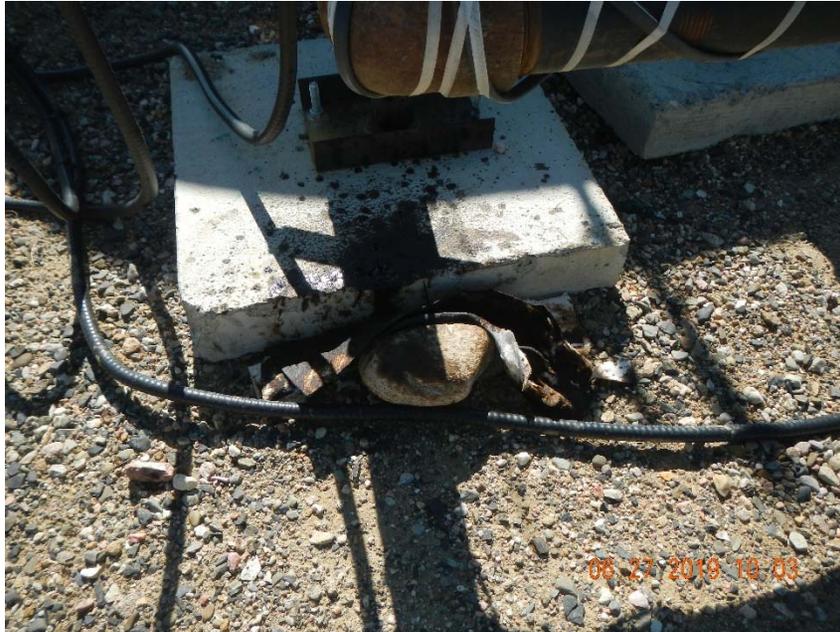
Photo 5. Drip at separator with rag held in place with rock beneath drip.

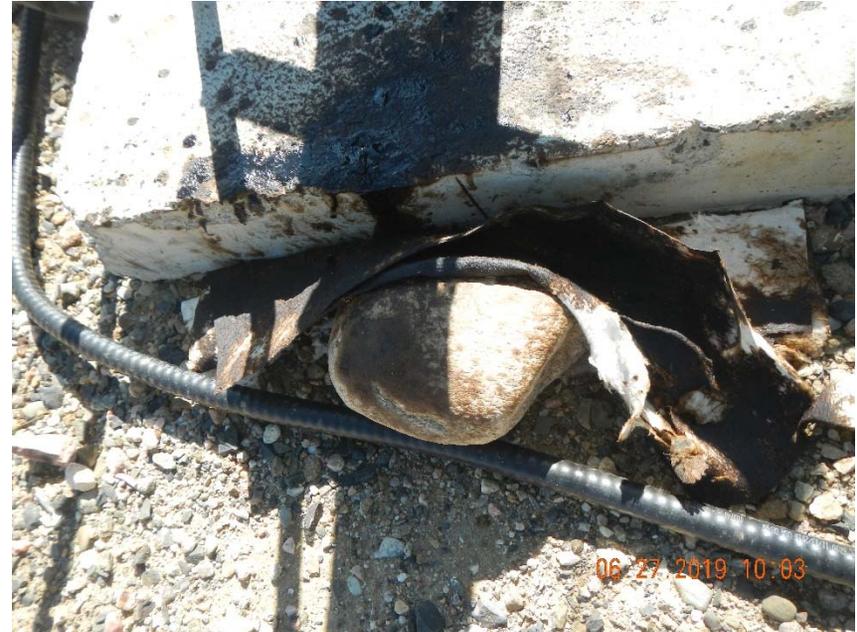
Photo 6. Close up of photo 5.

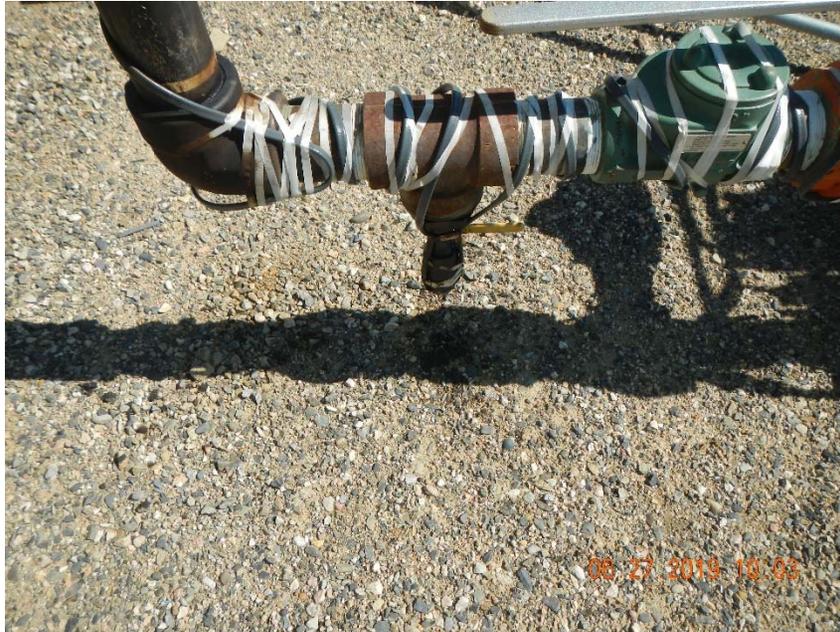
Photo 7. Example of additional drips on location.

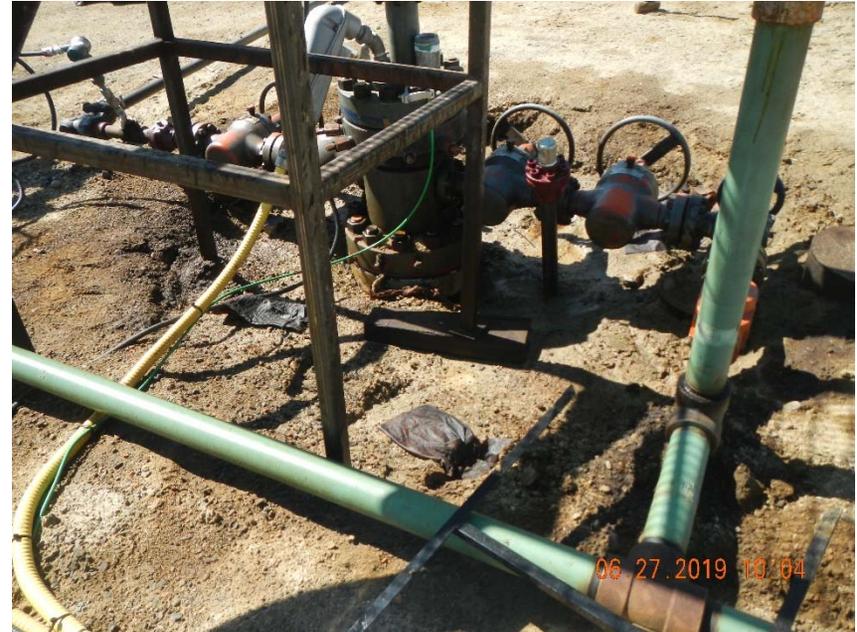
Photo 8. Stained soil at wellhead, oily rags and trash at wellhead.

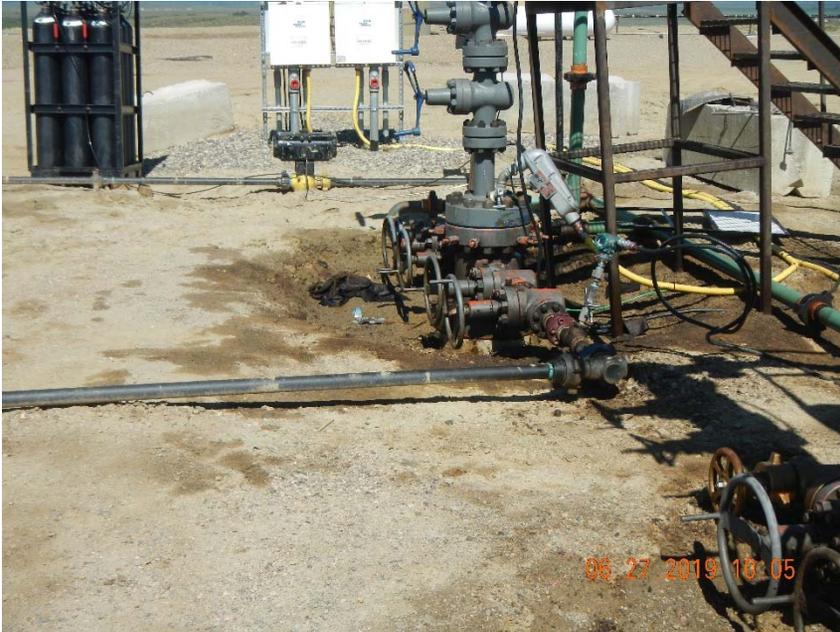
Photo 9. Stained soil at wellheads, oil rags and trash and wellheads.

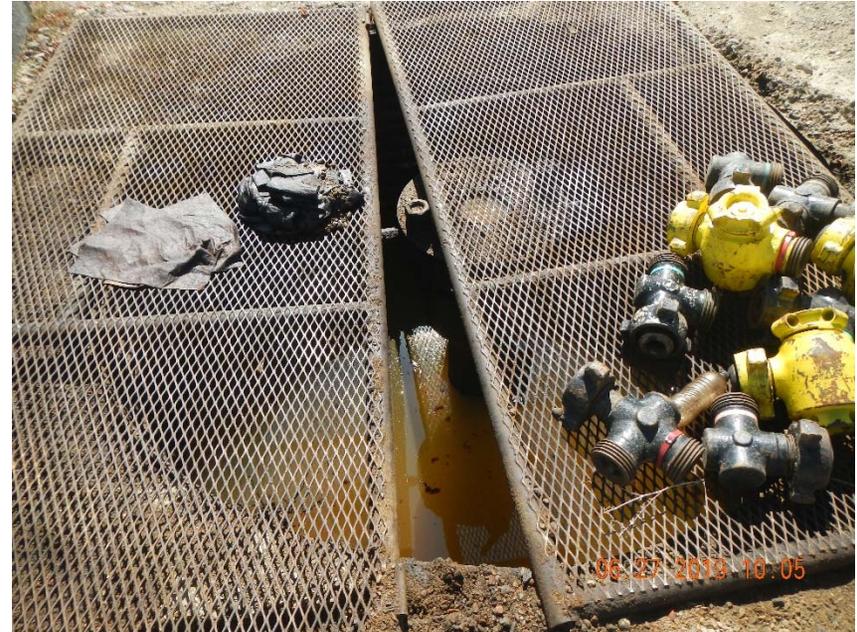
Photo 10. Trash and debris, stormwater with a sheen in cellar.

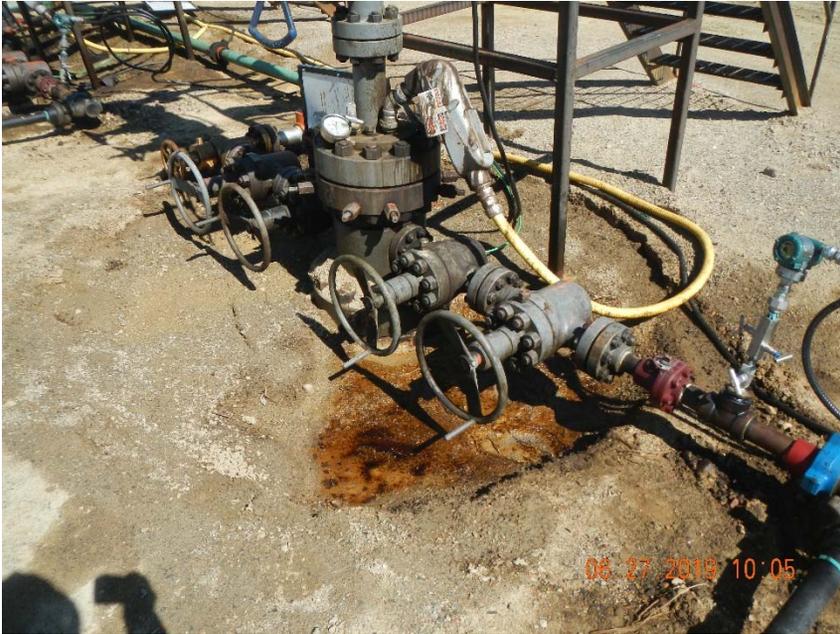
Photo 11. Free product at wellhead.

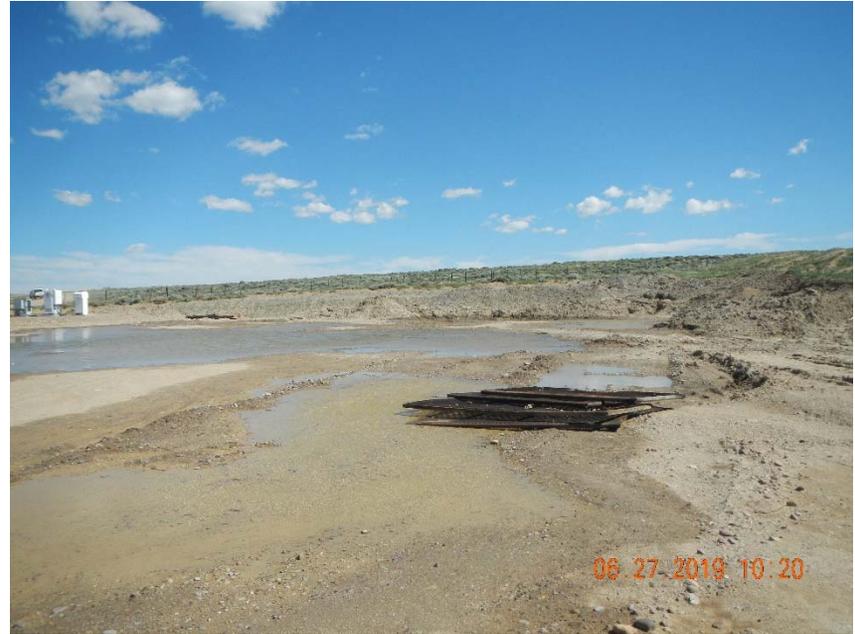
Photo 12. Example of soil piles, cuttings piles, trash and debris, site degradation.

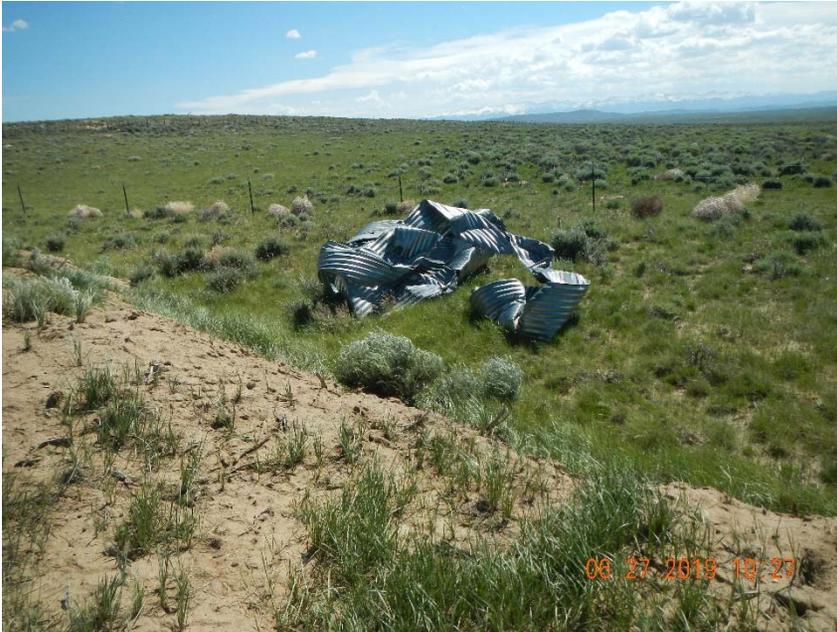
Photo 13. Debris migrating off location.

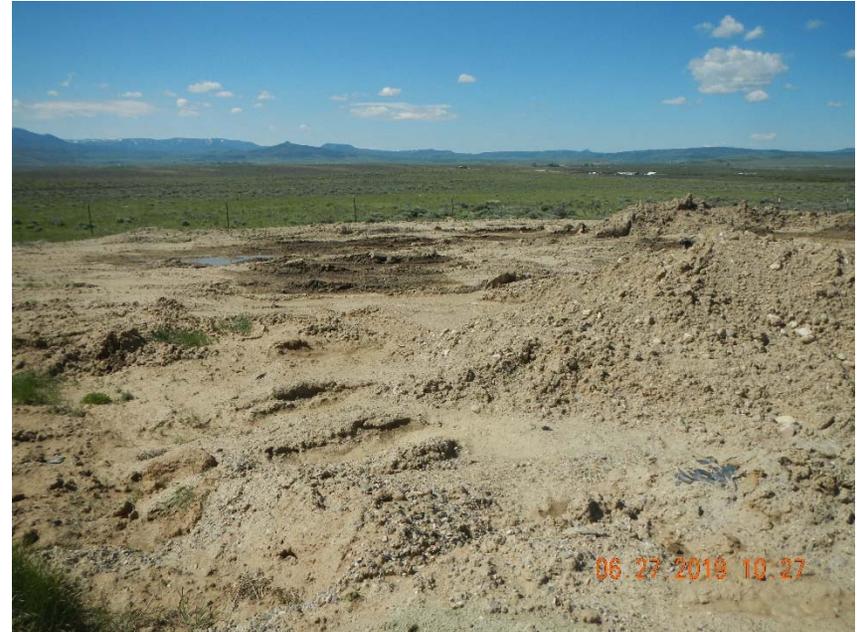
Photo 14. Perimeter berm on southeast corner of location has been compromised.
