**Inspection Photos**  
**Operator: SG Interests**  
**Location/API #: 051-06110**  
**Date: 6-18-2019**

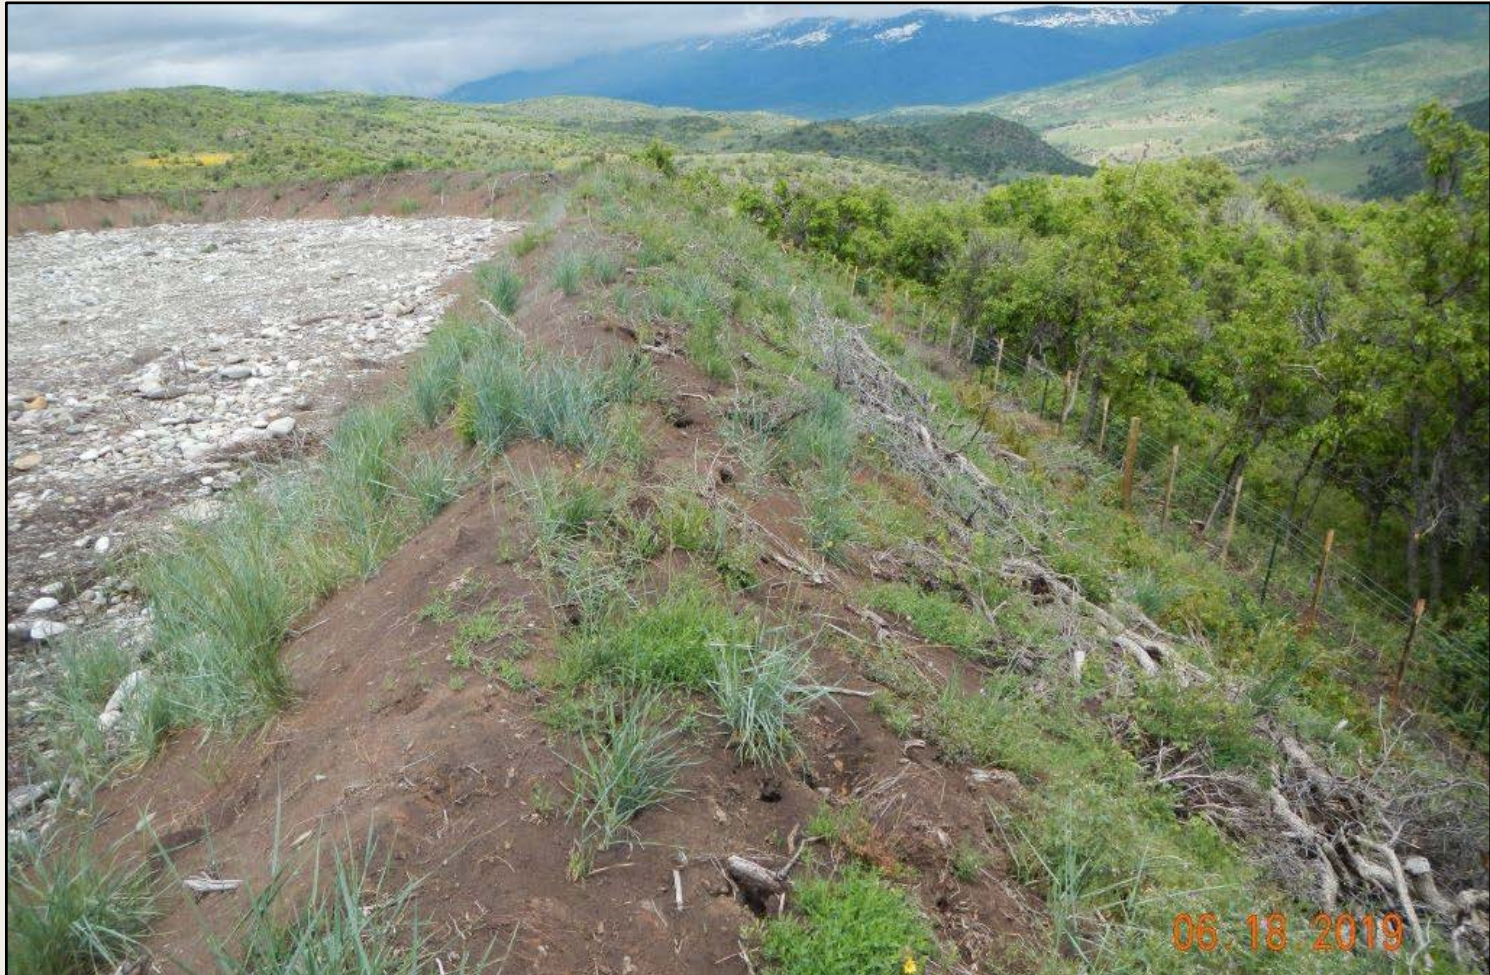
Photo 1. View of the eastern project area from the southeastern corner facing northward. Revegetation is progressing, however stability issues from cracking observed in fill slope. (see photos 4-6)

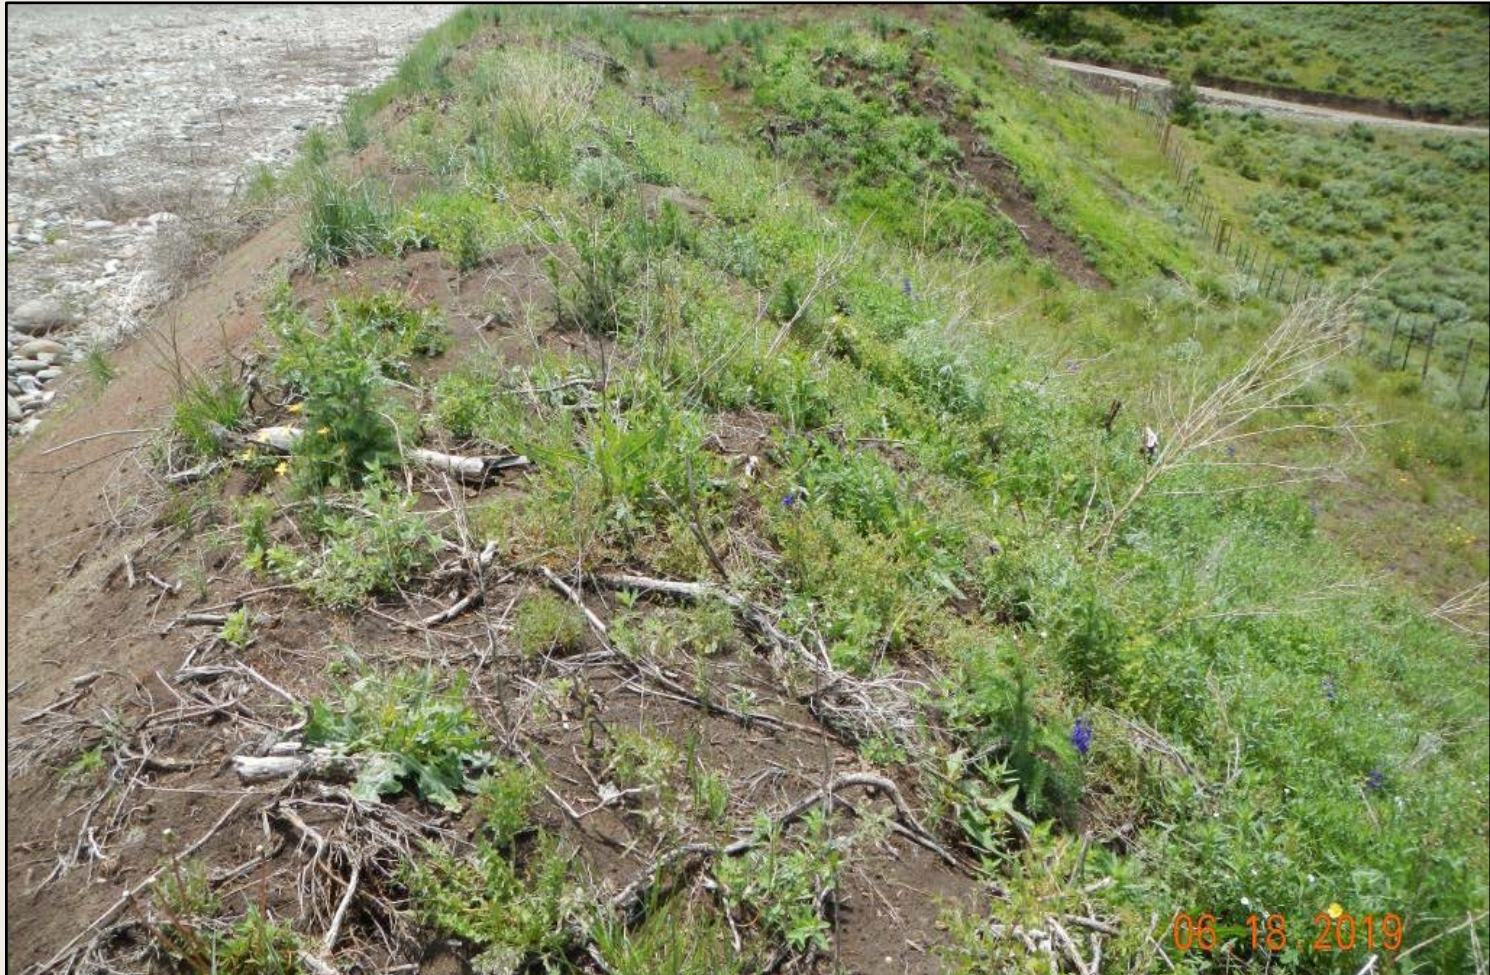
Photo 2. View of the northern project area from the northeastern project area facing westward.

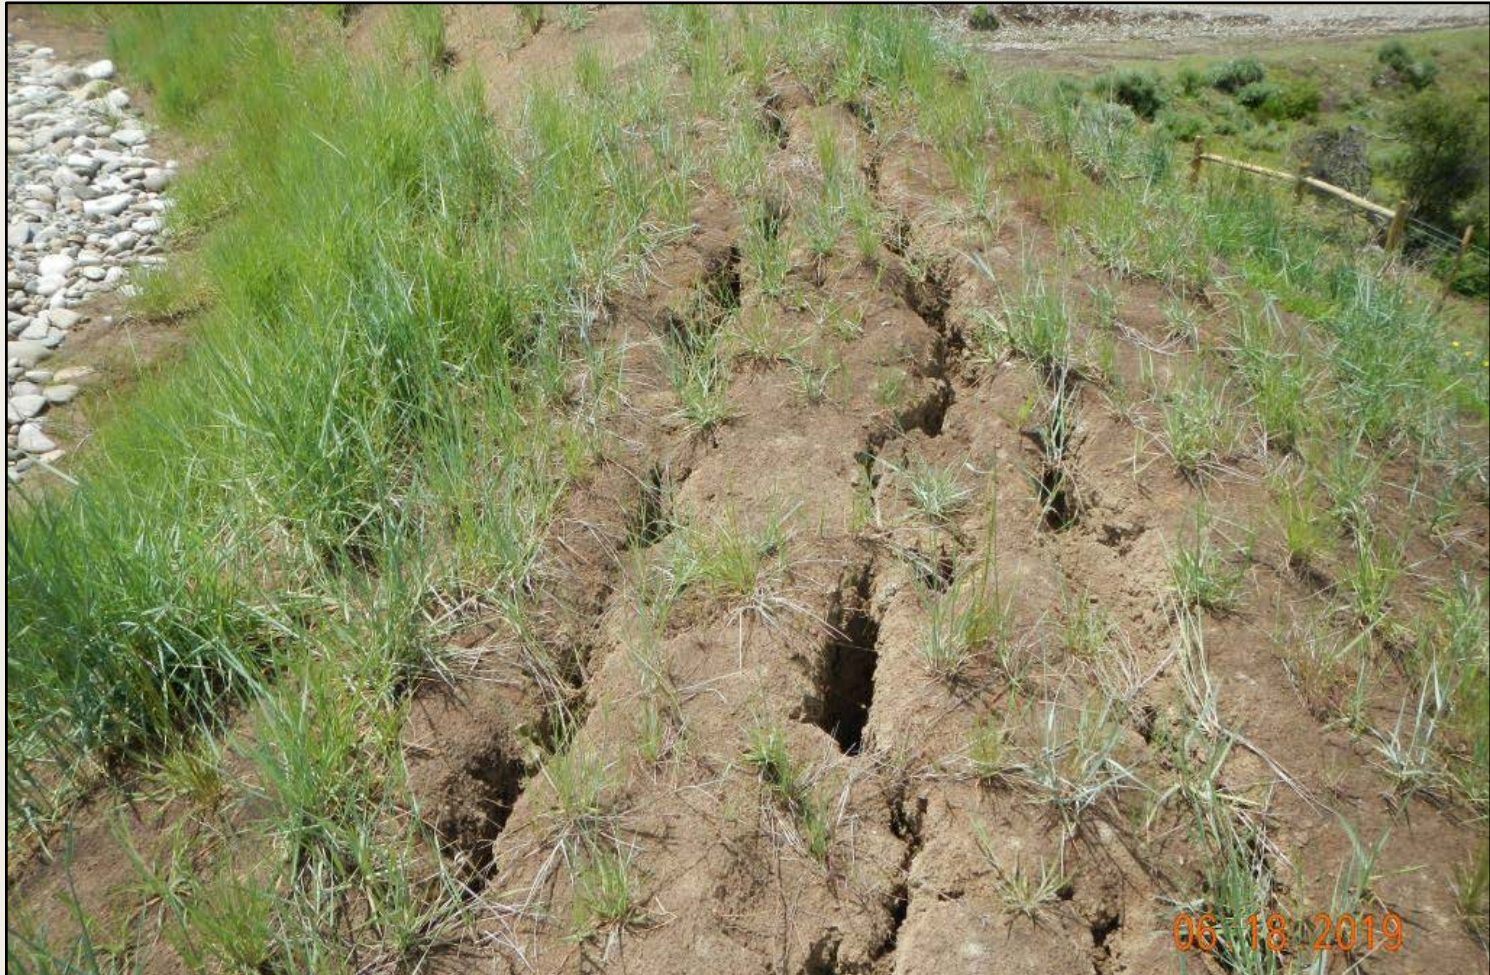
Photo 3. View of soil cracking up to 10 inches deep within the northern berm.

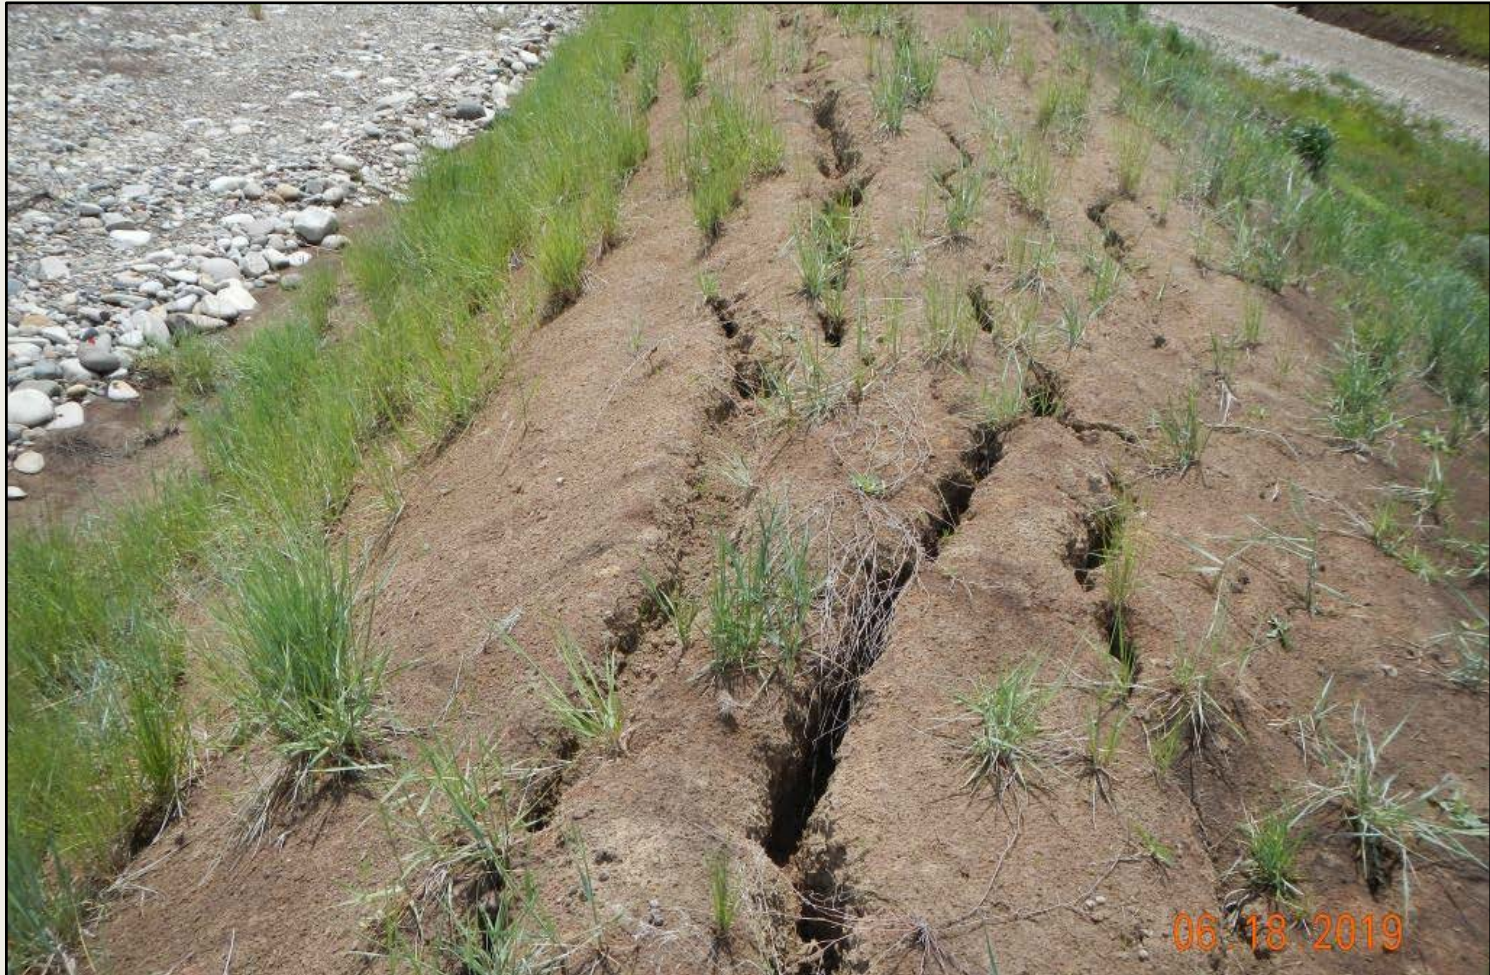
Photo 4. View of more soil cracking within the well pad berm.

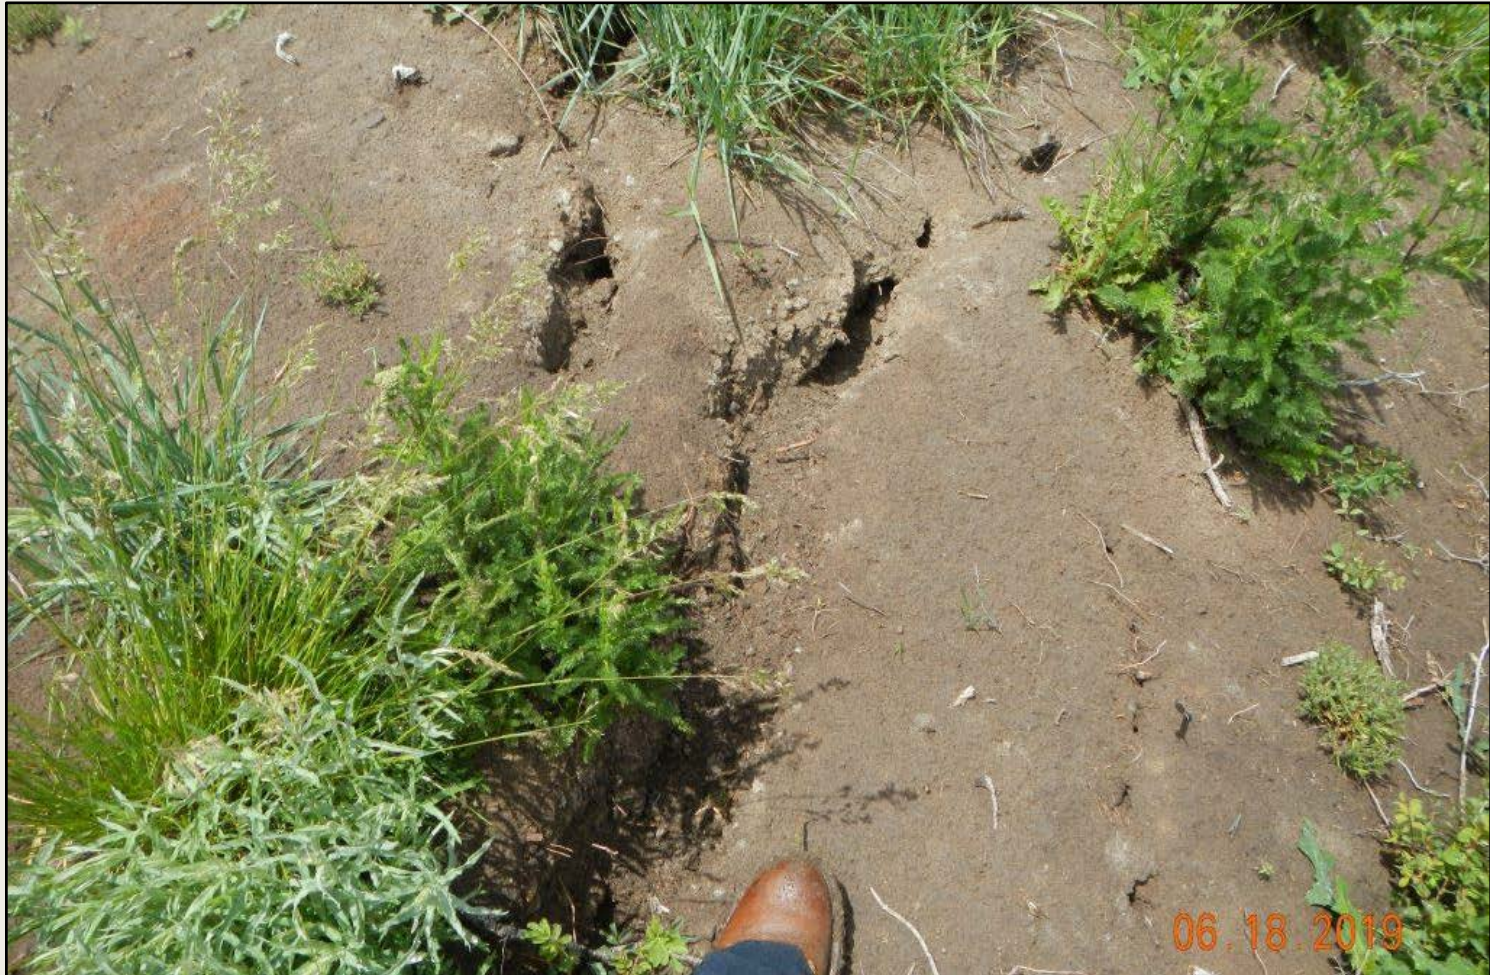
Photo 5. View of cracking within the eastern well pad berm.

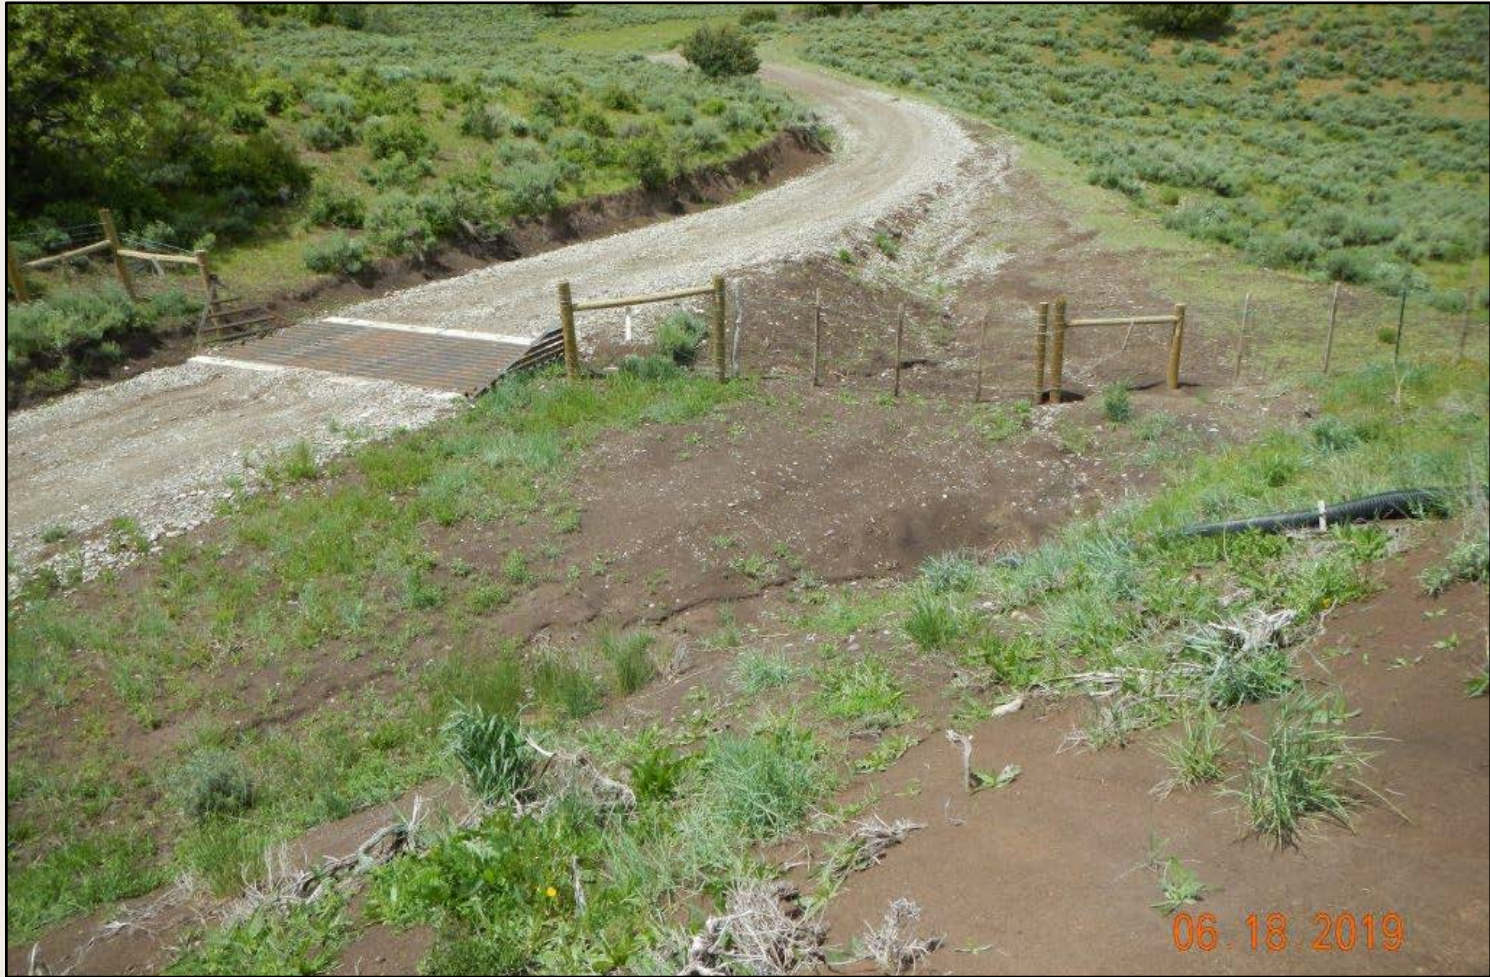
Photo 6. View of area in the northwestern project area where soils are not stabilized and erosion is occurring as stormwater flows north from the project area.

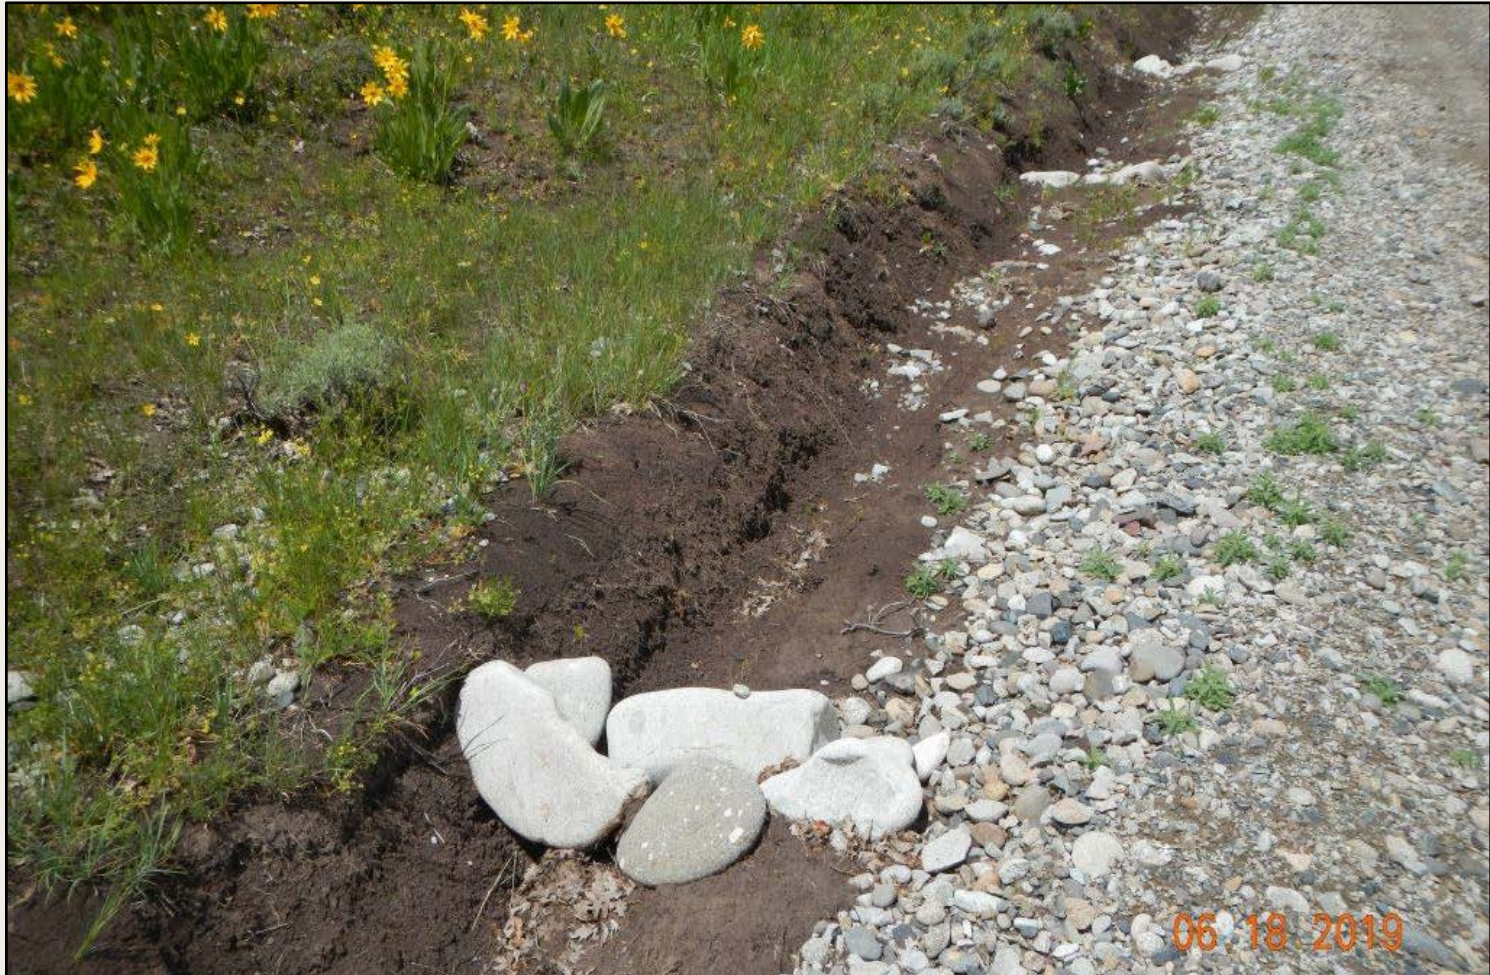
Photo 7. View of cobble velocity checks along the northwestern access road. These are not sufficient as erosional down-cutting from high velocity flows, and sediment deposition where flows settle, is evident.
