Inspection Photos

Loc#426365

Operator: Sandridge

Inspection Photos: Sandridge Peterson Ridge Loc#426365

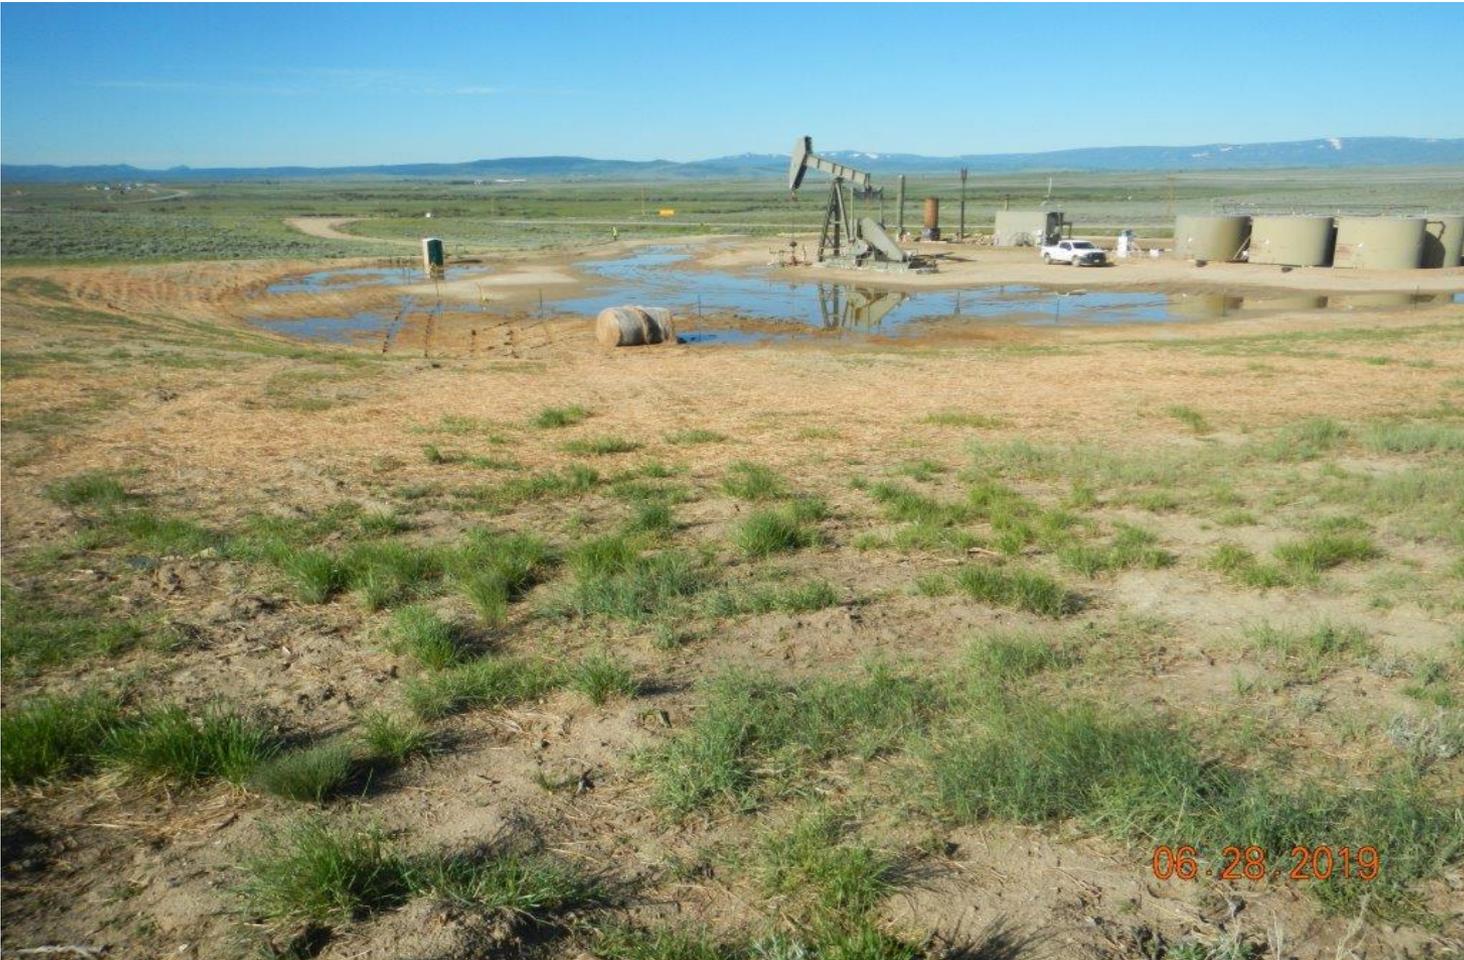
Photo#1:

Overview of Location from top of cut slope to Southwest. Note ponding on pad and Interim Reclamation area.

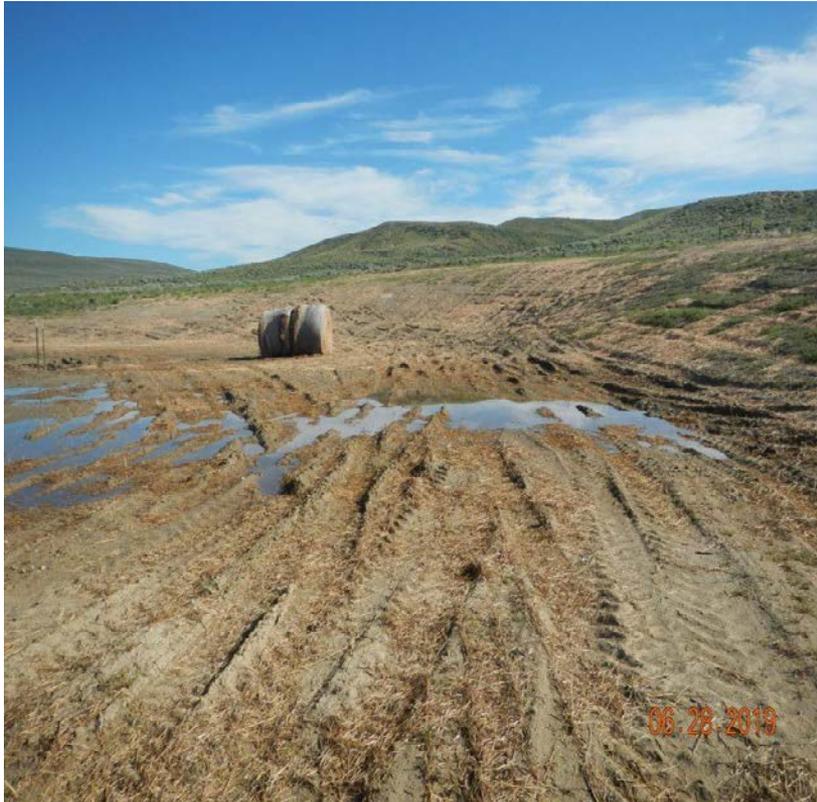
Photo#2:
Newly installed Interim Reclamation; pooled water, round bales and heavy equipment impact.

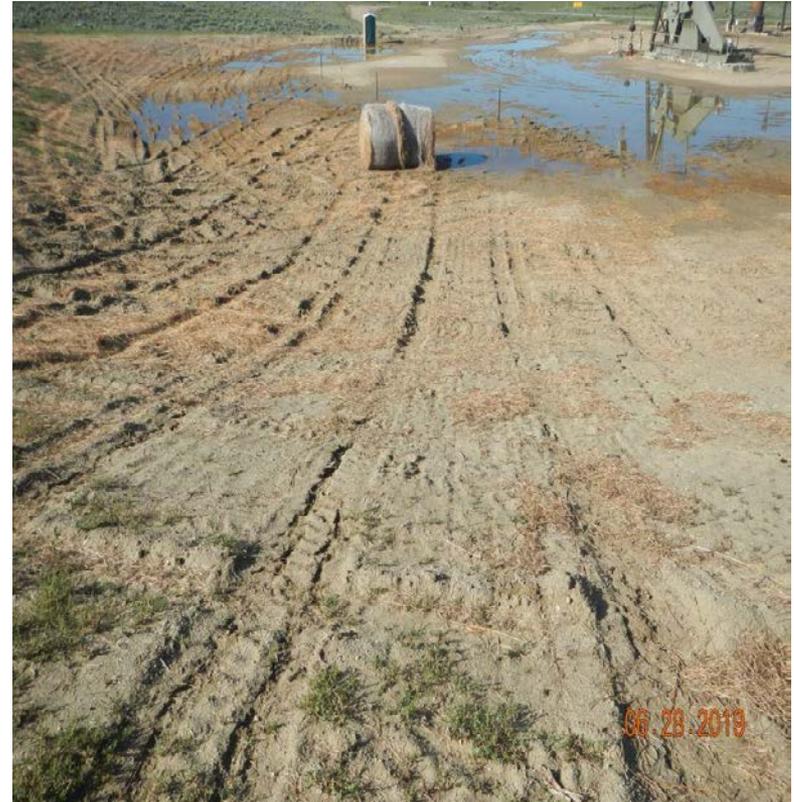
Photo#3:
Newly installed Interim Reclamation; pooled water, round bales and heavy equipment impact.

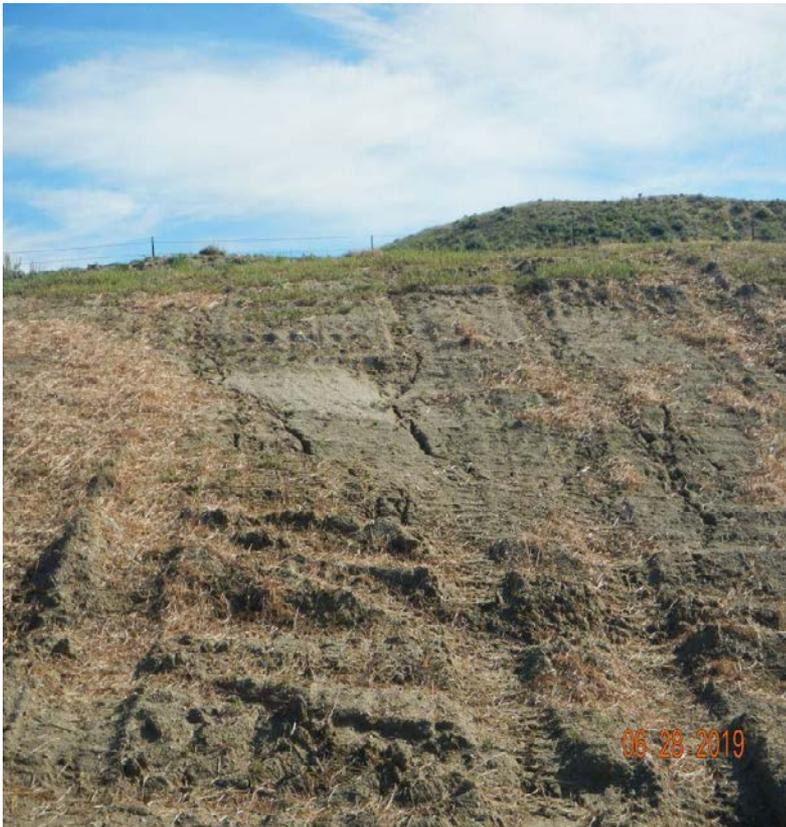
Photo#4:
Area where erosion is commencing on North Cut slope.

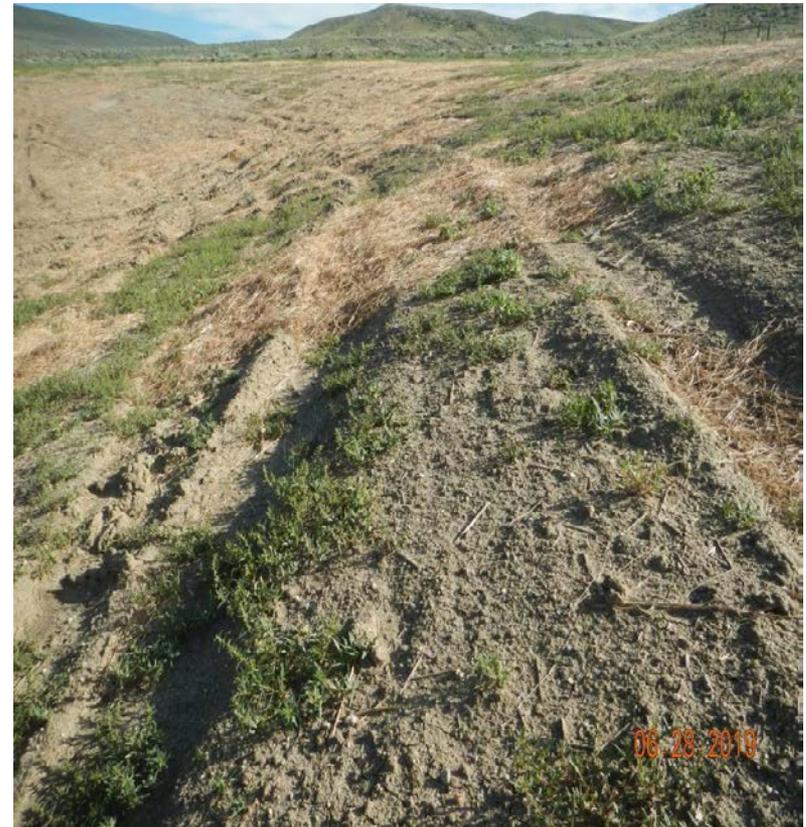
Photo#5:
Impressions (compaction) made by equipment during reclamation activities. Soil Moisture to high?

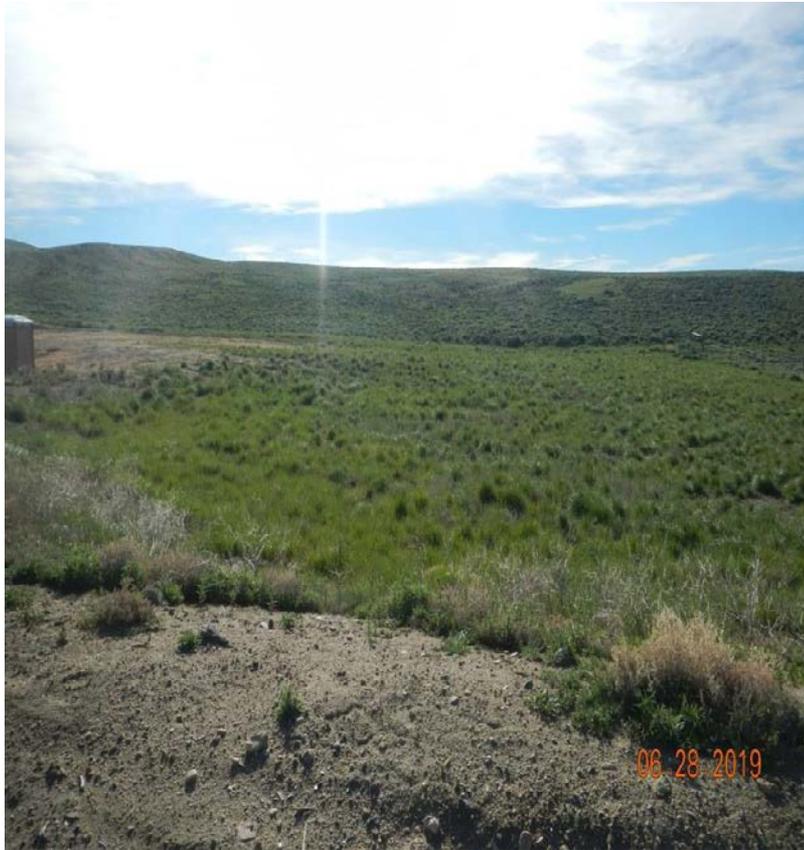
Photo#6:
Older Reclamation areas with established vegetation.

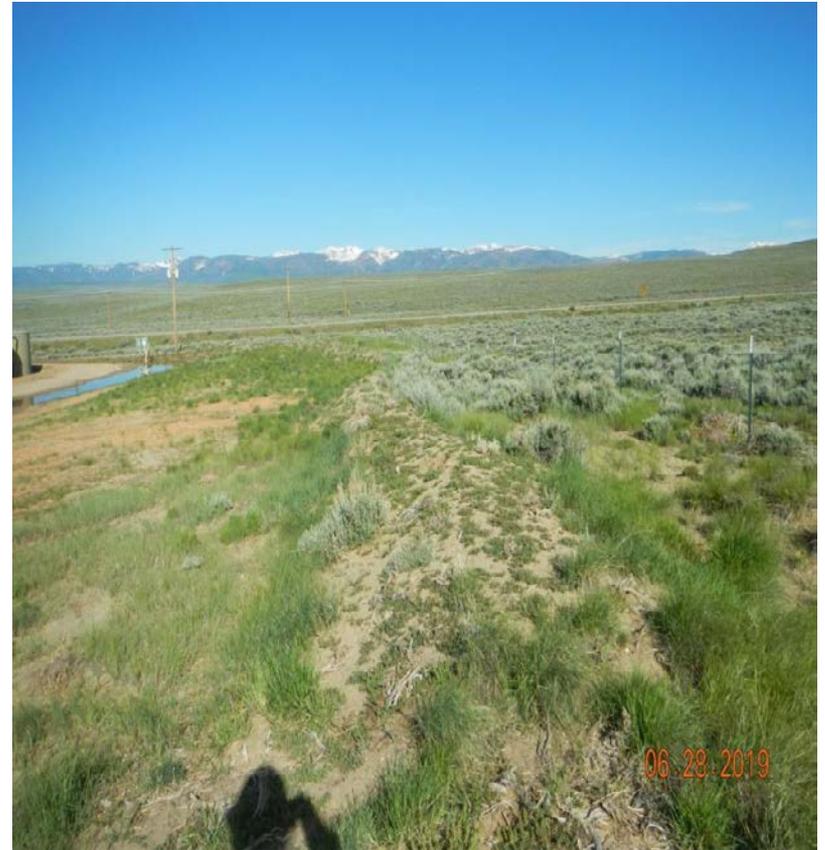
Photo#7:
Older Reclamation areas with established vegetation

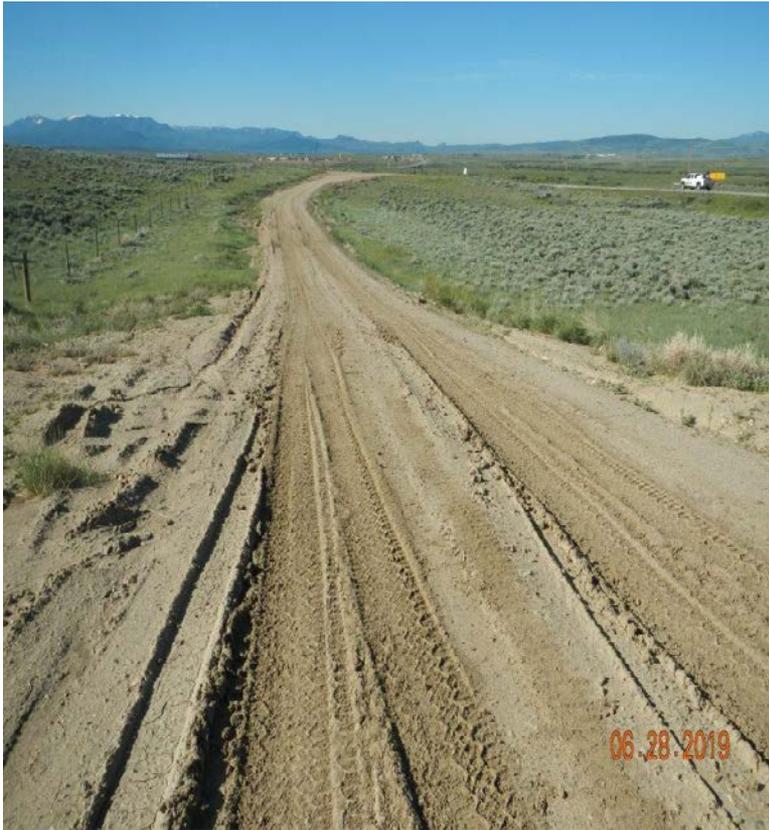
Photo#9:
Lack of BMPs along access road.

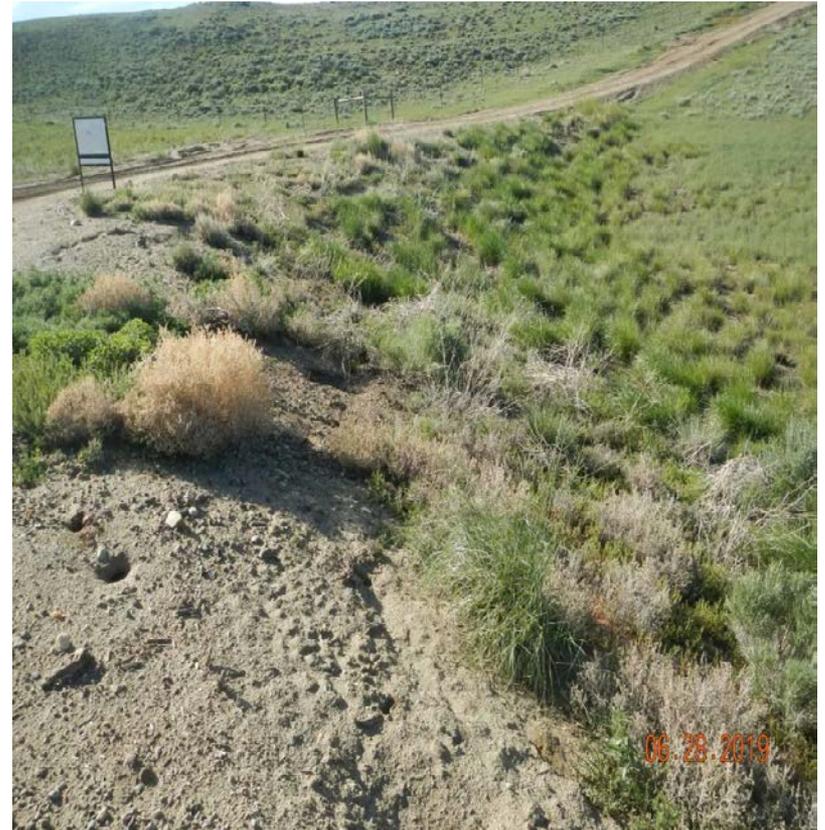
Photo#10:
Lack of BMPs at entry along access road.

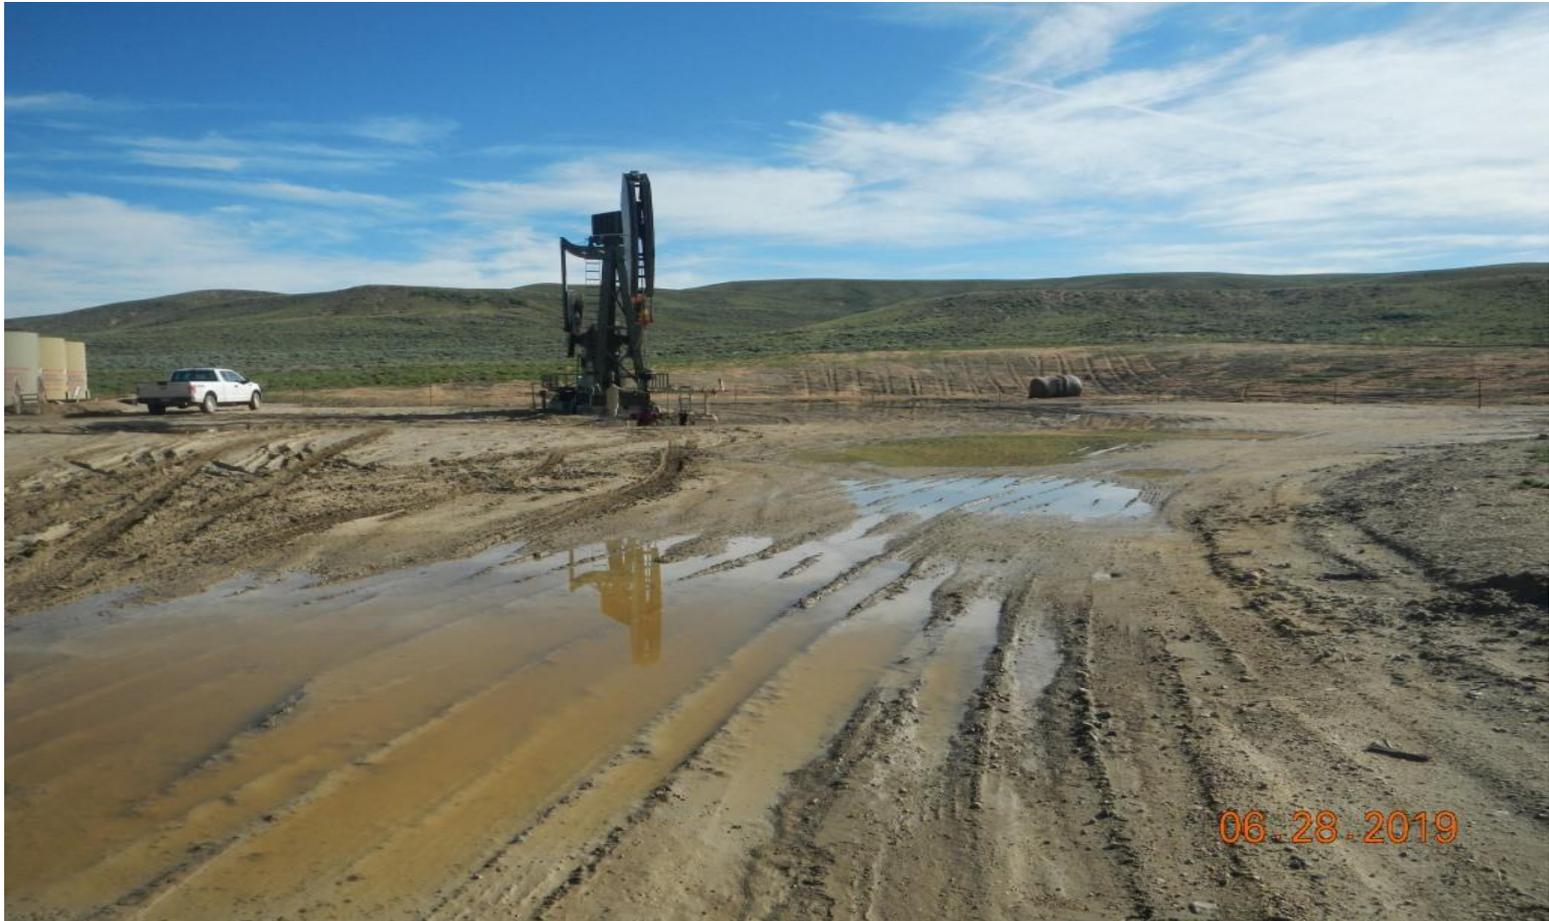
Photo#8:

BM Practices & pad have not been designed and maintained to minimize ponding of stormwater, leading to rutting, tracking and general degradation of pad surface.
