Inspection Photos
Operator: SG Interests
Location/API #: 051-06084
Date: 6-19-2019

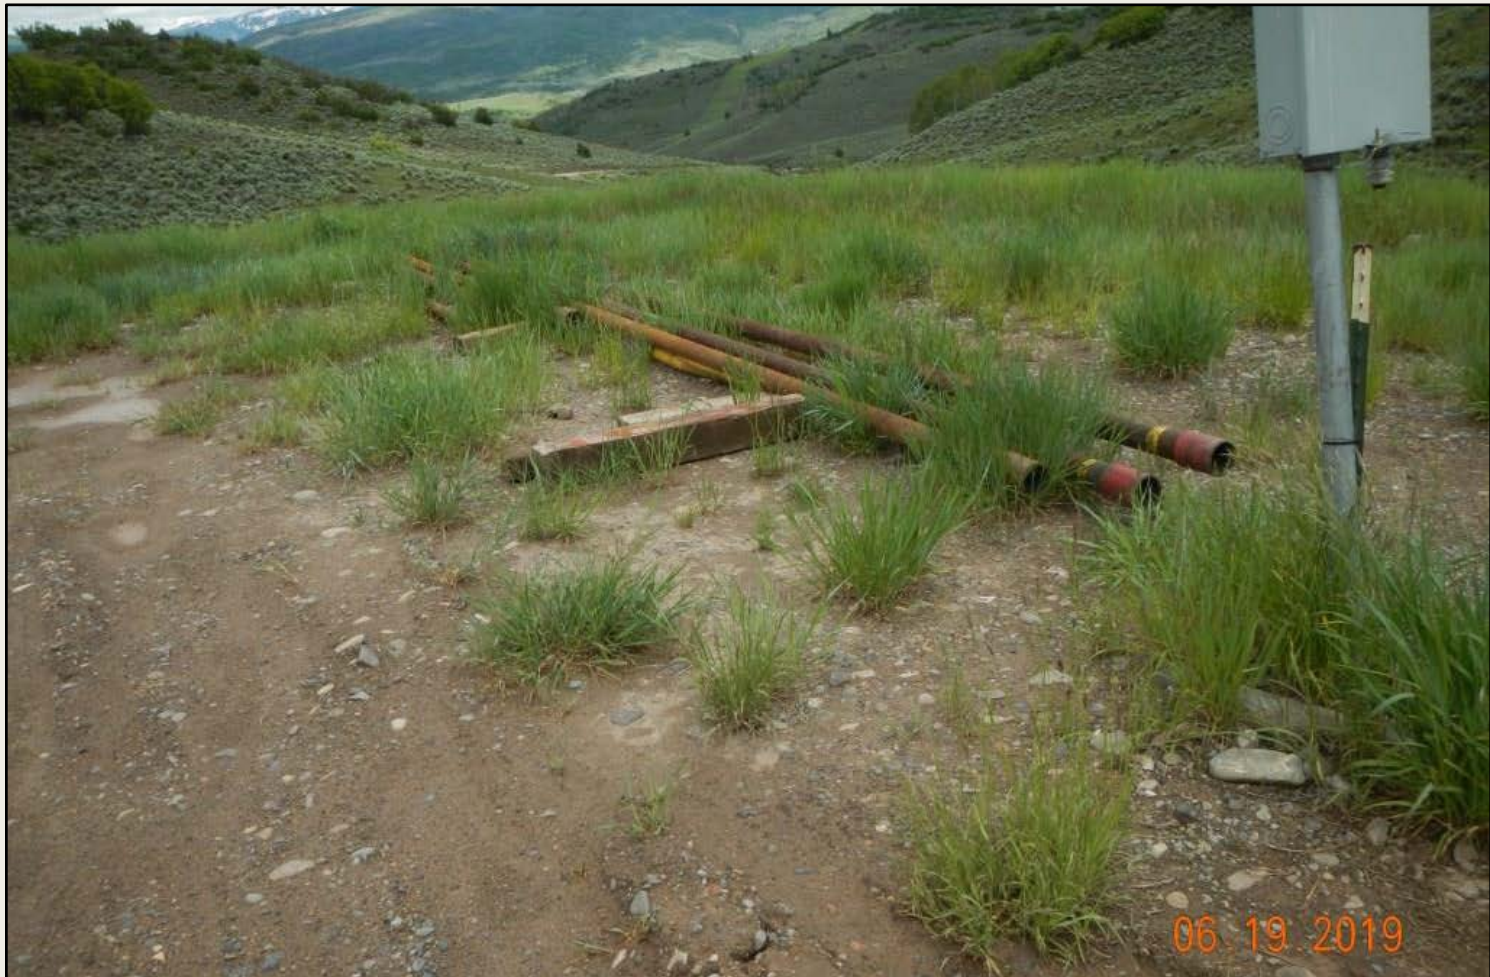
Photo 1. View of unused pipe within the southeastern project area.

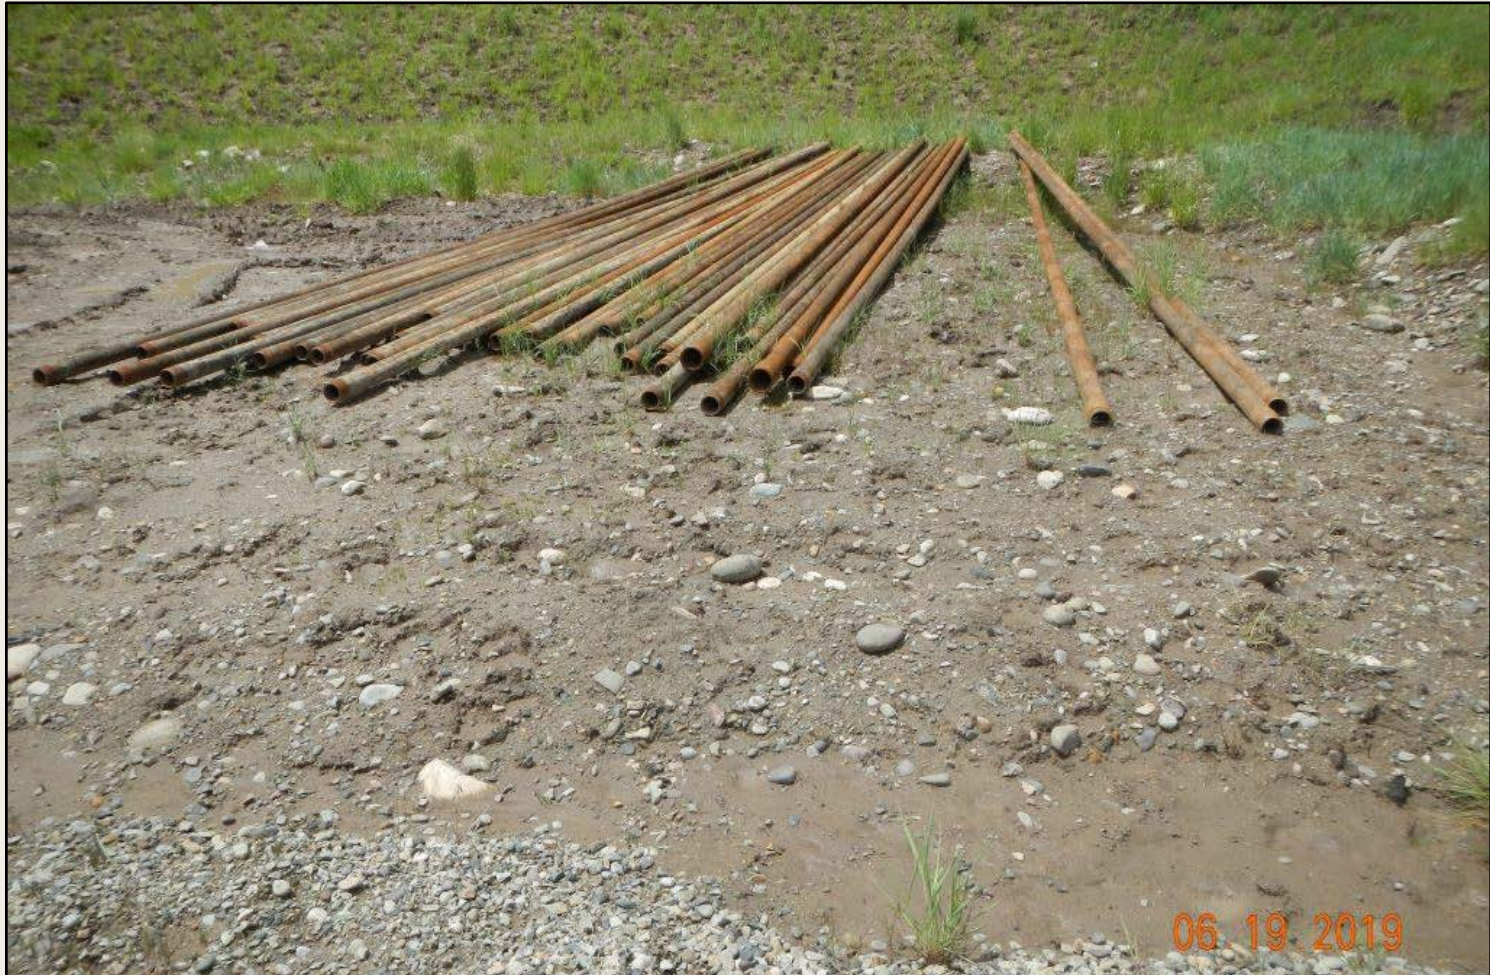
Photo 2. View of more unused pipe stored in the northeastern project area.

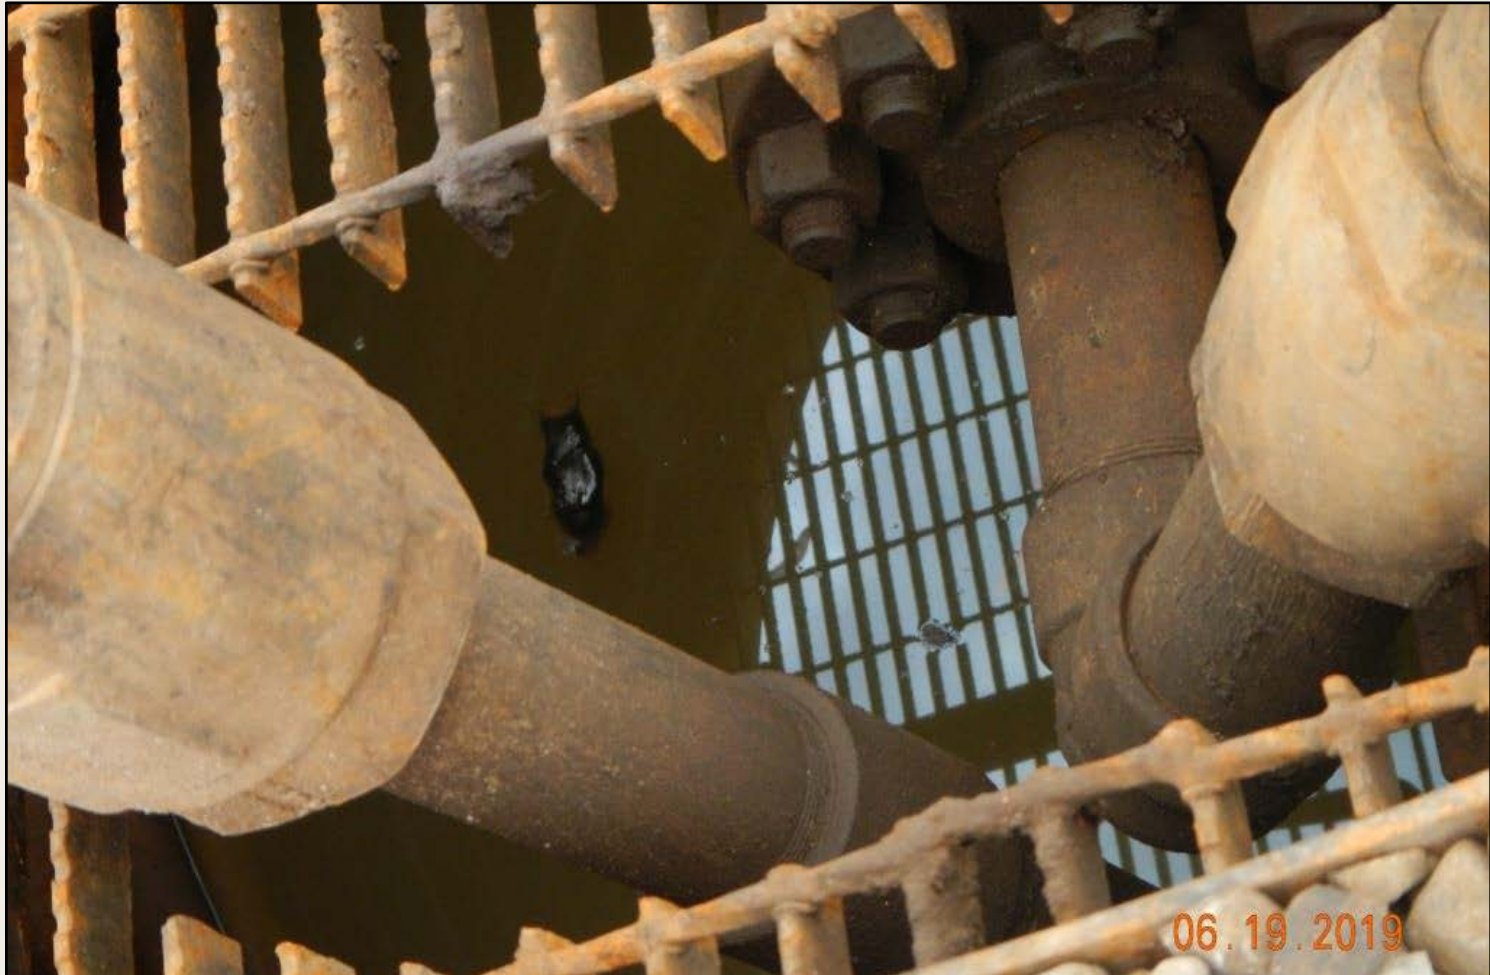
Photo 3. View of deceased animal within the well cellar.

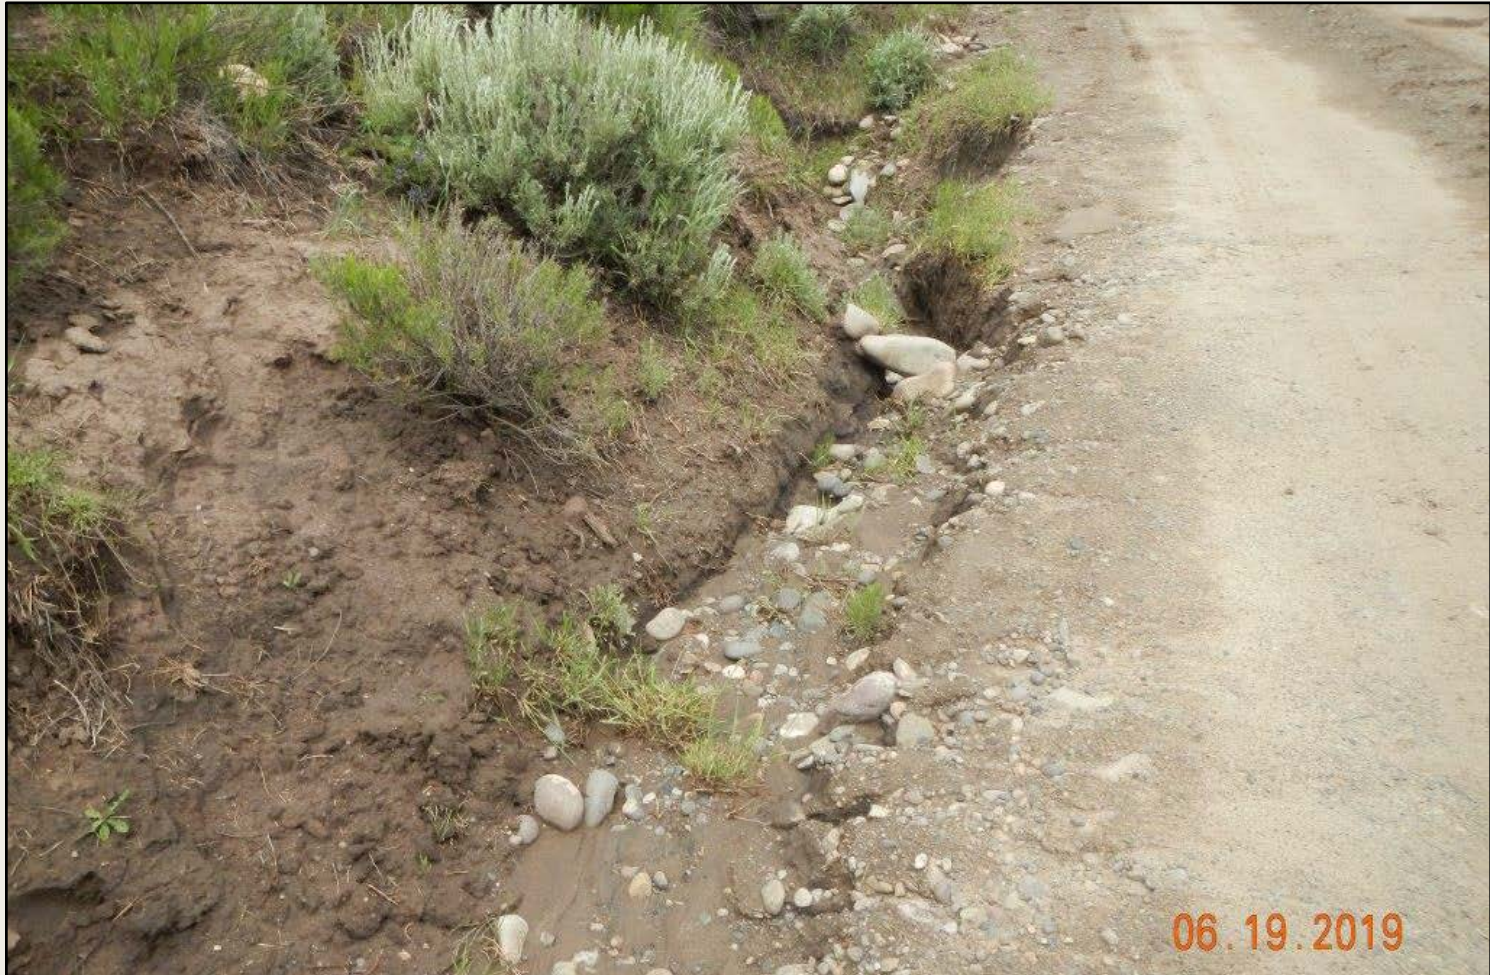
Photo 4. View of erosional channeling along the access road.

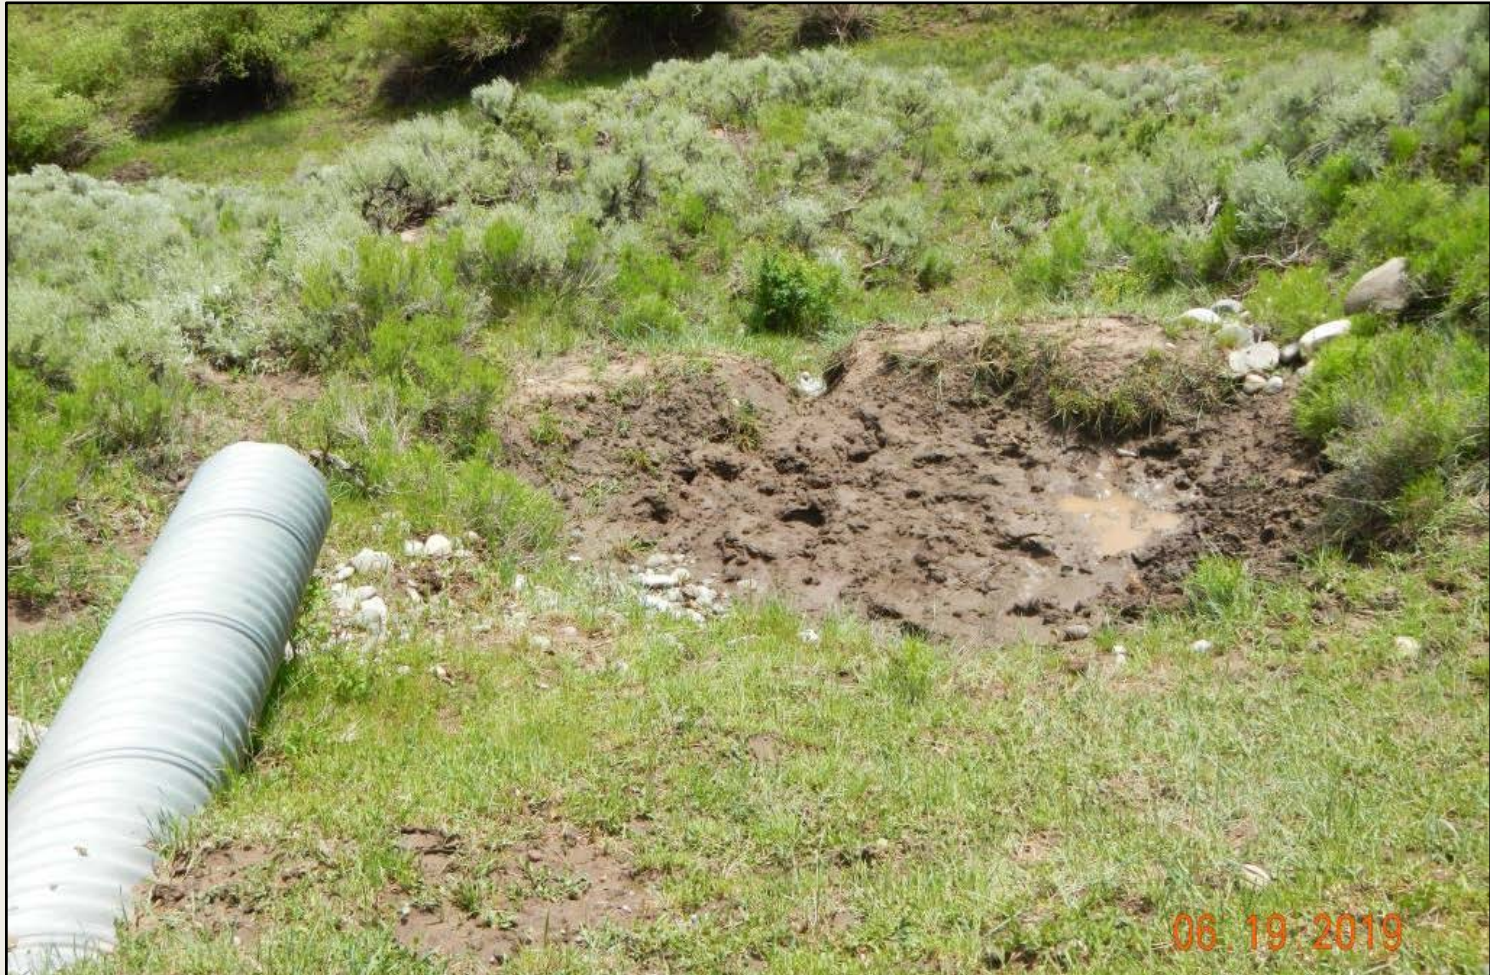
Photo 5. View of silt trap that is full of sediment and not stabilized. Culvert is installed above grade.

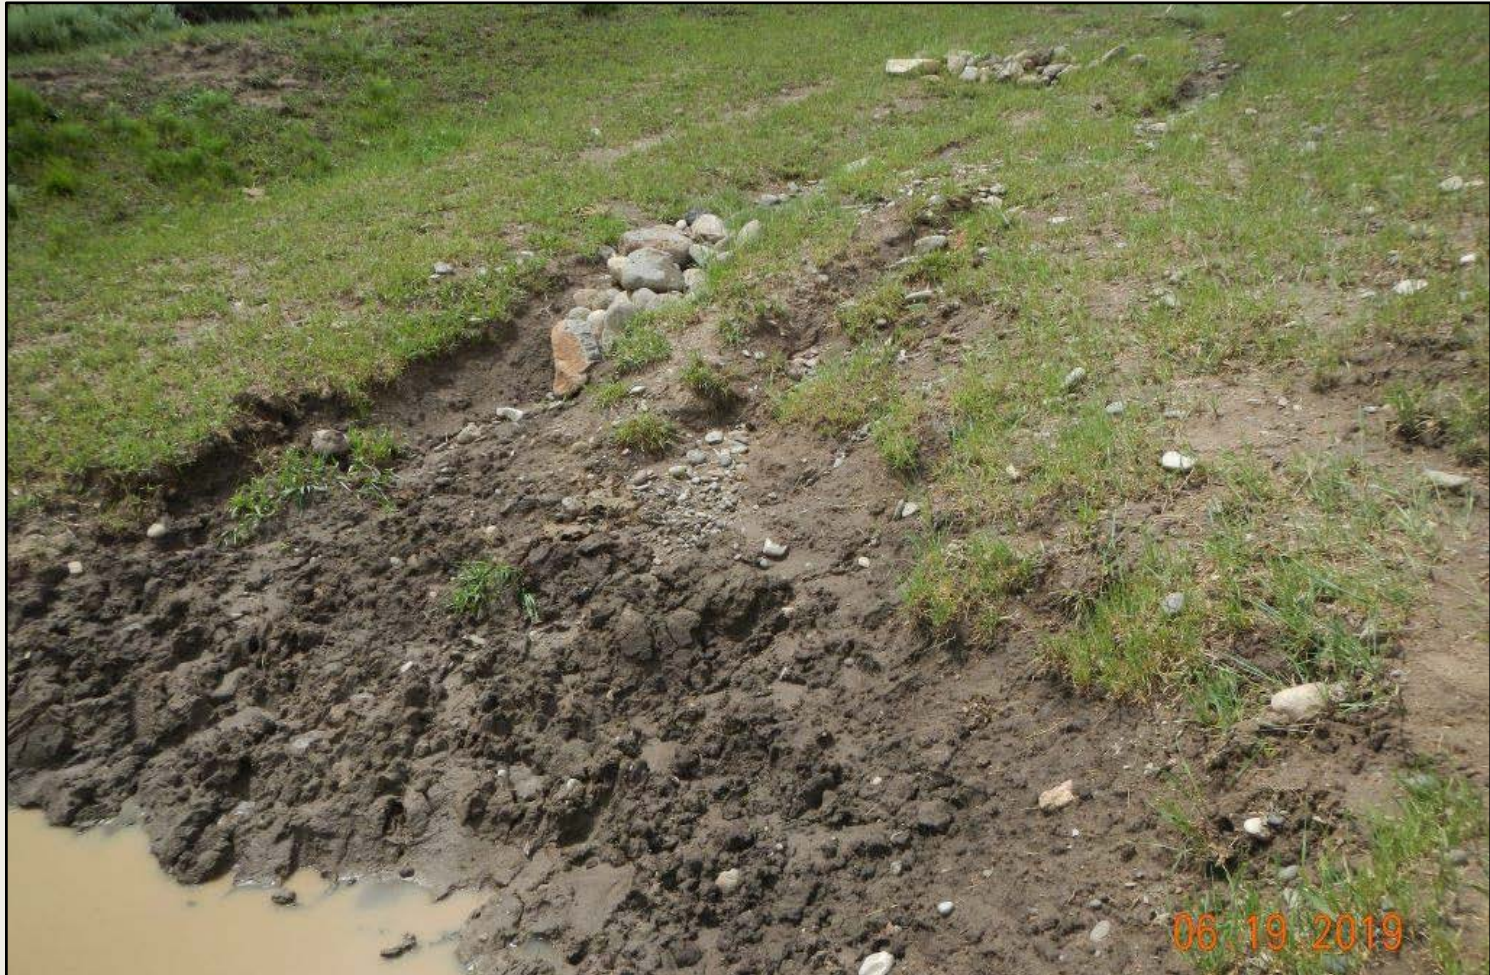
Photo 6. View of erosional down-cutting near the beginning of the access road.
