Inspection Photos
Operator: SG Interests
Location/API #: 051-06113
Date: 6-19-2019

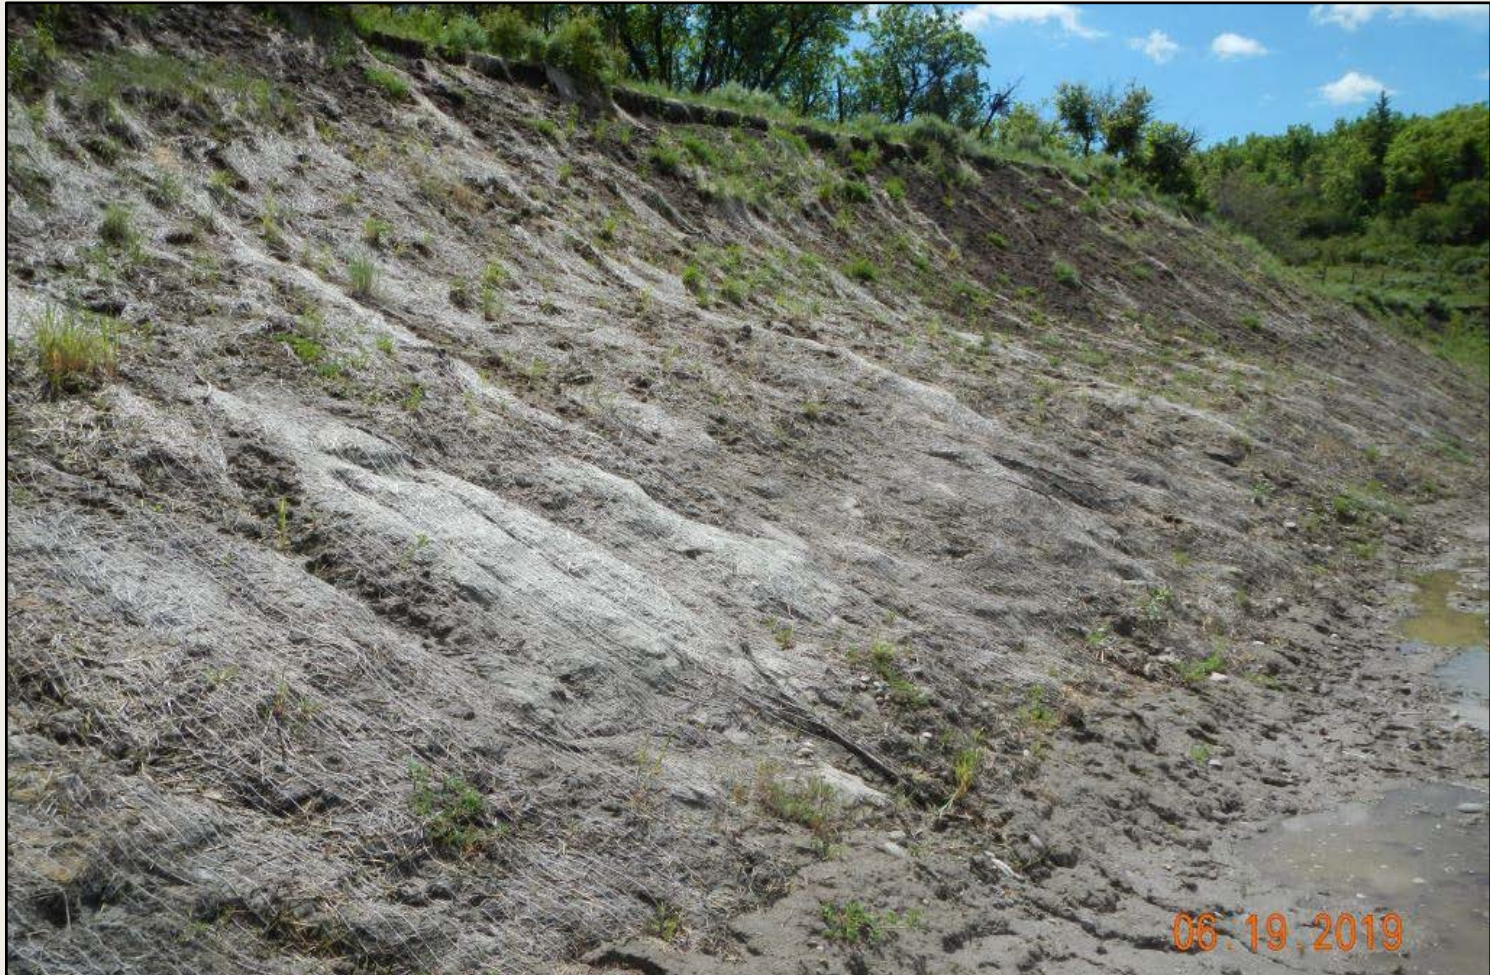
Photo 1. View of the eastern project area from the northeastern corner facing southward. Blanketing is torn and erosion is continuing.

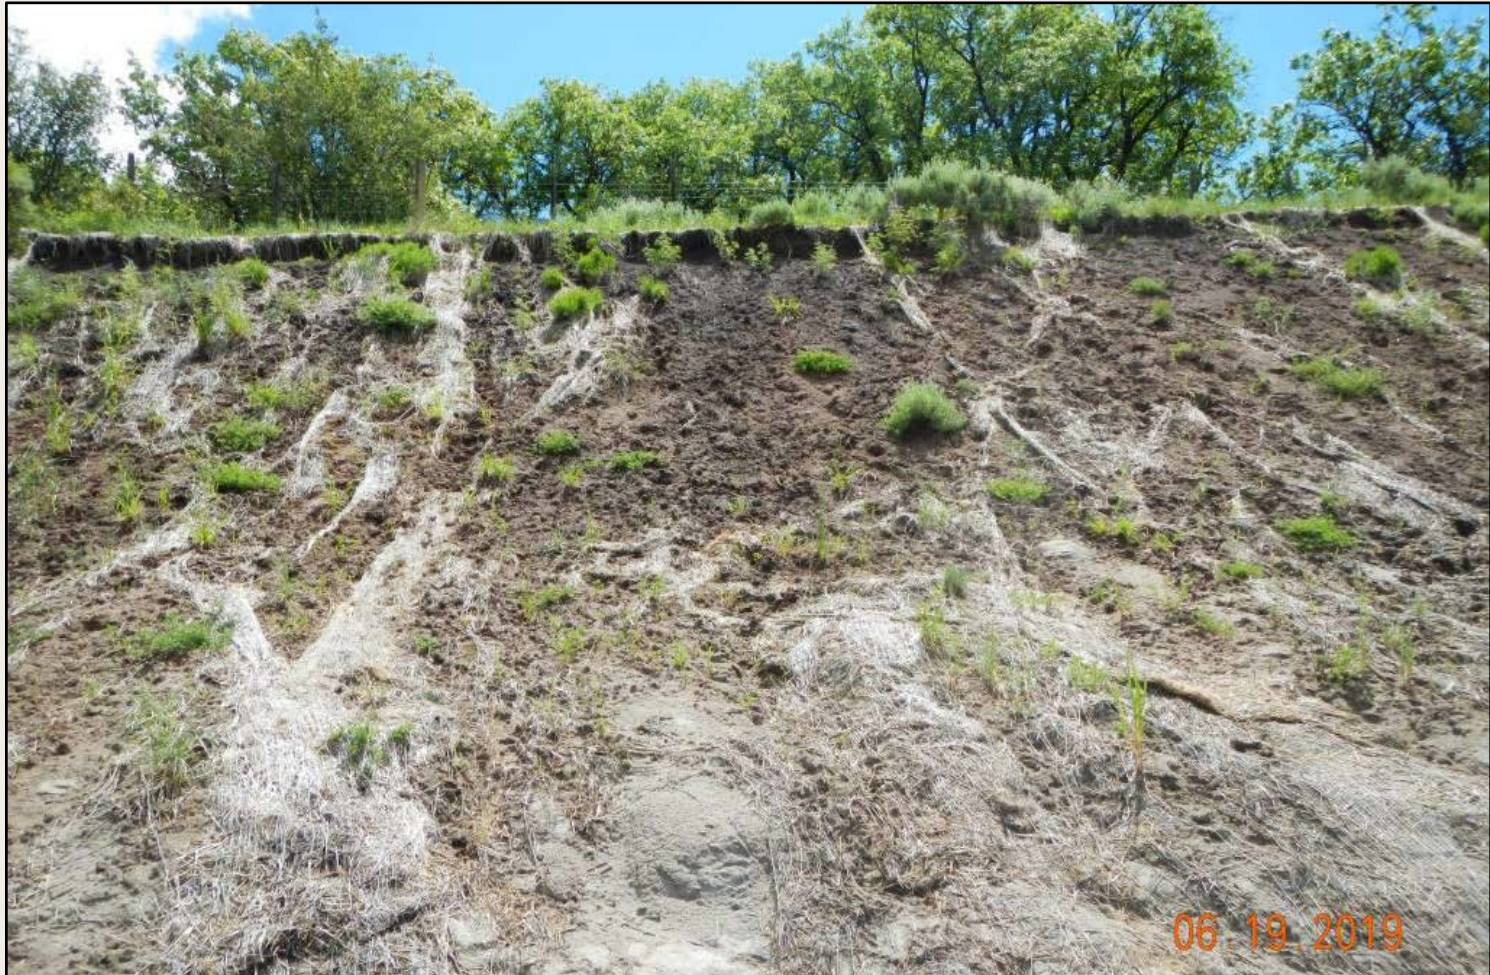
Photo 2. Another view of the eastern cut-slope with exposed soils and torn erosion control blanket.

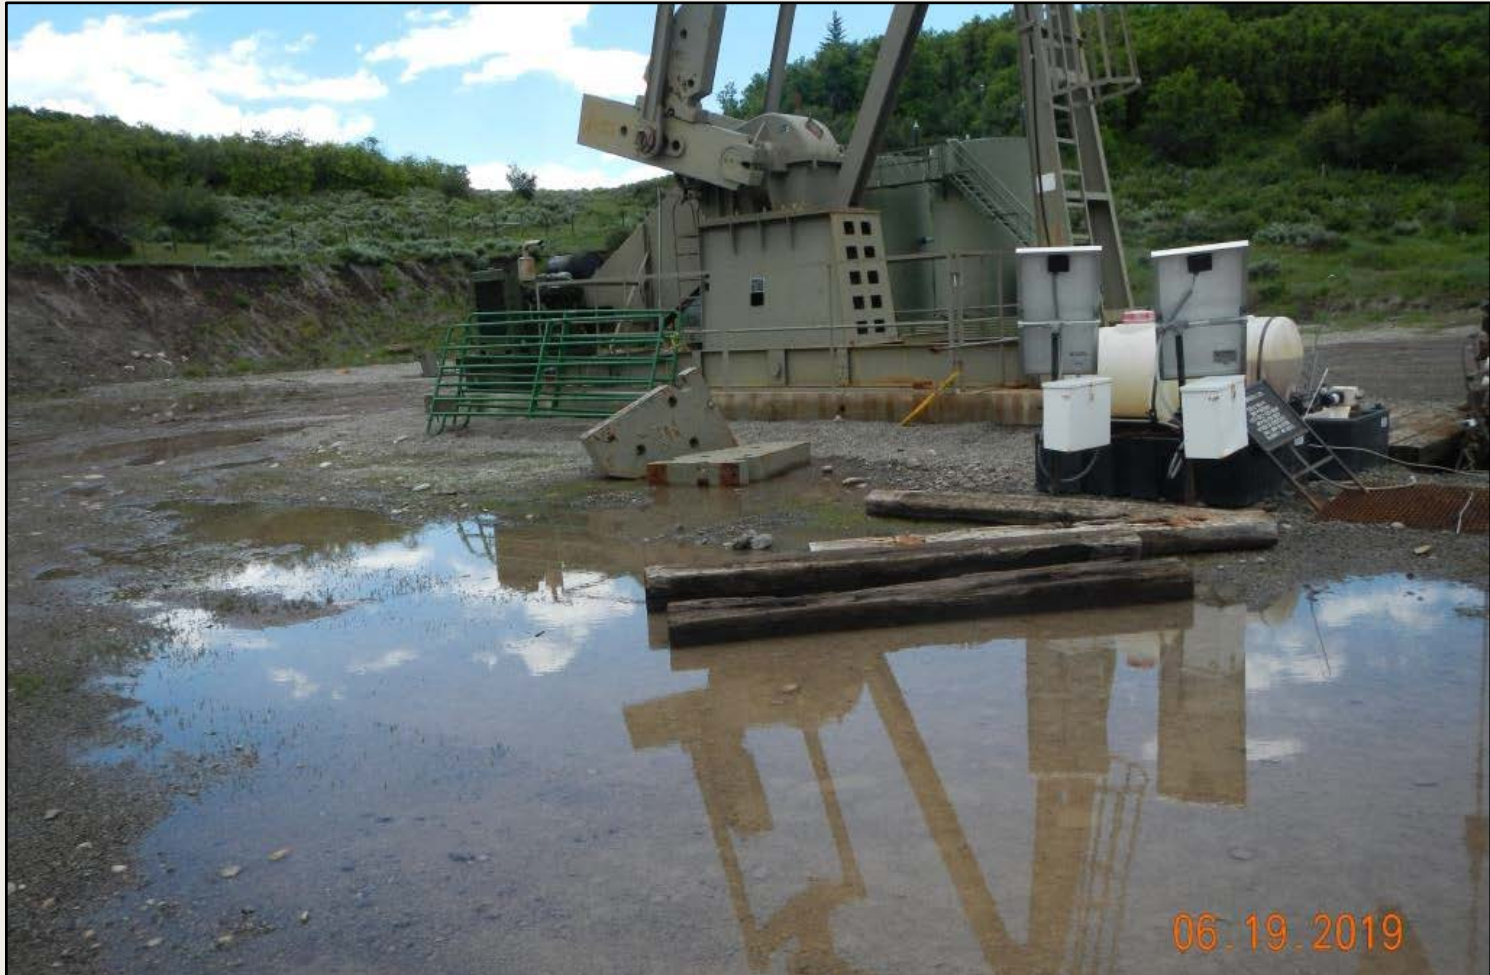
Photo 3. View of wellhead and unused/stored equipment within the project area. Ponding is occurring on well pad.

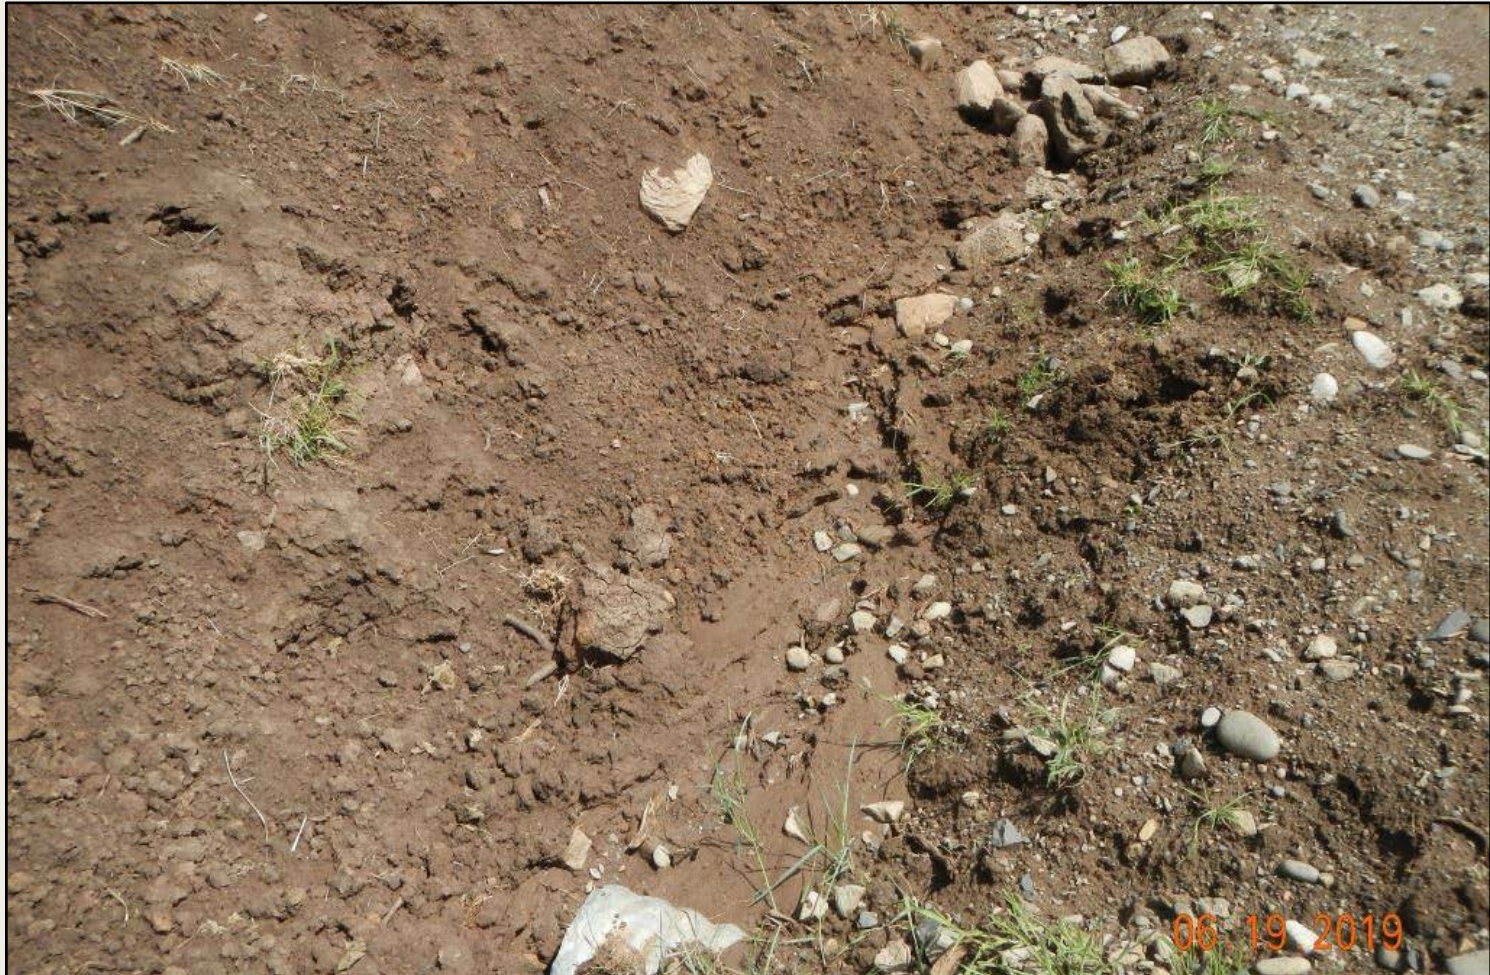
Photo 4. View of culvert and bare soils along the access road. Culvert is full of sediment and bare soils are not stabilized. Erosion is occurring within the roadside ditch.

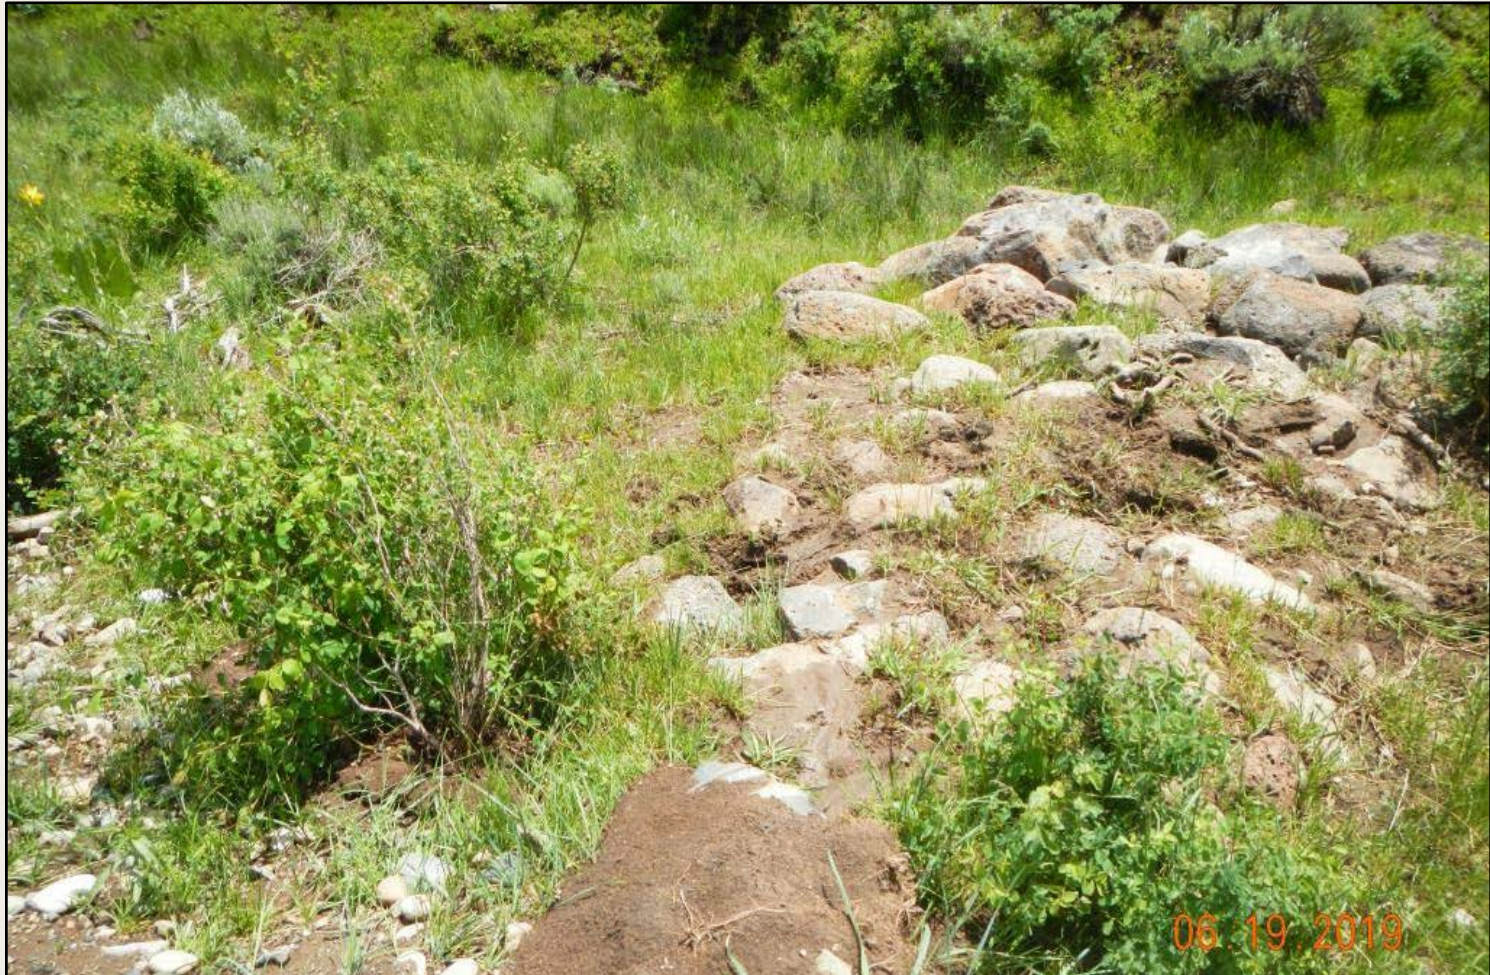
Photo 5. View of armoured culvert outlet along the access road facing downslope. Sediment in the foreground and on rocks is deposited from the culvert outlet. A perennial stream flows down-slope in the background.

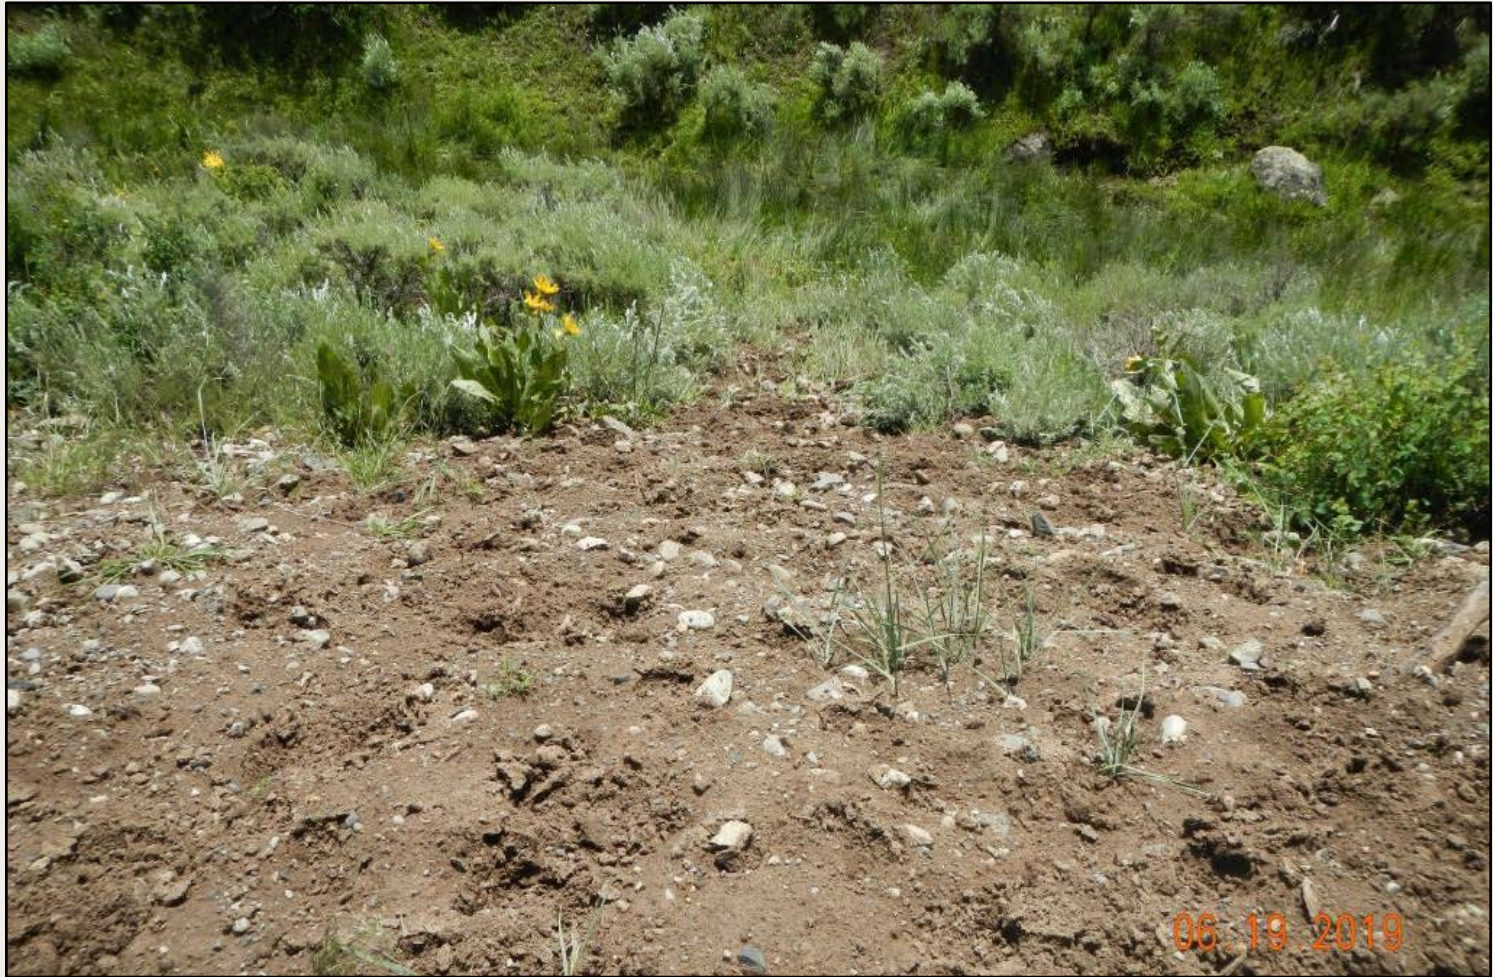
Photo 6. View of bare soils on down-slope side of access road. Bare soils are eroding downslope into the stream.

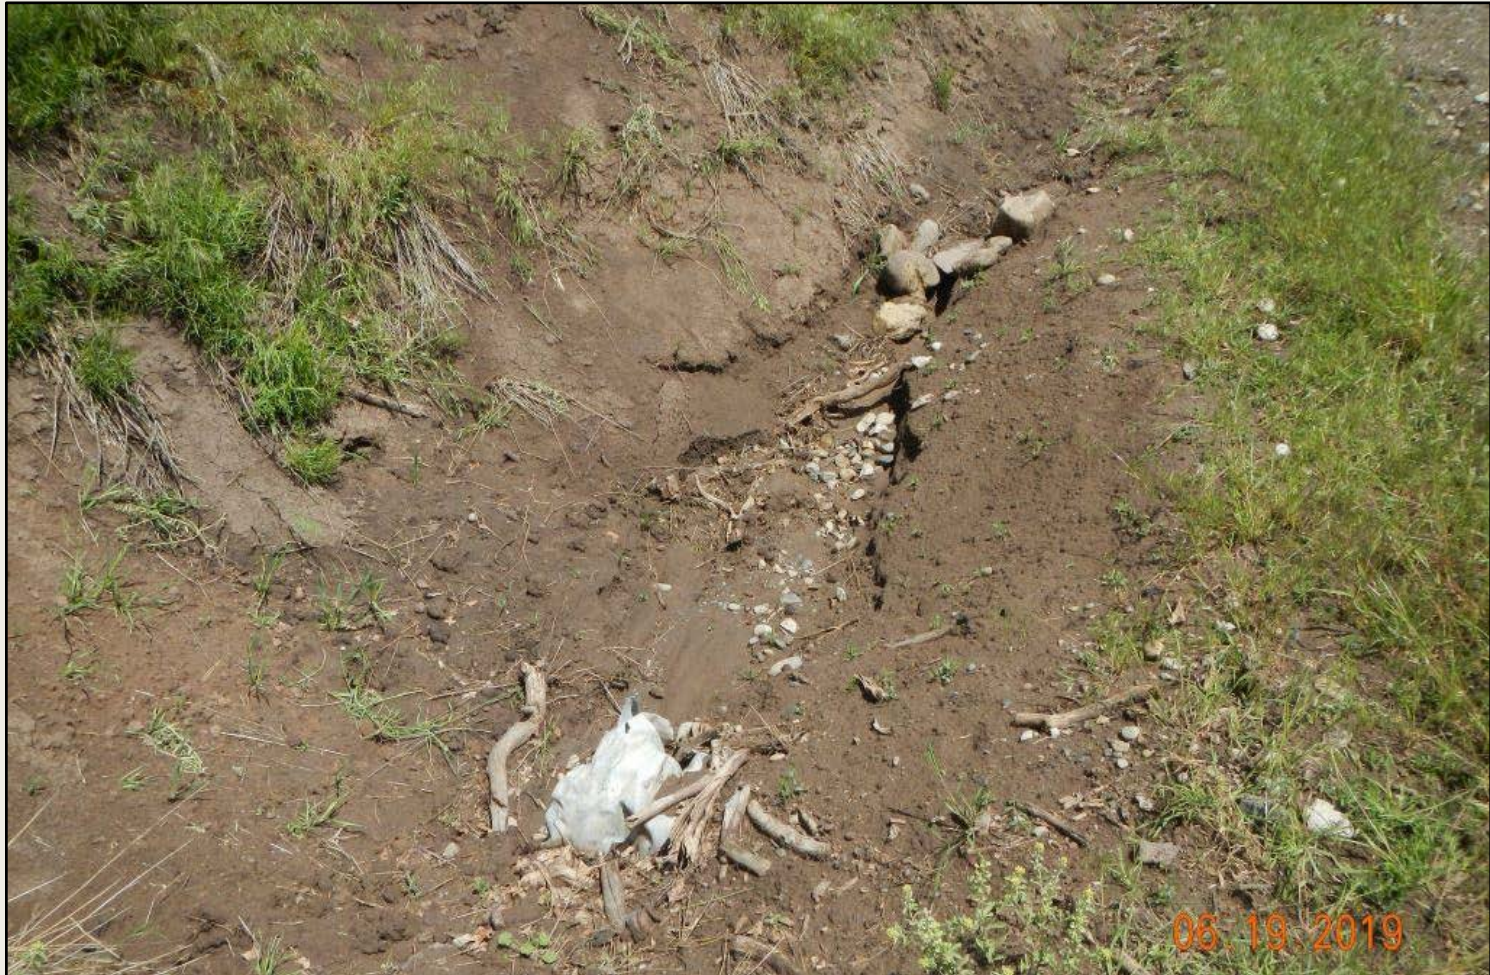
Photo 7. View of another culvert inlet along the access road. Culvert is full, drainage and loose soils on side slopes are not stabilized.

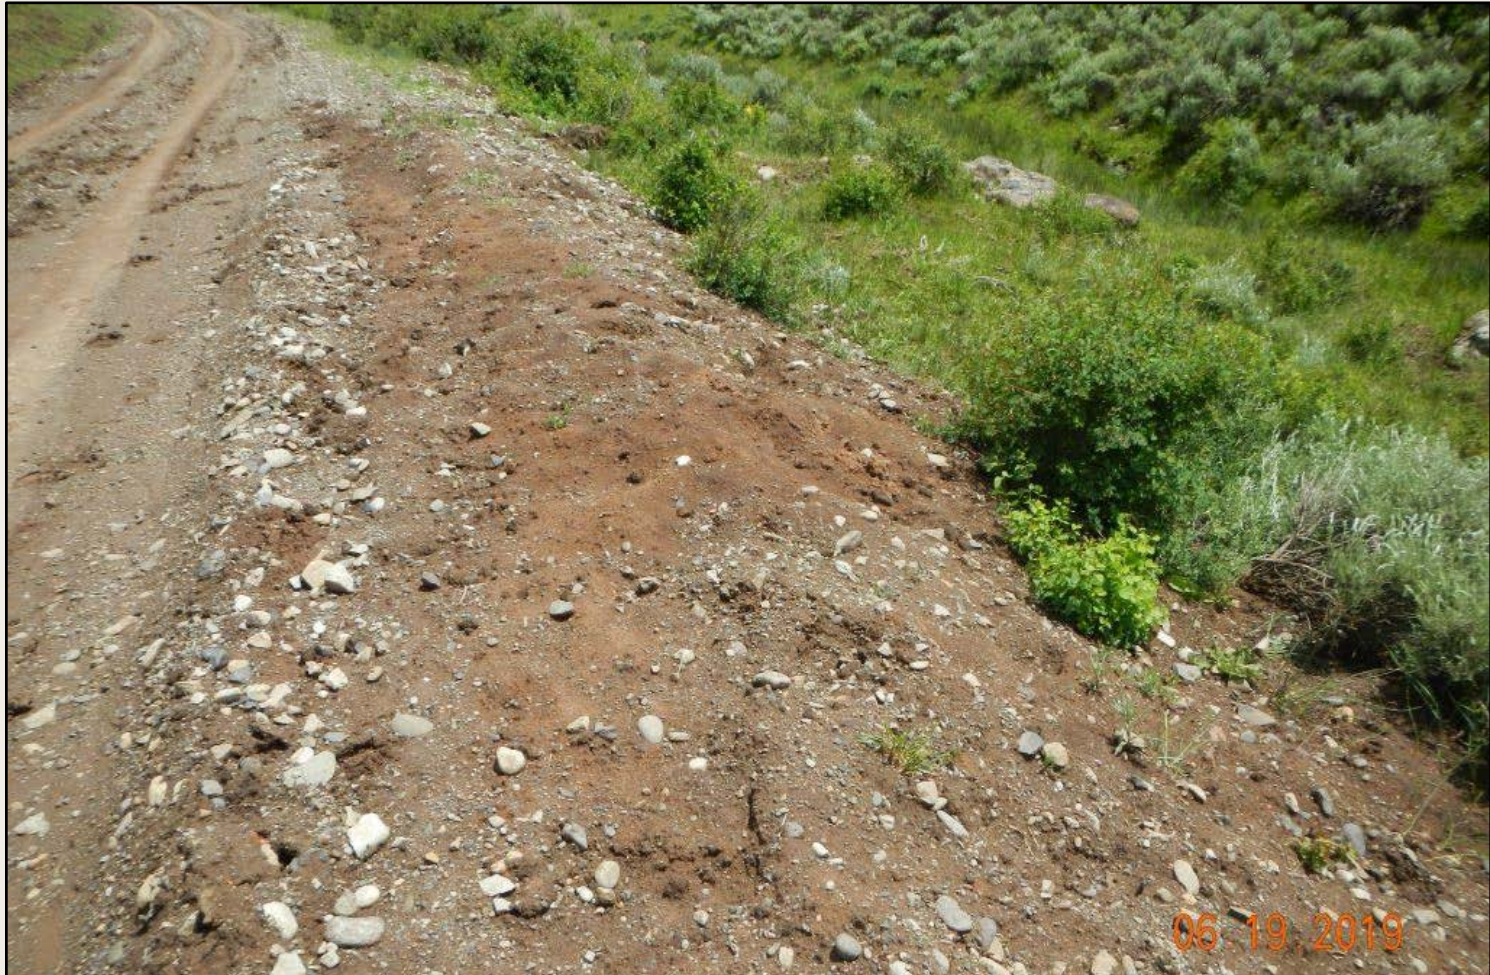
Photo 8. Another view of loose soils along the access road where soils are actively eroding downslope into the adjacent perennial stream.
