# Inspection Photos

API: 05-009-06134

Operator: SAMSON OIL COMPANY

Inspection Date: 7/9/2019

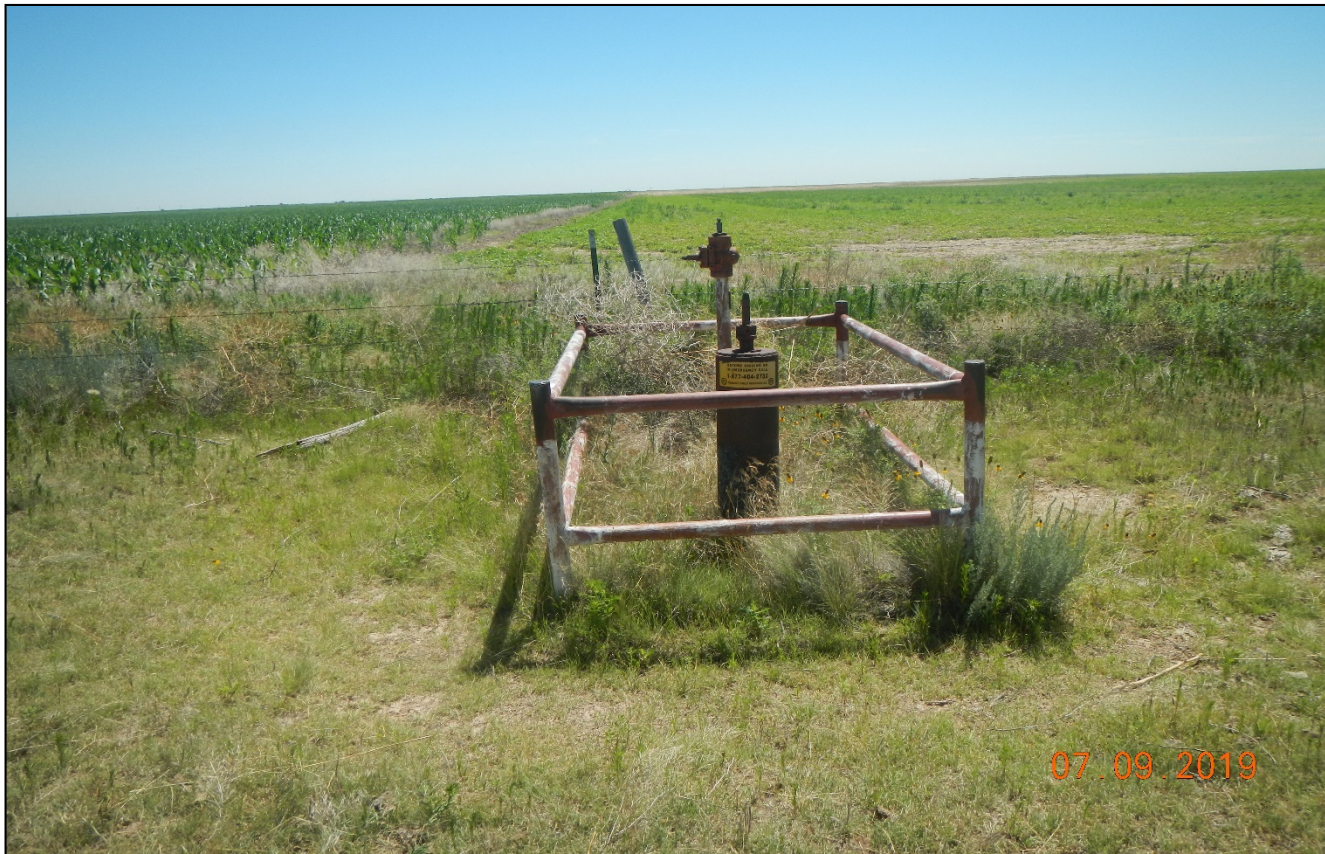
**Photo 1.** Pipe riser located 390 feet northeast of well site.

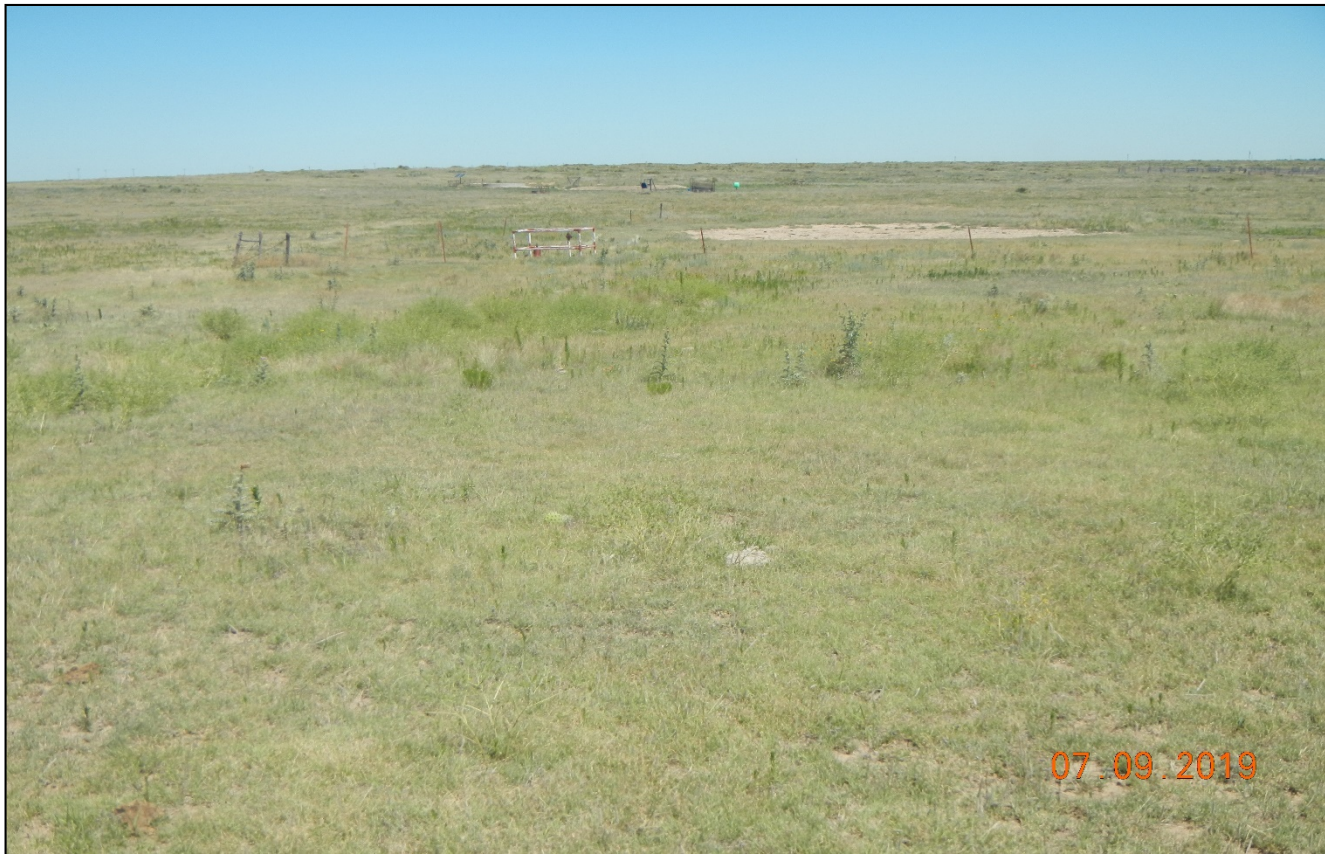
**Photo 2.** Facing north toward the location.

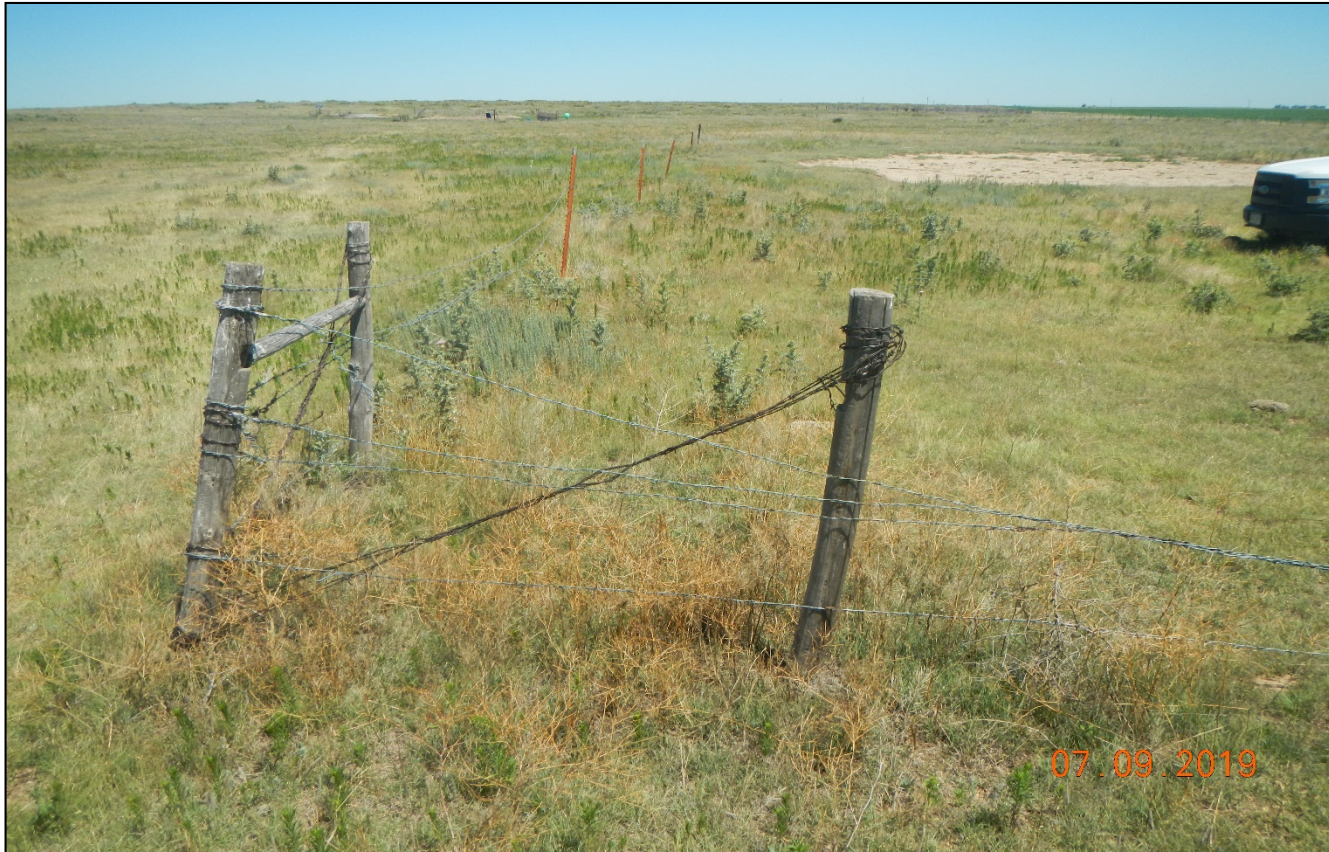
**Photo 3.** There is a degraded fence that remains around the location.

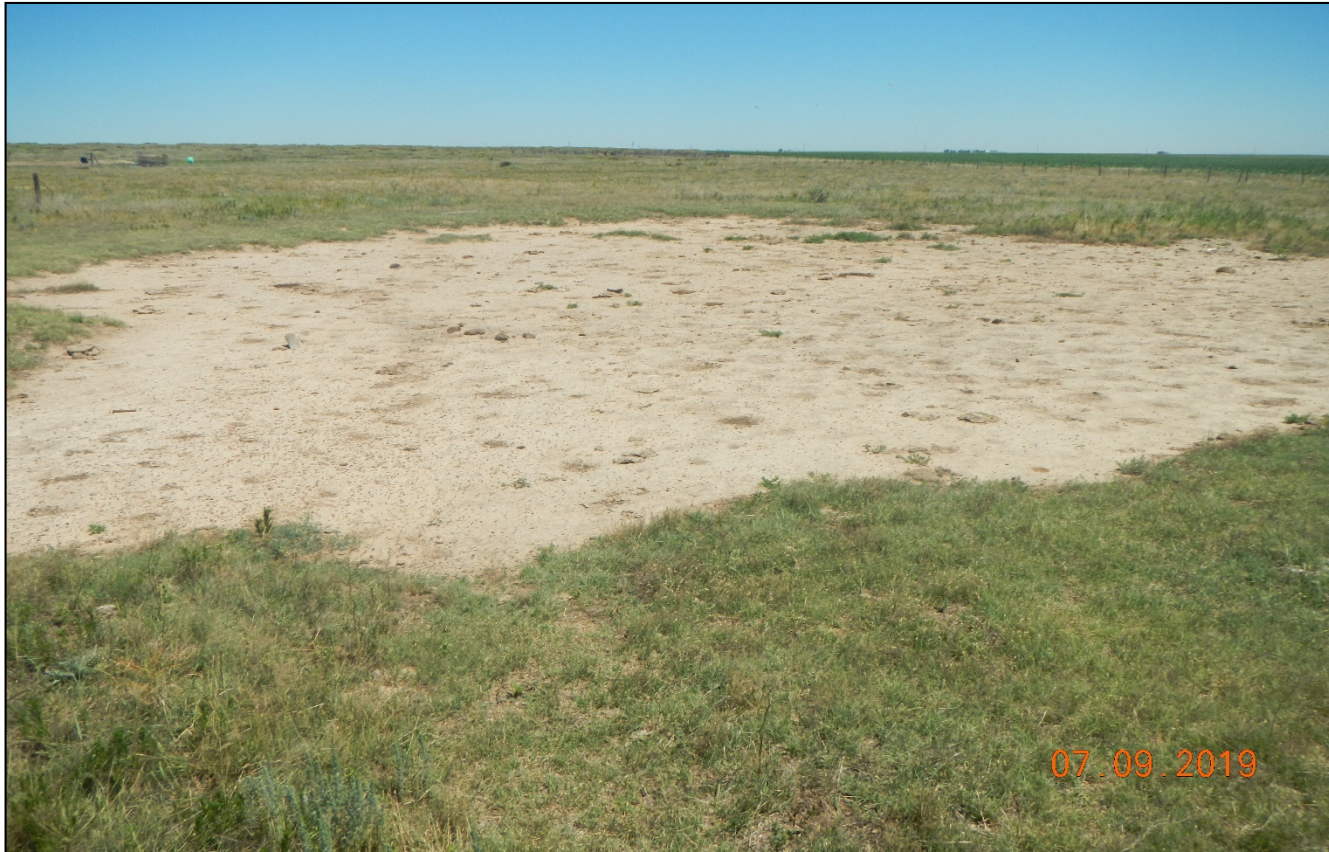
**Photo 4.** There is a bare area approximately 70'x70'.

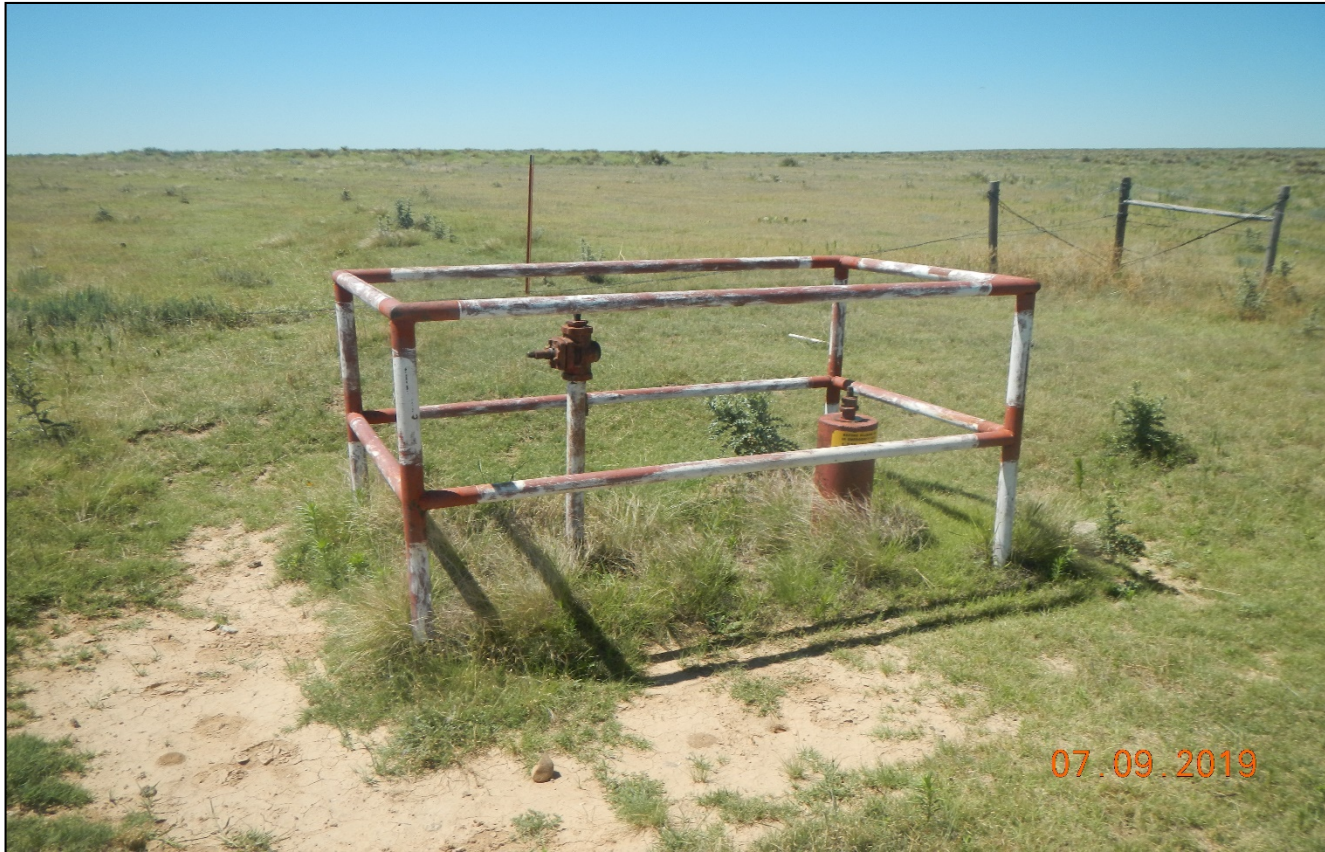
**Photo 5.** There is a second pipe riser 150 feet north of the well site.
