Inspection Photos

07/10/2019

Operator: FOUNDATION ENERGY
MANAGEMENT LLC - 10112

Location ID: 330865
Weld County, CO

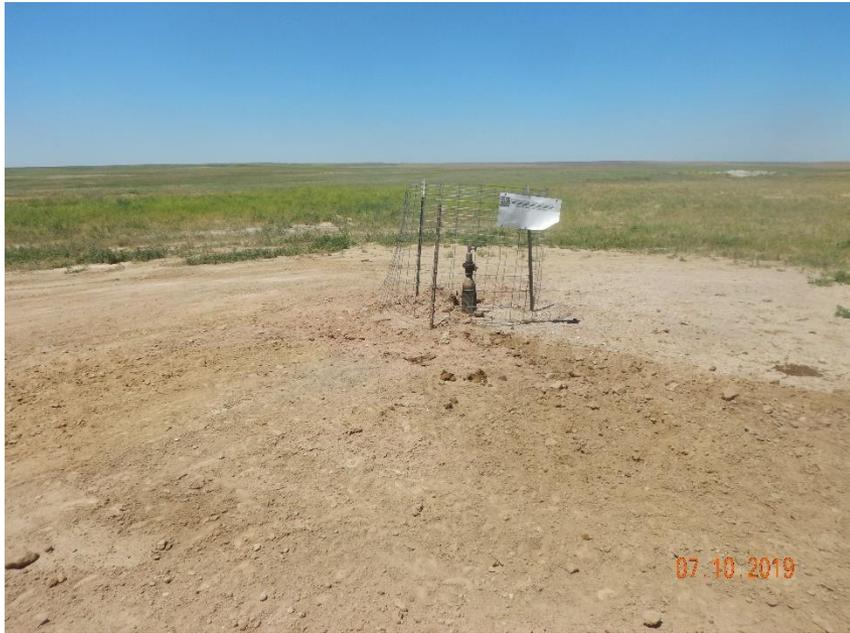
Photo 1: Photo taken from the well. Photo shows pump unit has been removed.

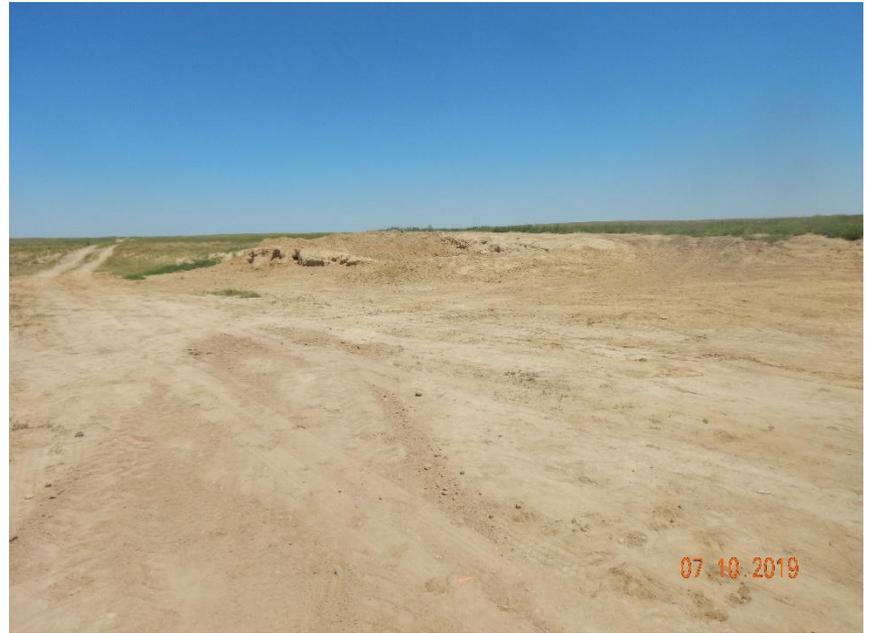
Photo 2: Photo taken from the location, facing north. Photos 2-4 provide an overview of the location from north, east, to southeast. Photos show equipment has been removed.

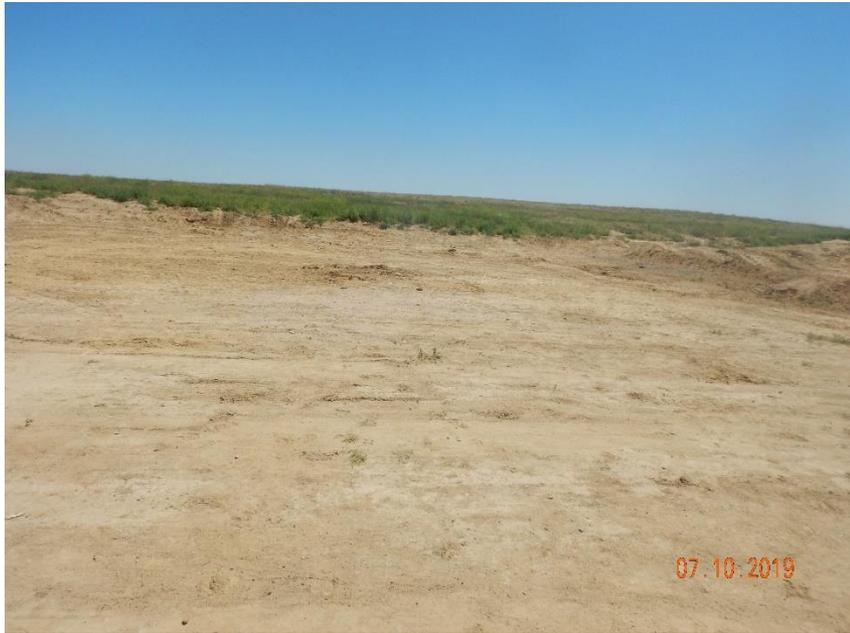
Photo 3: See comments under photo 2.

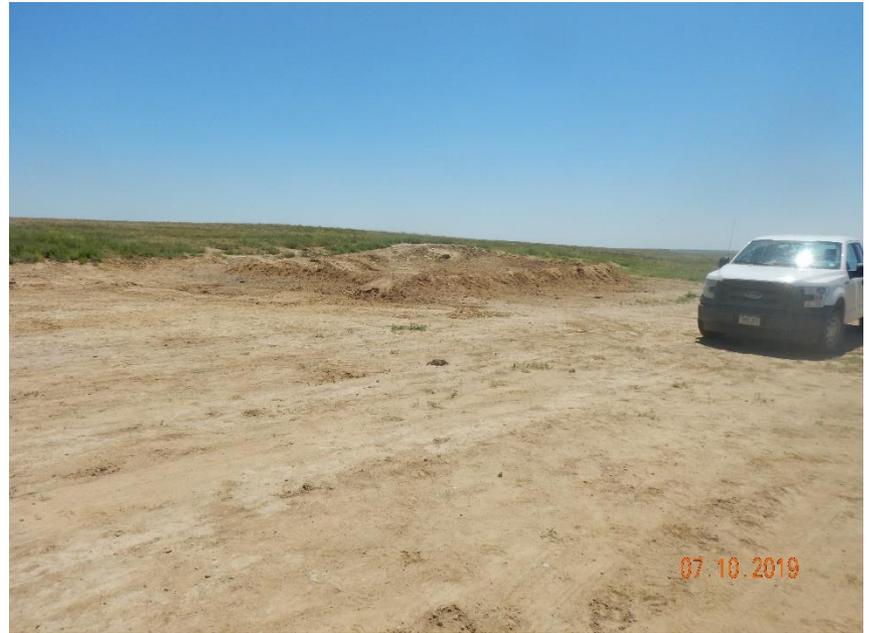
Photo 4: See comments under photo 2.

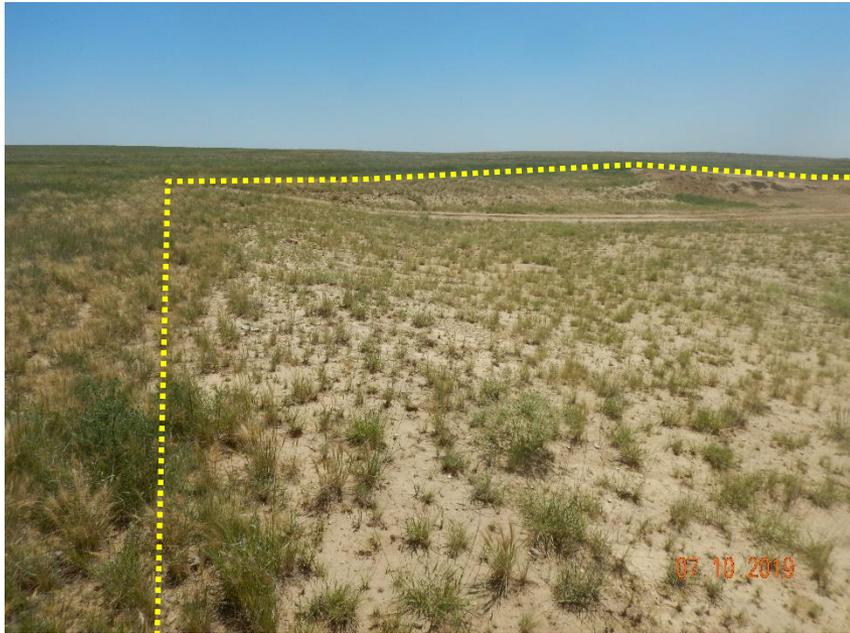
Photo 5: Photo taken from the north end of the location, facing east. Photos 5-8 provide an overview of the location from east, southeast, southwest to west. Previous inspections required operator to comply with 1003 and conduct interim reclamation on areas not needed for production. Photos show interim reclamation has not been conducted in accordance with Rule 1003.b. Yellow line shows approximate perimeter of the pad.

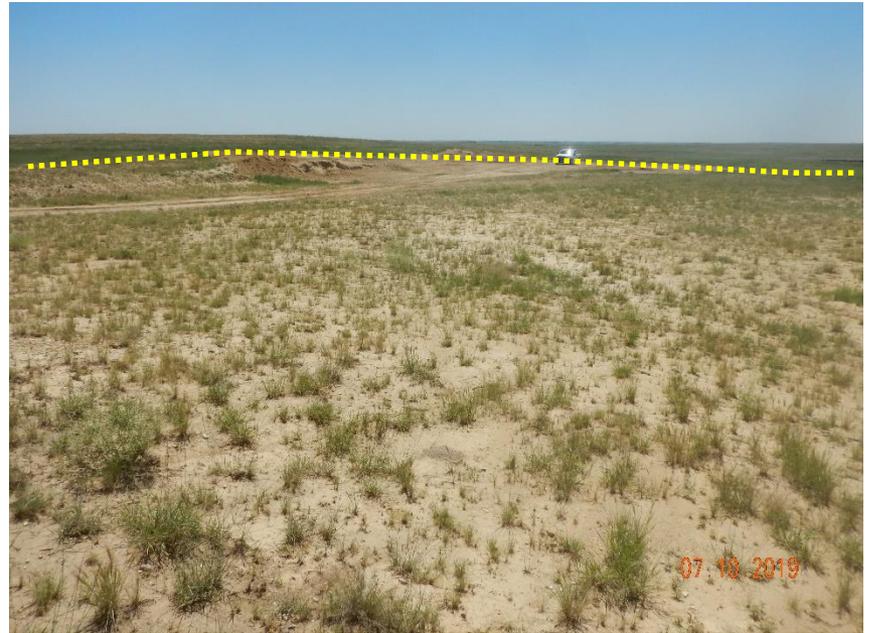
Photo 6: See comments under photo 5

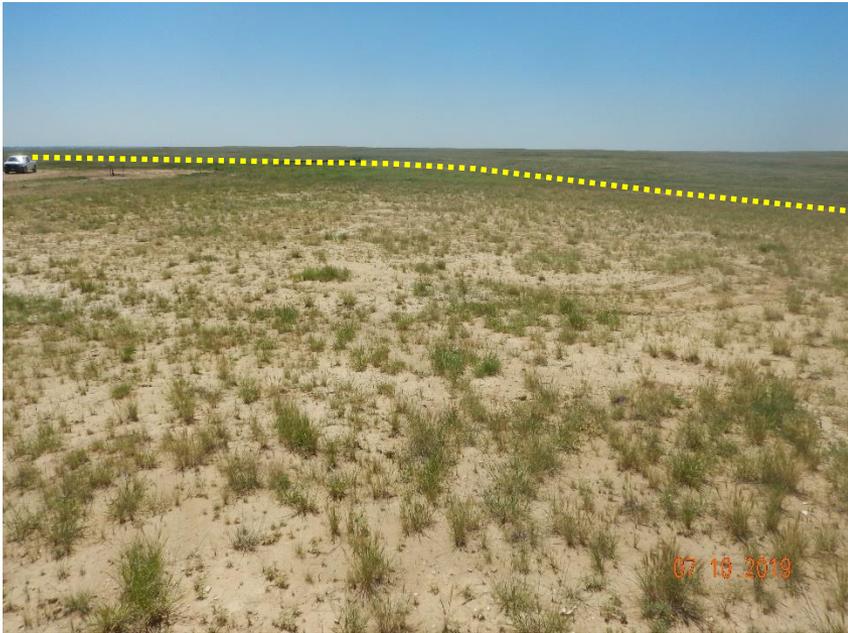
Photo 7: See comments under photo 5

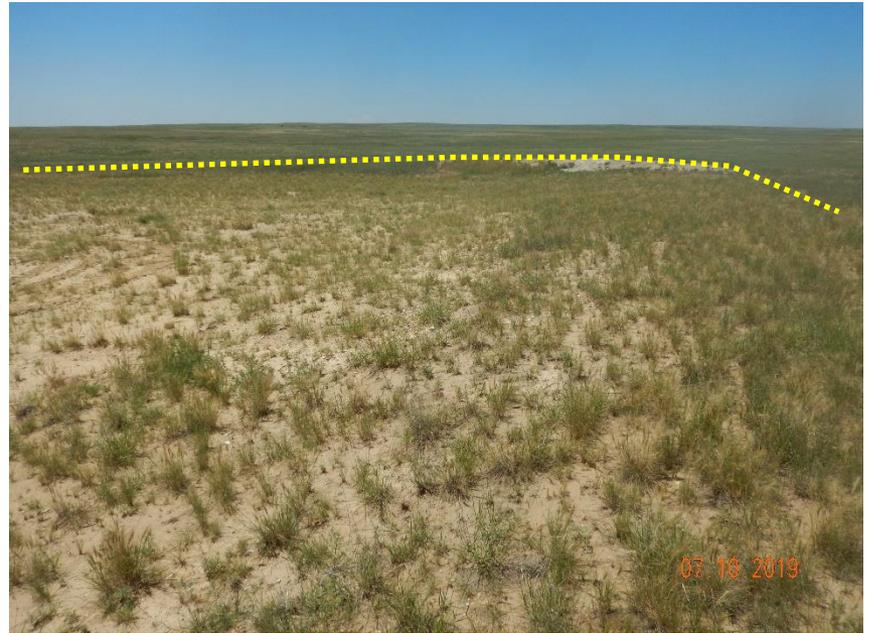
Photo 8: See comments under photo 5

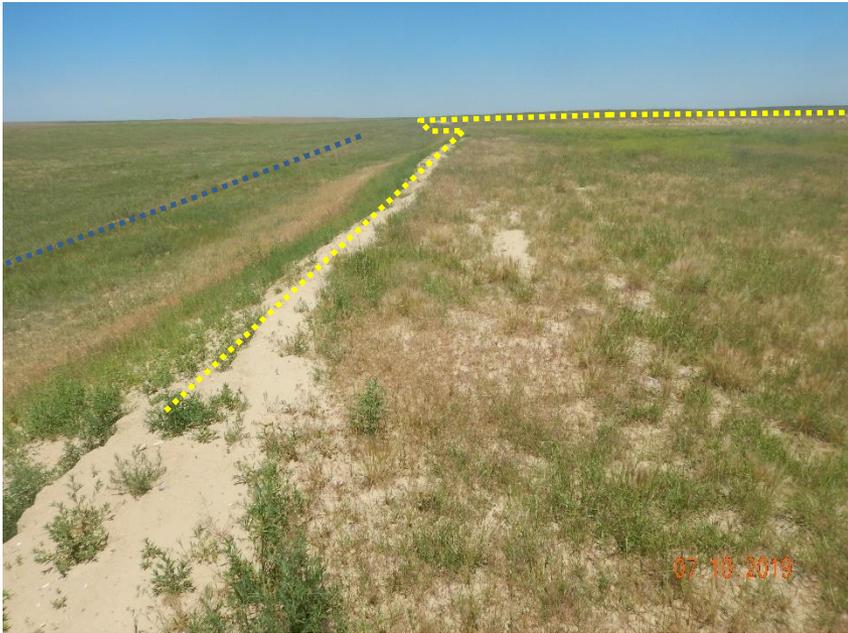
Photo 9: Photo taken from the southeast corner of the pad, facing north. See comments under photo 5. Blue line represents perimeter ditch.

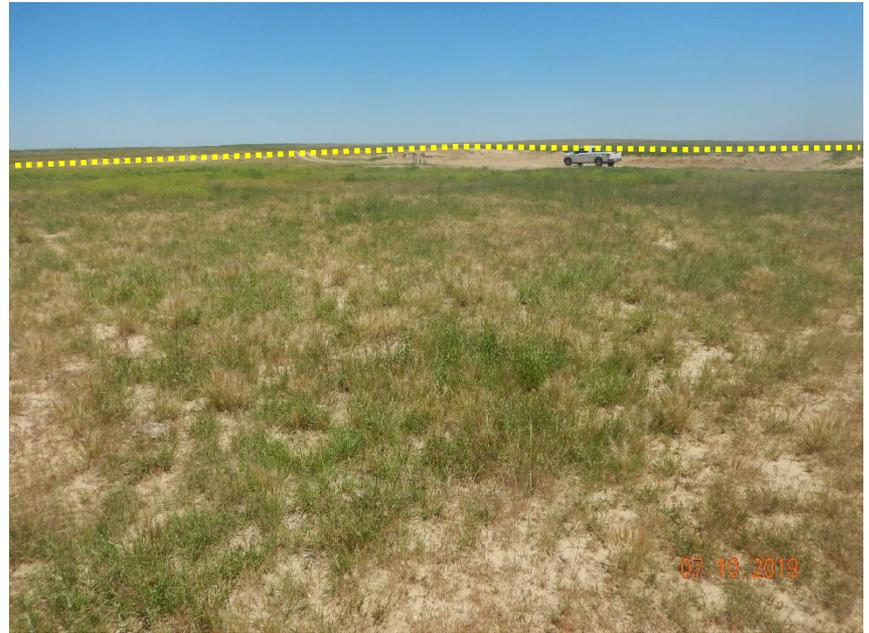
Photo 10: Photo taken from the southeast corner of the pad, facing northeast. See comments under photo 5. Blue line represents perimeter ditch.

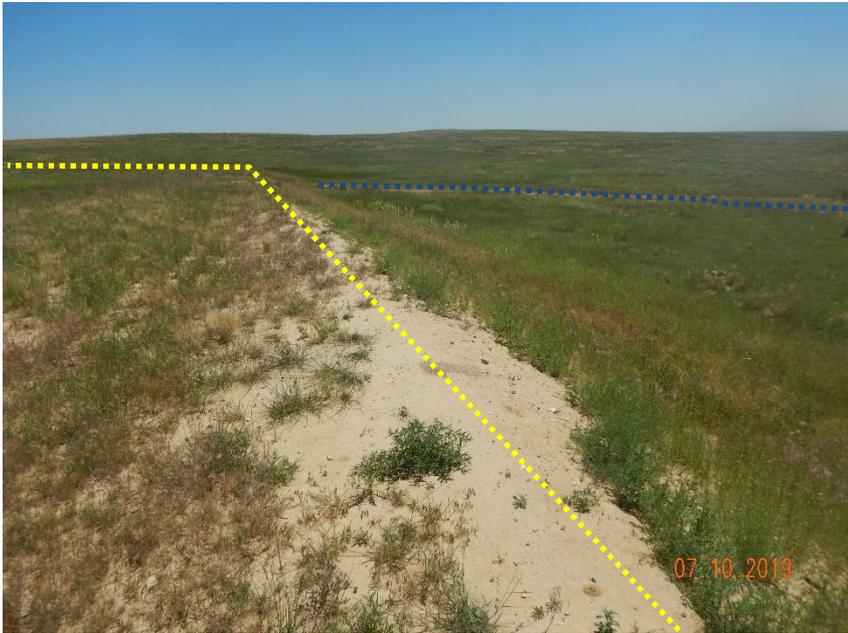
Photo 11: Photo taken from the southwest corner of the location, facing south

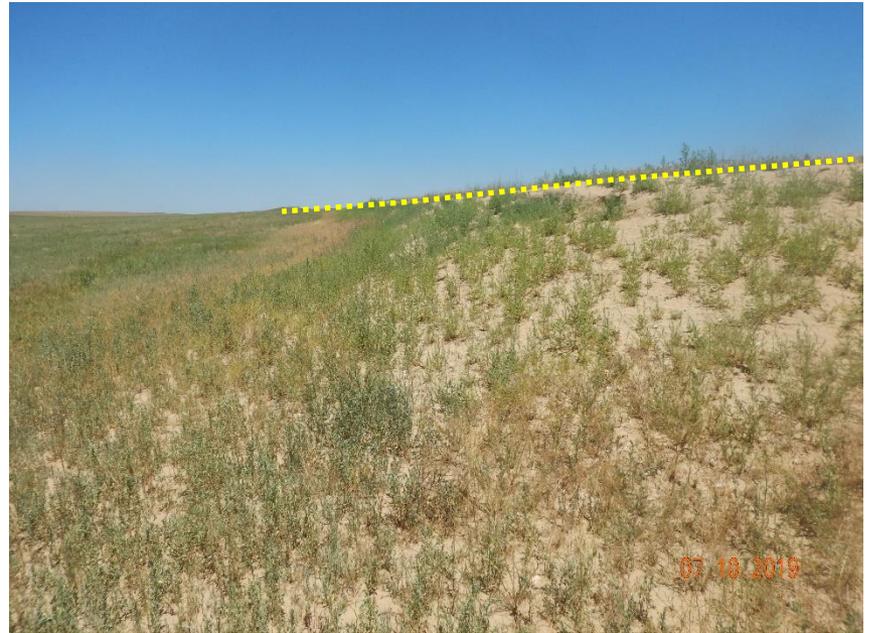
Photo 12: Photo taken from the southwest corner of the location, facing northeast. Previous inspections documented slopes on location remain predominantly bare and exposed soil, or vegetated by undesirable weedy plant species, stormwater and erosion degradation evident. Slopes remains bare and erosion degradation remains evident.

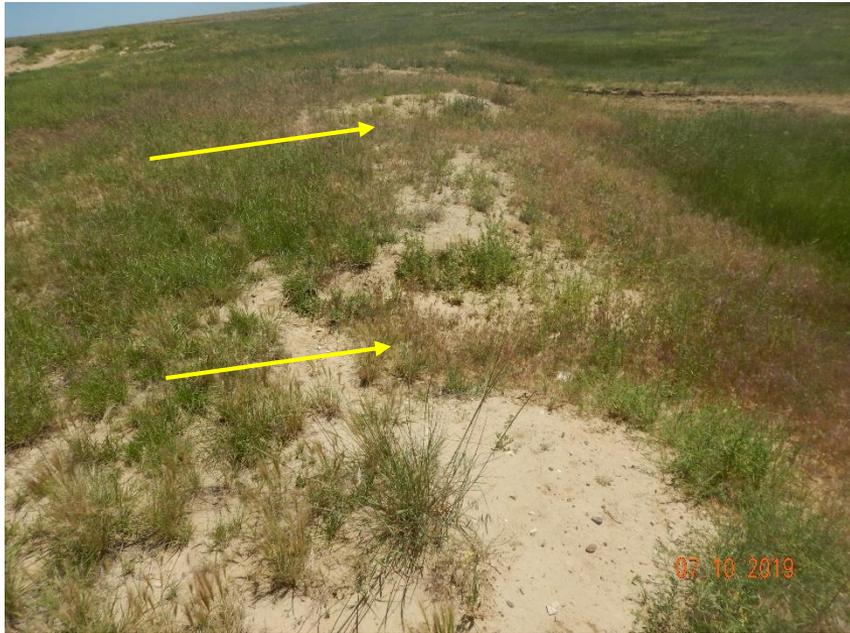
Photo 17: Photo taken from the south end of the location, facing east. Previous inspections documented erosion degradation on the location and required operator to implement BMPs in accordance with 1002.f. Photo shows erosion degradation remains, no BMPs have been installed or maintained.

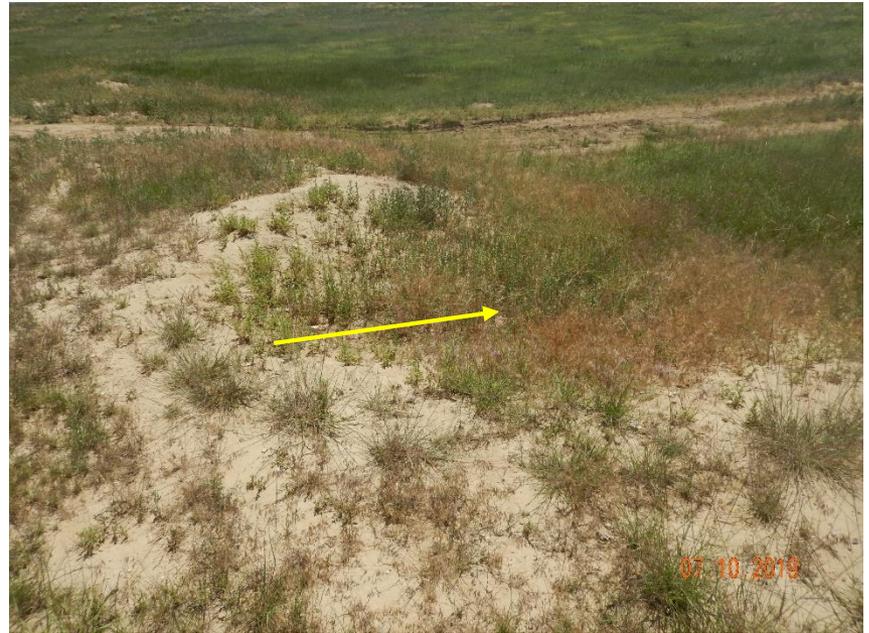
Photo 18: Photo taken from the south end of the location, facing east. Previous inspections documented erosion degradation on the location and required operator to implement BMPs in accordance with 1002.f. Photo shows erosion degradation remains, no BMPs have been installed or maintained.

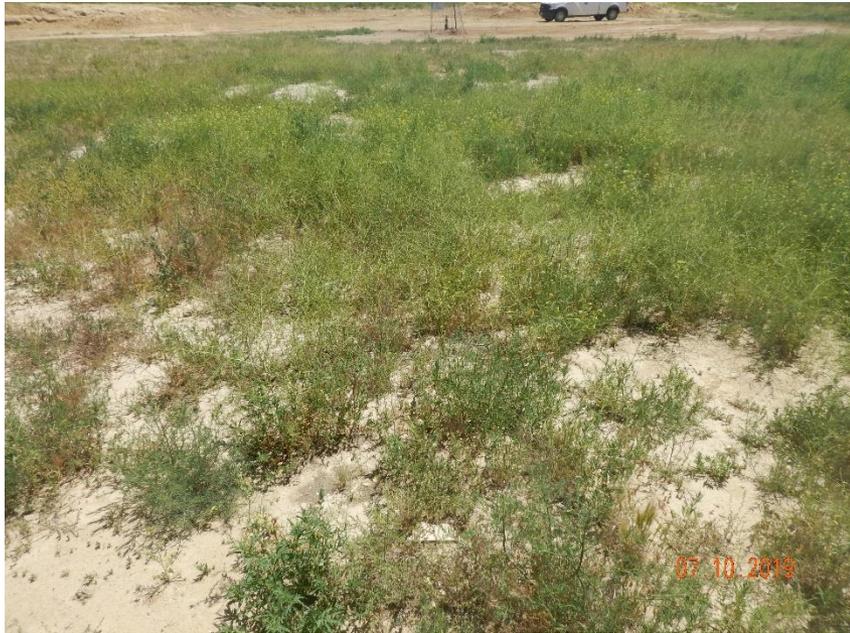
Photo 19: Photo taken from the west end of the location. Photo shows vegetation on location is predominantly undesirable weedy plant species such as Kochia, Russian thistle, Puncture vine, tumble mustard, etc...

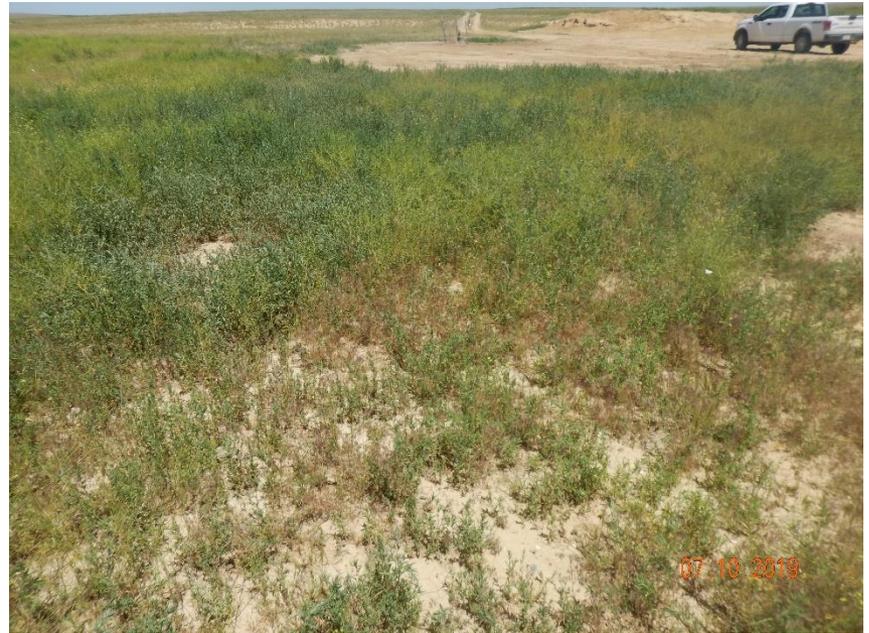
Photo 20: Photo taken from the south end of the location. Photo shows vegetation on location is predominantly undesirable weedy plant species such as Kochia, Russian thistle, Puncture vine, tumble mustard, etc...

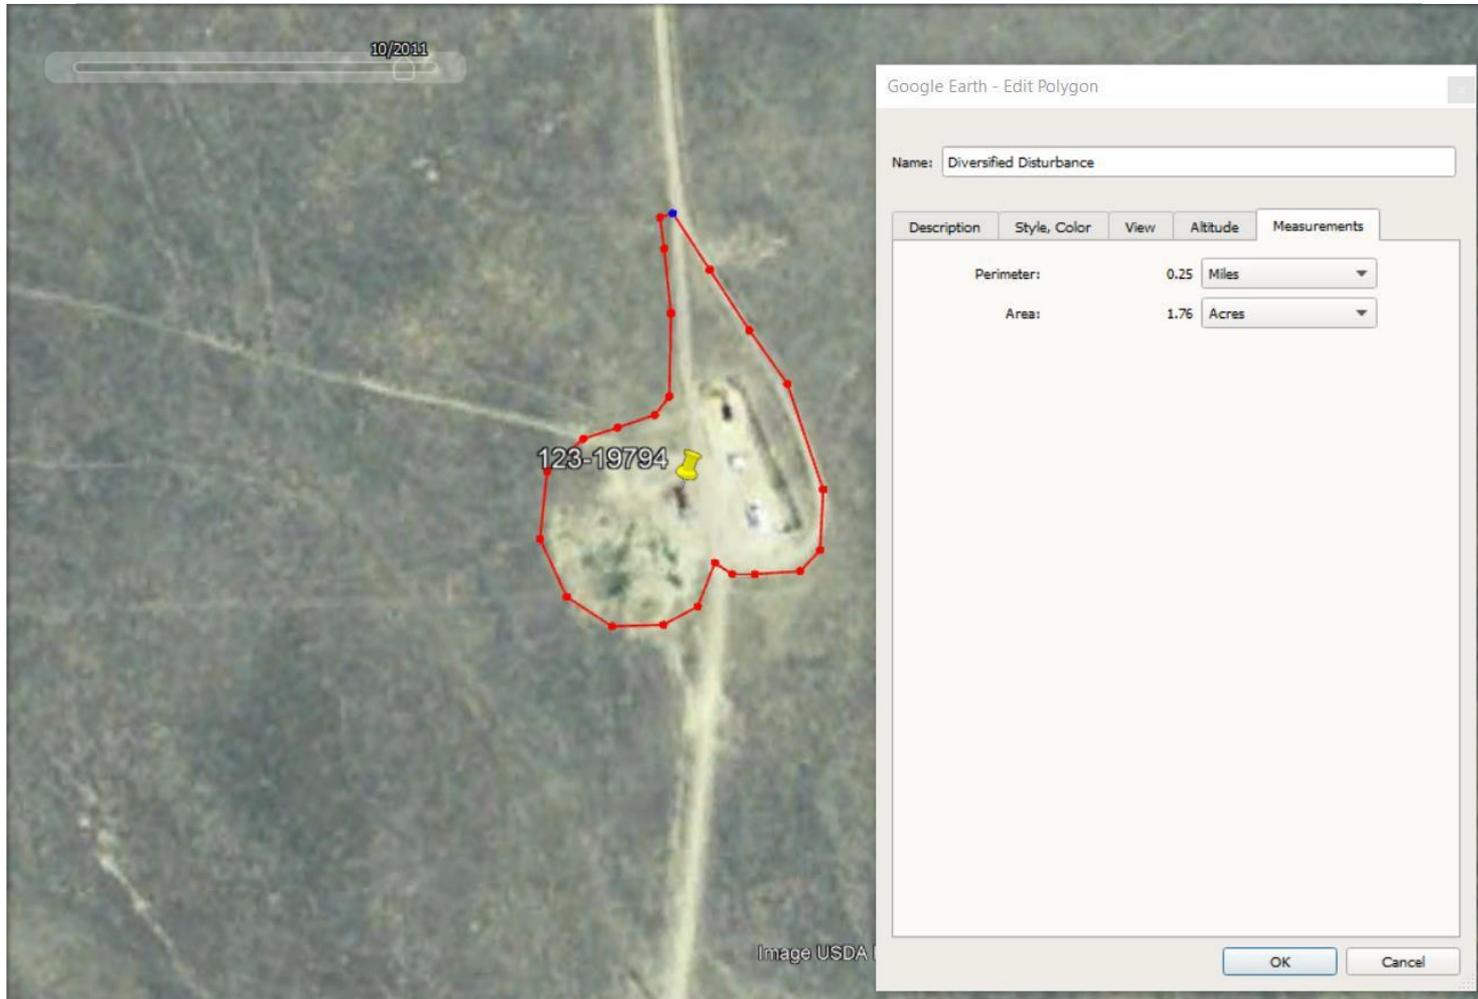
Photo 21: 2011 Aerial imagery. Location under the operation of Diversified Operating at time of image. Photo shows disturbance area to be ~1.76 acres

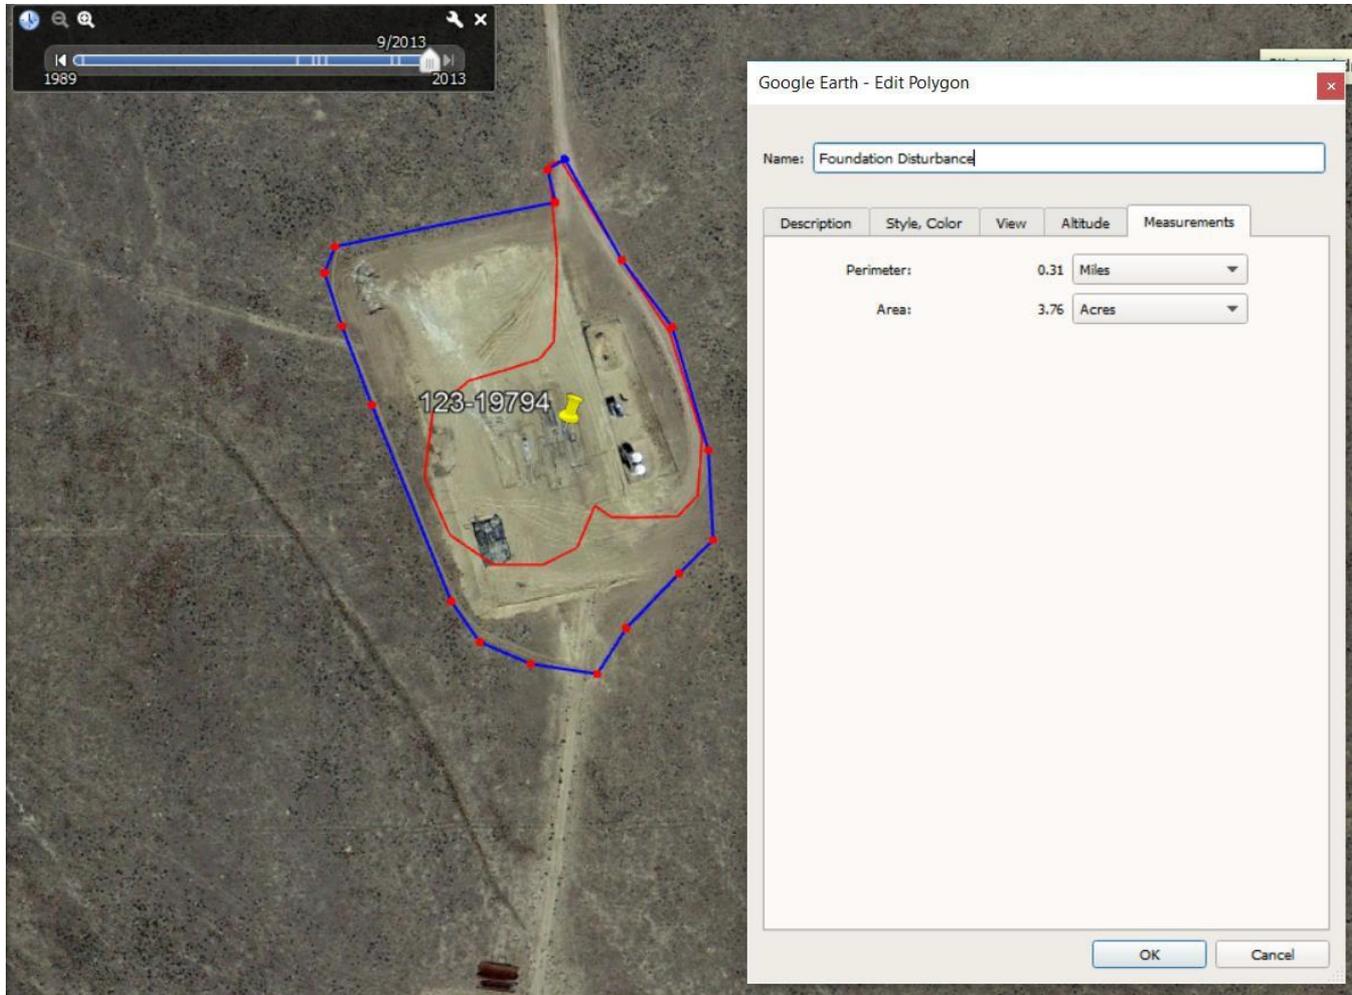
Photo 22: 2013 Aerial imagery. Location transferred ownership from Diversified to Foundation Energy in 2012. Photo shows Foundation expanded the disturbance of the location to its current size of ~3.76 acres. Location disturbance area, and areas not needed for production were not reclaimed in accordance with 1003.b.
