Inspection Photos
Location Name: GECKO 12-18
API#: 05-071-07712
INSP. #: 695101011

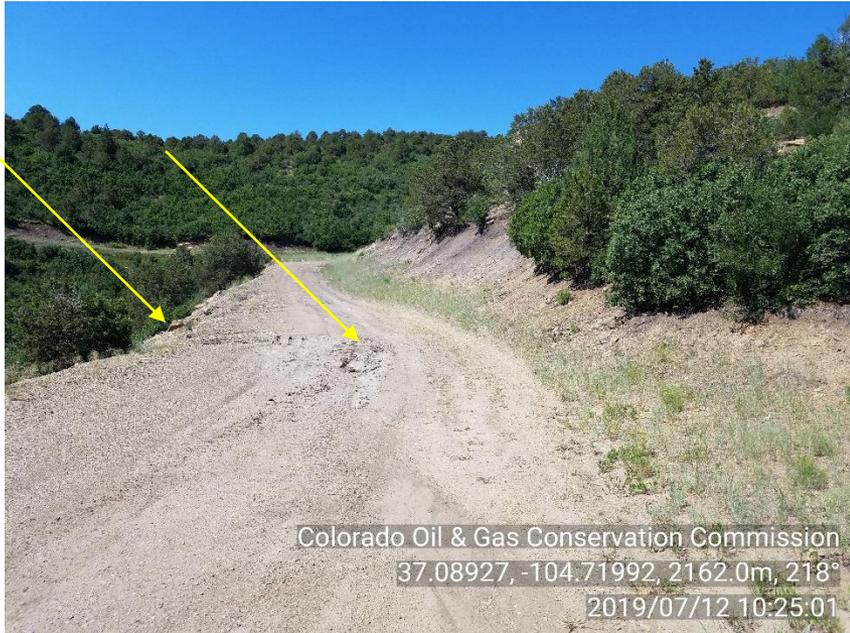
PHOTO 3: NO DITCHING OR BERMING ON ROW TO PREVENT STORMWATER POOLING ON ROW AND ROW SURFACE MATERIAL FROM MIGRATING OFF OF ROW AND BEYOND ORIGINAL ROW DISTURBANCE AREA. **INSTALL OR REPAIR BMP'S TO PREVENT STORMWATER POOLING ON ROW AND TO PREVENT ROW SURFACE MATERIAL FROM MIGRATING OFF OF ROW IN ACCORDANCE WITH RULE 1002.f. CA DATE 9/12/19.**

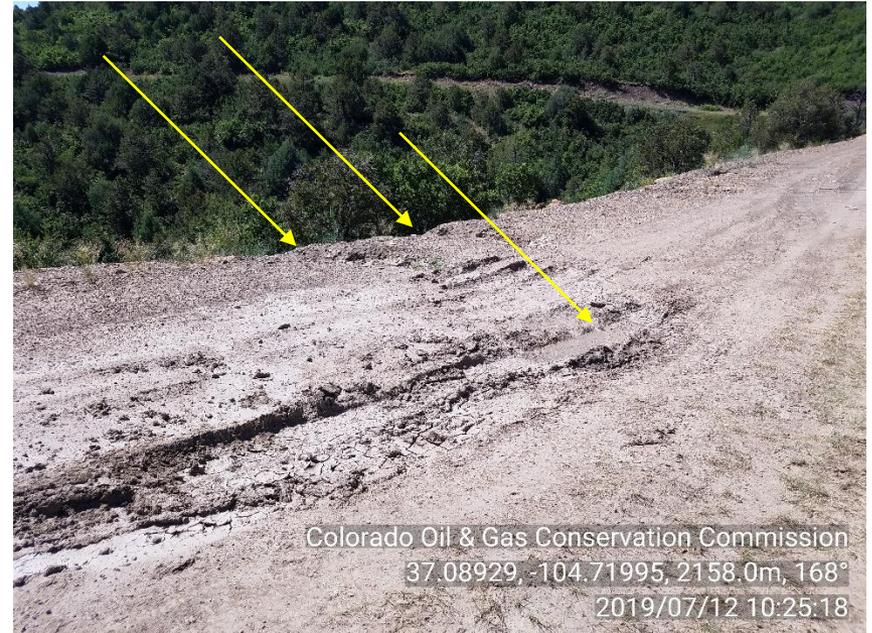
PHOTO 4: CLOSER VIEW FROM PREVIOUS PHOTO (PHOTO 3). PHOTO SHOWING STORMWATER POOLING ON ROW AND EROSION OF ROW SURFACE MATERIAL OFF OF ROW.

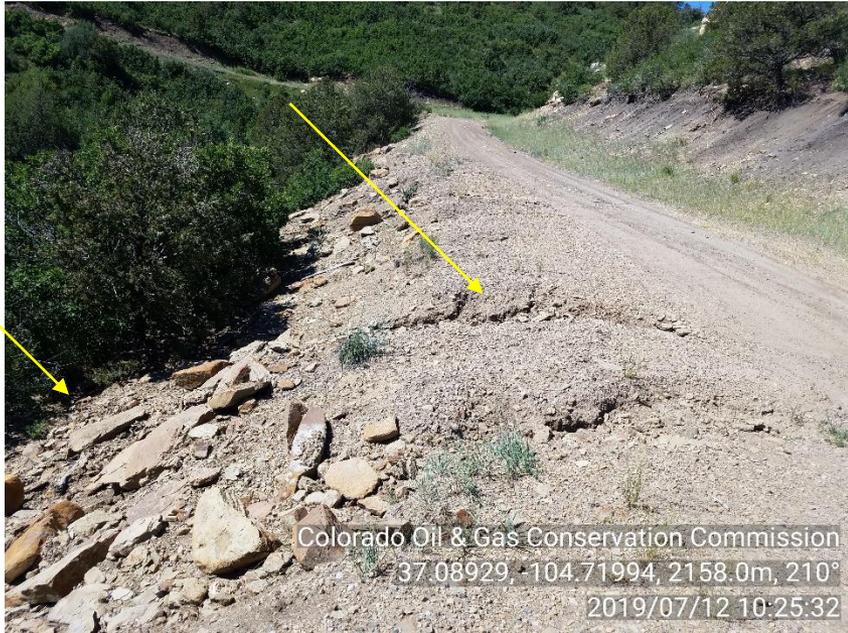
PHOTO 5: CLOSER VIEW OF ROW EROSION AND ROW SURFACE MATERIAL MIGRATION OF ORIGINAL ROW DISTURBANCE AREA FROM THE PREVIOUS 2 PHOTOS (PHOTO'S 3 & 4).

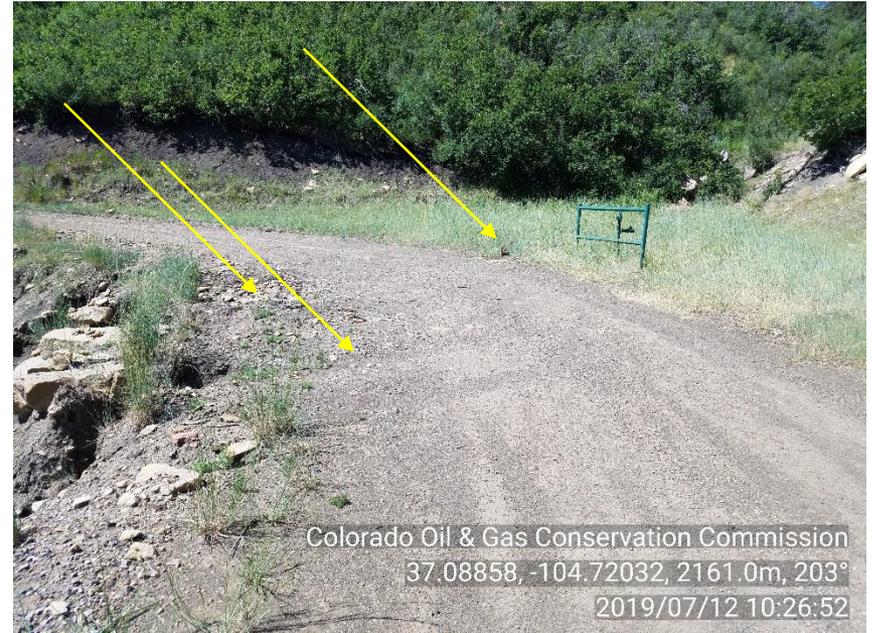
PHOTO 6: ANOTHER AREA APP. 200 YARDS SOUTH FROM PREVIOUS PHOTOS OF NO DITCHING OR BERMING ON ROW TO PREVENT STORMWATER CAUSING ROW SURFACE MATERIAL TO MIGRATING OFF OF ROW AND BEYOND ORIGINAL ROW DISTURBANCE AREA. **INSTALL OR REPAIR BMP'S TO PREVENT STORMWATER POOLING ON ROW AND TO PREVENT ROW SURFACE MATERIAL FROM MIGRATING OFF OF ROW IN ACCORDANCE WITH RULE 1002.f. CA DATE 9/12/19.**

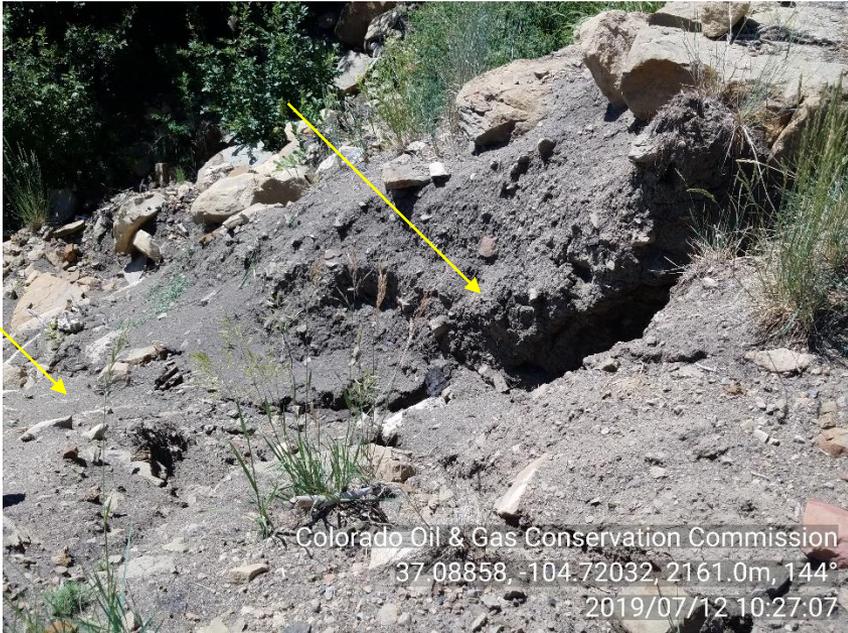
PHOTO 7: CLOSER VIEW OF EROSION FROM THE PREVIOUS PHOTO (PHOTO 6).

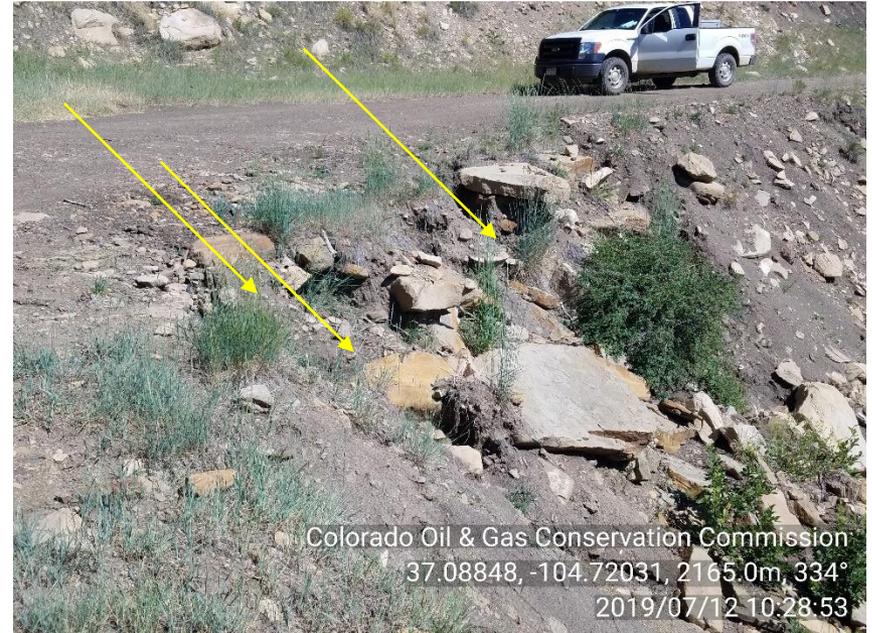
PHOTO 8: VIEW OF SAME EROSION FROM PREVIOUS 2 PHOTOS (PHOTO'S 6 & 7). FROM THE OPOSITE SIDE (SOUTH VIEW).

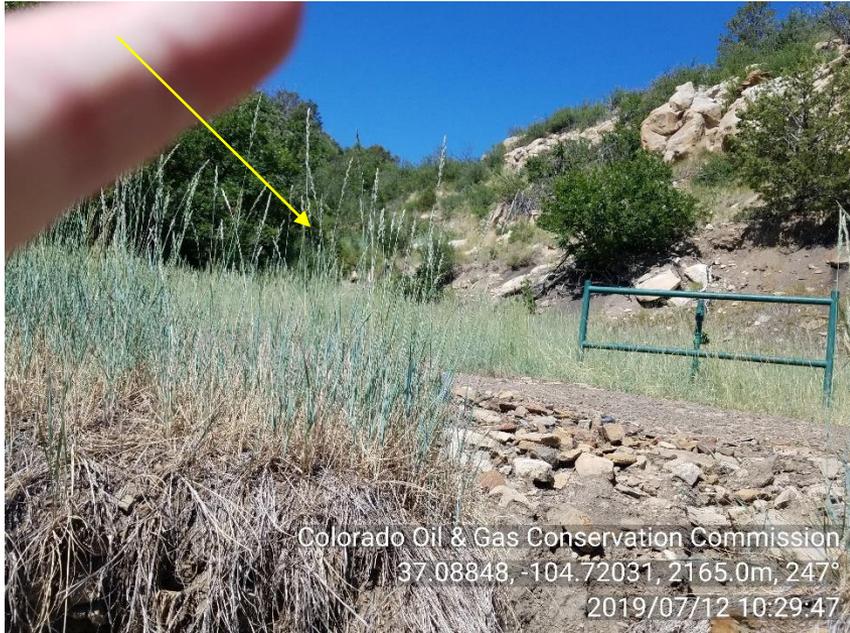
**PHOTO 9: NATURAL DRAIN UPSLOPE FROM ROW EROSION
AREA WITH NO BMP'S IN PLACE.**
