Inspection Photos
Location Name: TURKEY 24-7
API#: 05-071-06574
INSP. #: 695101013

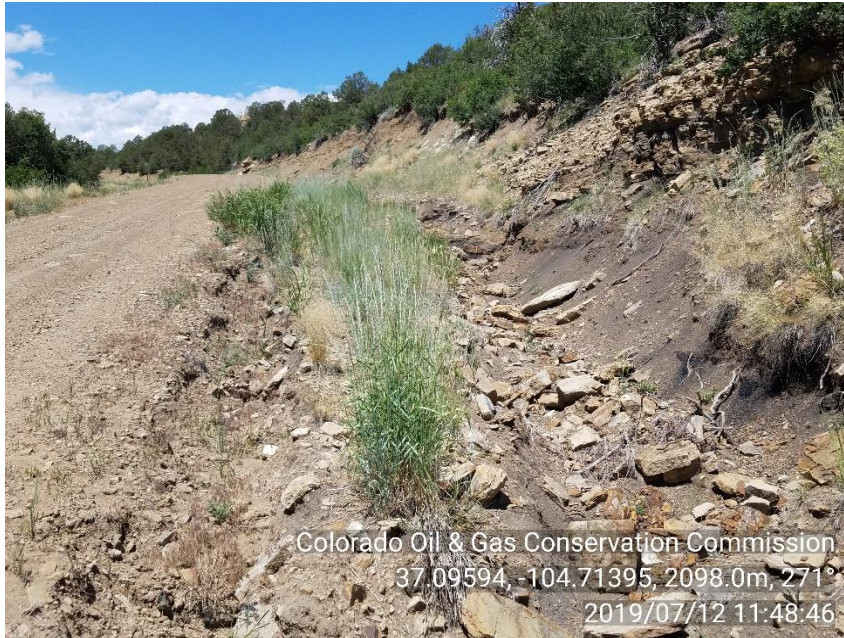
PHOTO 3: AREA OF EROSION ON MAIN ROW NORTH OF LOCATION TOWARD THE BOTTOM OF THE HILL. REPAIR EROSION AND REPAIR OR INSTALL BMP'S TO PREVENT EROSION AND COMPLY WITH RULE 1002.f. CA DATE 8/12/19

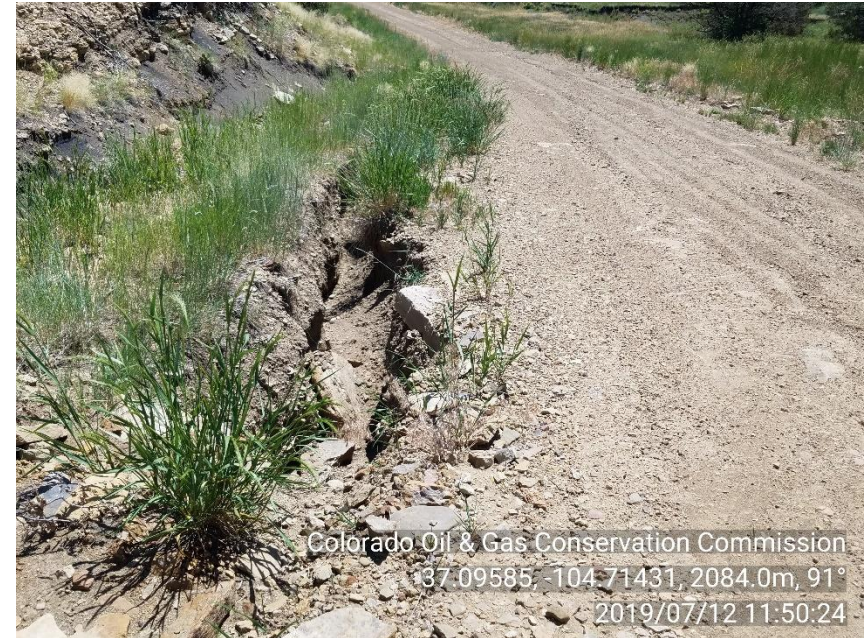
PHOTO 4: CLOSER VIEW OF EROSION FROM PREVIOUS PHOTO (PHOTO 3).
