Inspection Photos

Loc#416625

Operator: Sandridge

Inspection Photos: Sandridge Surprise Damfino Loc#416625

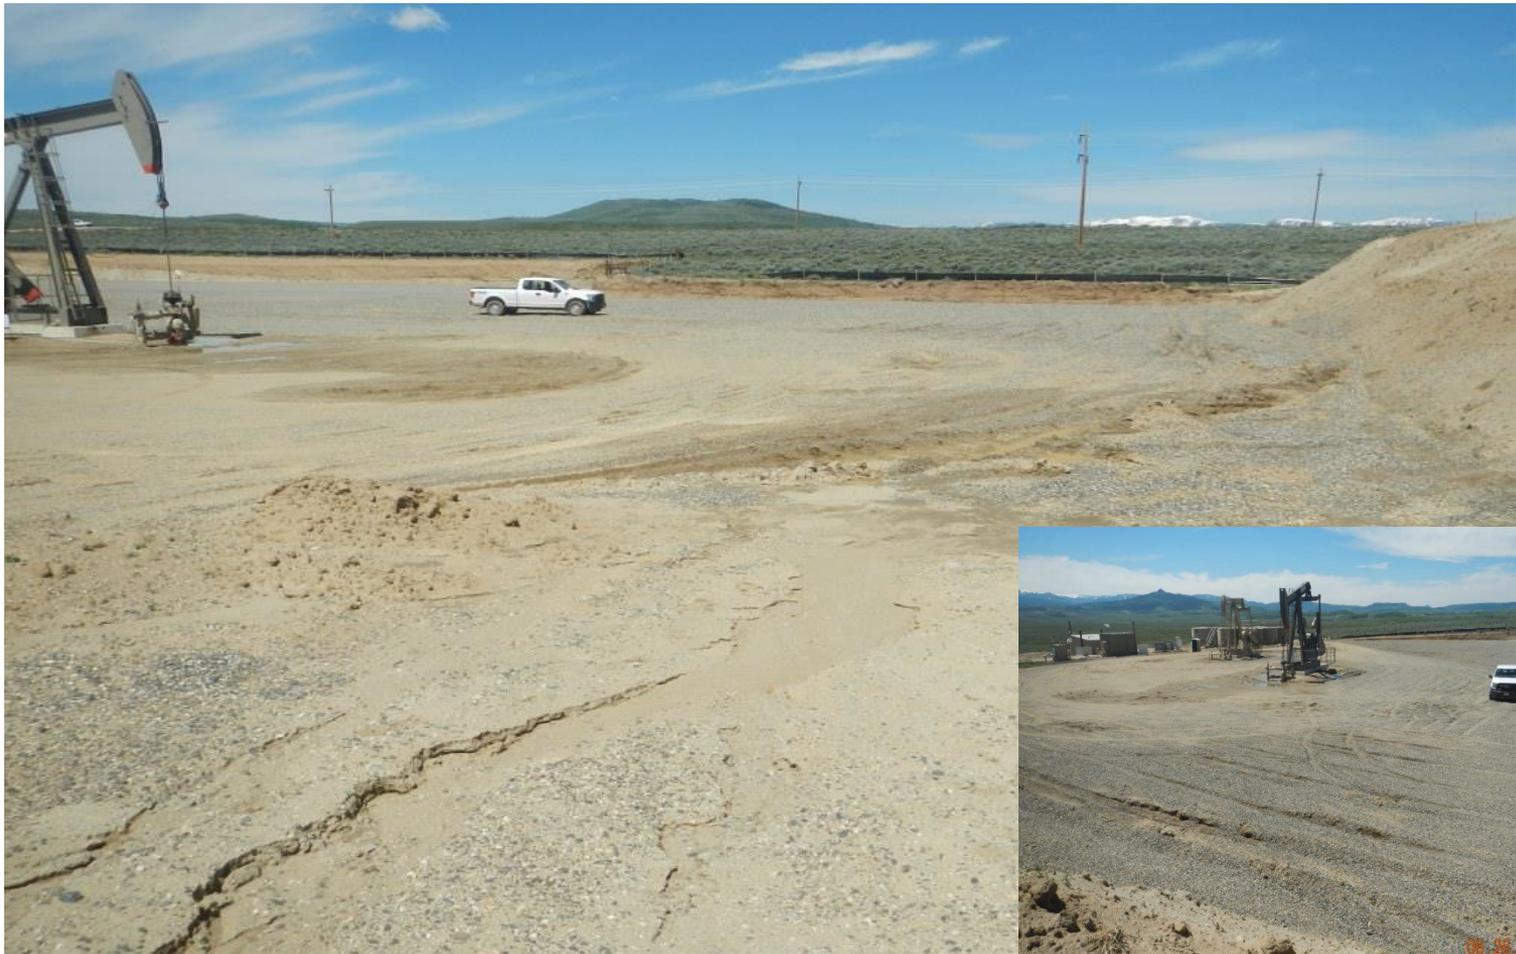
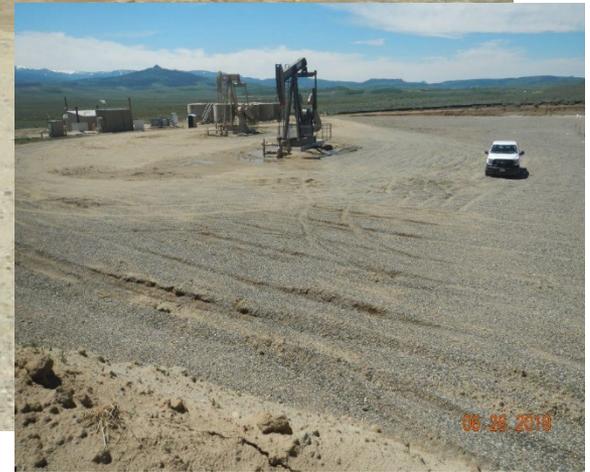
Photo#1:
Overviews of Location.

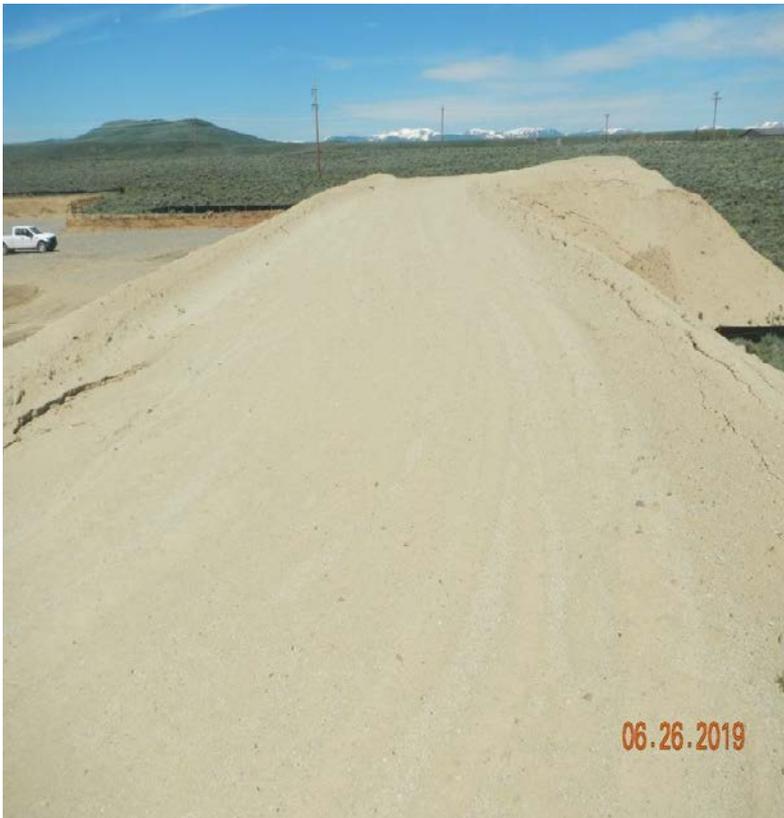
Photo#2:
View from top of stockpile pile to Northwest.

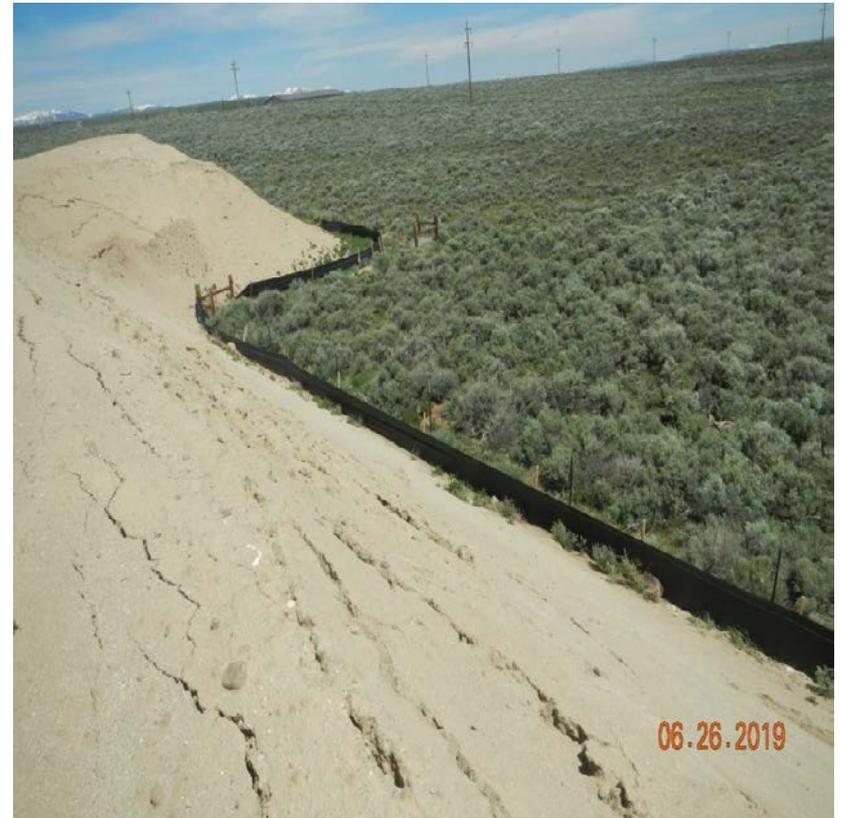
Photo#3:
View along unstable stockpile pile perimeter.

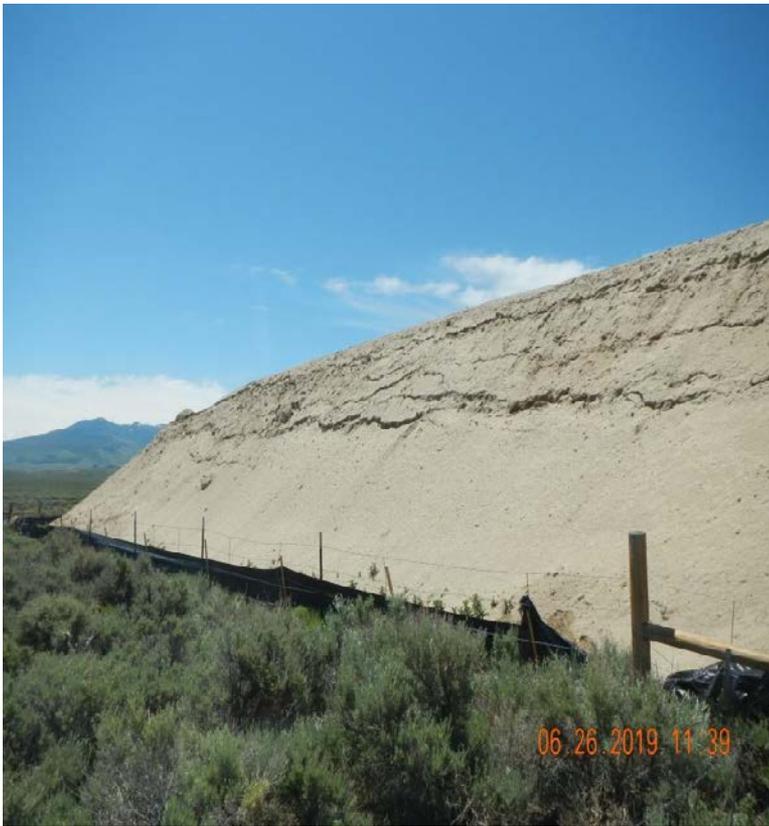
Photo#4:
View of unstable stockpile to Southeast.

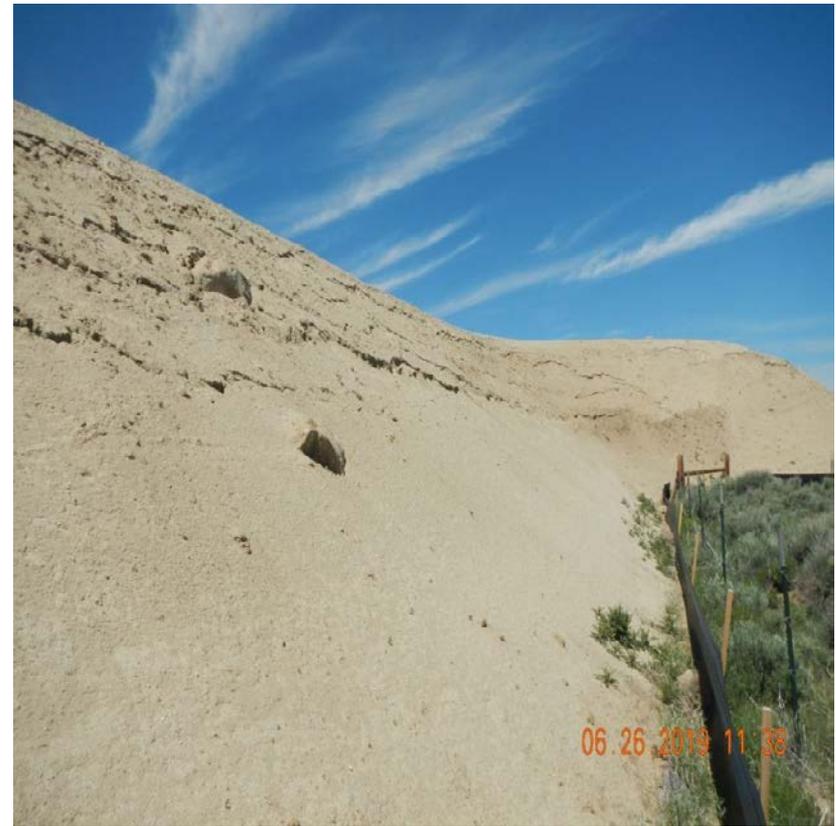
Photo#5:
View along base of unstable stockpile to Northwest.

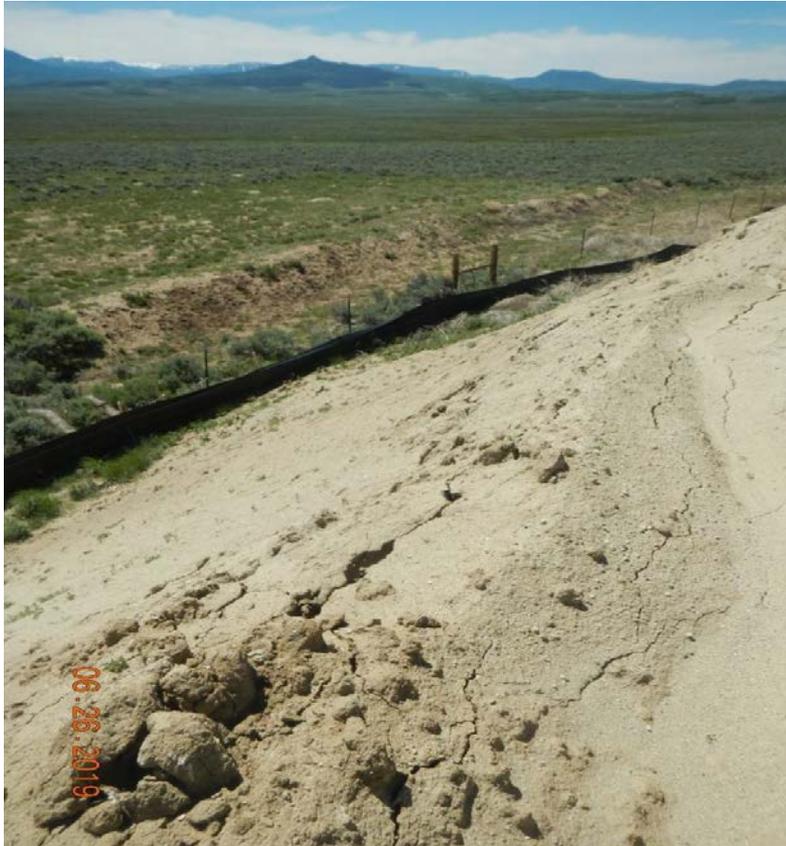
Photo#6:
Cracking, sloughing, erosion of stockpile.

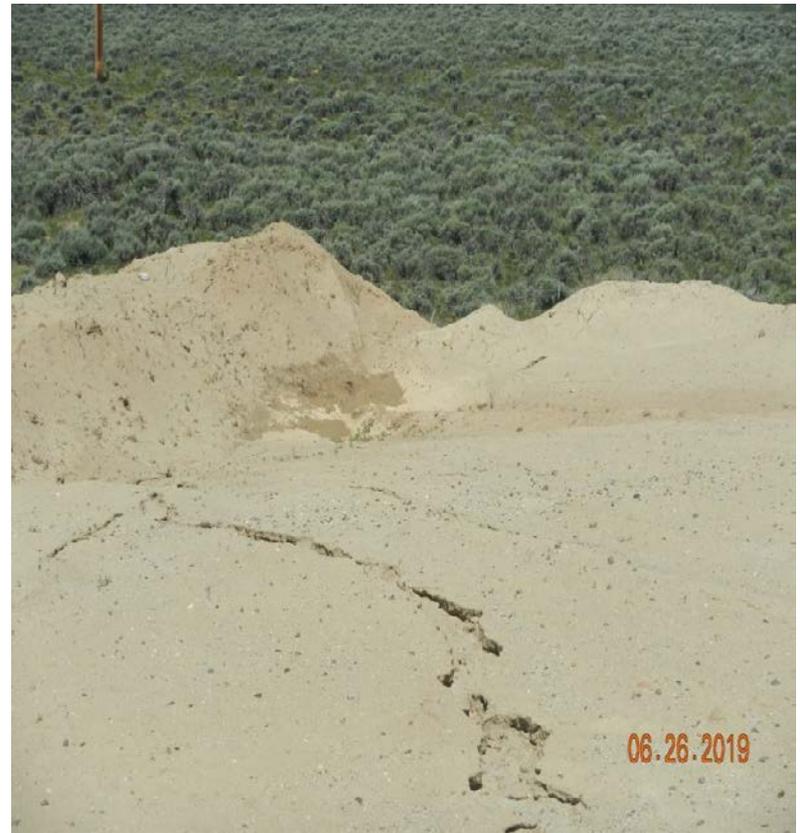
Photo#7:
Cracking, sloughing, erosion of stockpile.

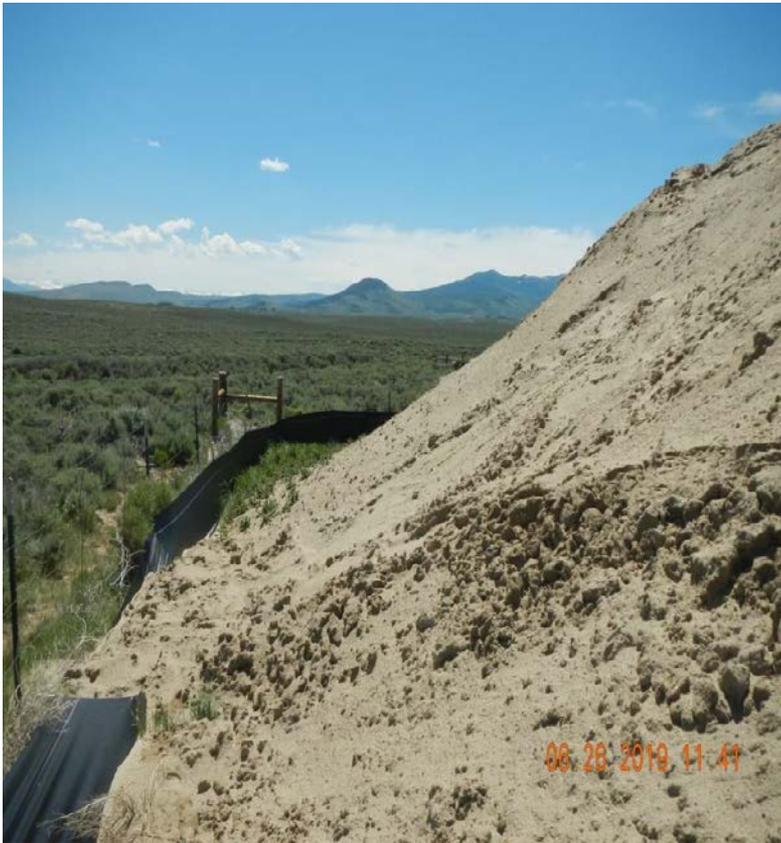
Photo#8:
Point along base of stockpile where silt fence has Failed.

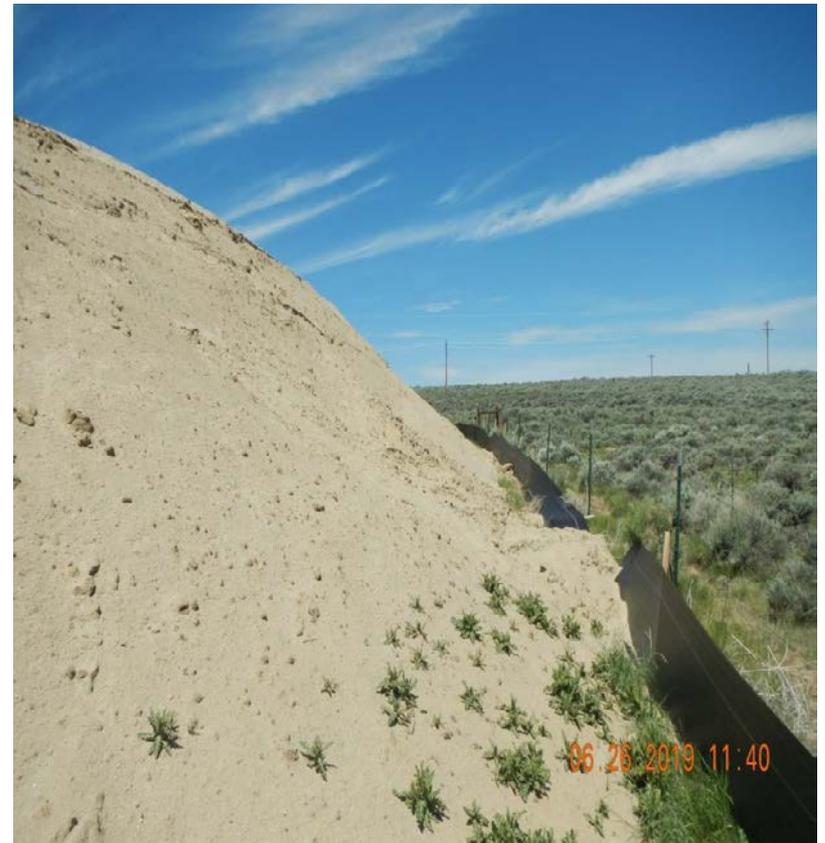
Photo#9:
Point along base of stockpile where silt fence has Failed.

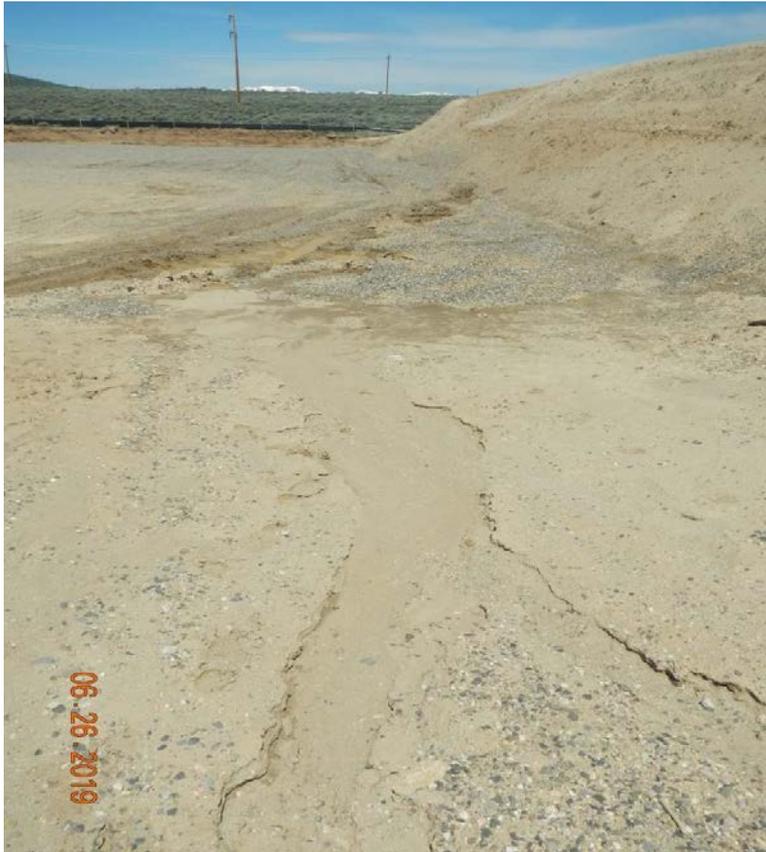
Photo#10:
South or Location side of stockpile, no BMPs;
run-on and degradation occurring.

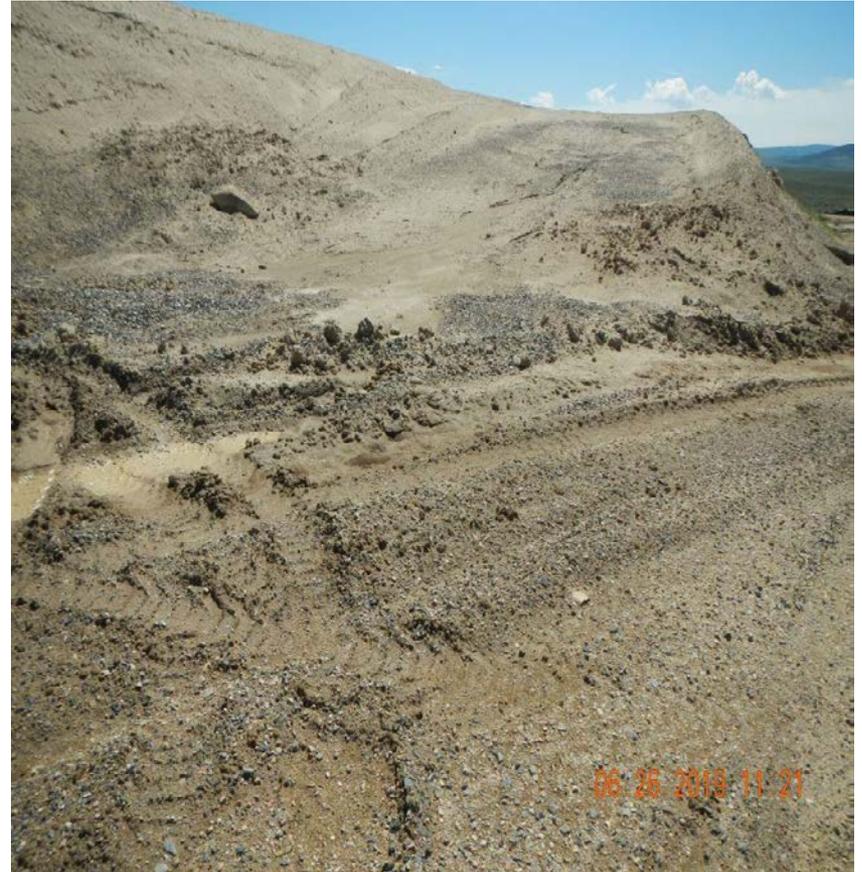
Photo#11:
South or Location side of stockpile, no BMPs;
run-on and degradation occurring.

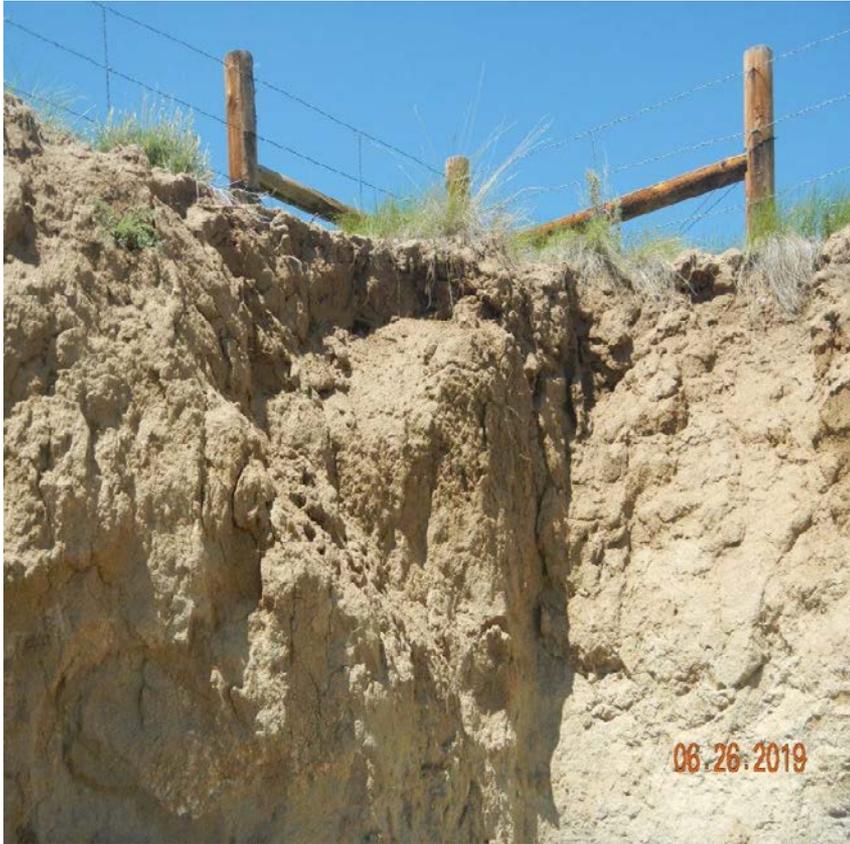
Photo#12:
Cut at Southwest corner of site; sloughing/erosion evident.

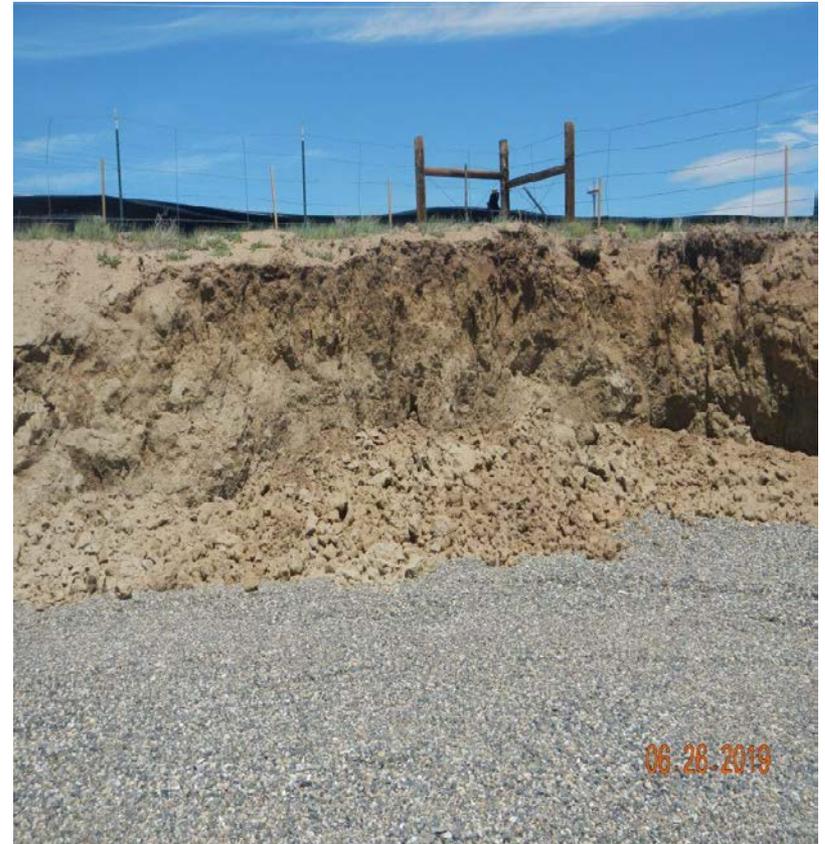
Photo#13:
Cut at Southwest corner of site; sloughing/erosion evident.

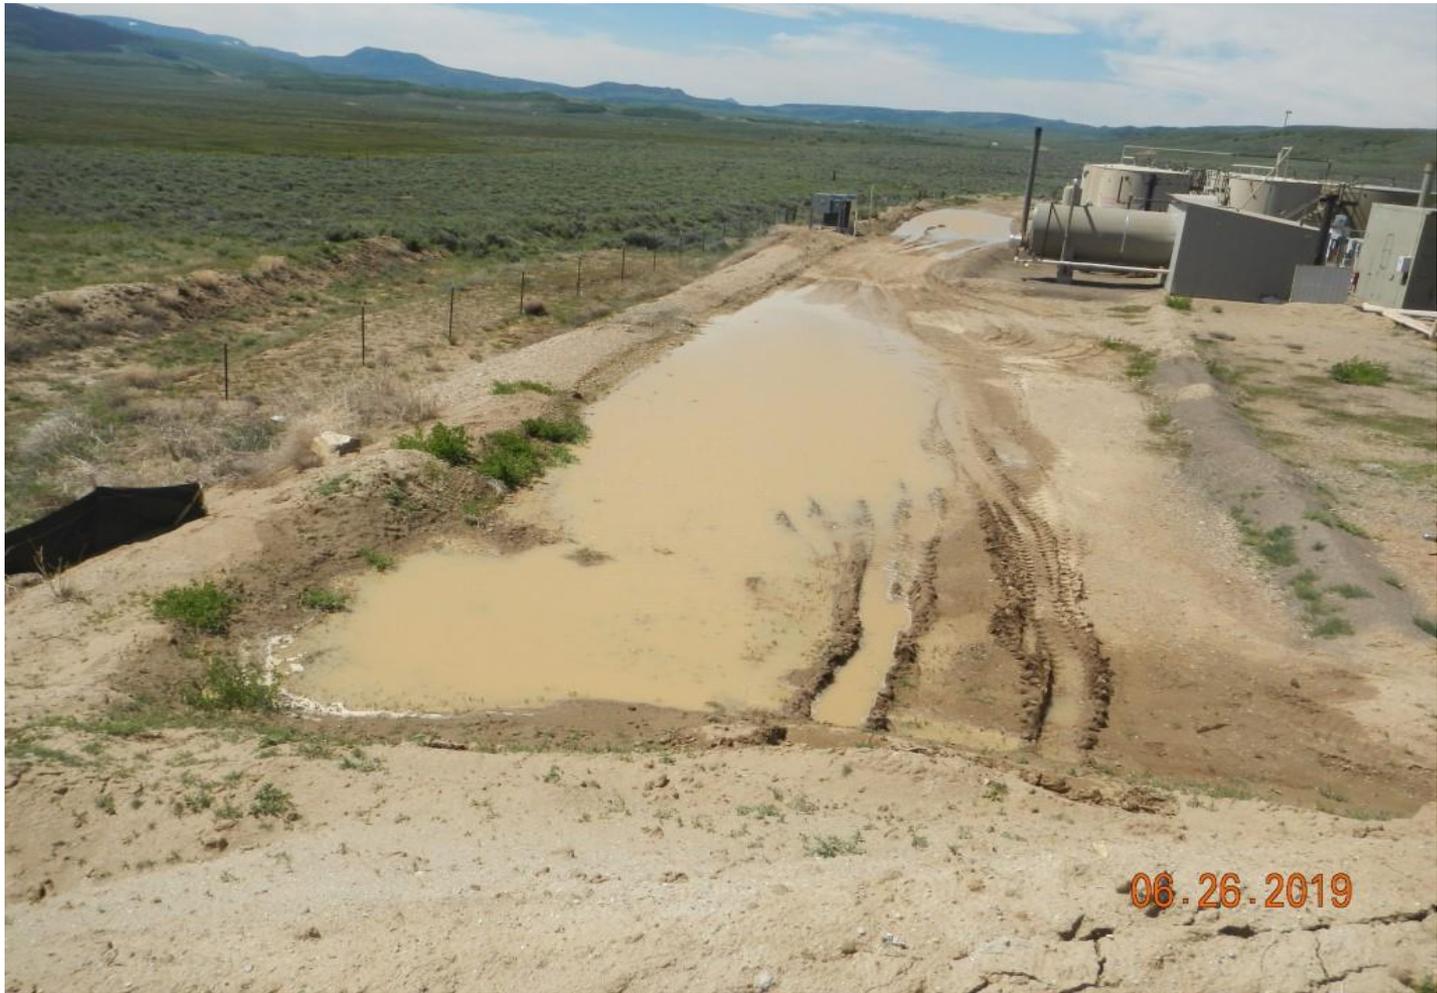
Photo#14:
Stormwater is improperly ponding on East side of site.
