# *Inspection Photos*

*Loc#438250*

*Operator: Sandridge*

*Inspection Number: 692401143*

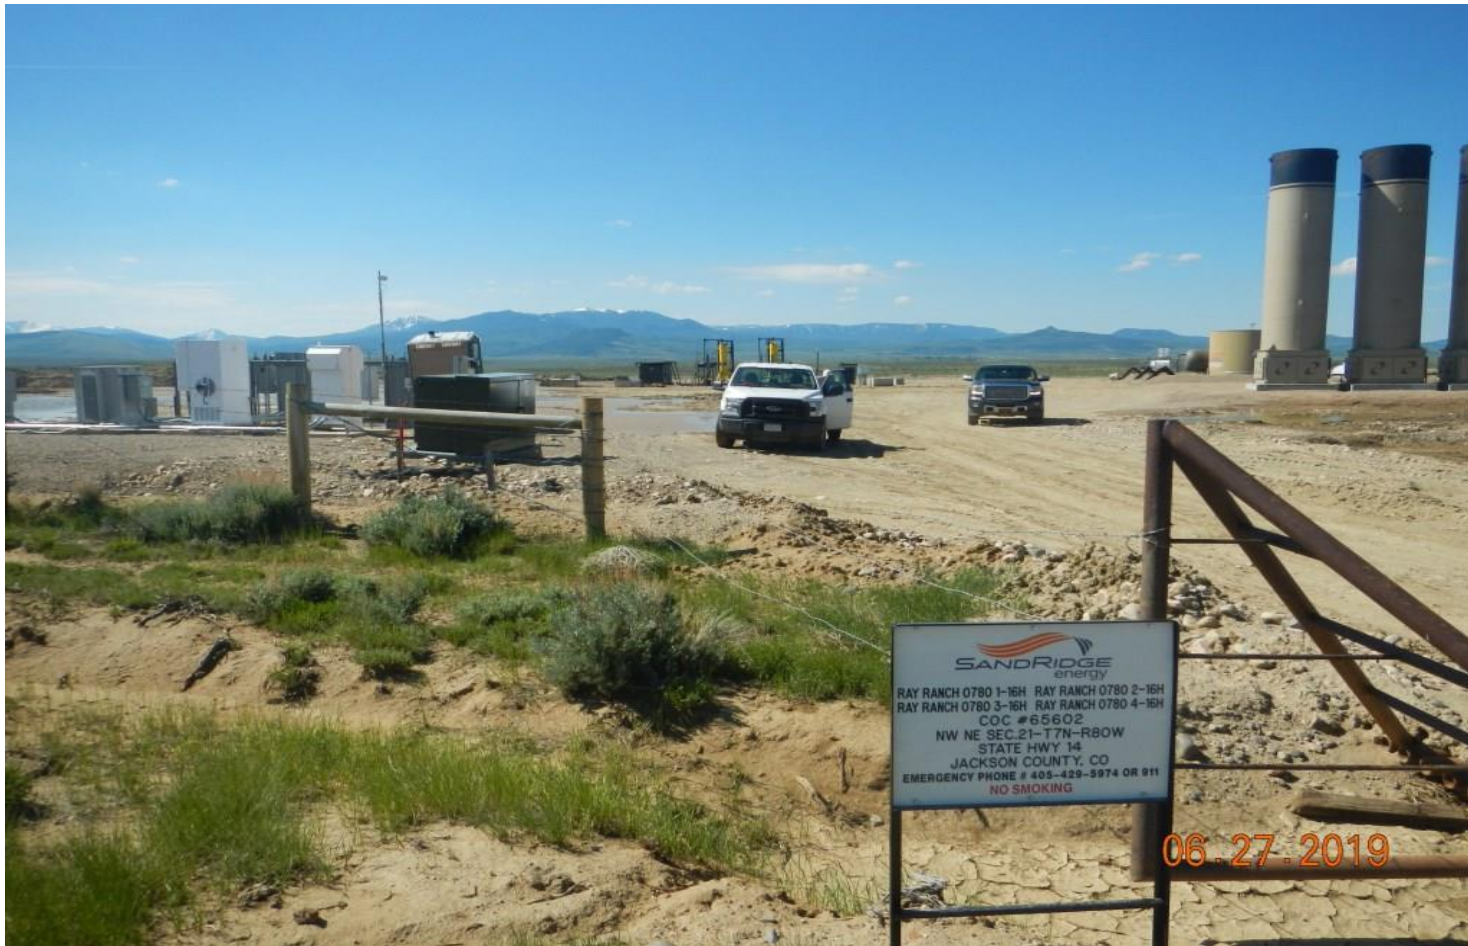
Photo#1:  
Overview of Location from Entry to South.

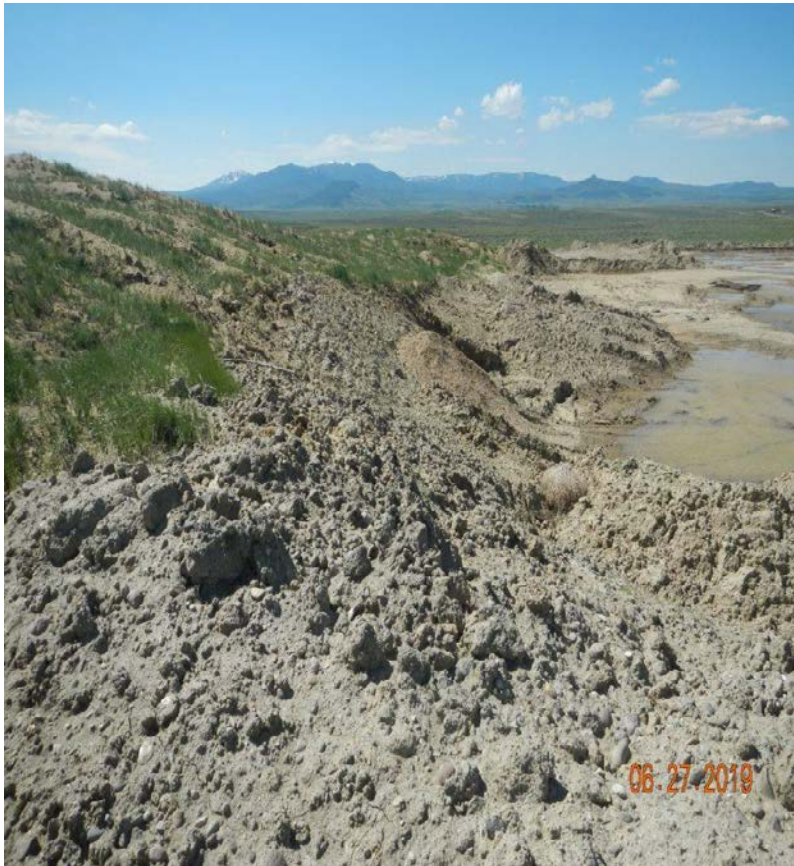
Photo#2:  
Unknown Material (Cuttings?) spread on cut slope.

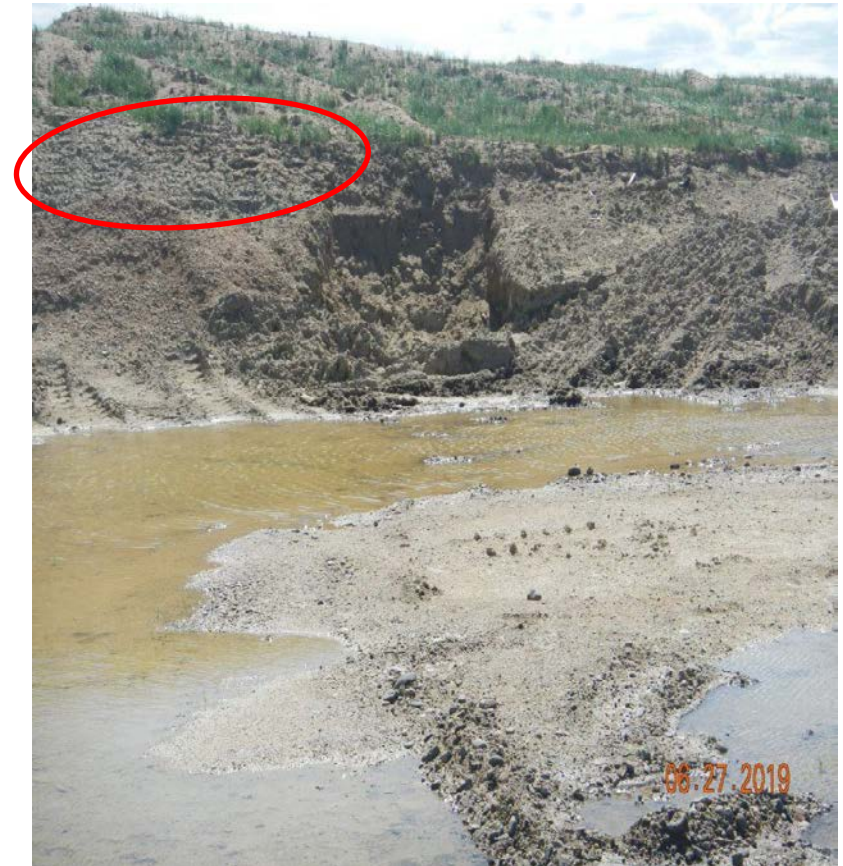
Photo#3:  
Excavation area in cut slope. Oval shows  
unknown material in photo#2.

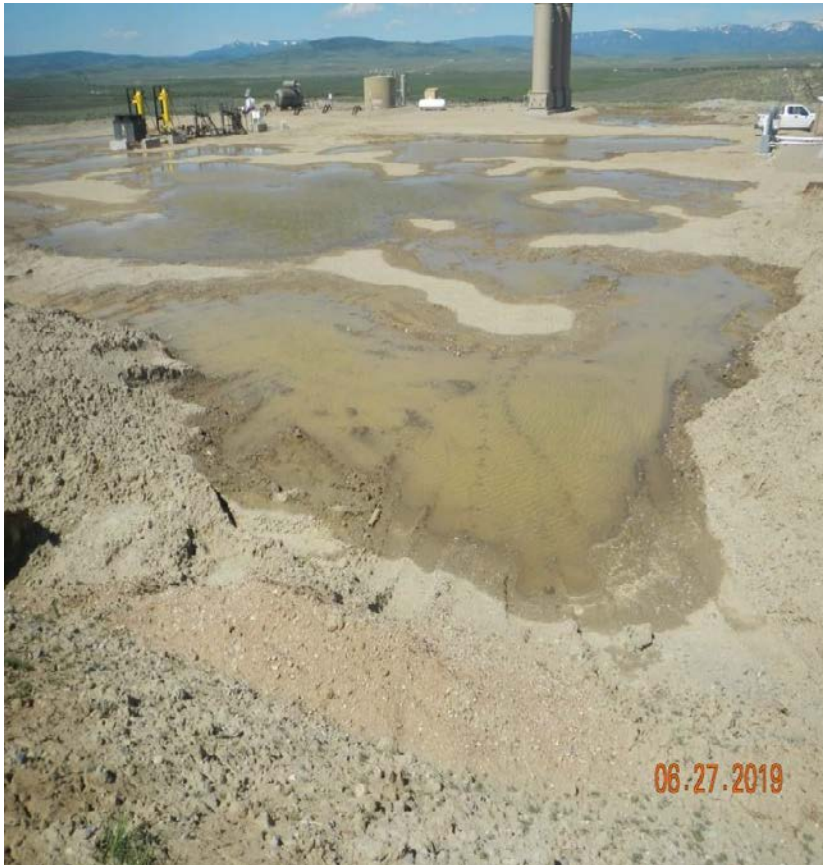
Photo#4:  
Ponding stormwater inundating unknown material (cuttings?).

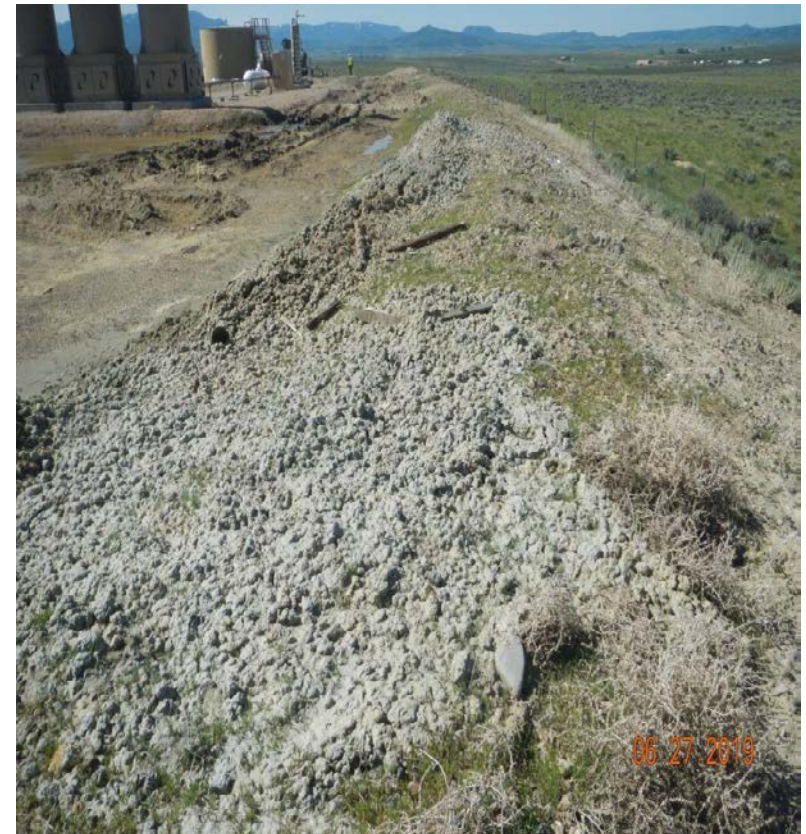
Photo#5:  
Unknown material on West berm.

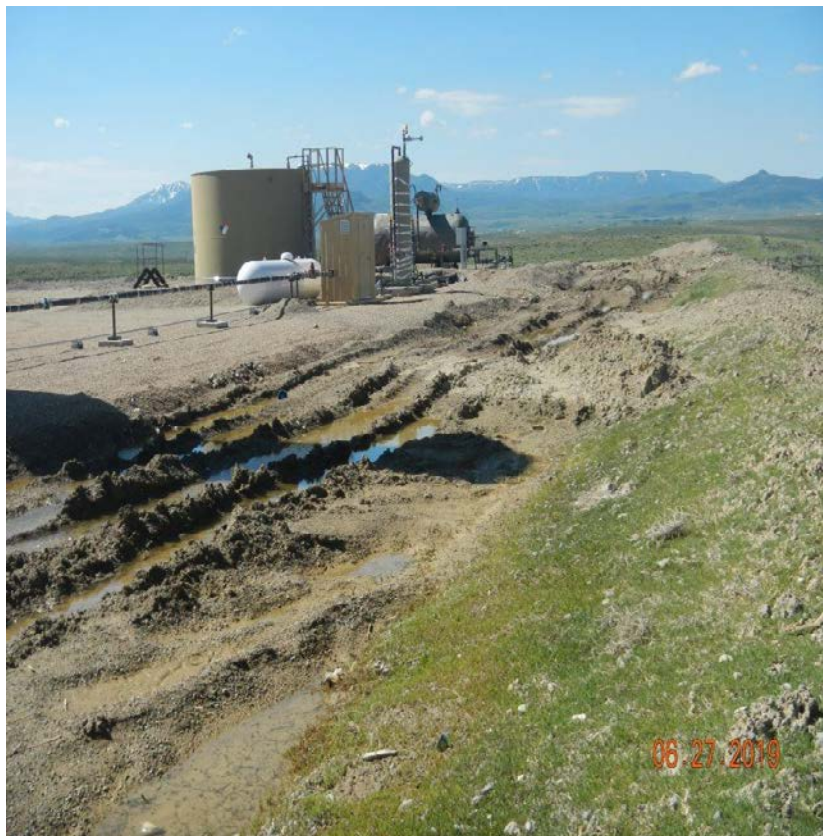
**Photo#6:**  
Rutting, ponding and degradation of site.

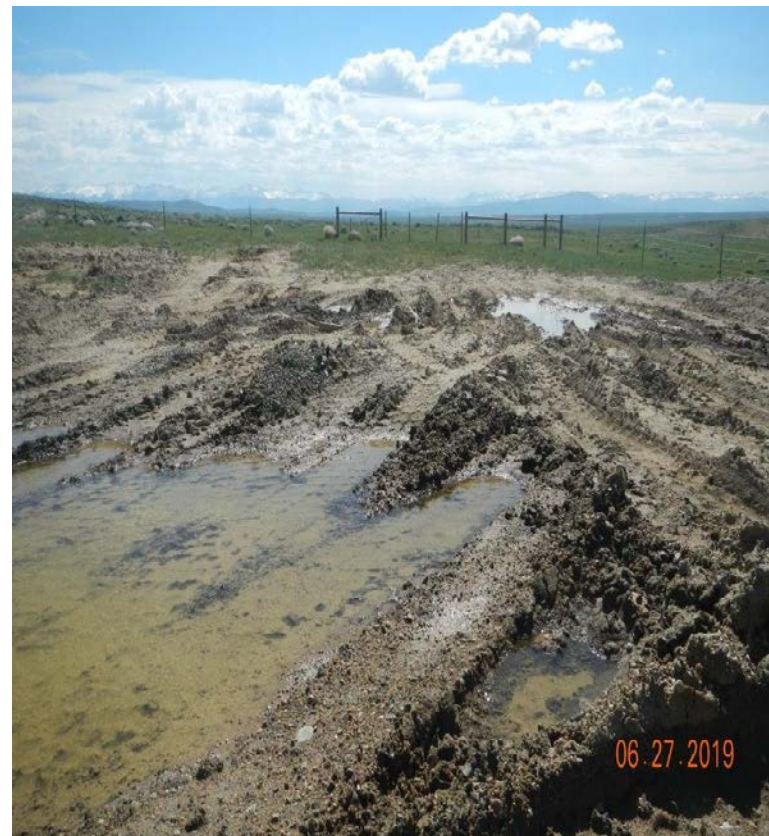
**Photo#7:**  
Rutting, ponding and degradation of site.

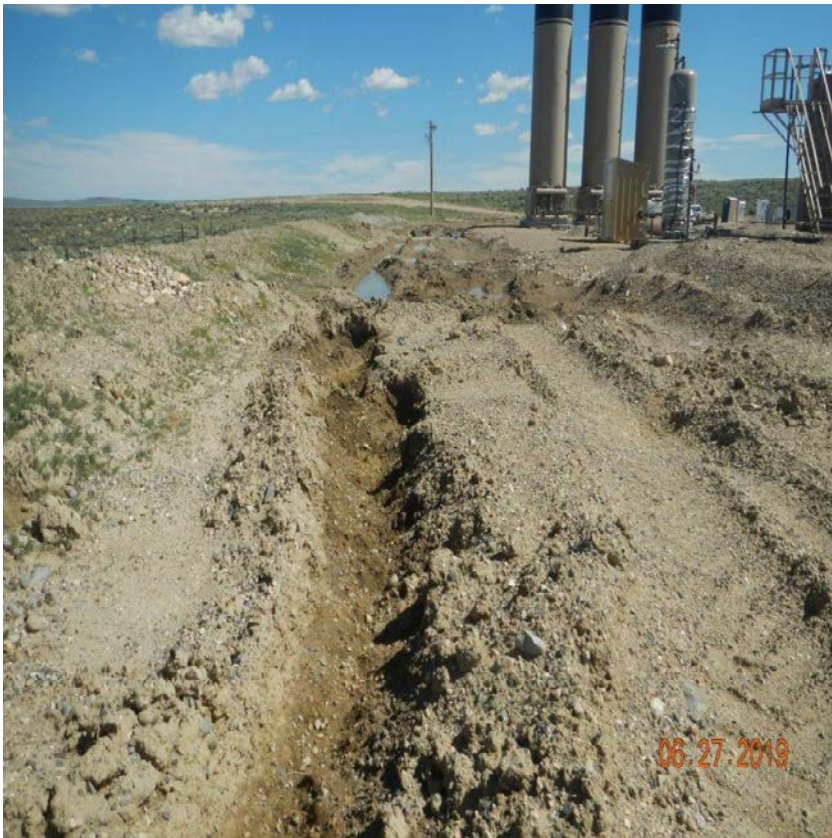
**Photo#8:**  
Rutting, ponding and degradation of site.

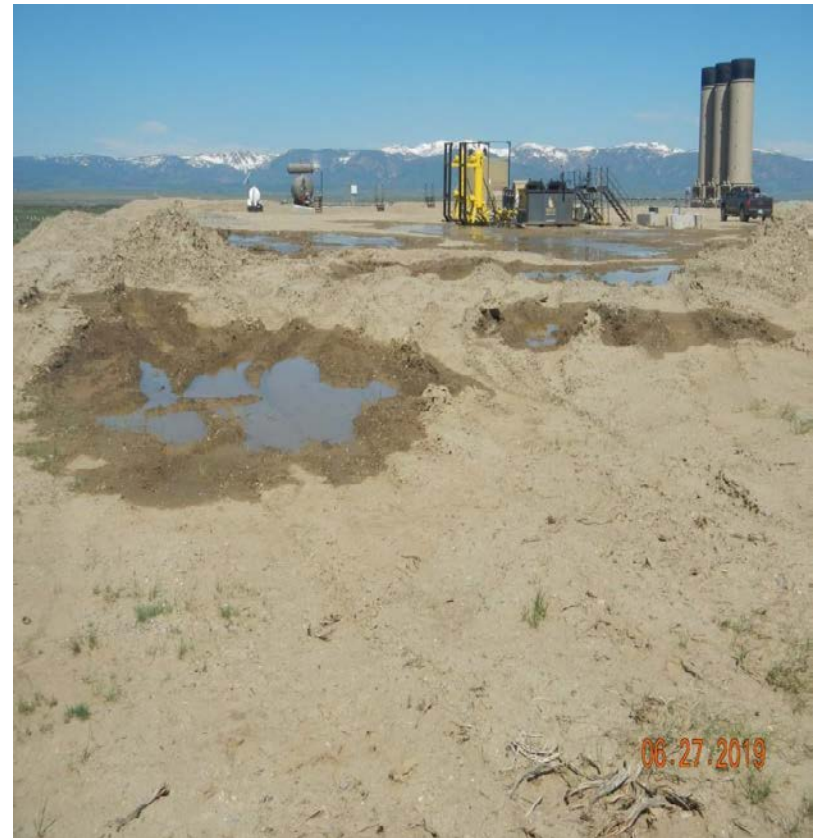
**Photo#9:**  
Rutting, ponding and degradation of site.

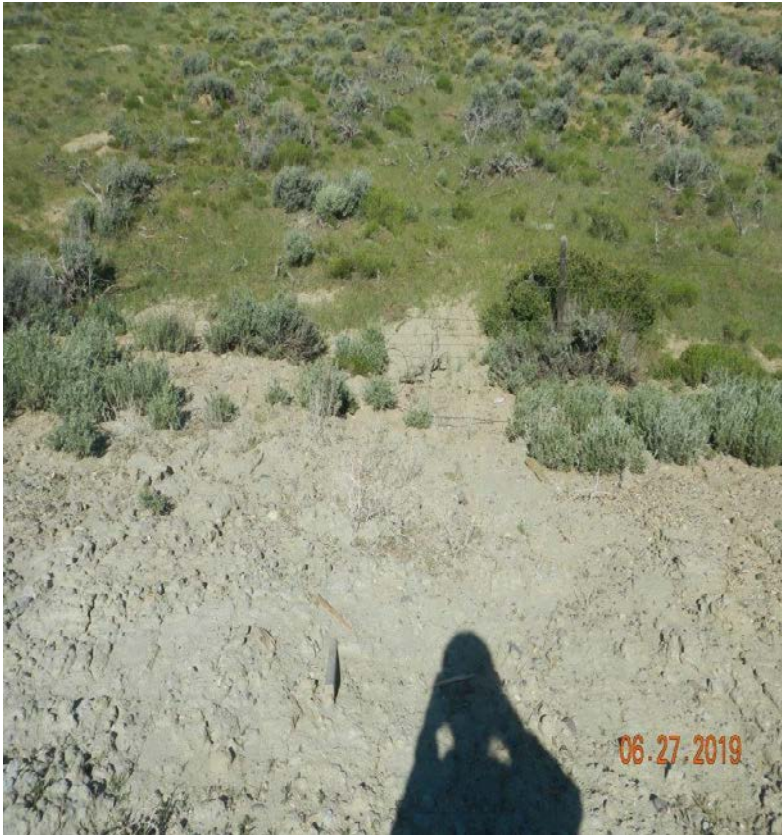
**Photo#10:**

BMPs are not installed along base of west fill slope;  
sediment migration occurring.

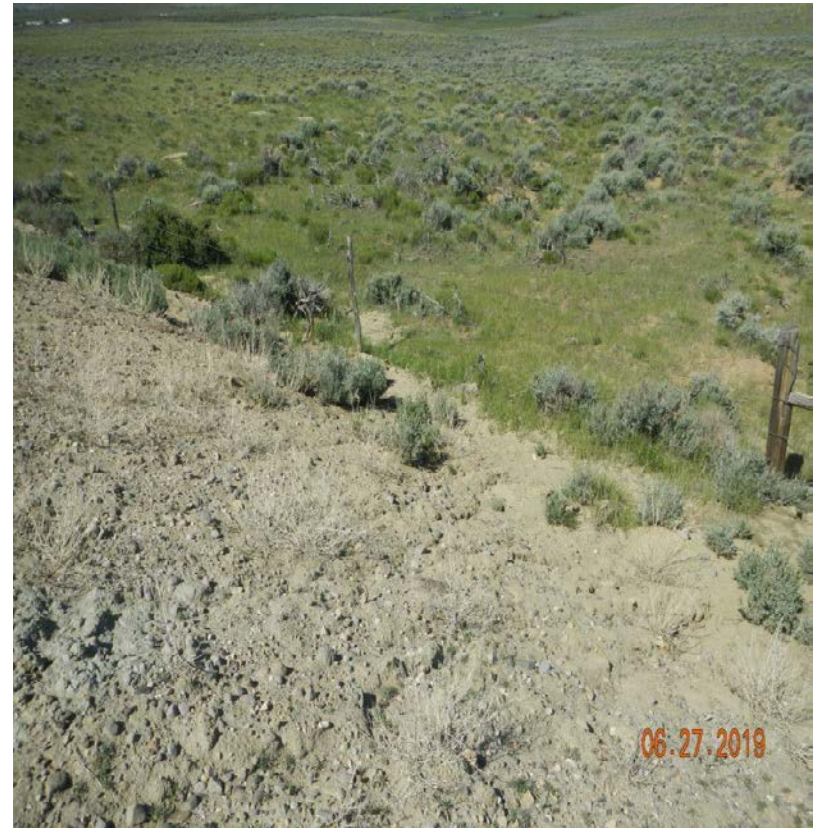
**Photo#11:**

BMPs are not installed along base of west fill slope;  
sediment migration occurring.

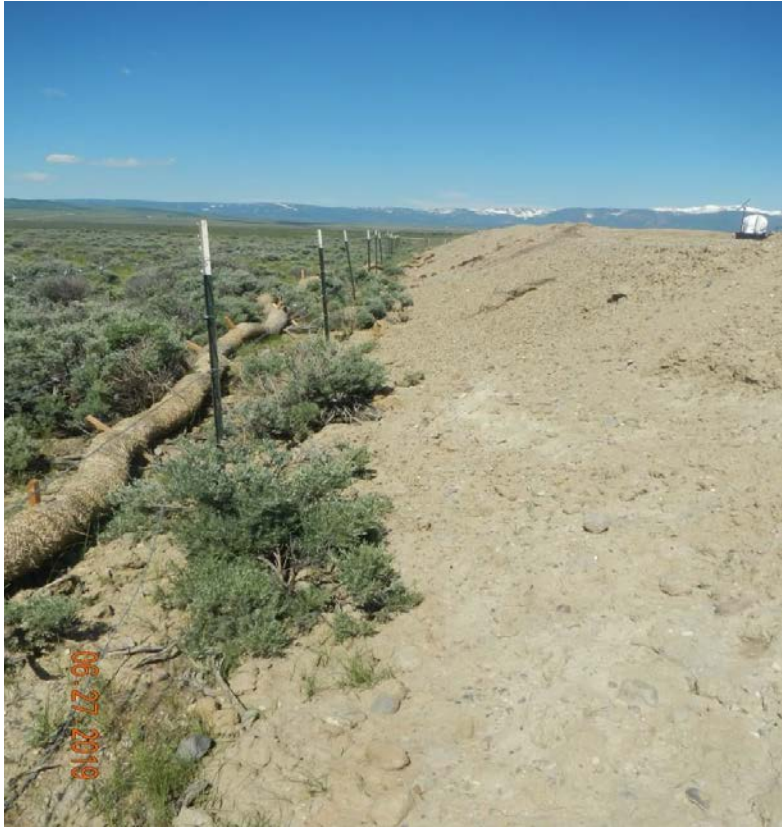
Photo#12:  
Wattles installed on perimeter of new construction need maintenance.

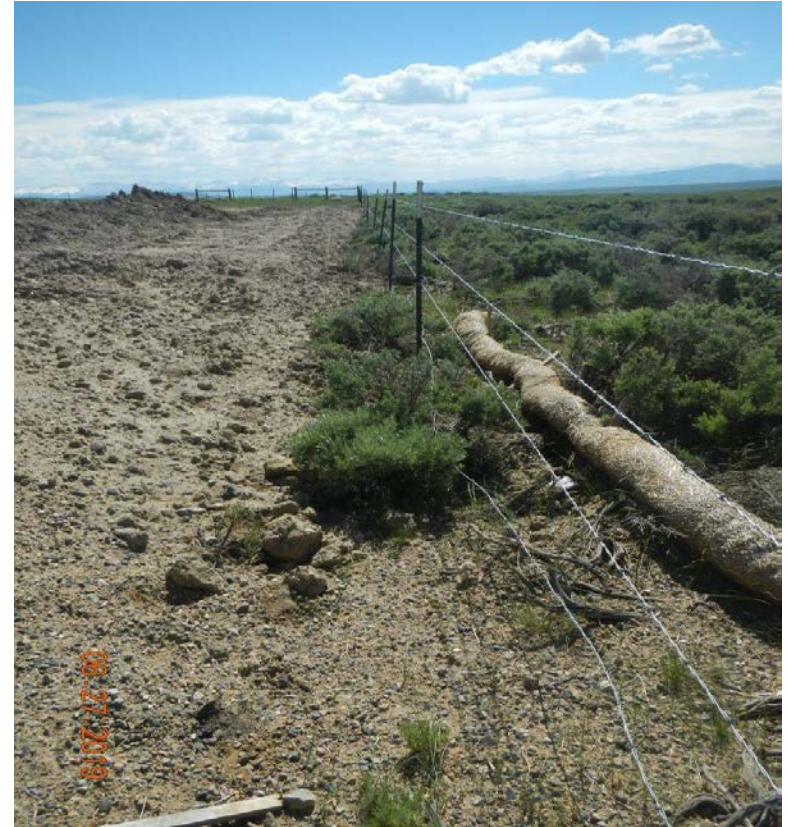
Photo#13:  
Wattles installed on perimeter of new construction need maintenance.

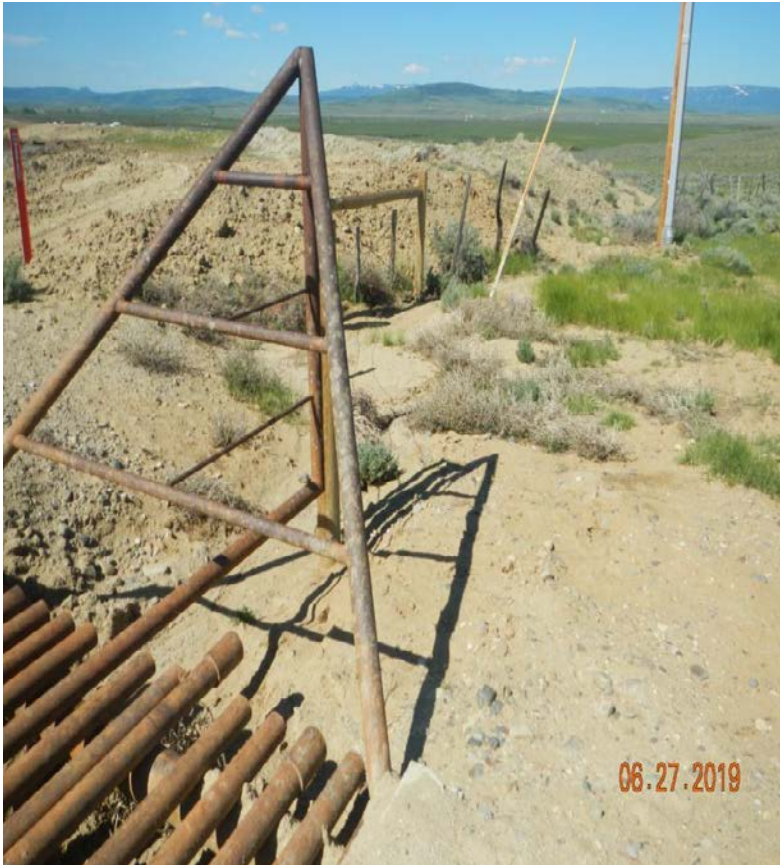
Photo#14:  
Lack of BMPs at Cattle guard entry.

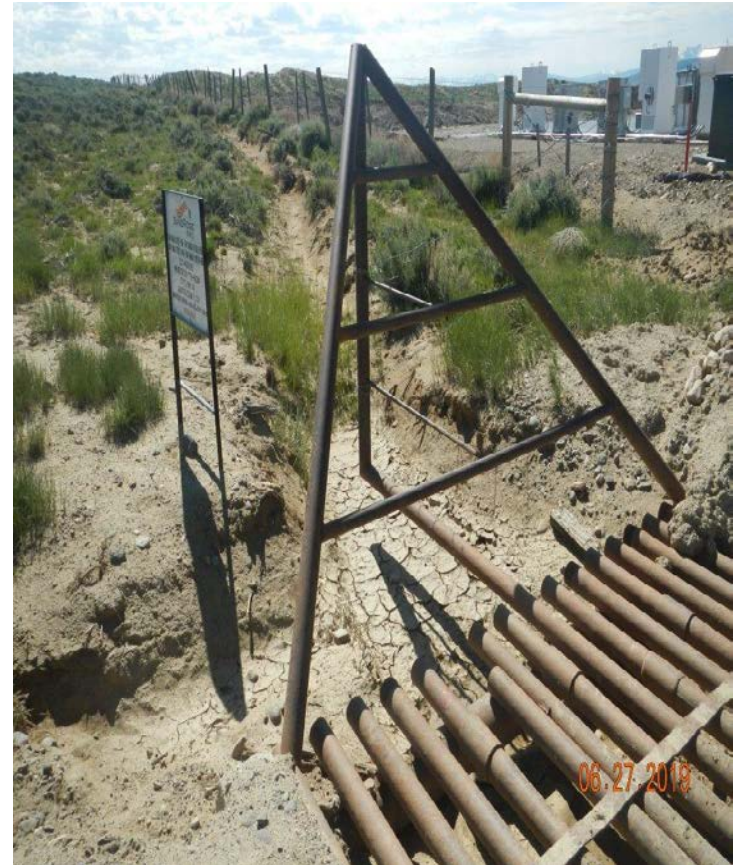
Photo#15:  
Lack of BMPs at Cattle guard entry

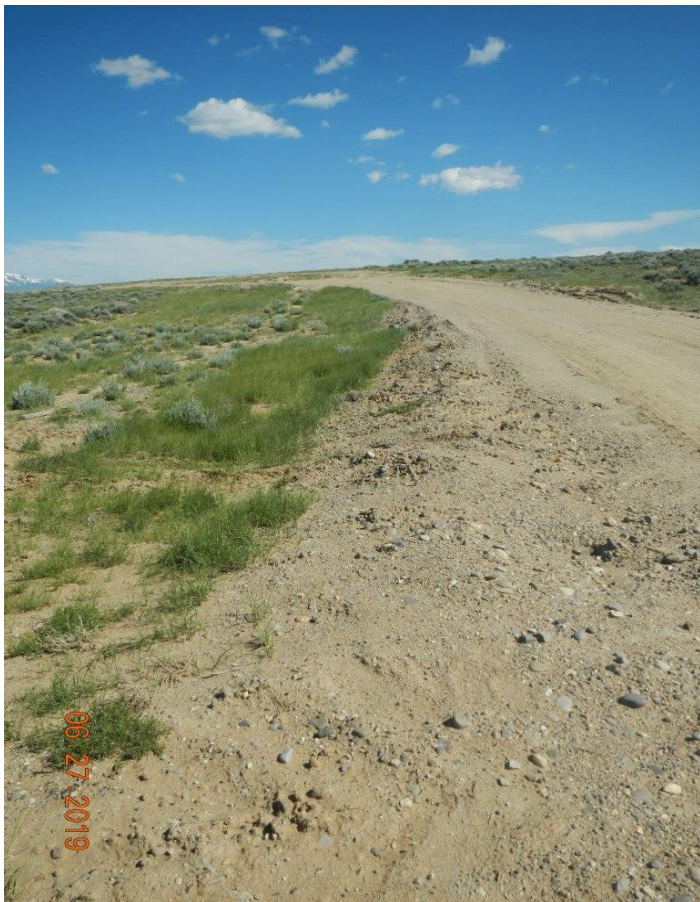
Photo#16:  
Lack of BMPs along access road

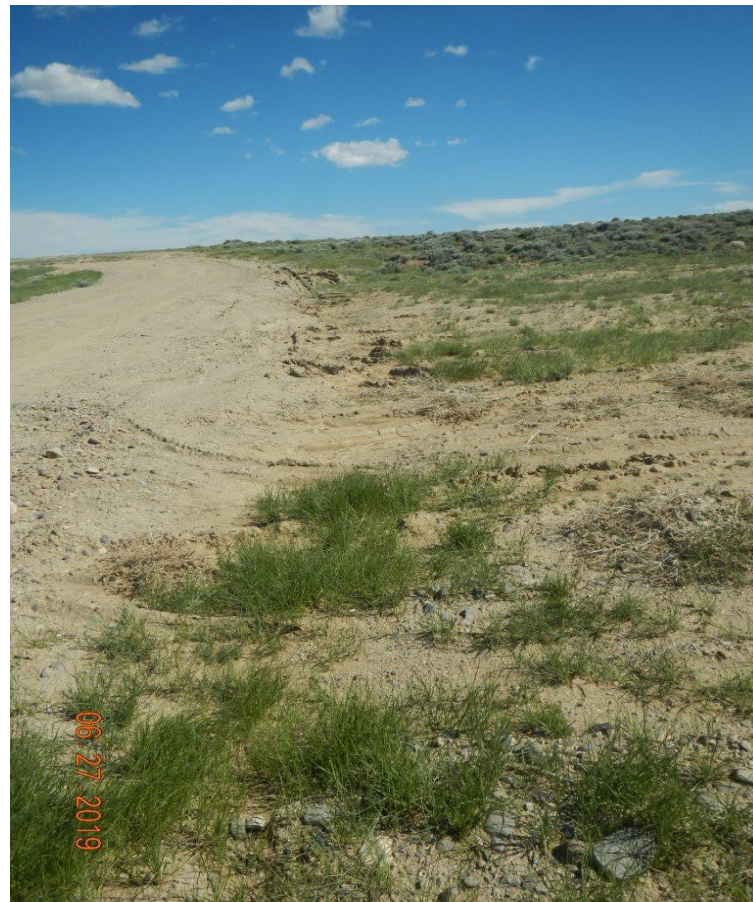
Photo#17:  
Lack of BMPs along access road.

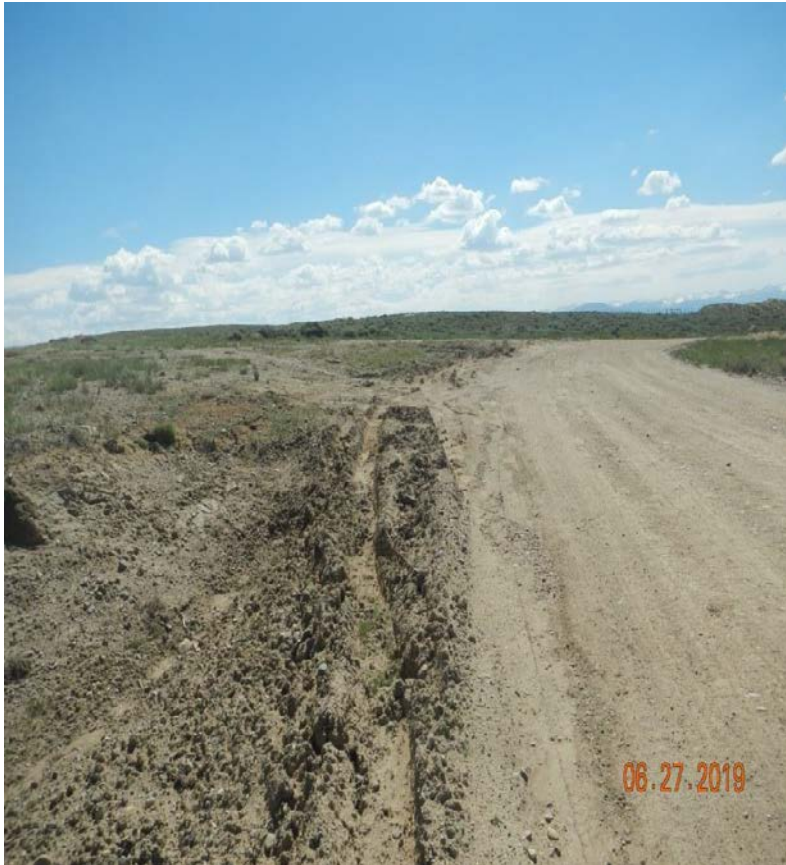
Photo#18:  
Lack of BMPs along access road.

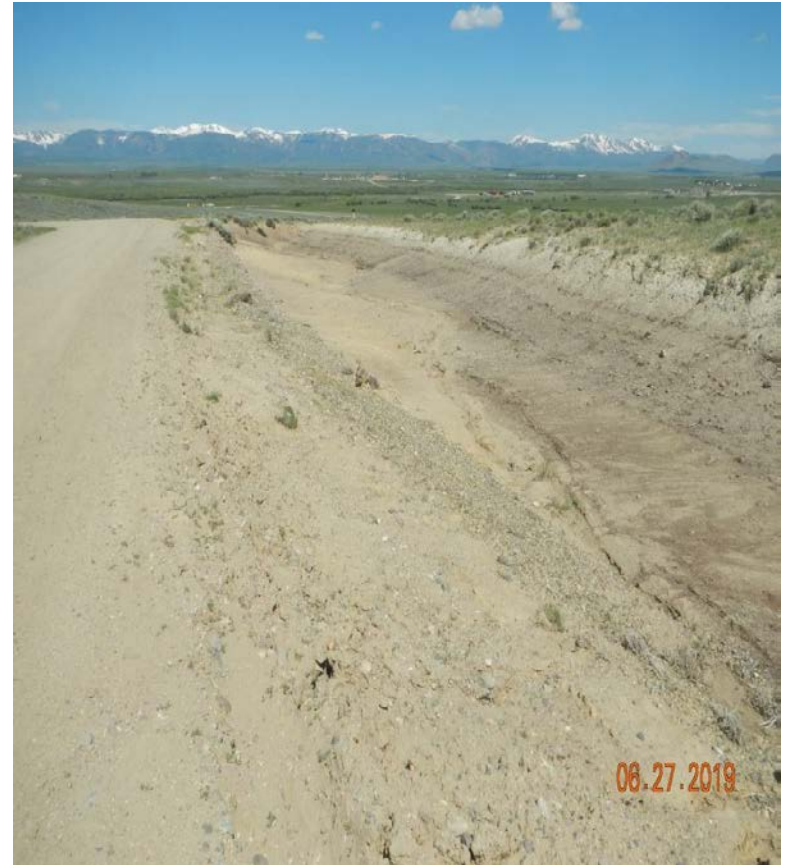
Photo#19:  
Lack of BMPs along access road.
