Inspection Photos

Loc#446527

Operator: Sandridge

Inspection Number: 692401144

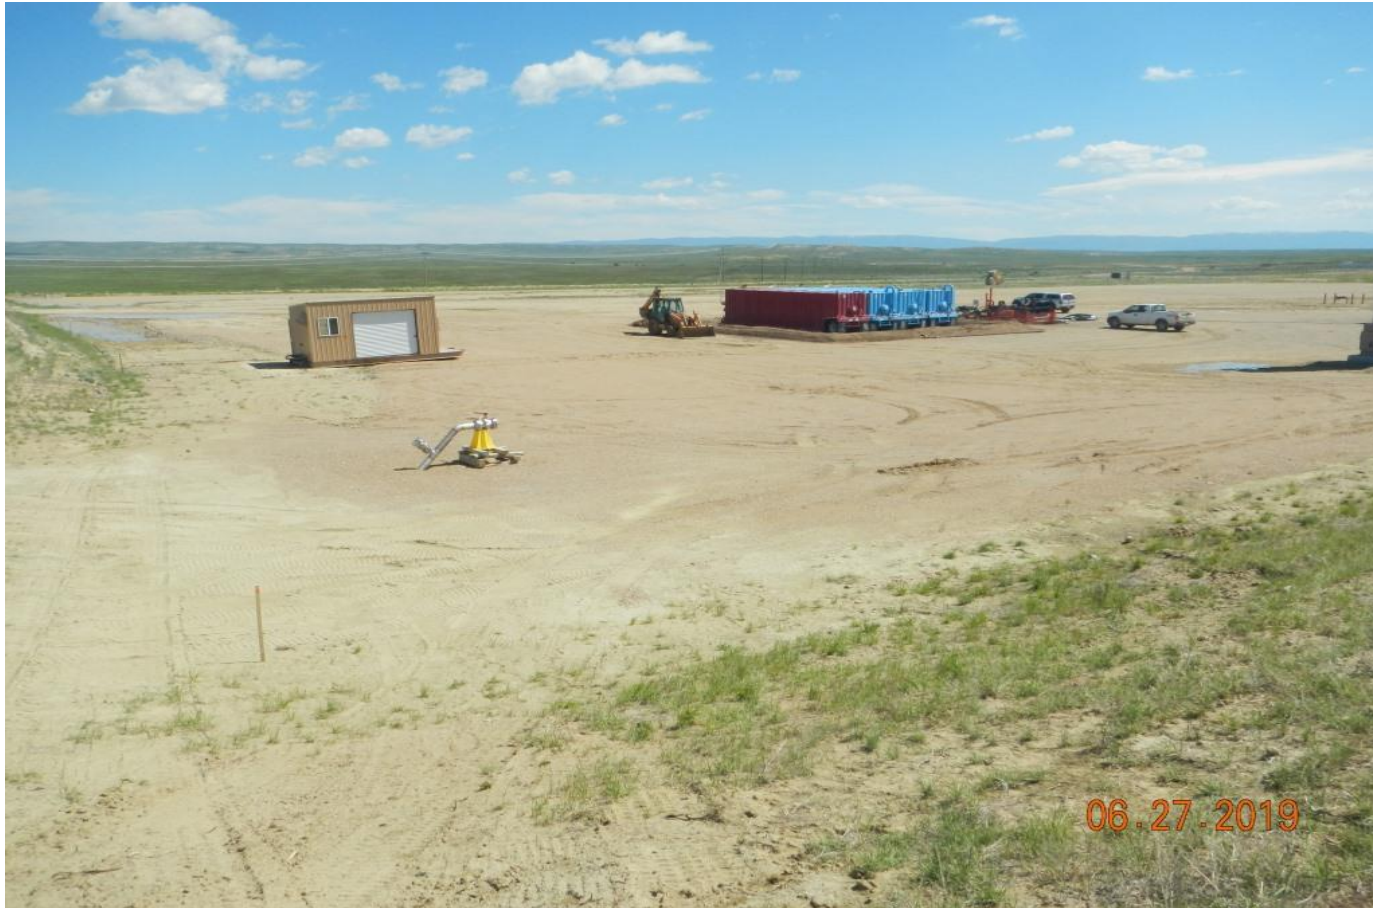
Photo#1:
Overview of Location to Northeast.

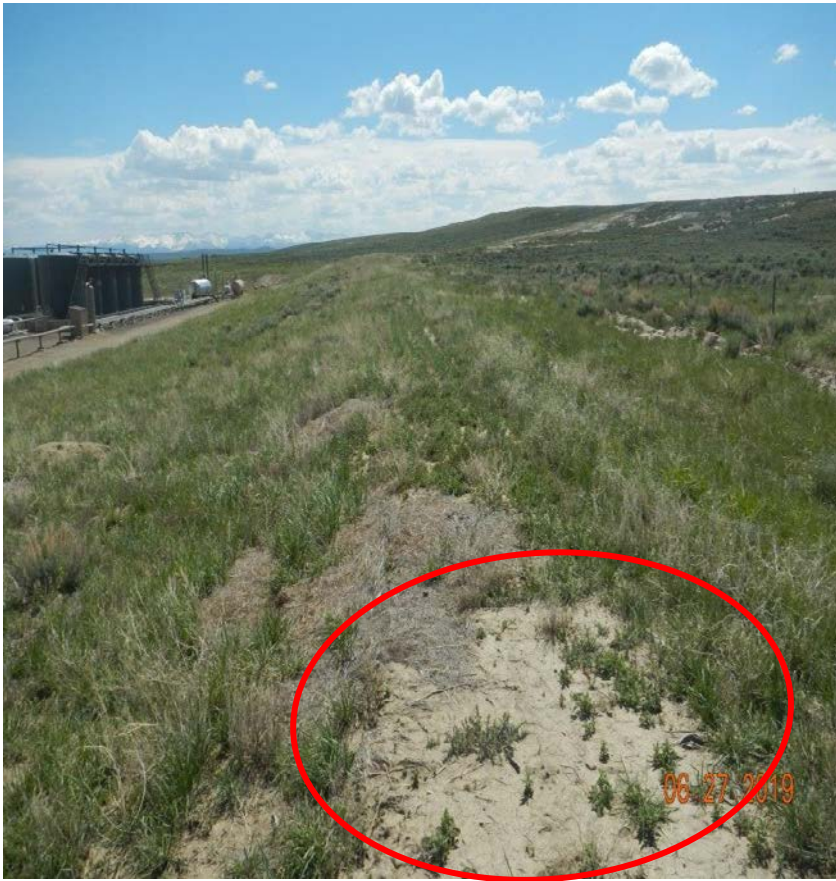
Photo#2:

Desirable vegetation is establishing on top of Cut, along topsoil berm; though Canada thistle (Noxious Weed) is also established (in foreground).

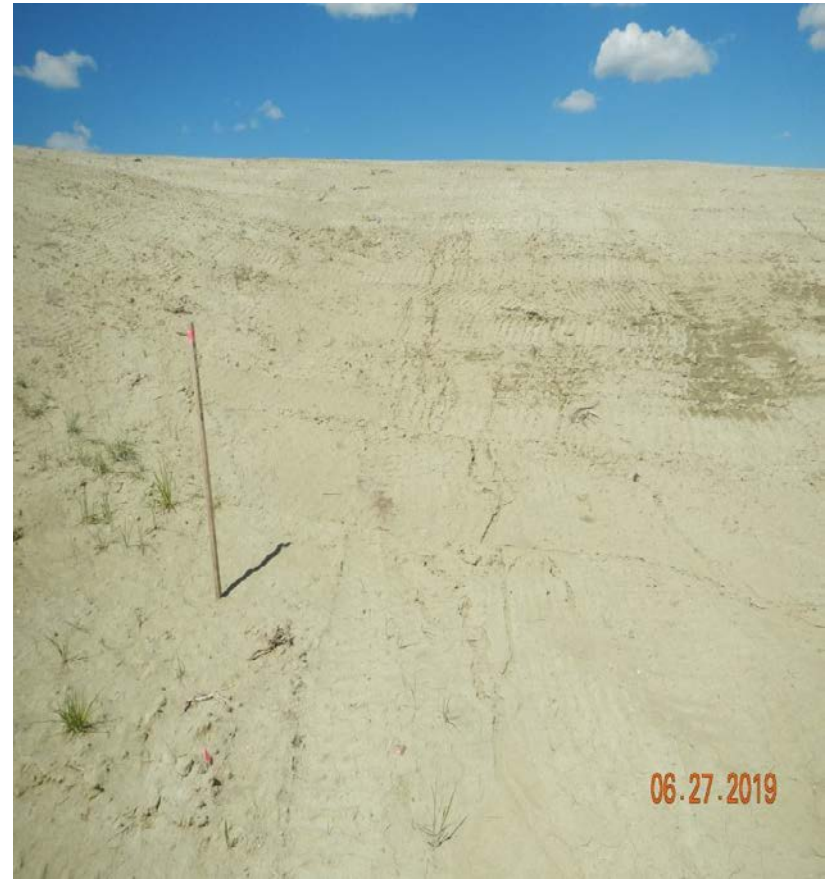
Photo#3:

Erosion initiating on Southwest corner of Cut slope.

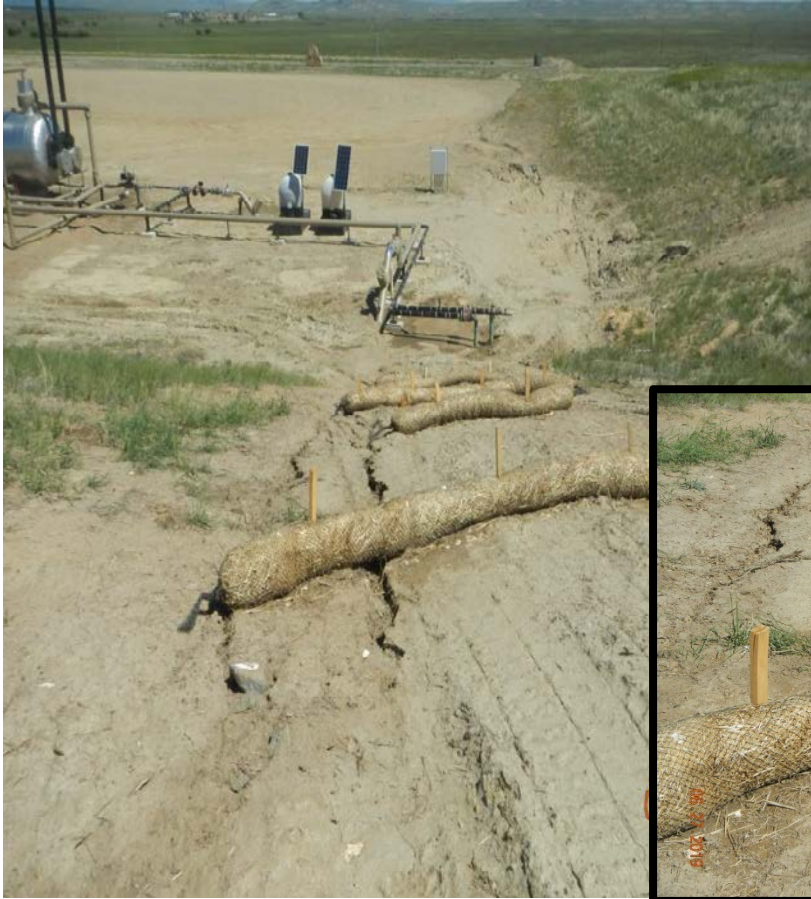
Photo#4:
BMPS have failed; erosion occurring on Southeast corner of cut slope. Note undercutting of improperly seated wattles.

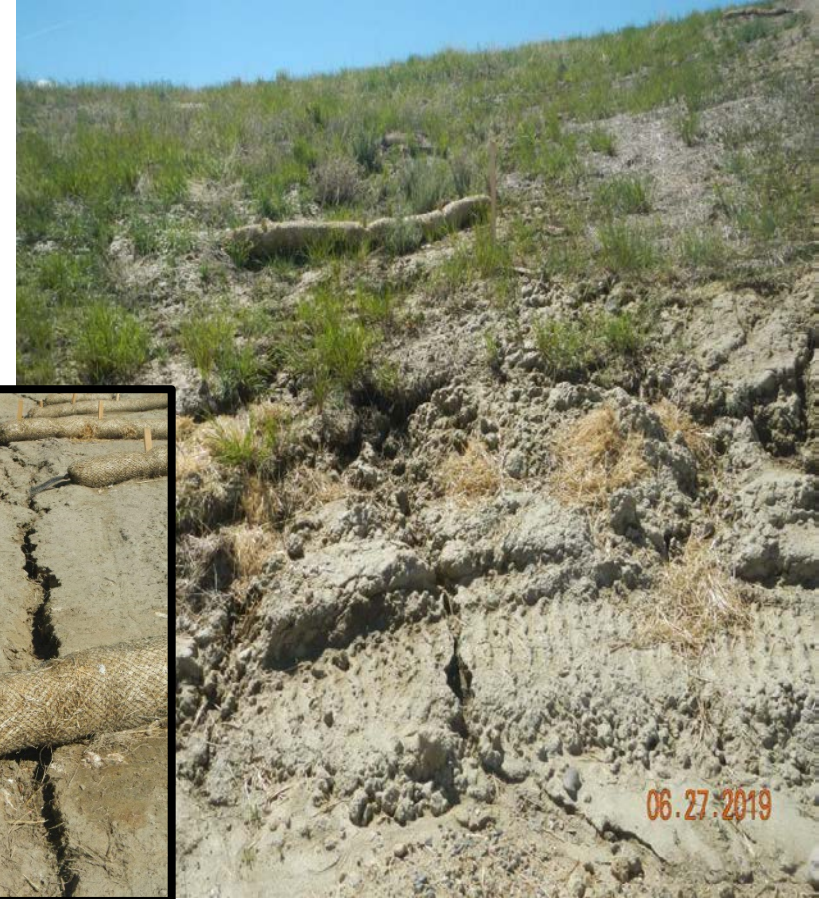
Photo#5:
BMPS have failed; erosion occurring on Southeast corner of cut slope.

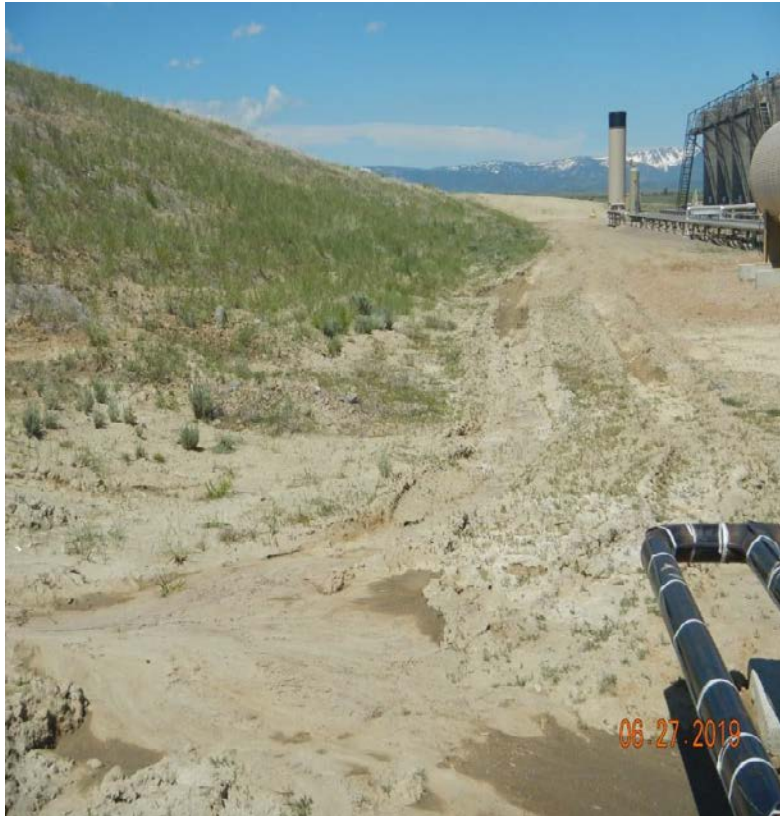
Photo#6:
Sediment run-on, degradation of site still occurring behind equipment in Southeast corner.

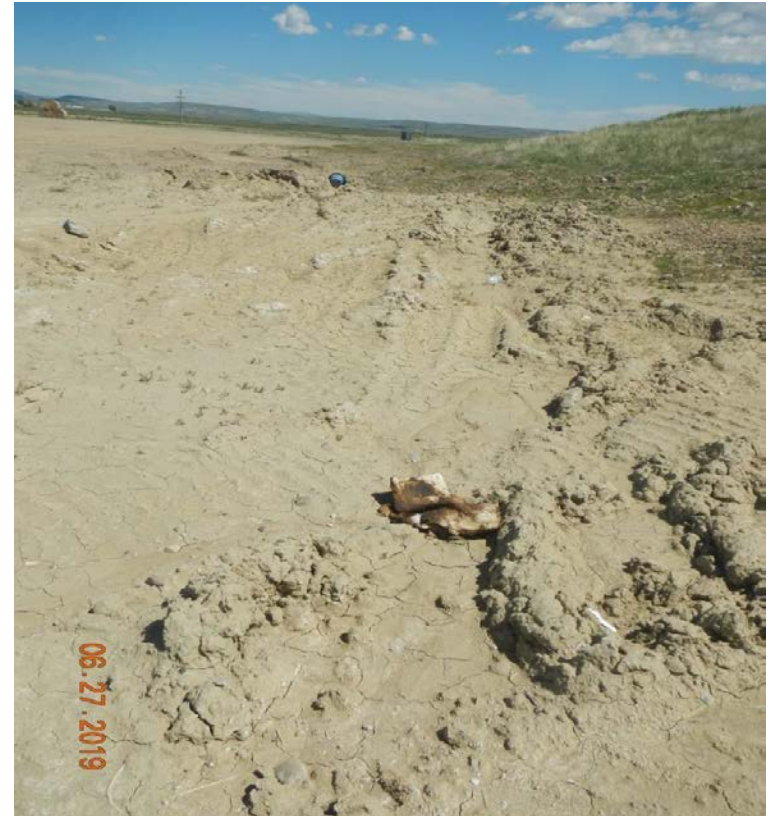
Photo#7:
Sediment run-on, degradation of site still occurring behind equipment in Southeast corner.

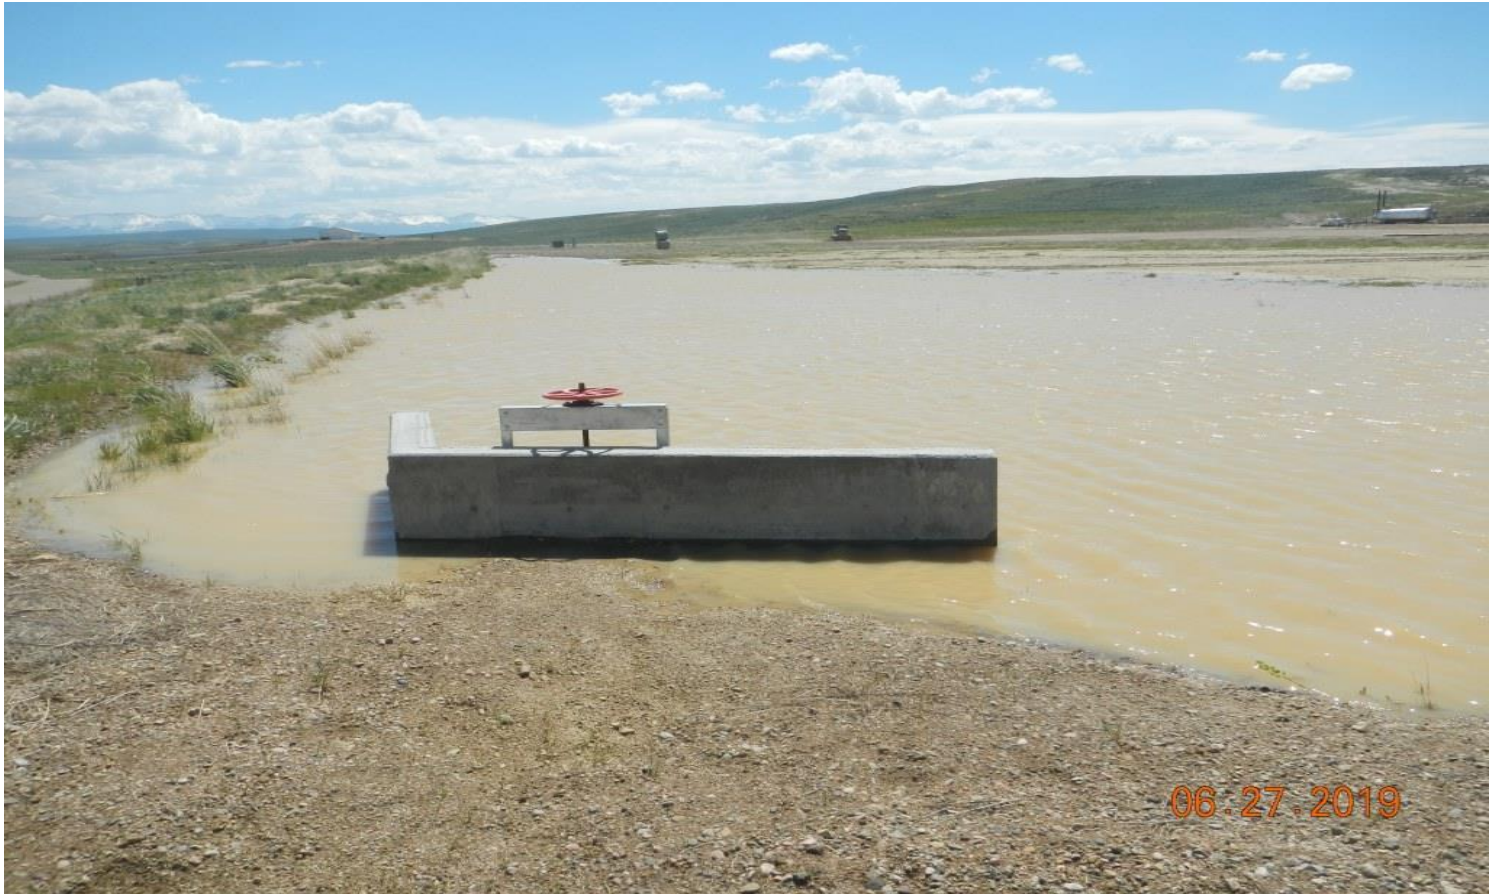
Photo#8:
Weir installed at Northwest corner retaining Stormwater.

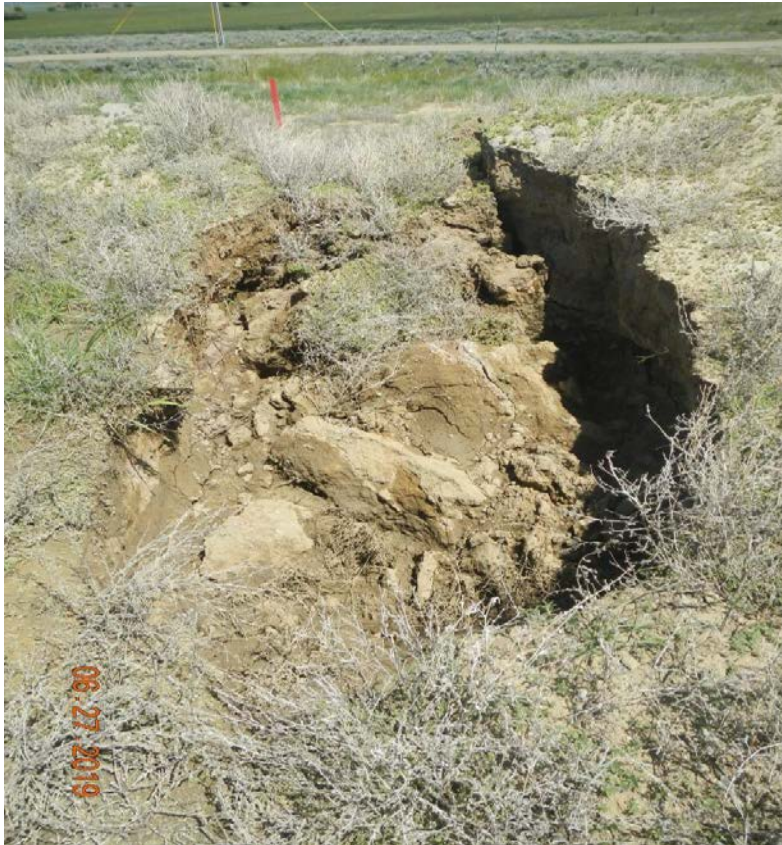
Photo#9:
Washout at Northeast corner of fill slope; from
top of slope.

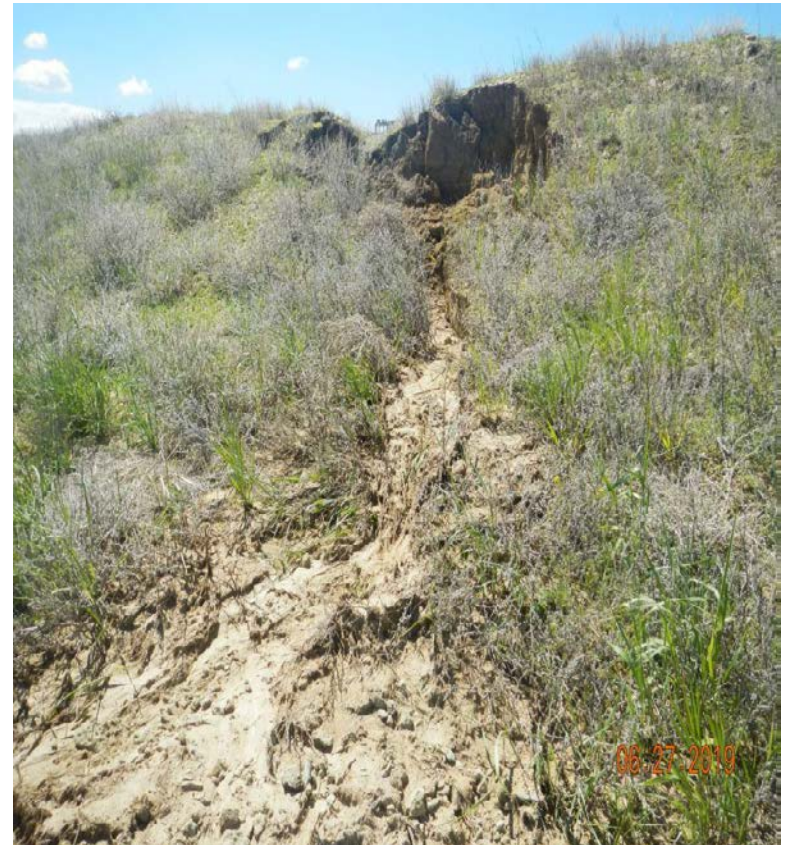
Photo#10:
Washout at Northeast corner of fill slope; from
base of slope to top.
