**Inspection Photos**  
**Location Name: Jolley-66S91W 21NENW**  
**Location ID: #335514**  
**Inspection Date: July 11, 2019**

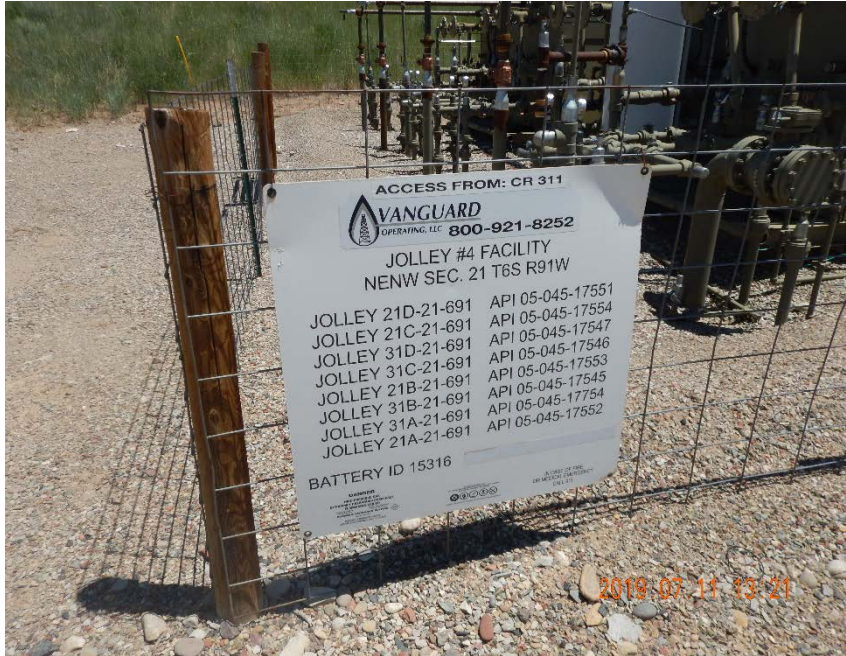
**Photo #1 – Facility sign.**

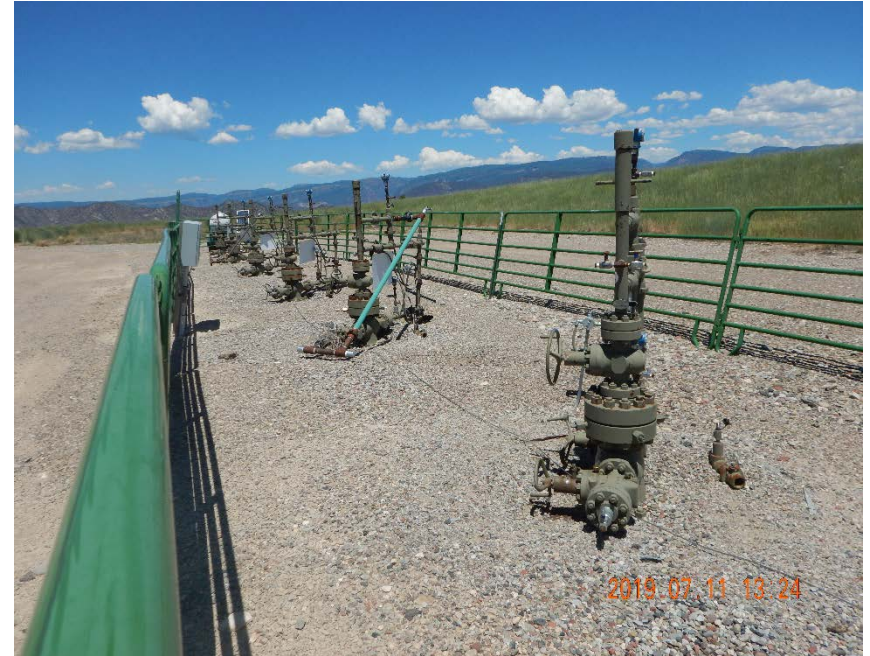
**Photo #2 – View of wellheads from southeast.**

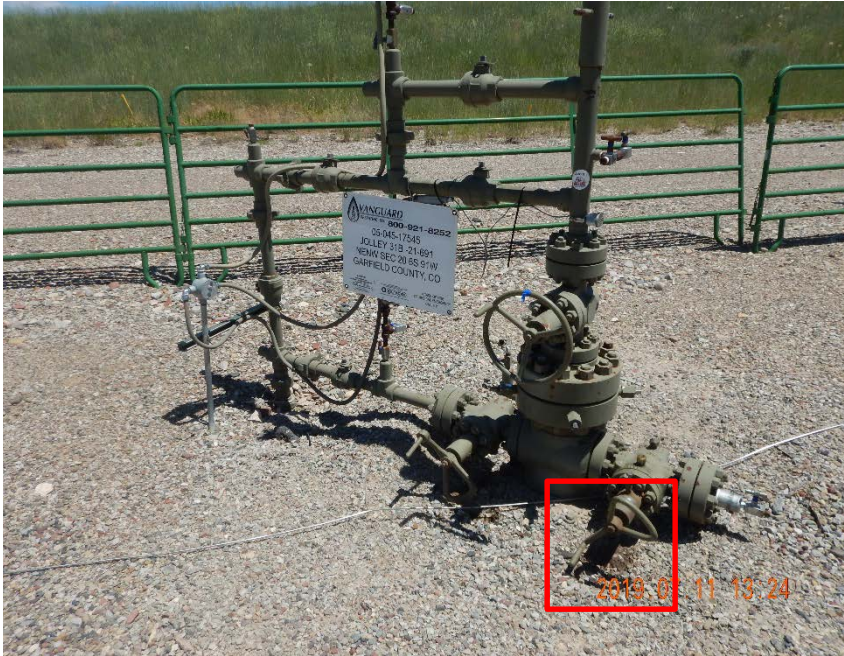
**Photo #3 – Jolley 31B-21-691 wellhead. Note localized accumulation of oil-stained material beneath valve.**

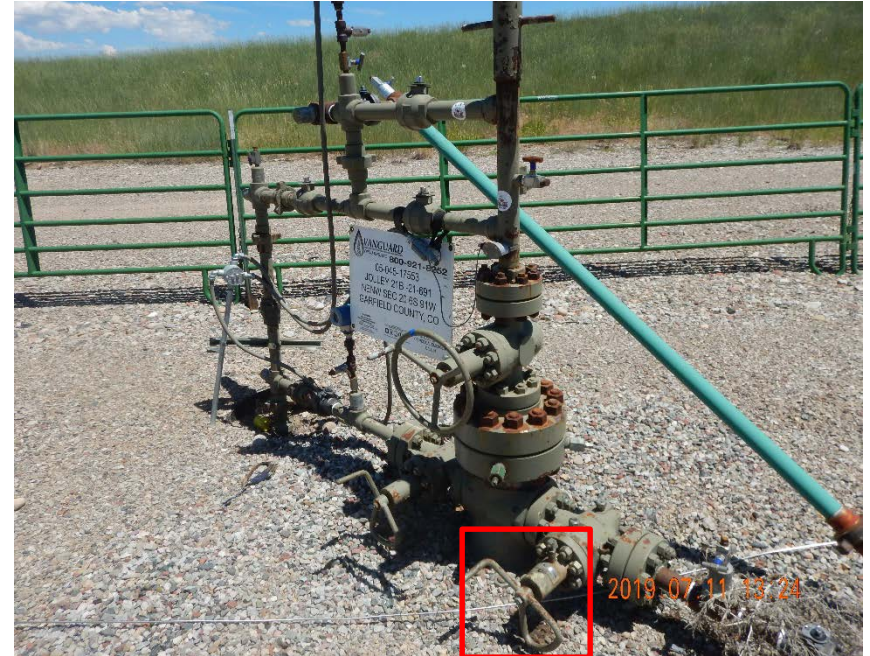
**Photo #4 - Jolley 21B-21-691 wellhead. Note localized accumulation of oil-stained material beneath valve.**

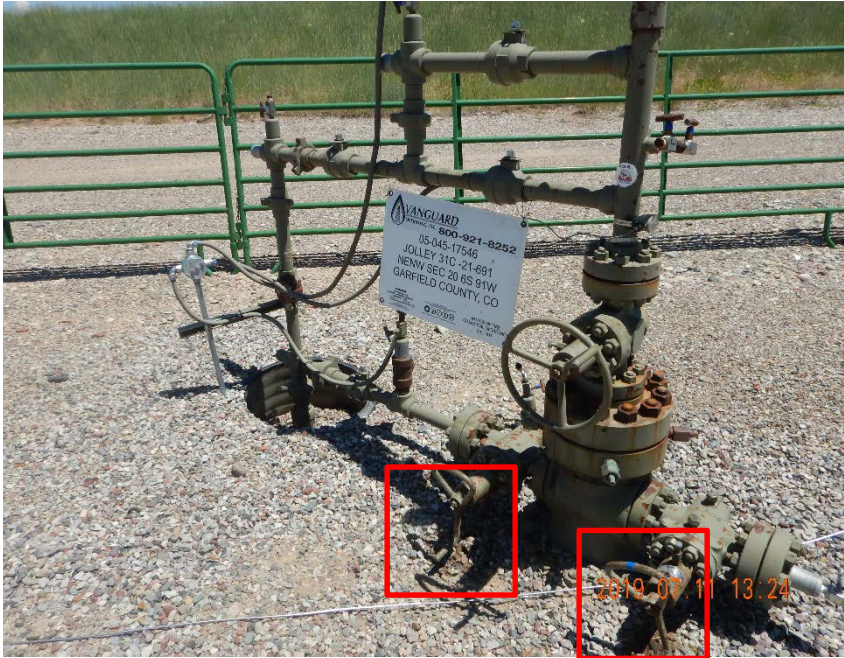
**Photo #5 - Jolley 31C-21-691 wellhead. Note localized accumulation of oil-stained material beneath valves.**

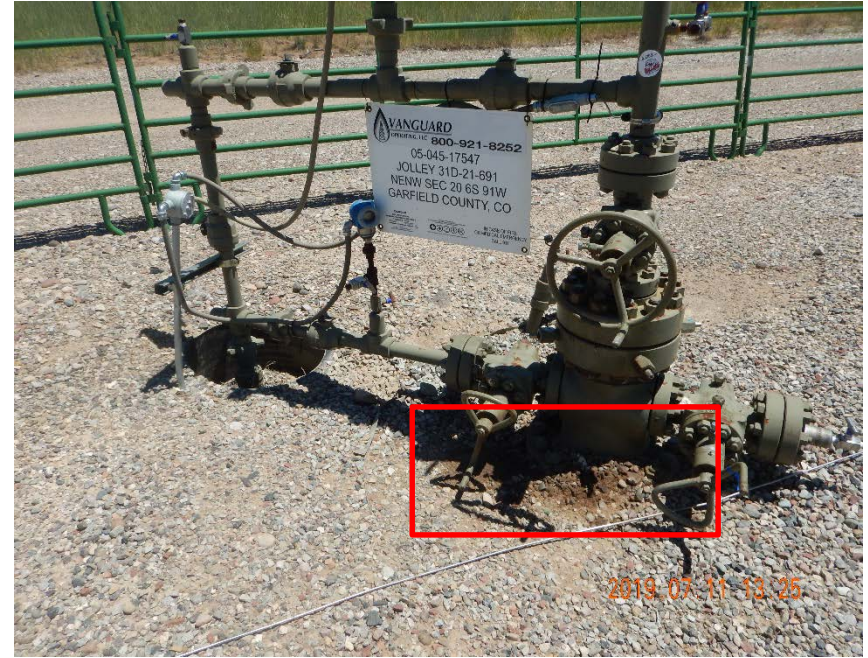
**Photo #6 - Jolley 31D-21-691 wellhead. Note localized accumulation of oil-stained material beneath wellhead.**

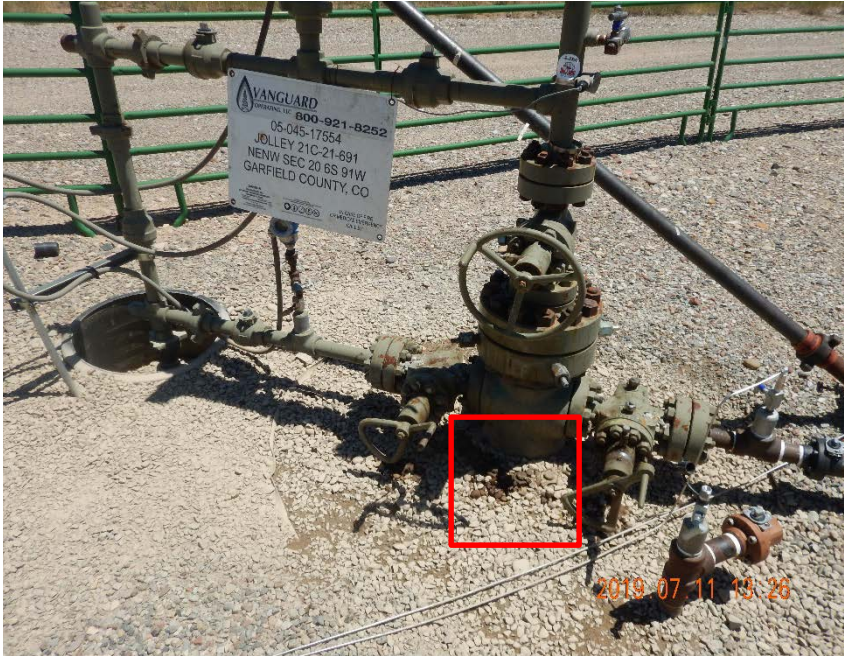
**Photo #7 - Jolley 21C-21-691 wellhead. Note localized accumulation of oil-stained material beneath wellhead.**

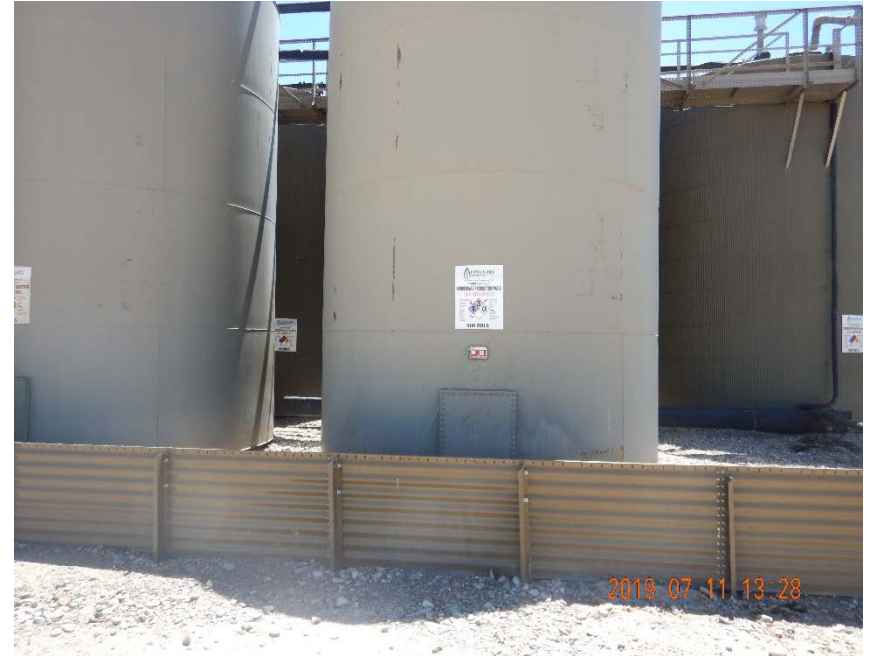
**Photo #8 – View of tank battery in southwest corner of pad (from north).**

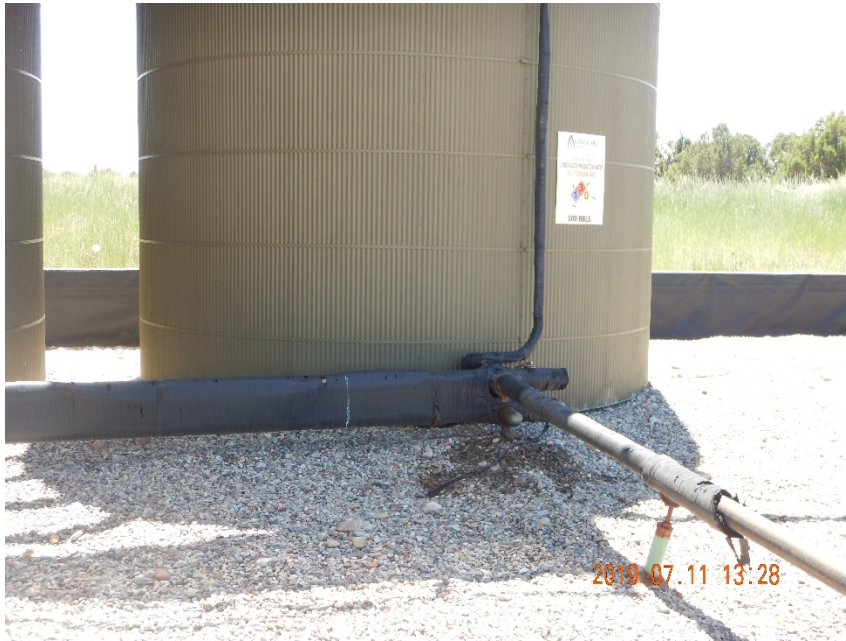
**Photo #9 – Localized accumulation of oil-stained material beneath valve on southwest condensate/produced water AST.**

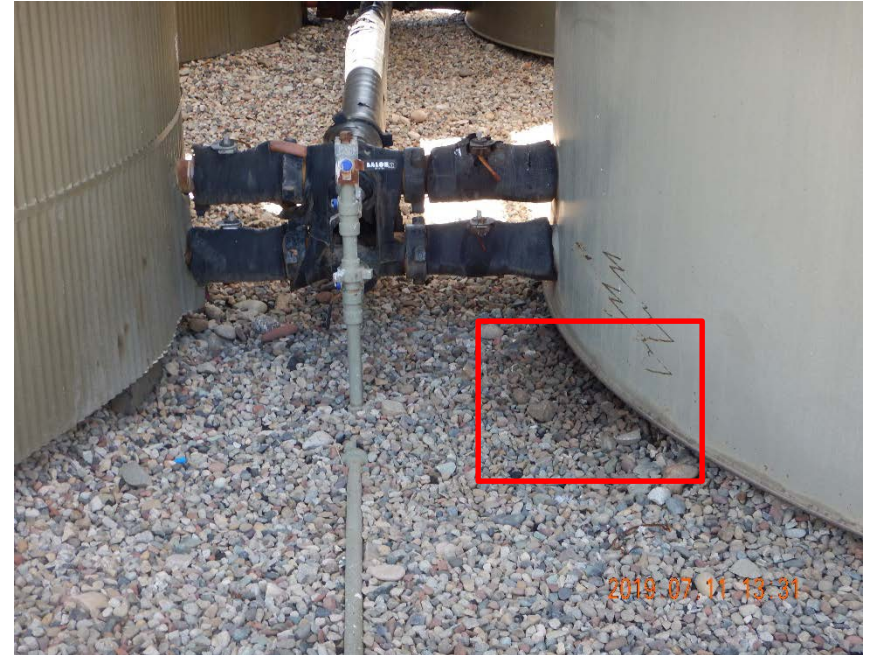
**Photo #10 - Localized accumulation of oil-stained material beneath south side of northeast condensate/produced water AST.**

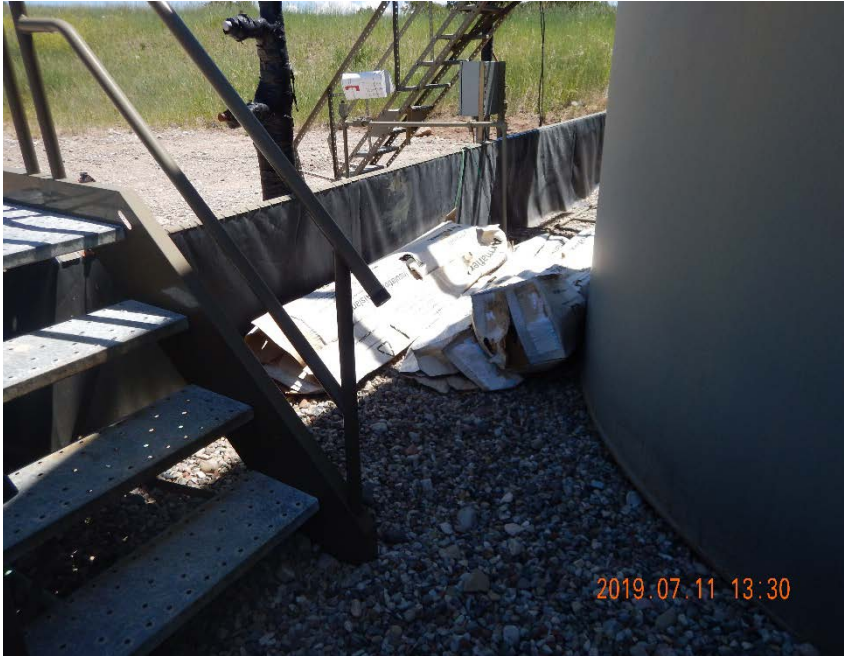
**Photo #11 – Cardboard boxes stored inside of tank battery secondary containment.**

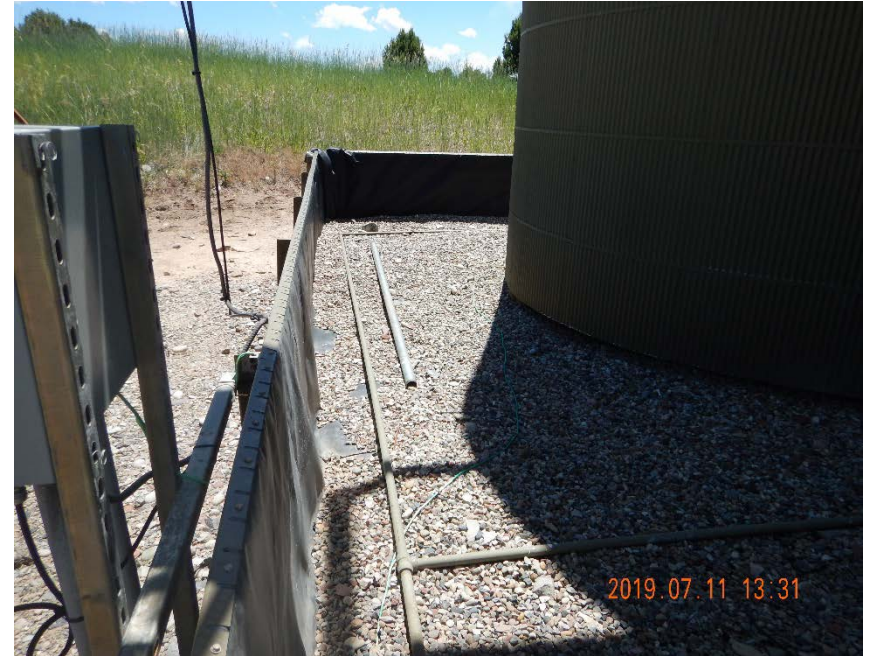
**Photo #12 – Metal pole stored inside of tank battery secondary containment.**

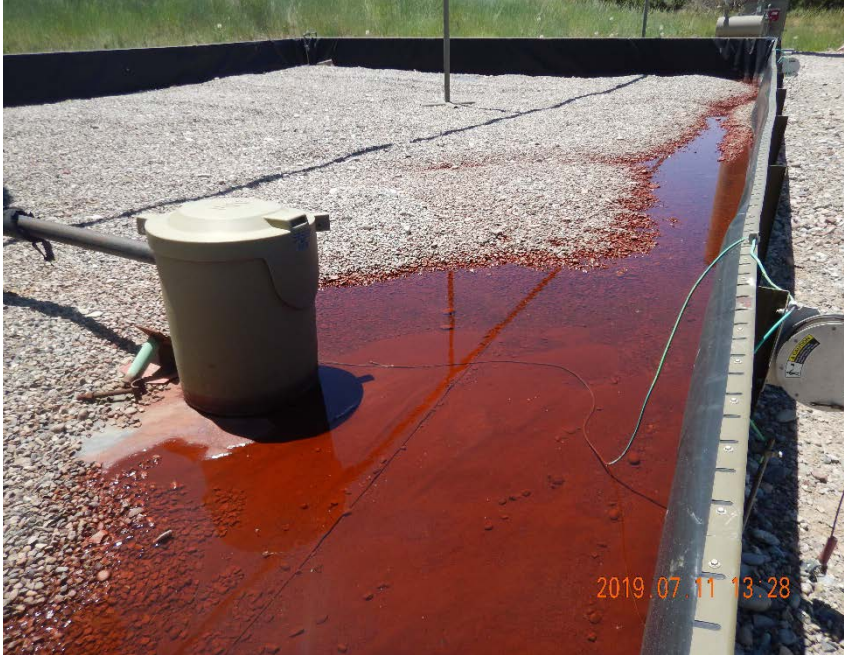
**Photo #13 – Unidentified red fluid and staining inside north side of tank battery secondary containment.**

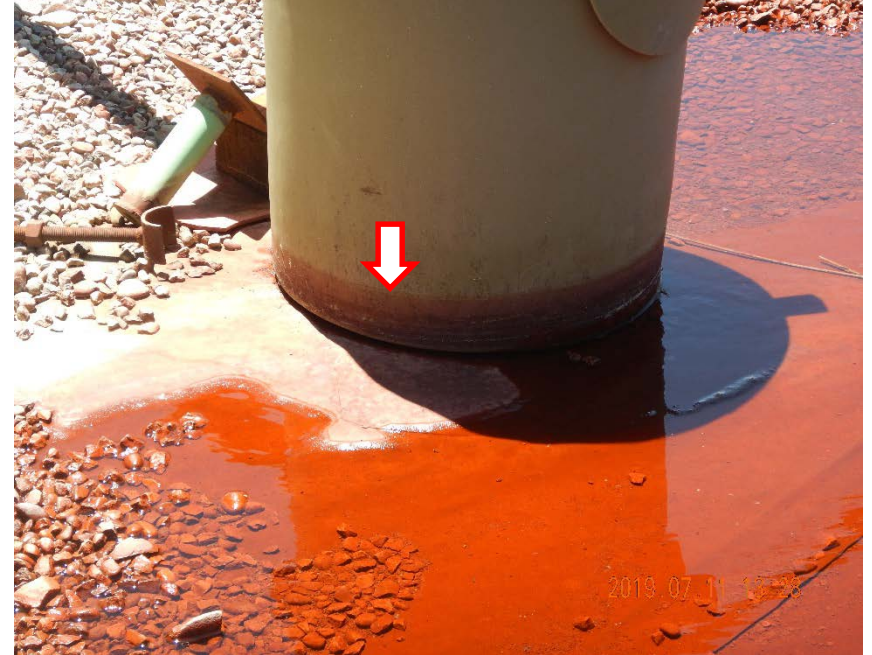
**Photo #14 – Red staining on truck loadout containment device indicates previous fluid level.**

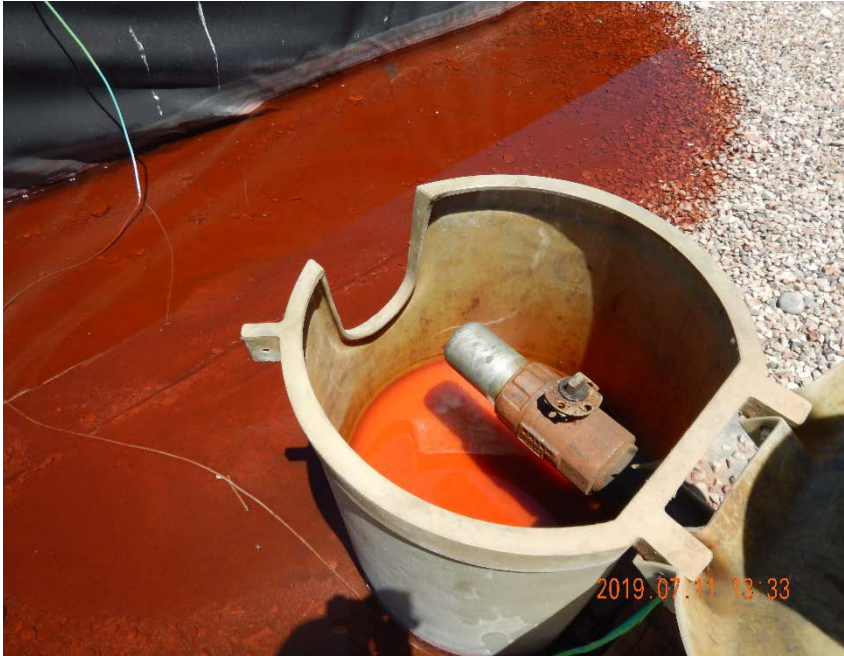
**Photo #15 – Unidentified red fluid inside of truck loadout containment device.**

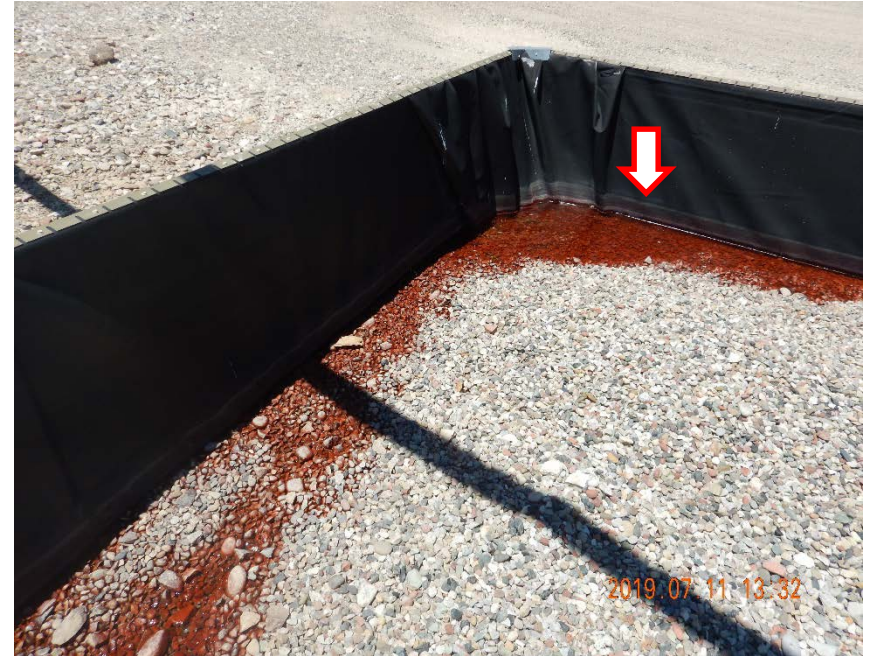
**Photo #16 – Red fluid accumulation at northwest corner of tank battery secondary containment, note staining level on liner.**
