Inspection Photos

API: 05-073-06621

Operator: PIONEER NATURAL RESOURCES

Inspection Date: 5/15/2019

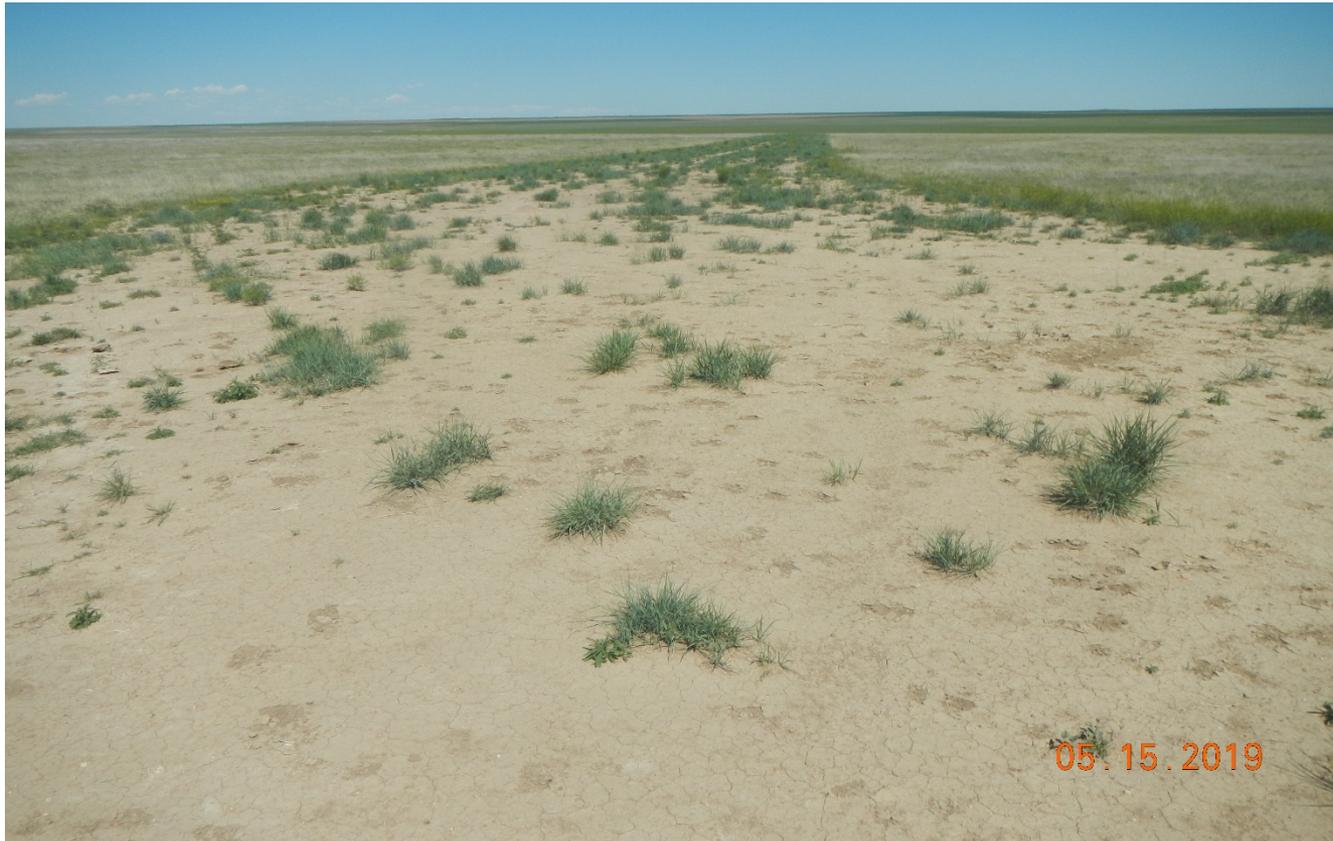
Photo 1. Facing northwest along the reclaimed access road. There are areas along the road where vegetation is not establishing. Vegetation that has established does not reflect the surrounding pasture.

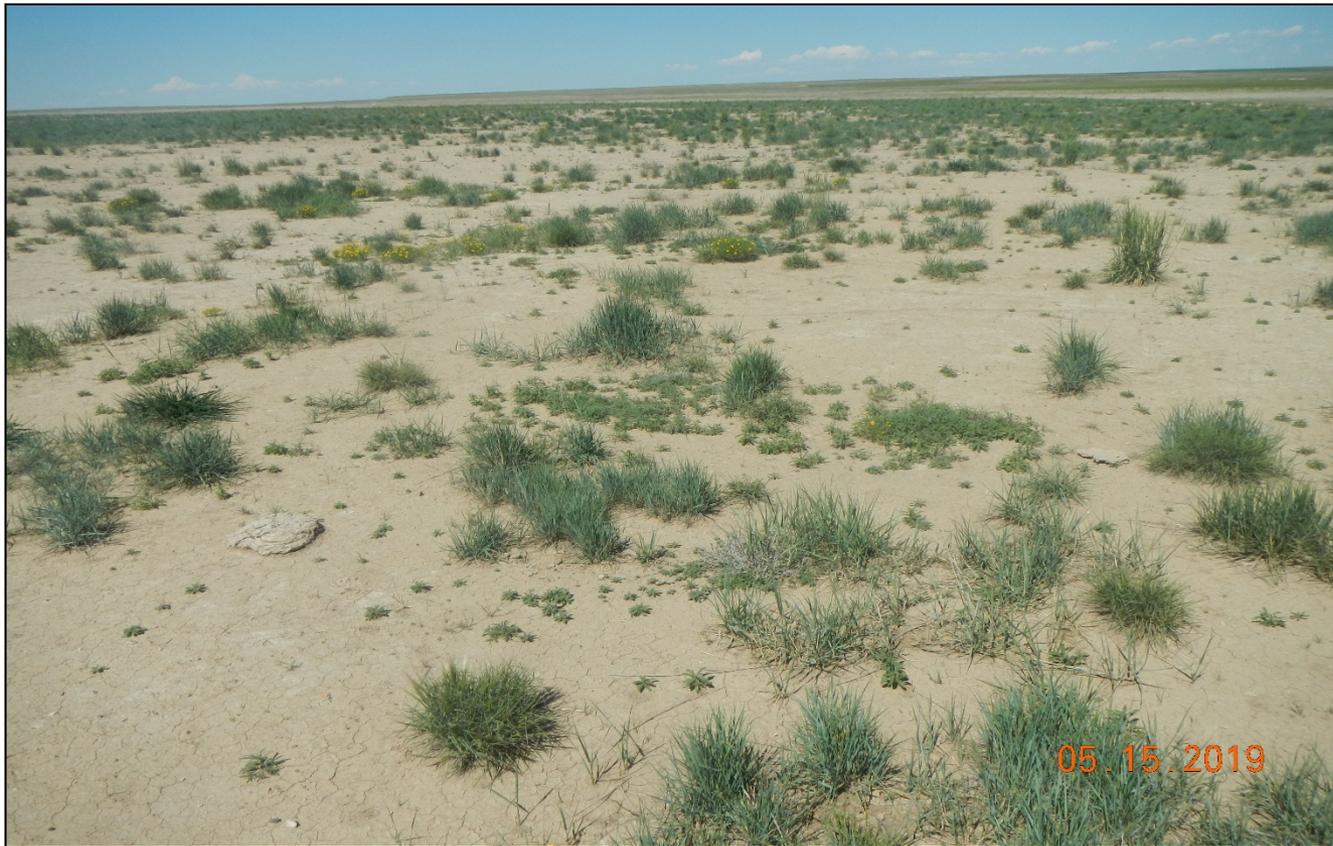
Photo 2. Facing west toward the location. Vegetation that has established does not reflect the surrounding pasture. There are areas that are bare of vegetation.

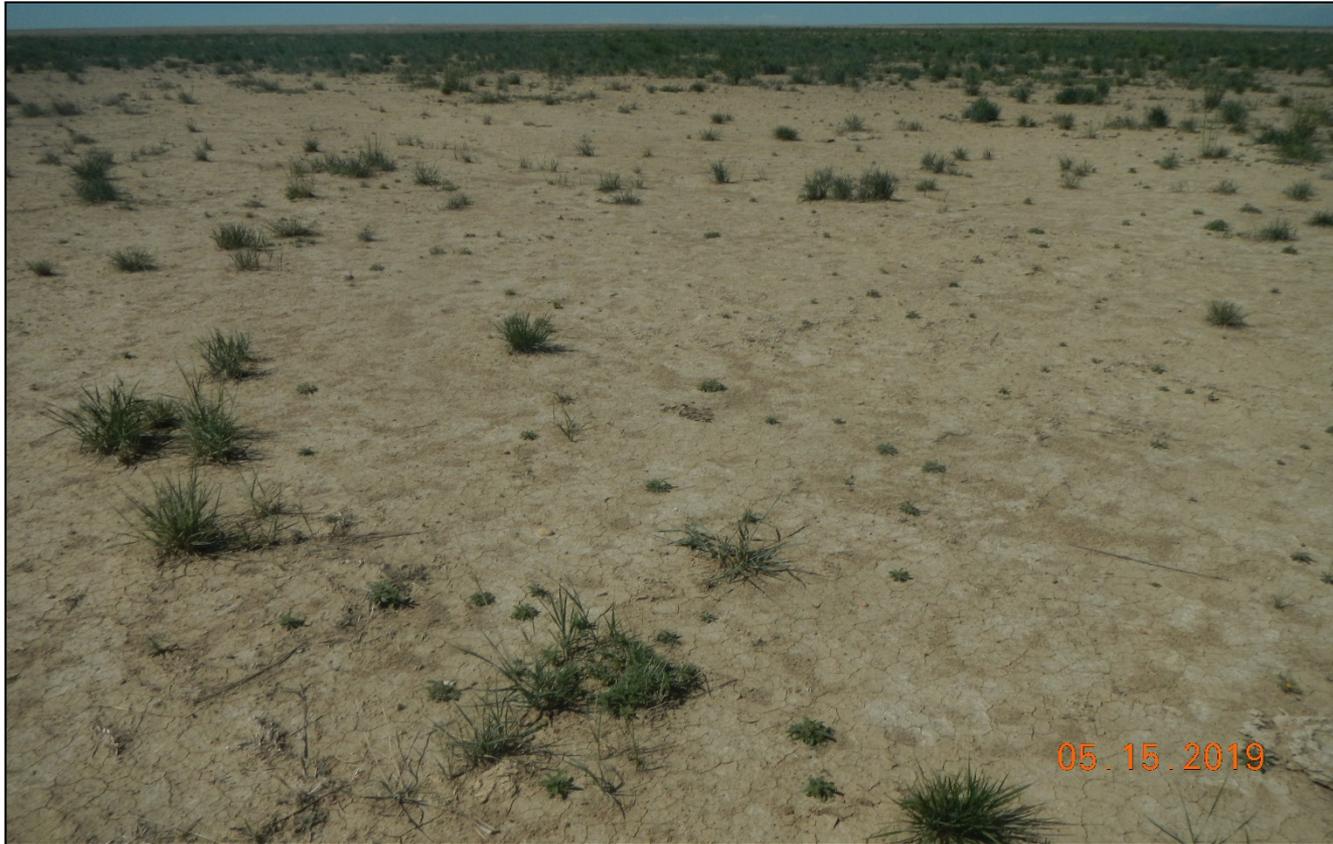
Photo 3. Facing west toward the location. Vegetation that has established does not reflect the surrounding pasture. There are areas that are bare of vegetation.

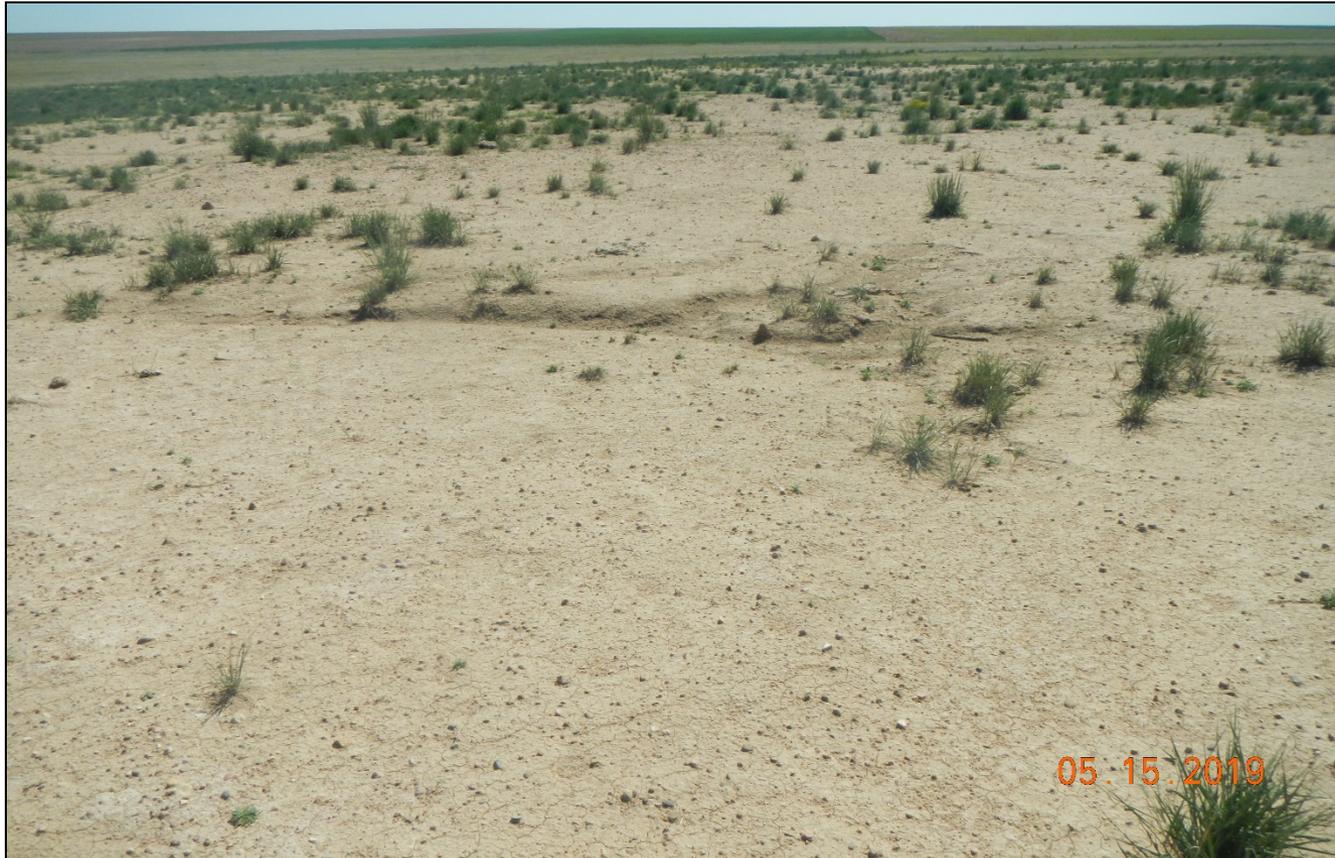
Photo 4. Facing east toward the location. Vegetation that has established does not reflect the surrounding pasture. There are areas that are bare of vegetation.

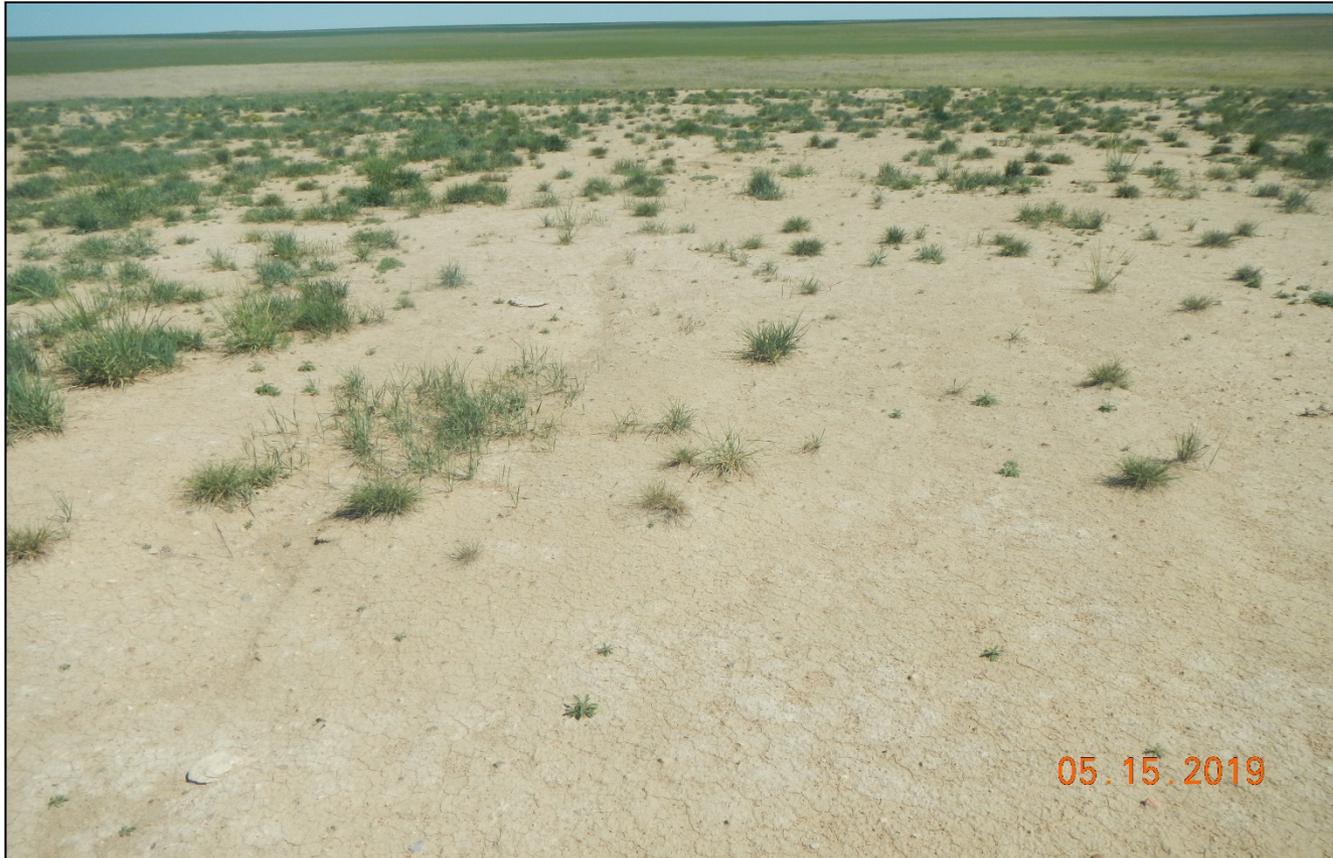
Photo 6. Facing north toward the location. Vegetation that has established does not reflect the surrounding pasture.

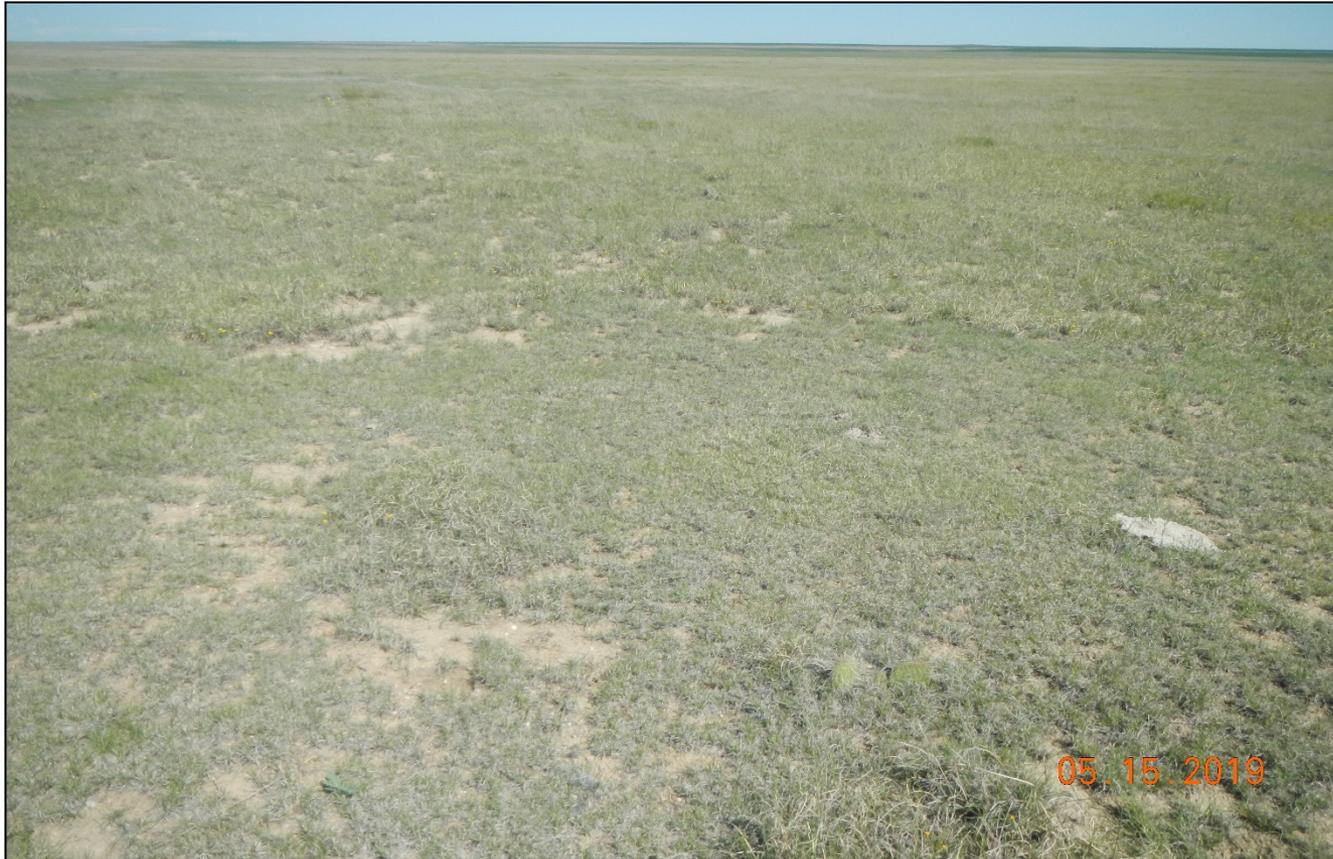
Photo 7. Facing toward the surrounding undisturbed pasture which contains Bou gra, Spo cry, Oli ari, Pas smi, among other native plants.
