Inspection Photos
Location Name: Clifford R Haller 32-11-1
Location ID: 318153

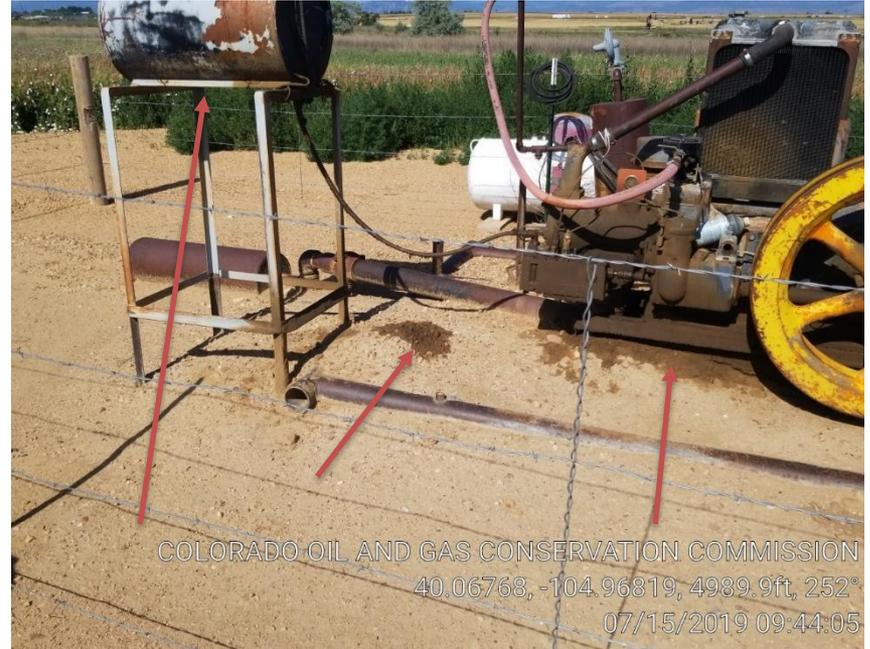
Pic 2 stained soil, no BMP

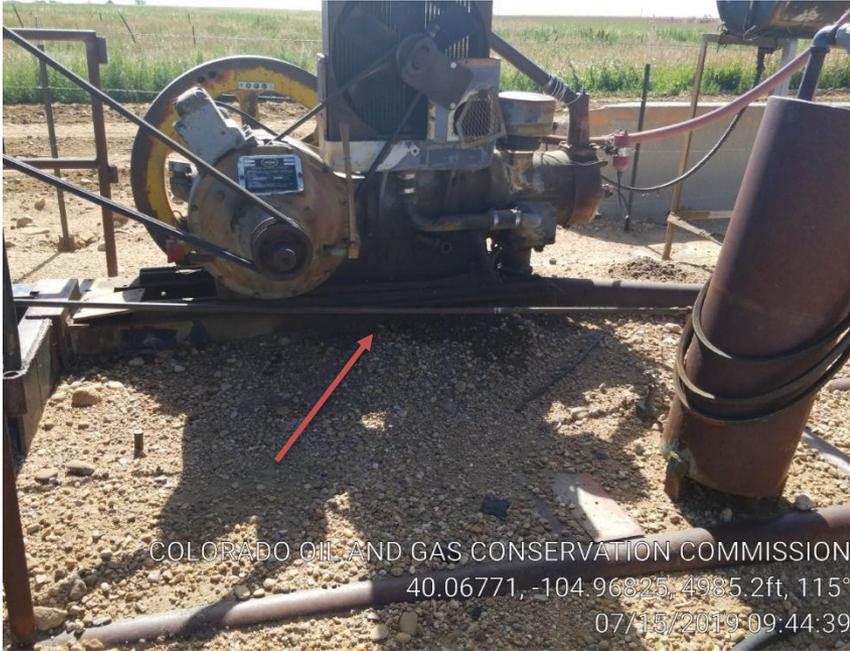
Pic 4 stained soil

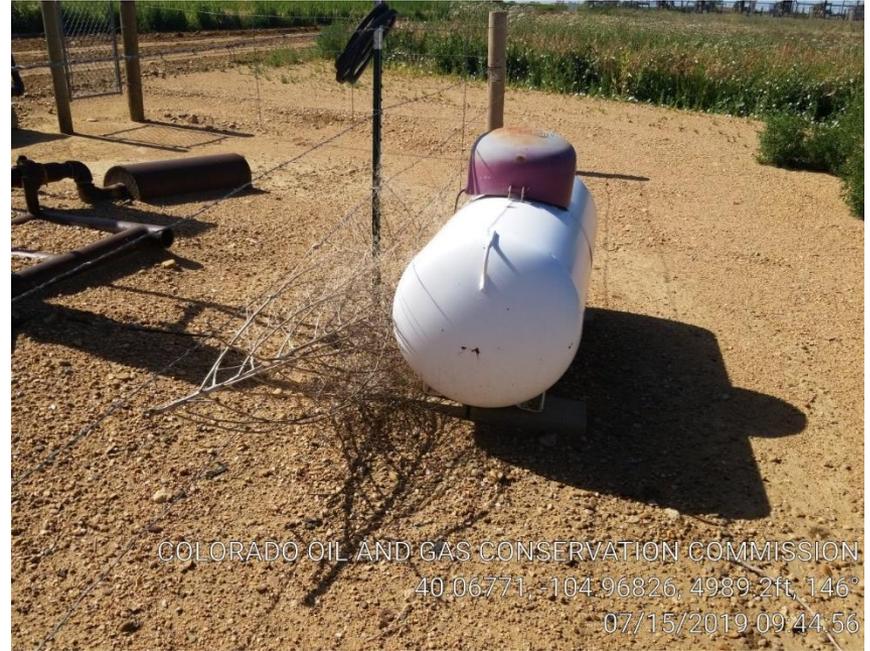
Pic 5 unused propane tank/closed

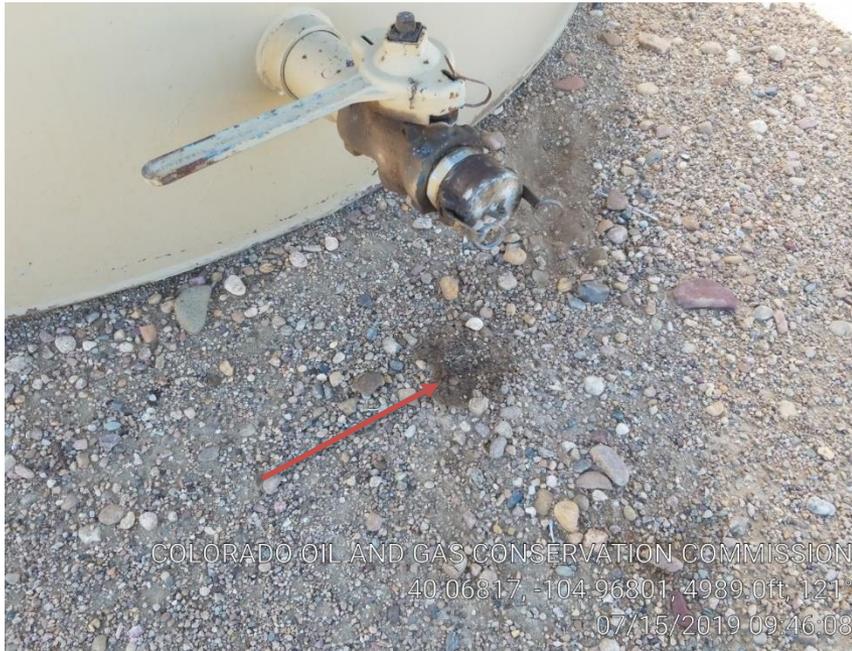
Pic 6 stained soil under load line

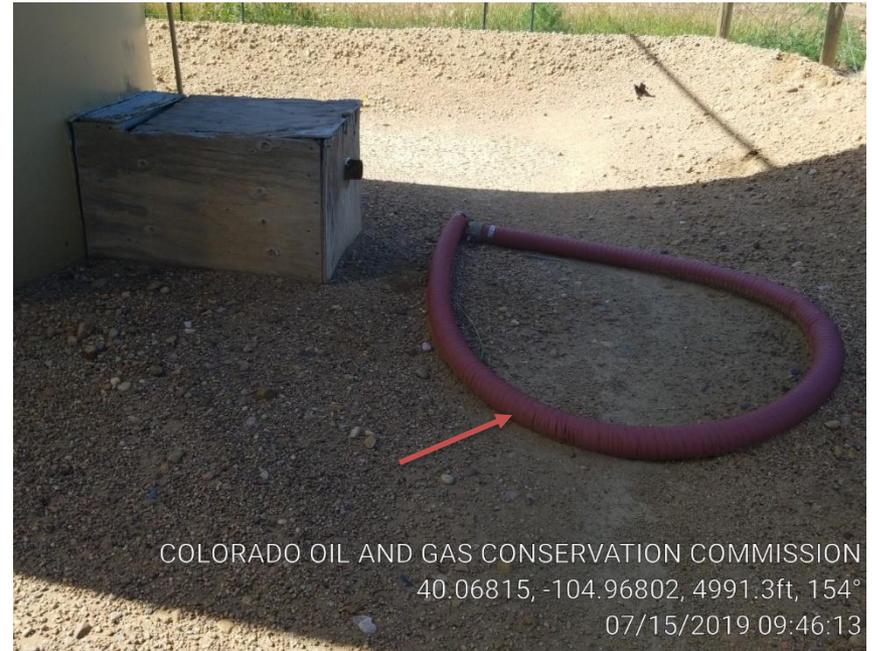
Pic 7 unused hose near tank battery.

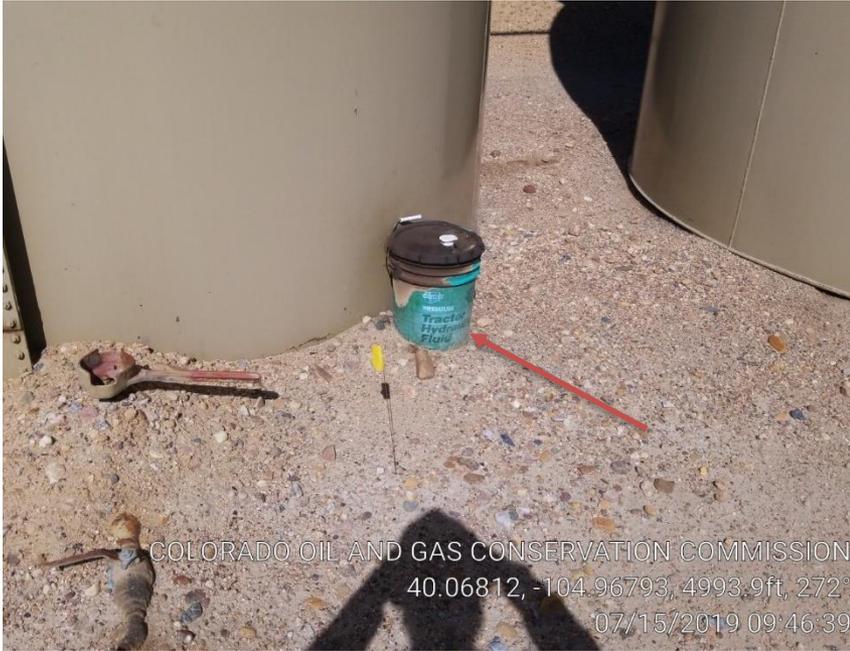
Pic 8 bucket of unknown contents behind tank, no BMP used

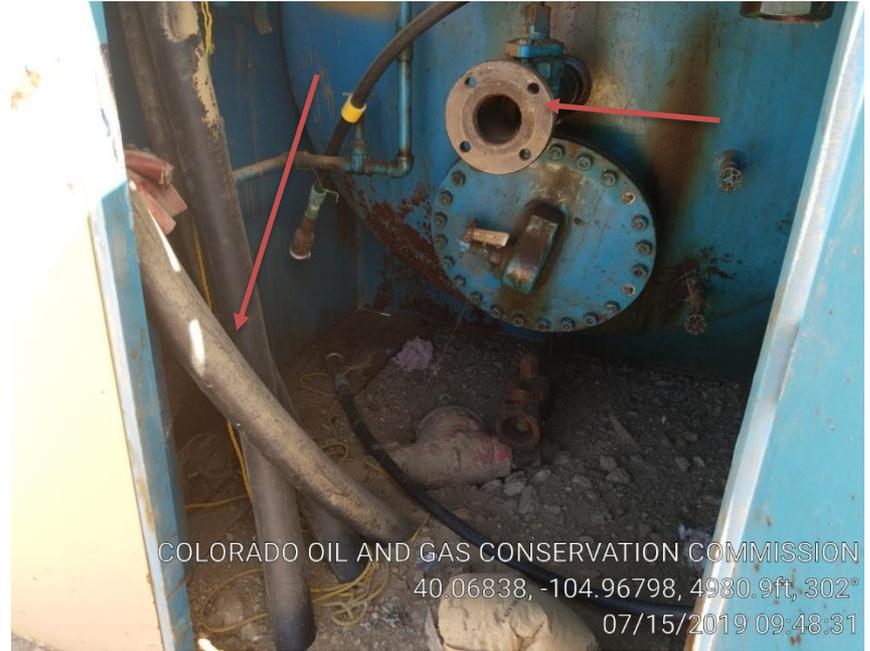
Pic 9 stained soil and open fitting on separator house/trash in separator house

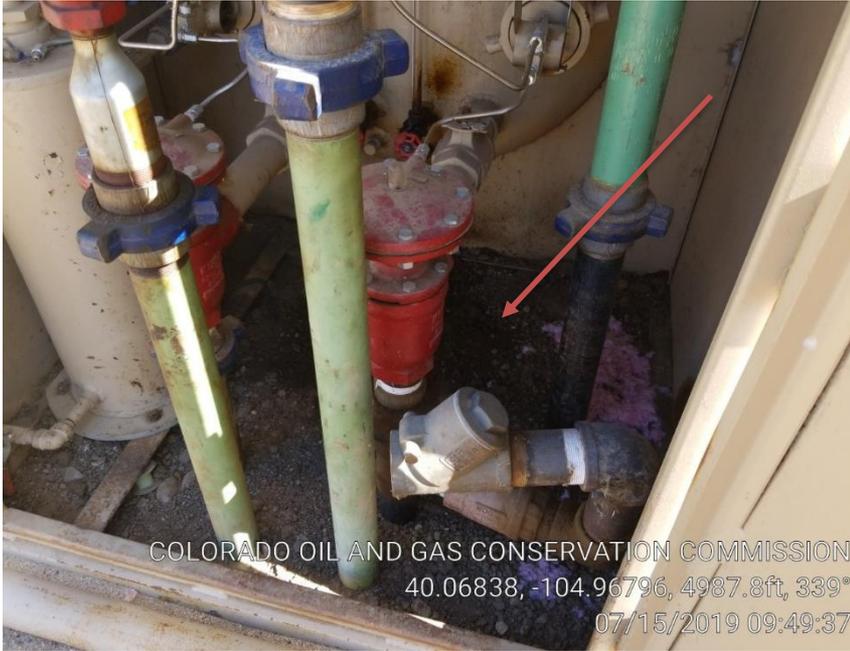
Pic 10 stained soil in separator house, possible leak

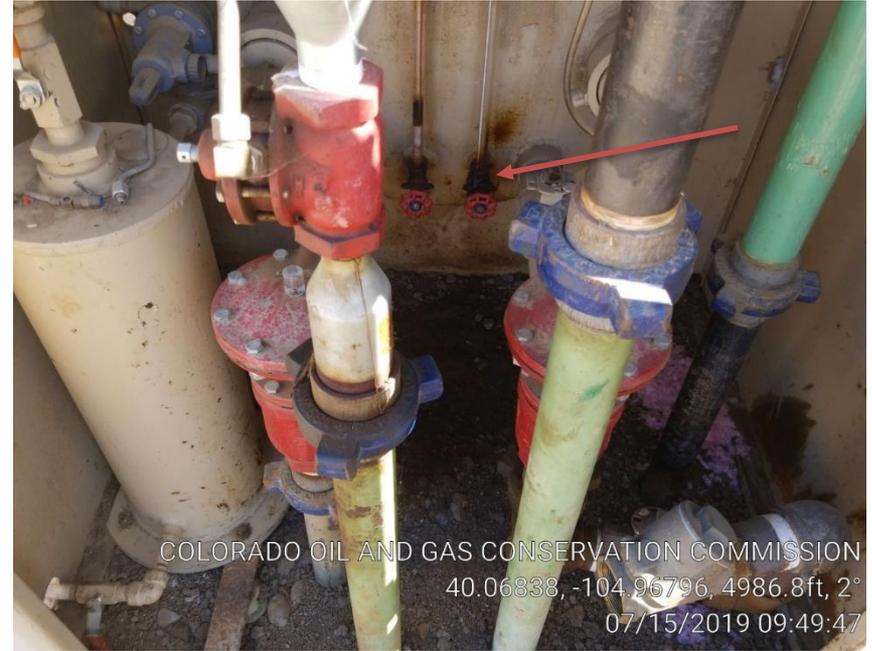
Pic 11 stained soil in separator house/possible leak

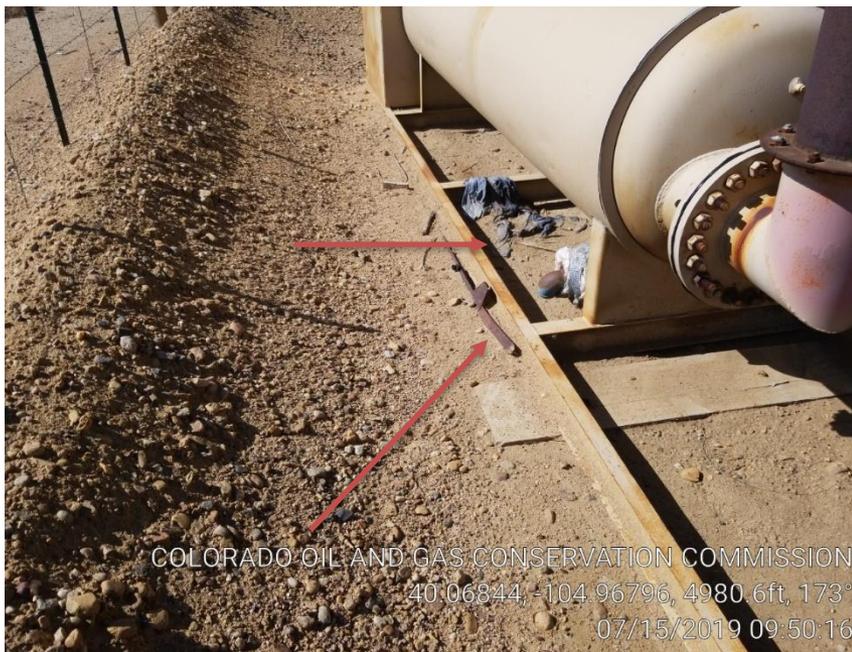
Pic 11 trash under seperator
