Inspection Photos
Location Name: Tiffany 4
Location ID: 451594

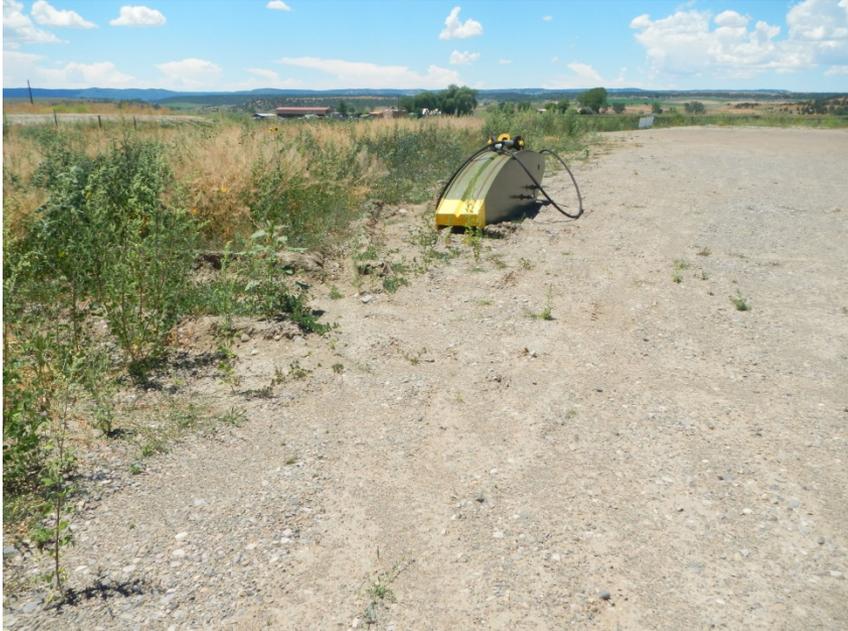
Unused equipment/pumping unit disabled

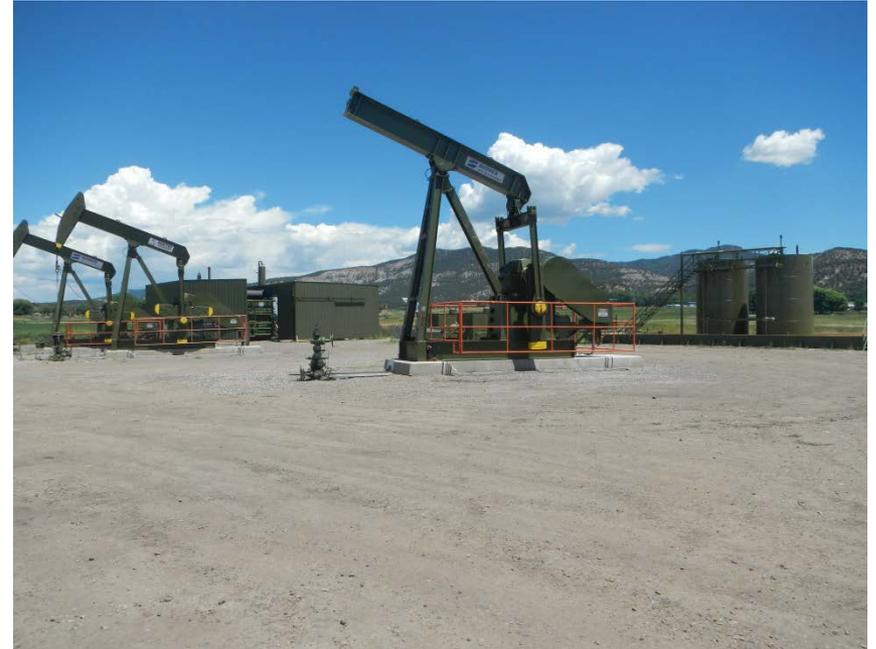
2) Pumping units, Tiffany 4-3 in state of TA

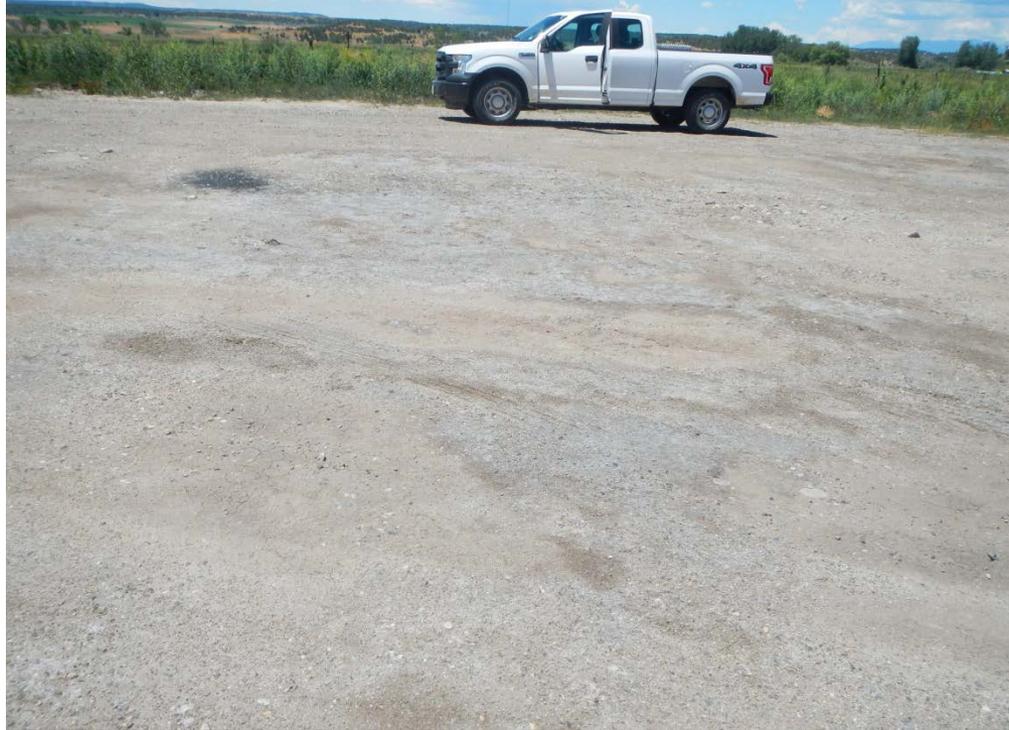
3) Discolored area of dried up fluid release

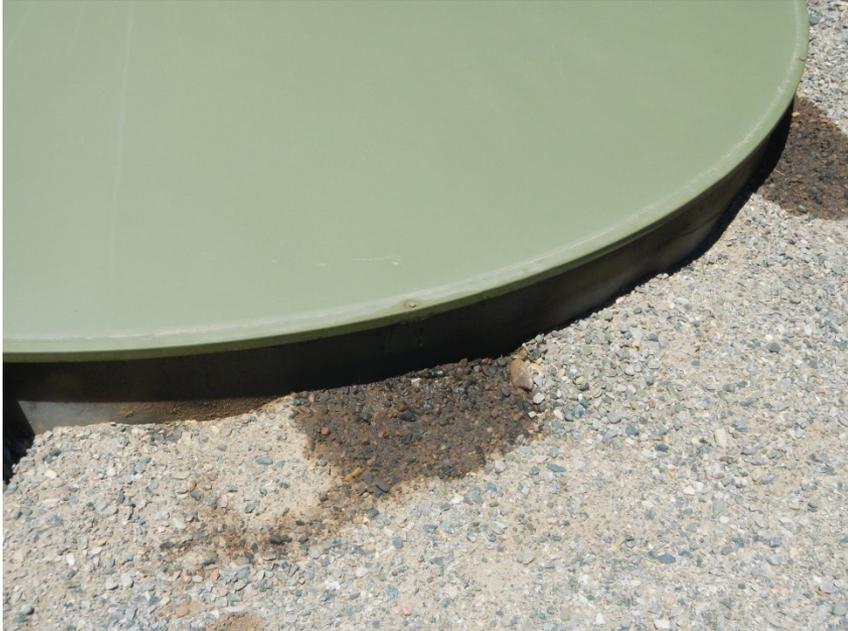
4) Actively leaking PBV, no labels or placarss

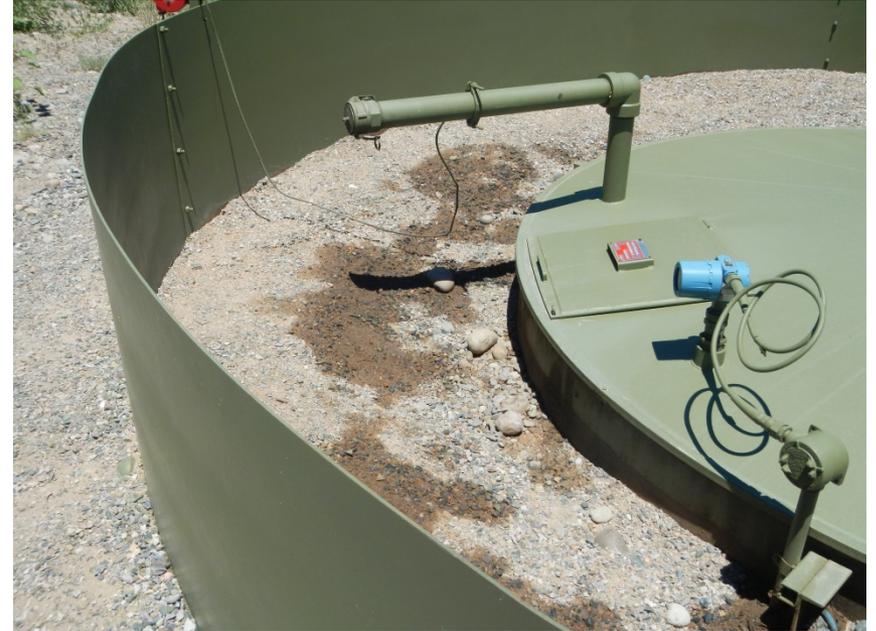
5) PBV no labels or placards, stained soils

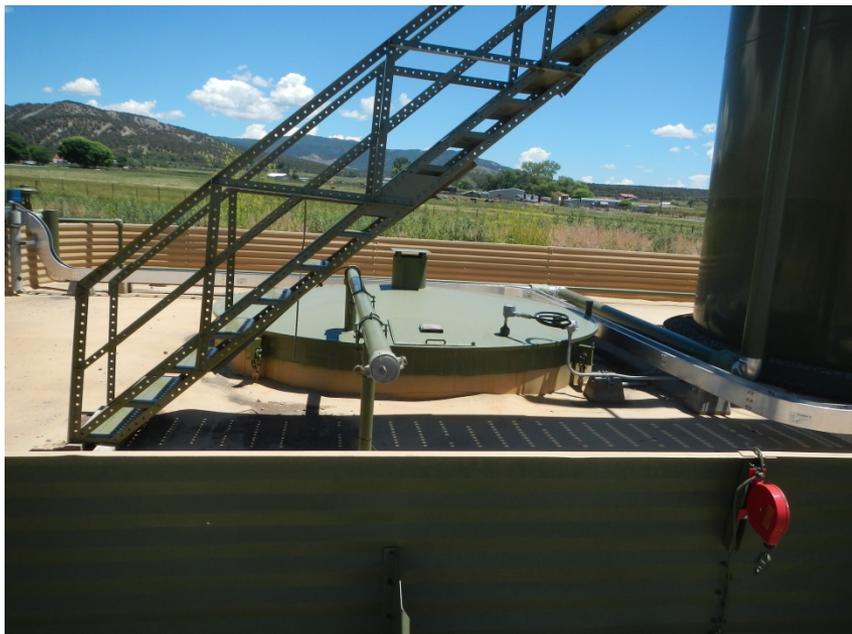
6) PSV, no labels or placards 7/15/19

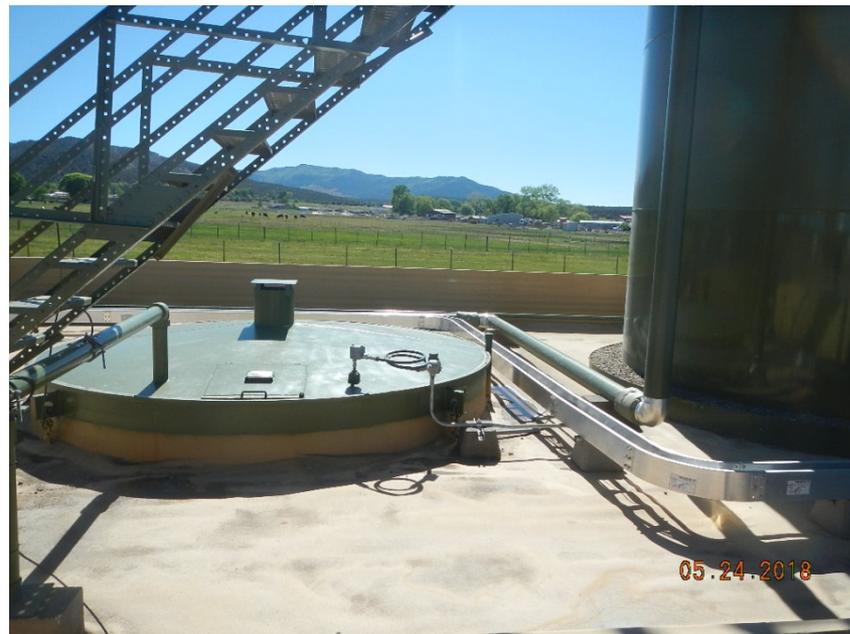
7) PSV no labels or placards 5/24/18

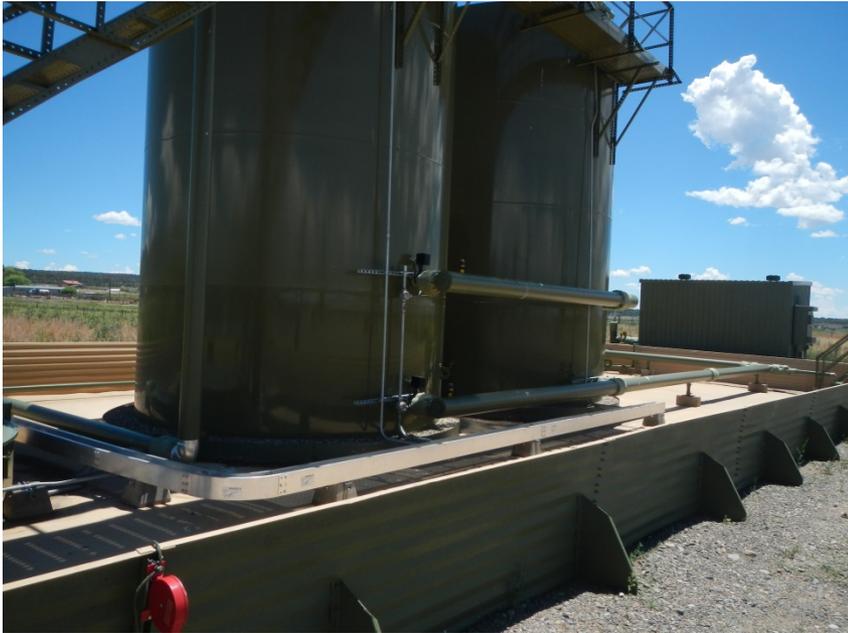
8) AST, no labels or placards 7/15/19

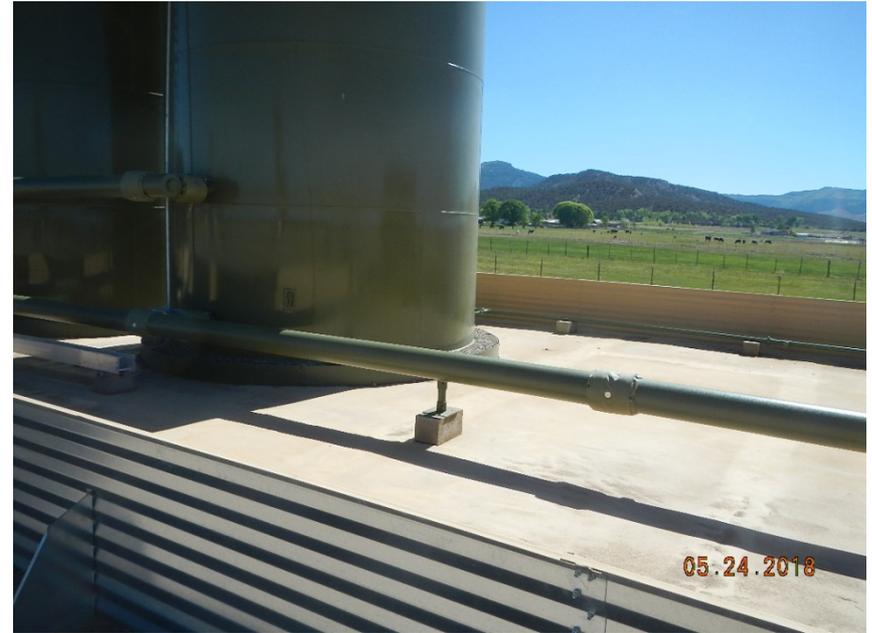
9) ASR no labels or placards 5/24/18

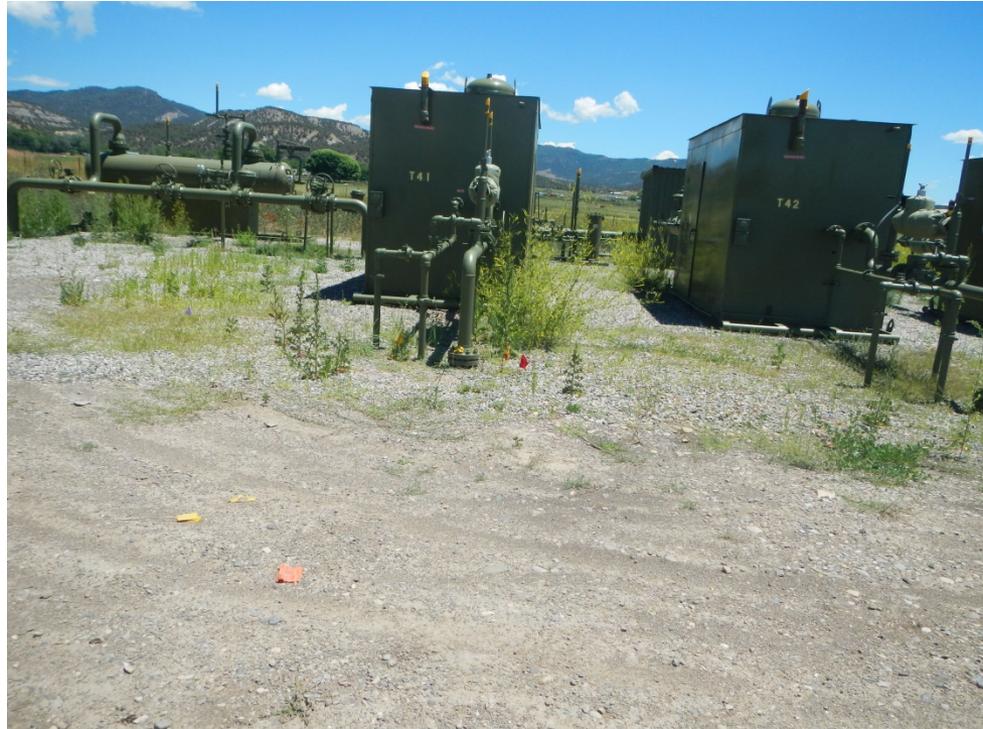
10) Weeds around fired equipment

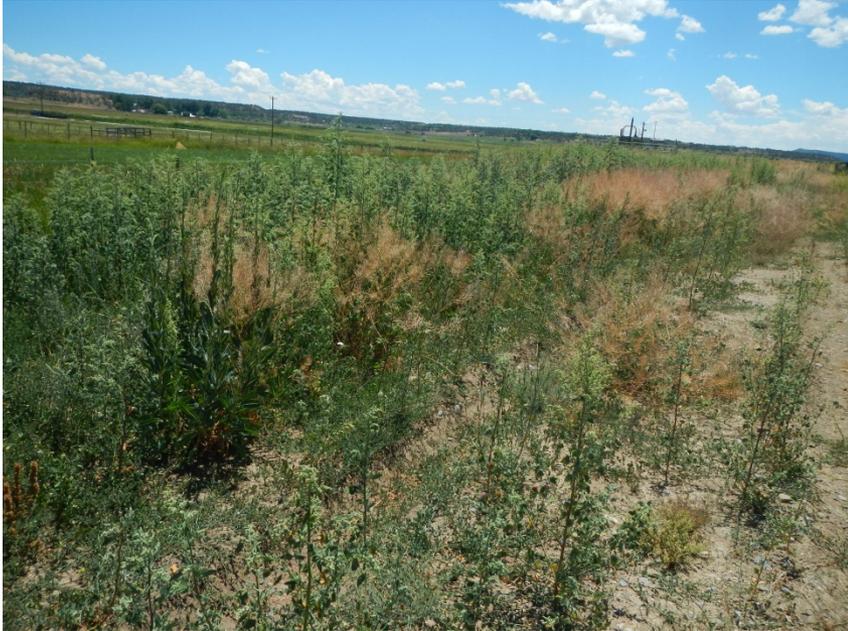
11) Interim revegetation of weeds, west side of location

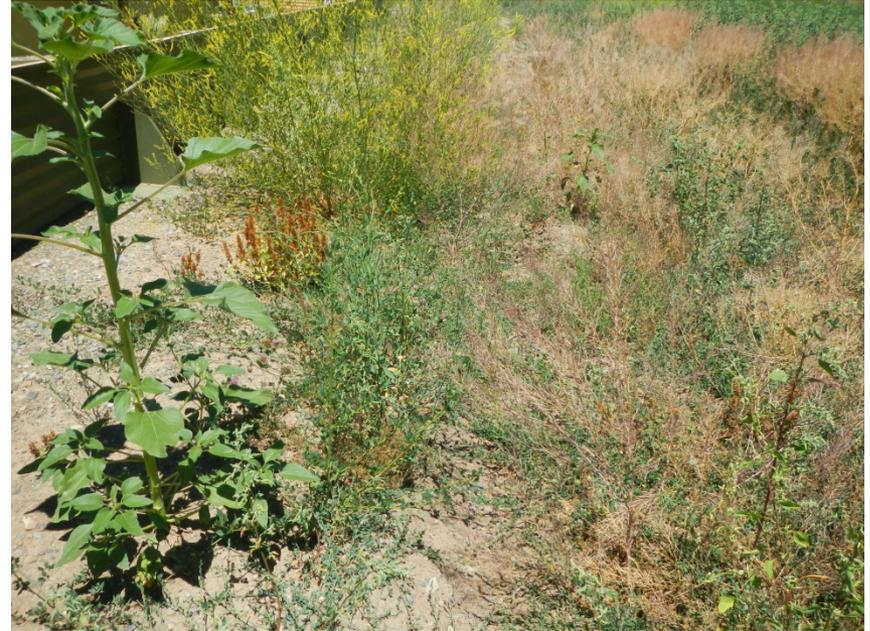
12) Weeds on east edge of location

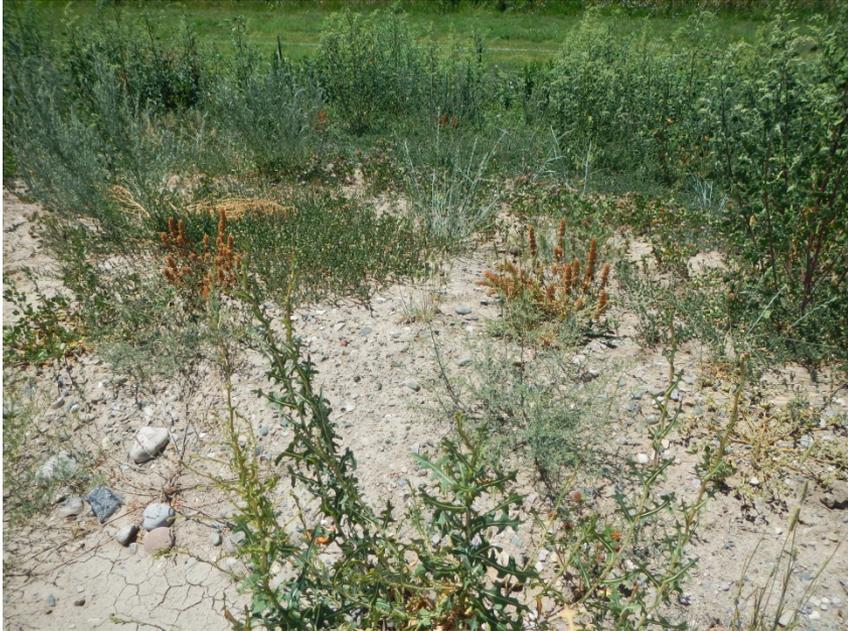
13) Noxious weeds on west edge of location

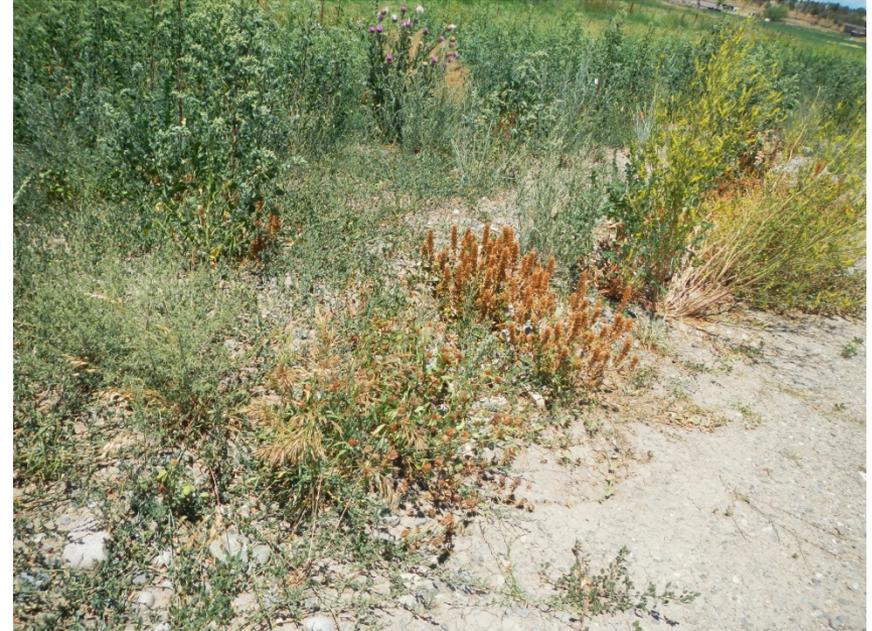
14) Weeds and noxious weeds in interim reclamation area west side of location

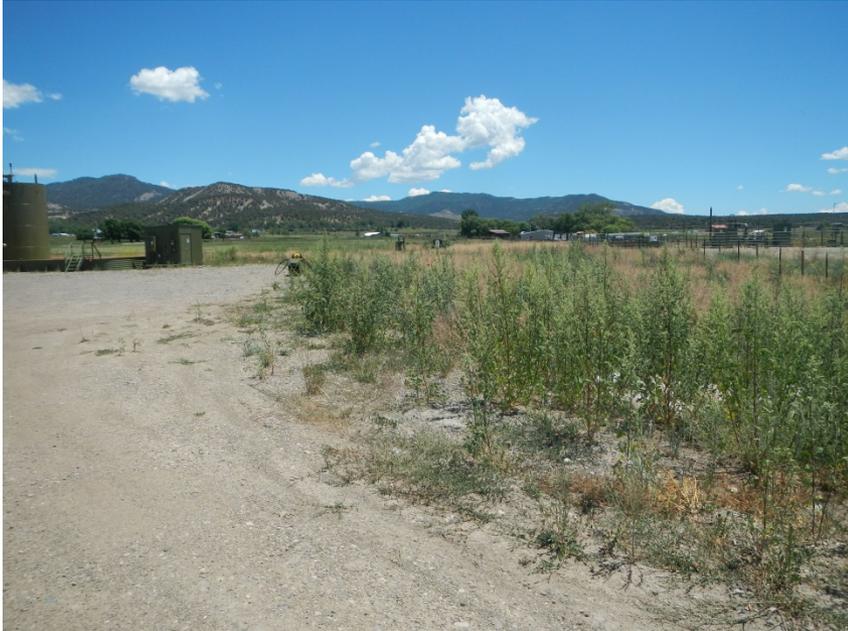
15) Weedy revegetation east side of entrance to location

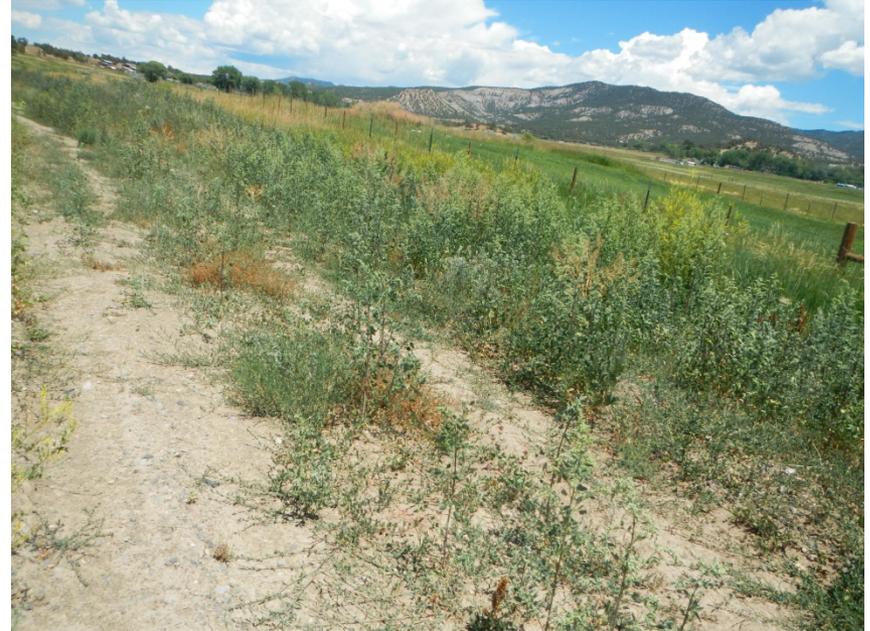
16) Weedy revegetation on east side of location

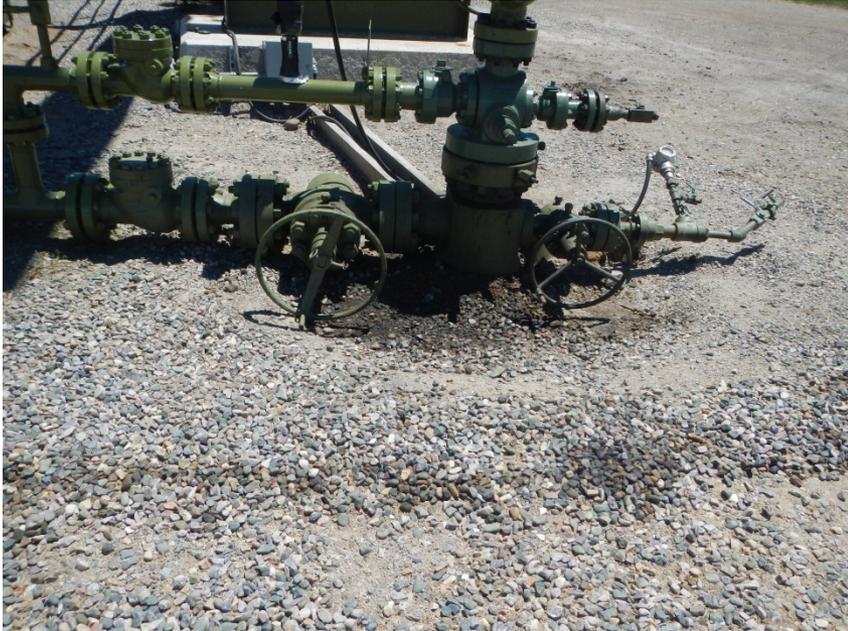
17) Housekeeping – impacted material around wellhead

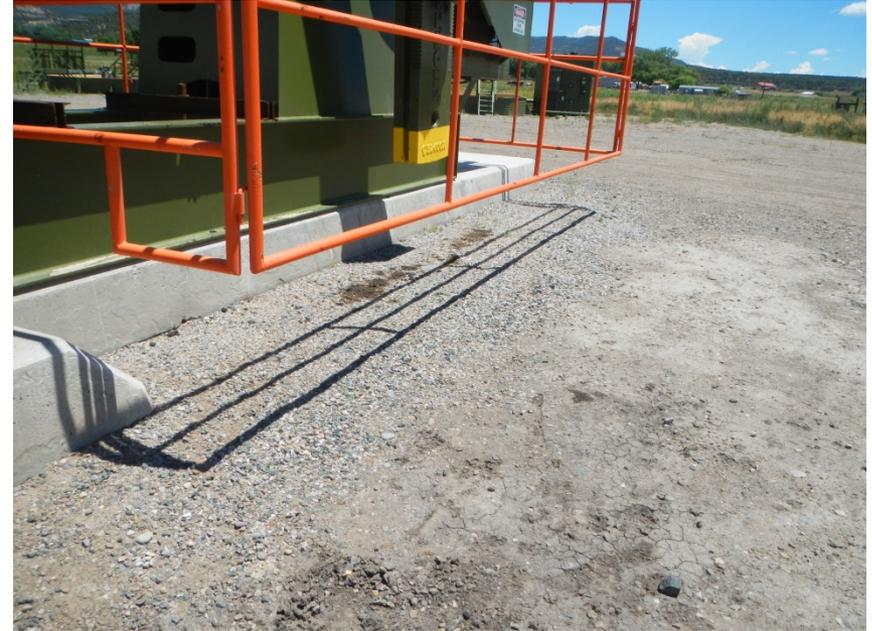
Housekeeping – lube oil accumulating on ground

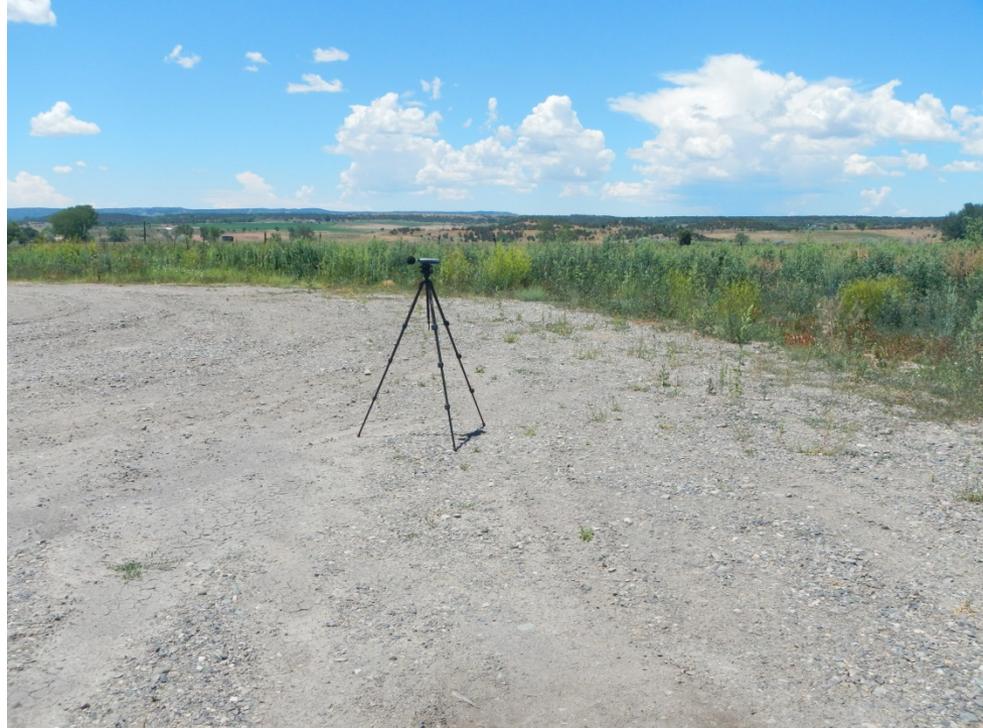
19) Sound meter location and weedy revegetation on NW corner of location
