Inspection Photos
Location Name: Energy Minerals Unit B #1
Location ID: 318873

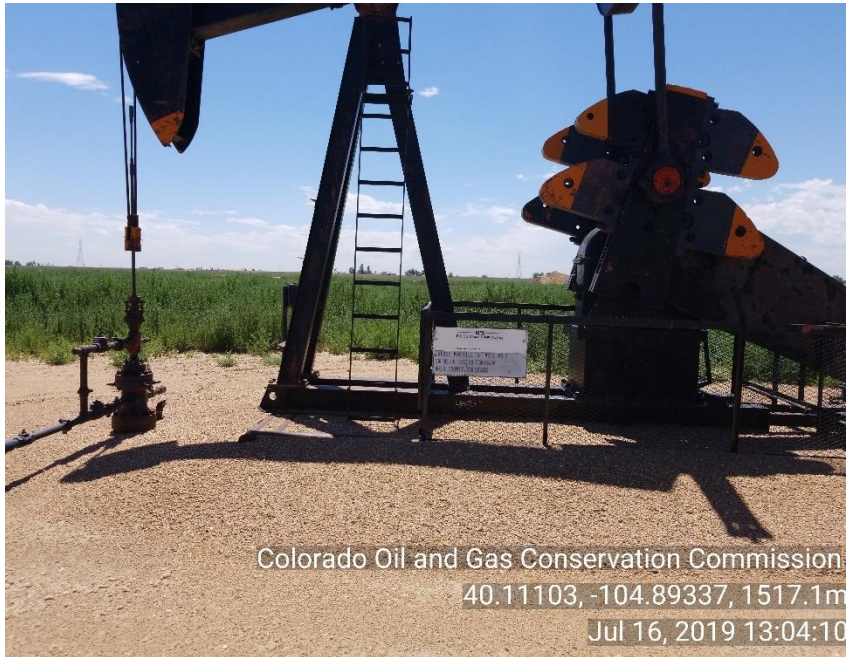
Photo 1 well head sign faded and not legible

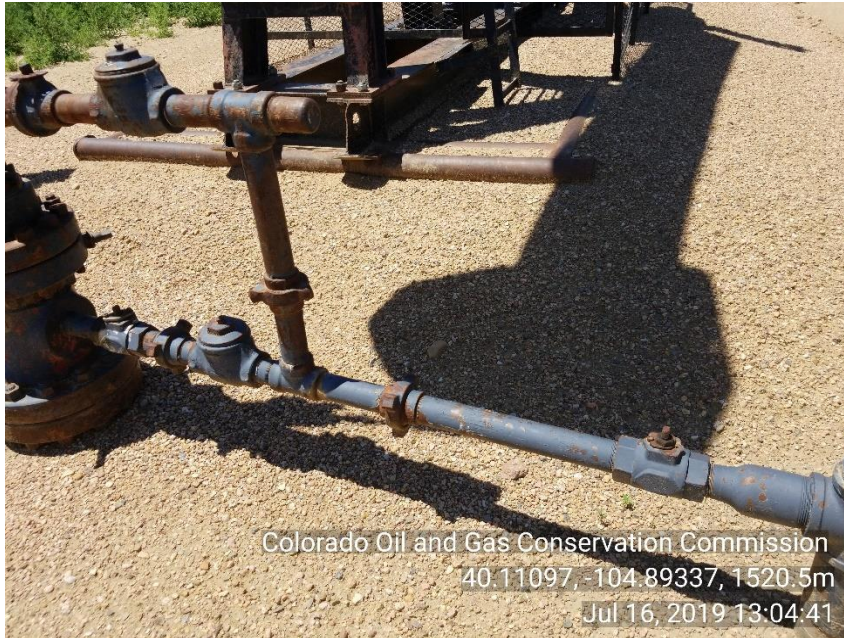
Photo 3 flow lines from Well head are closed

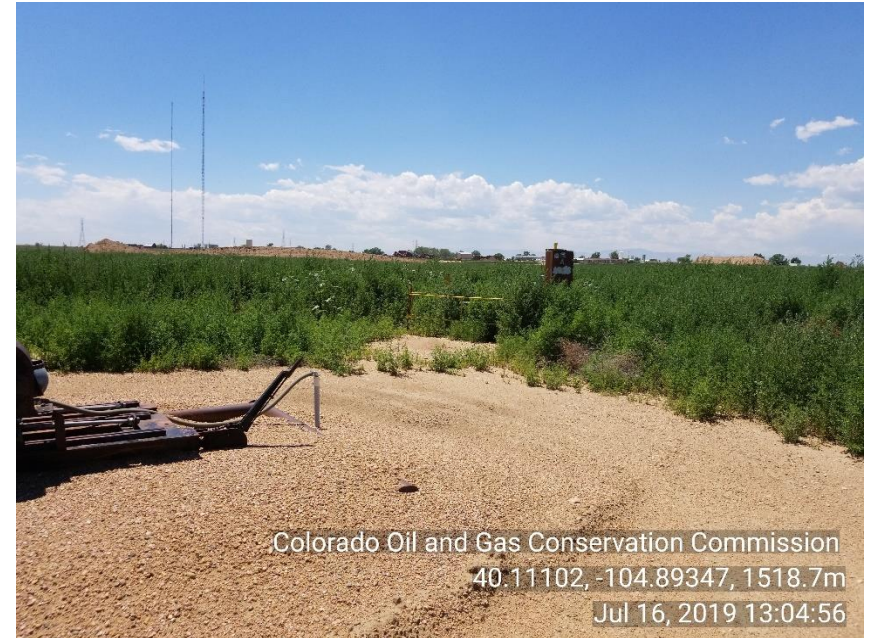
Photo 4 Weeds around electric panel

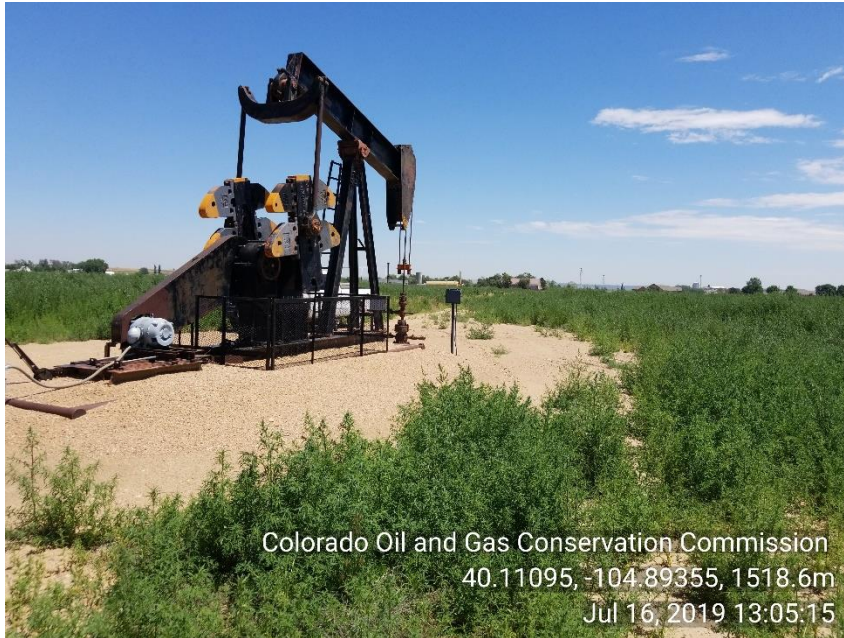
Photo 5 Weeds on location

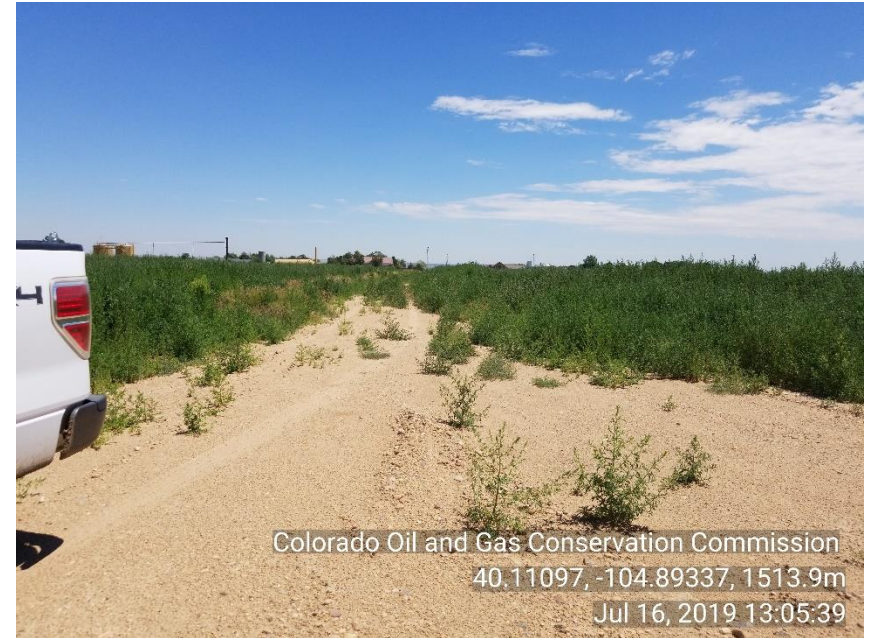
Photo 6 Access road covered by weeds.

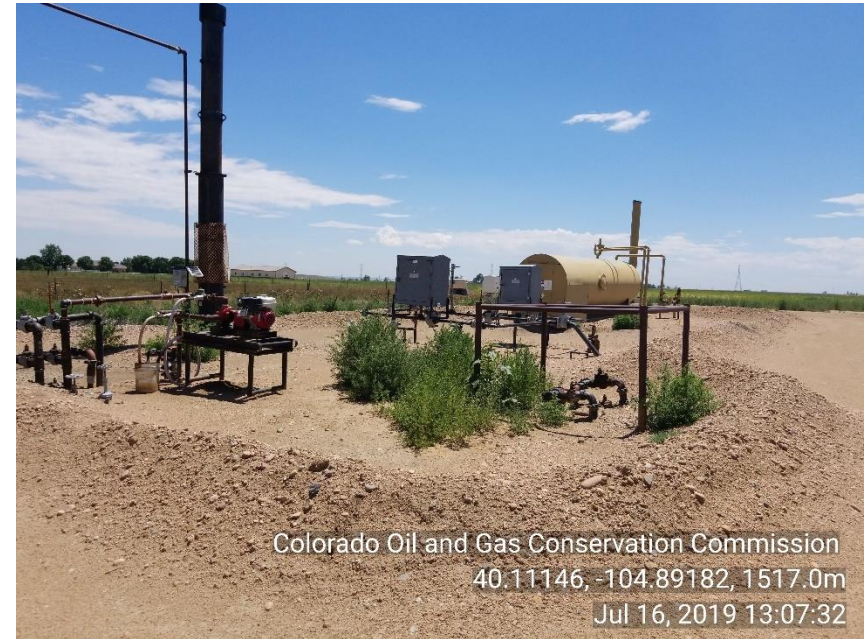
**Photo 8 sep/meter runs and ECD equipment not running.
Weeds around equipment.**

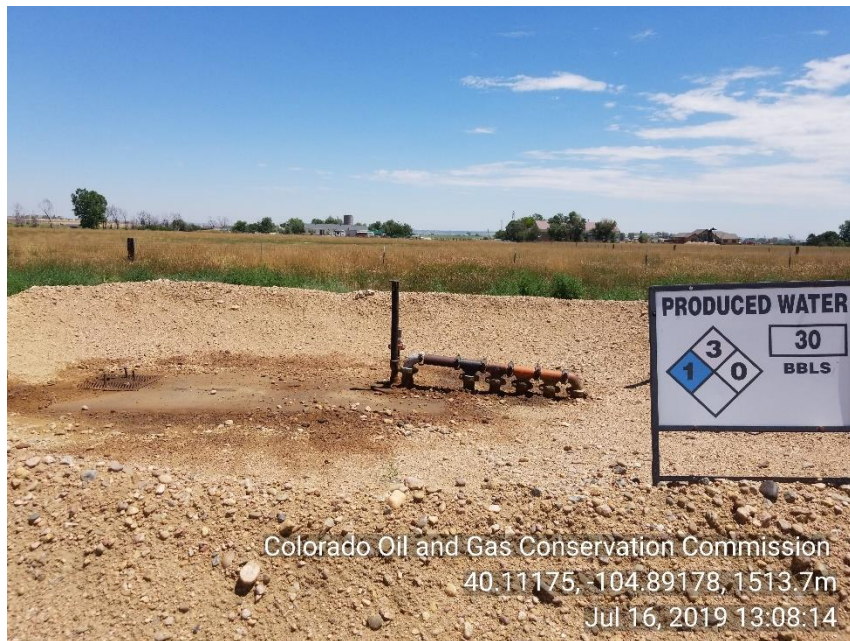
Photo 9 Produced water tank. Appears tank overflowed inside containment. Spill

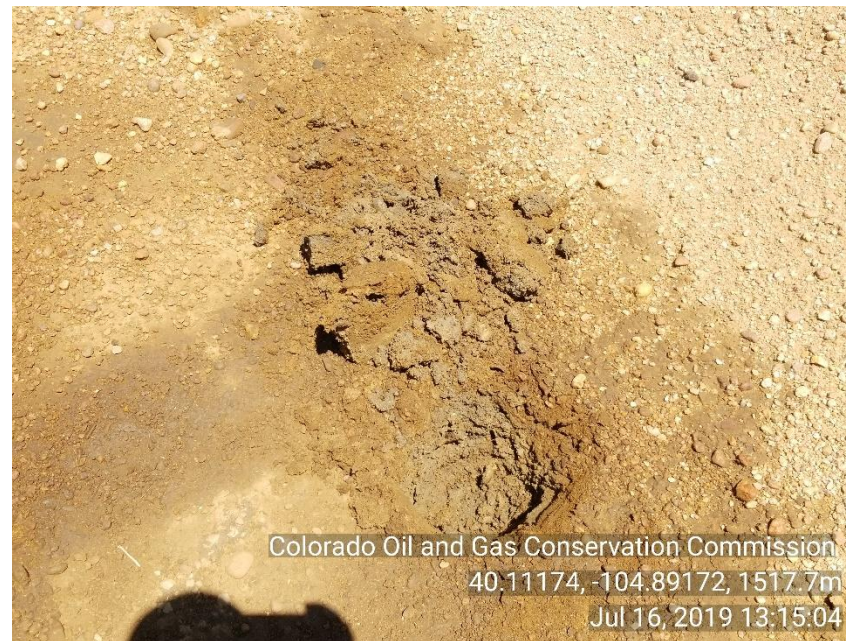
Photo 10 Dug down approx.. 1 ft next to produced water tank ground saturated with what appears to be E&P substance.

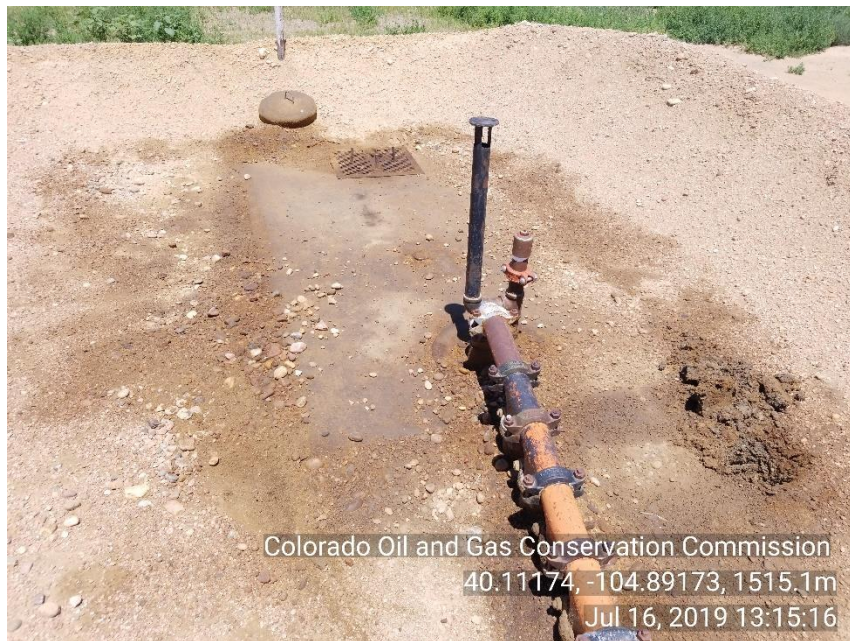
Photo 11 Produced water tank. Appears tank overflowed inside containment. Spill

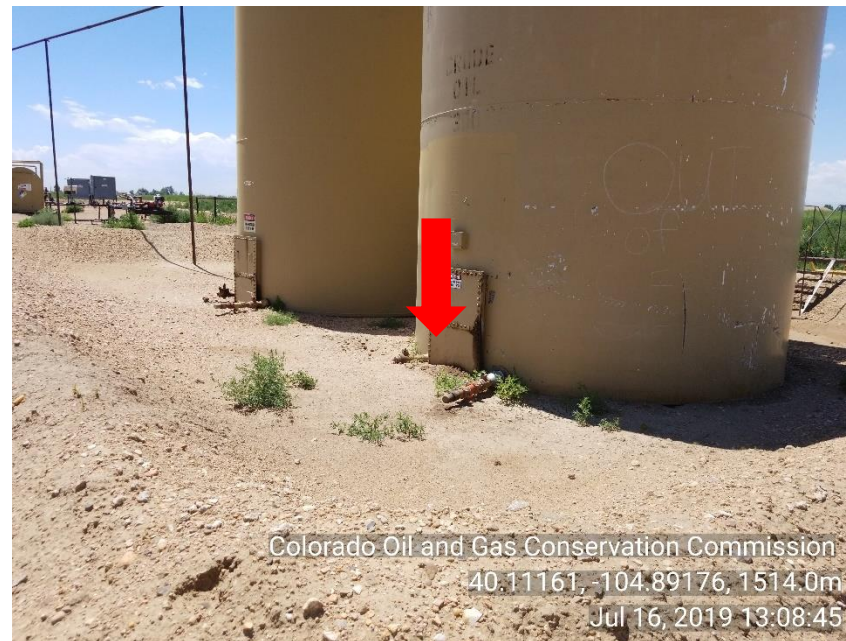
Photo 12 Stained soil around inspection hatch of Crude oil tank.

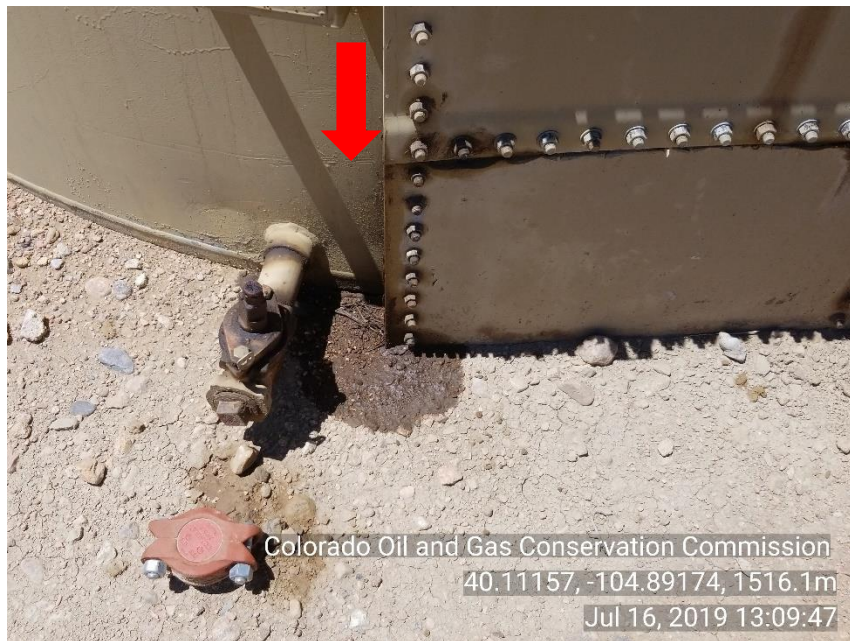
Photo 13 stained soil around load line of crude oil tank

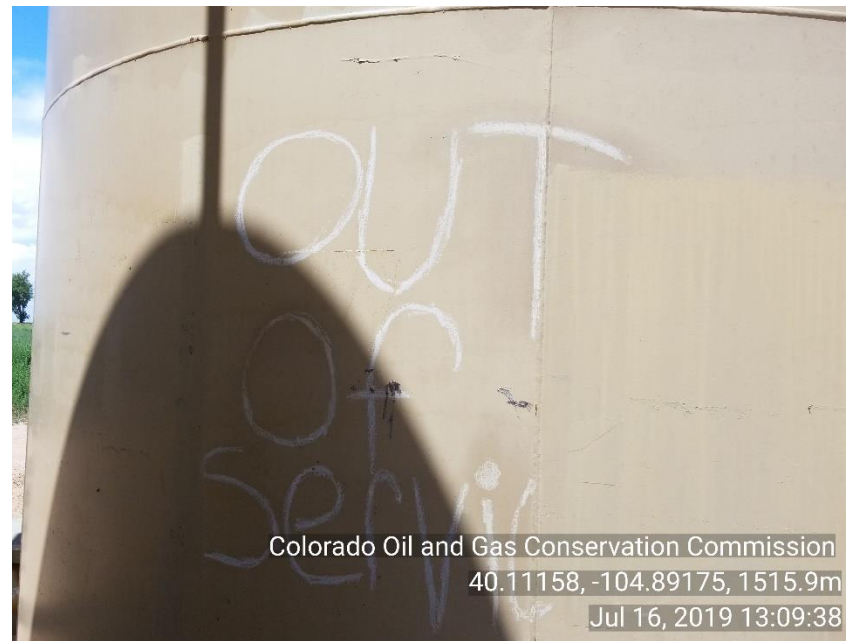
Photo 14 Unused equipment: North crude oil tank has OUT OF SERVICE in multiple spots on tank. Front load line valve is closed.

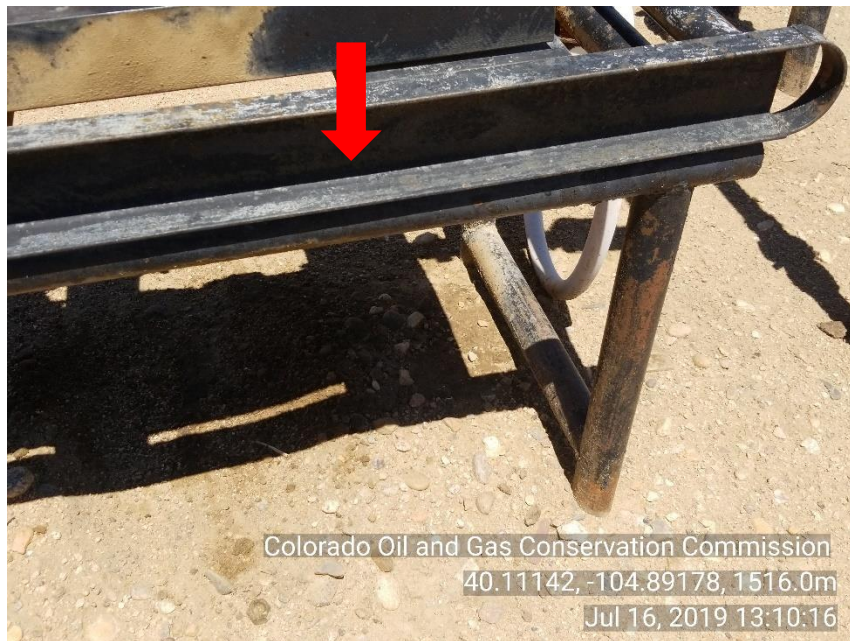
Photo 15 Stained soil underneath recirc pump

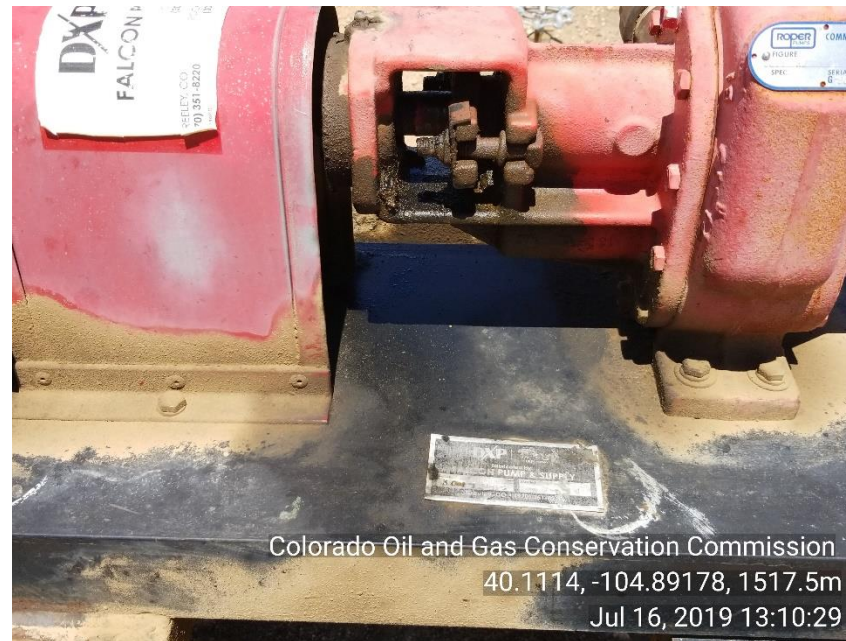
Photo 16 Mechanical issue: recirc pump appears to be leaking.

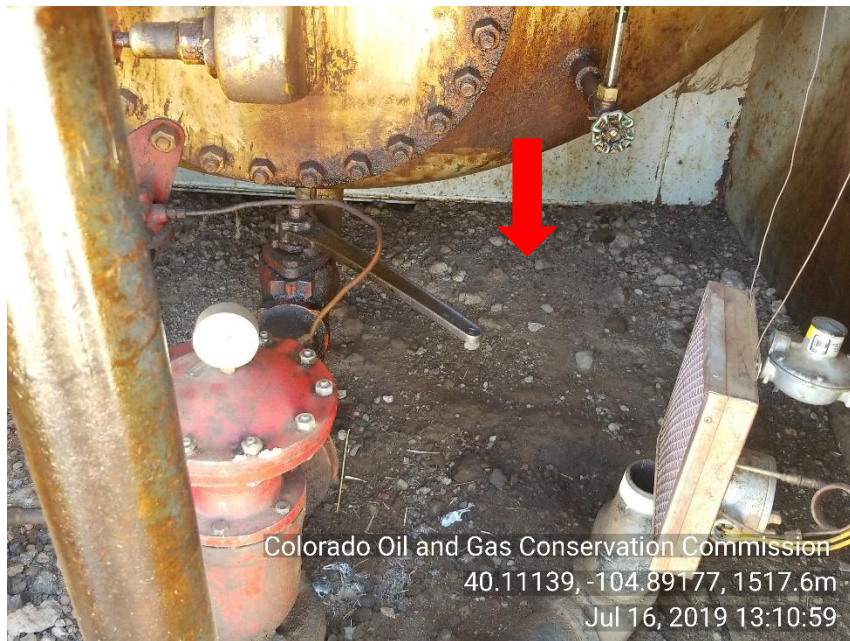
Photo 17 stained soil inside Separator house. Mechanical Issue: Piping on separator.

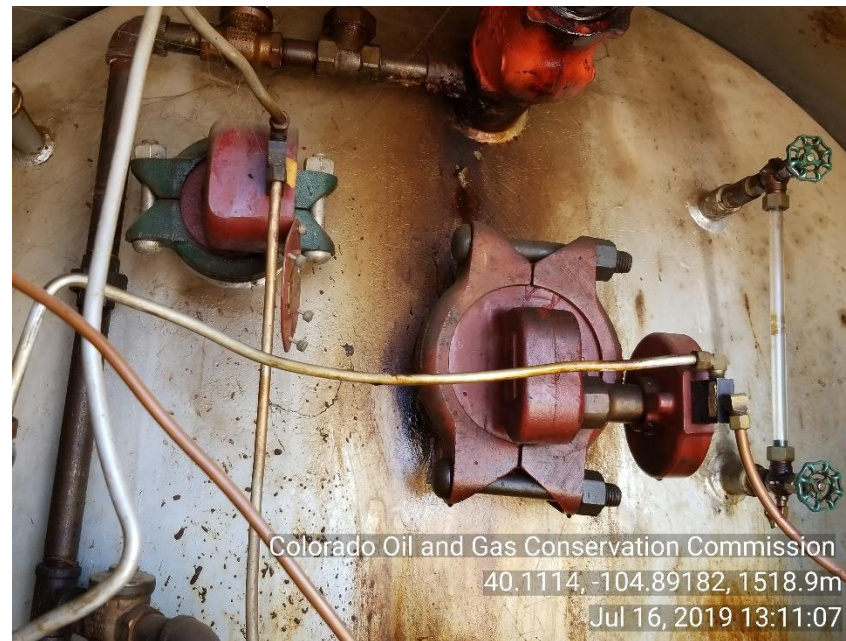
Photo 18 Mechanical issue: Piping on separator
