Inspection Photos

Loc#439603

Operator: Sandridge

Inspection Number: 692401145

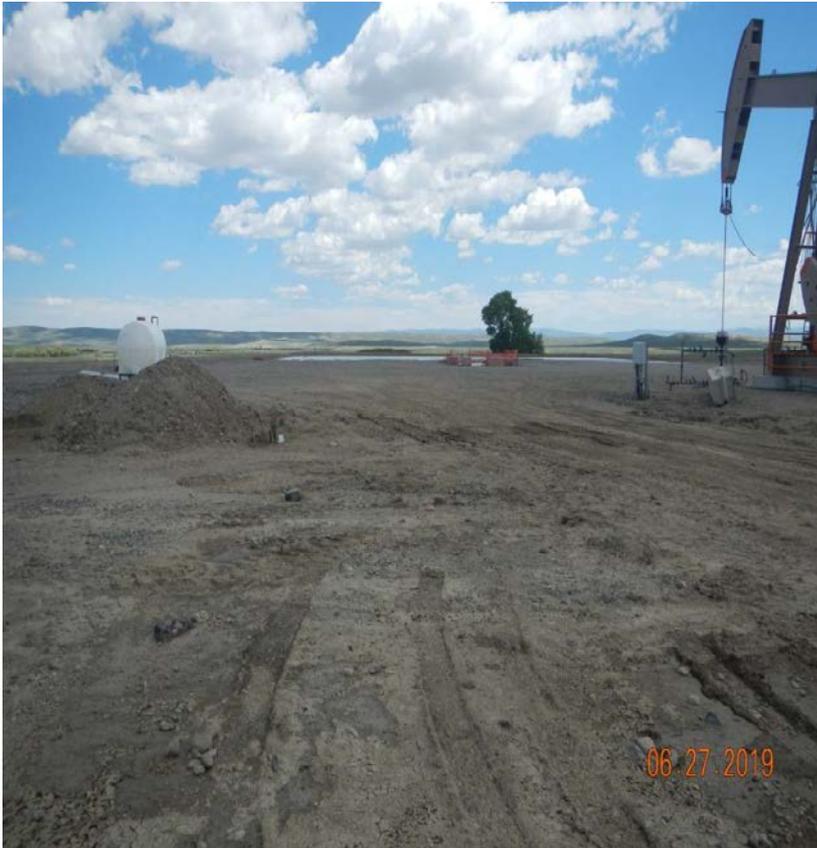
Photo#1:
View to North over most recent expansion of
Location.

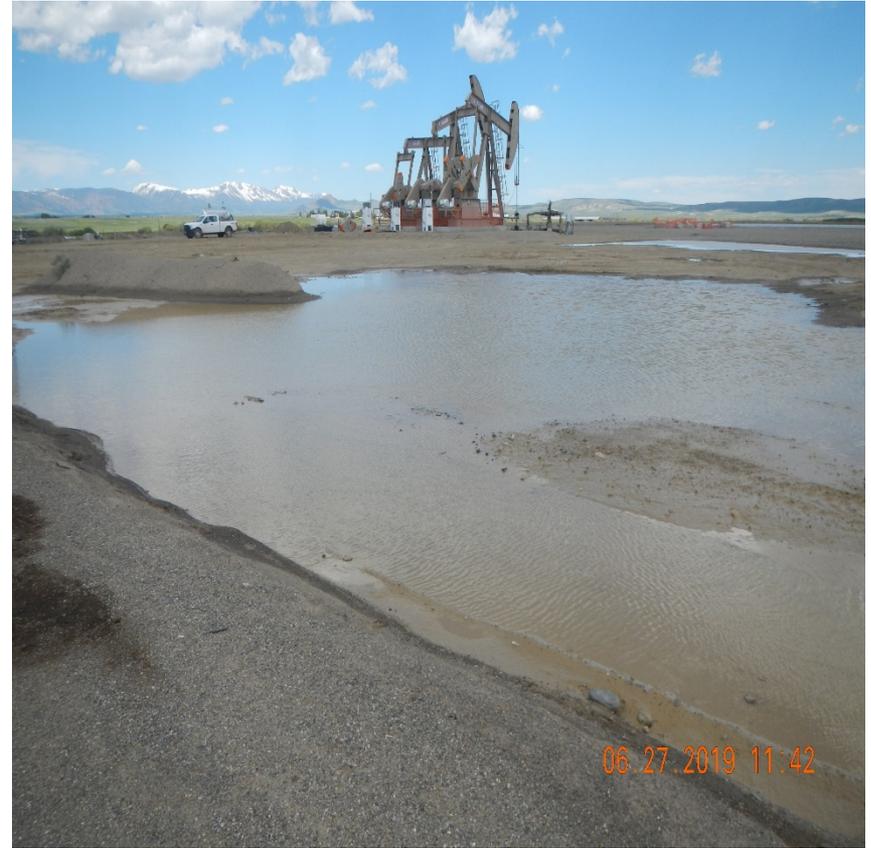
Photo#2:
View from recent expansion to South

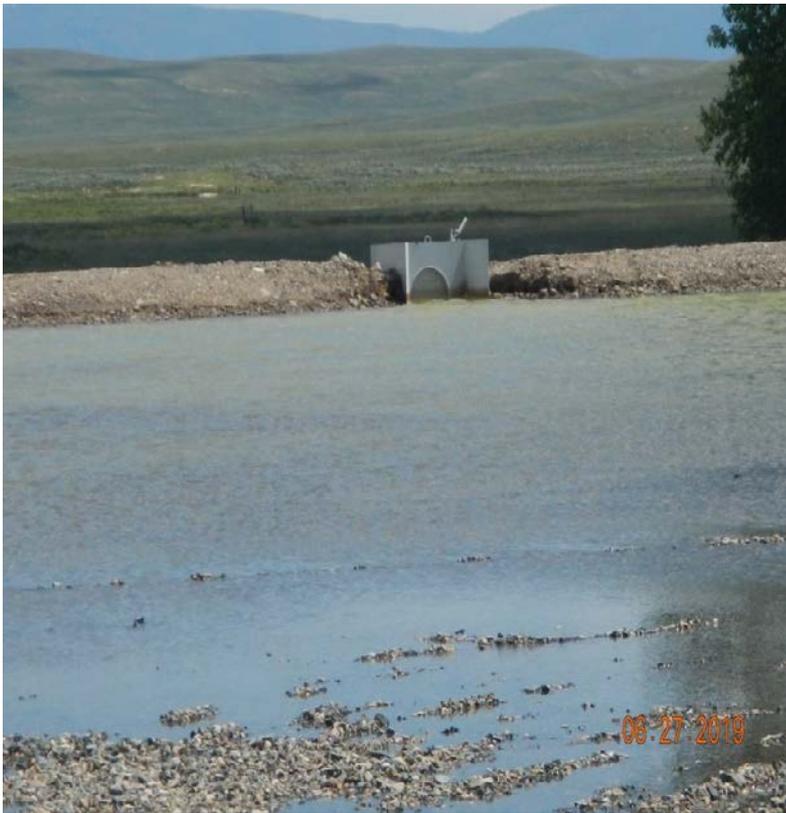
Photo#3:
Weir retaining stormwater at north end of site.

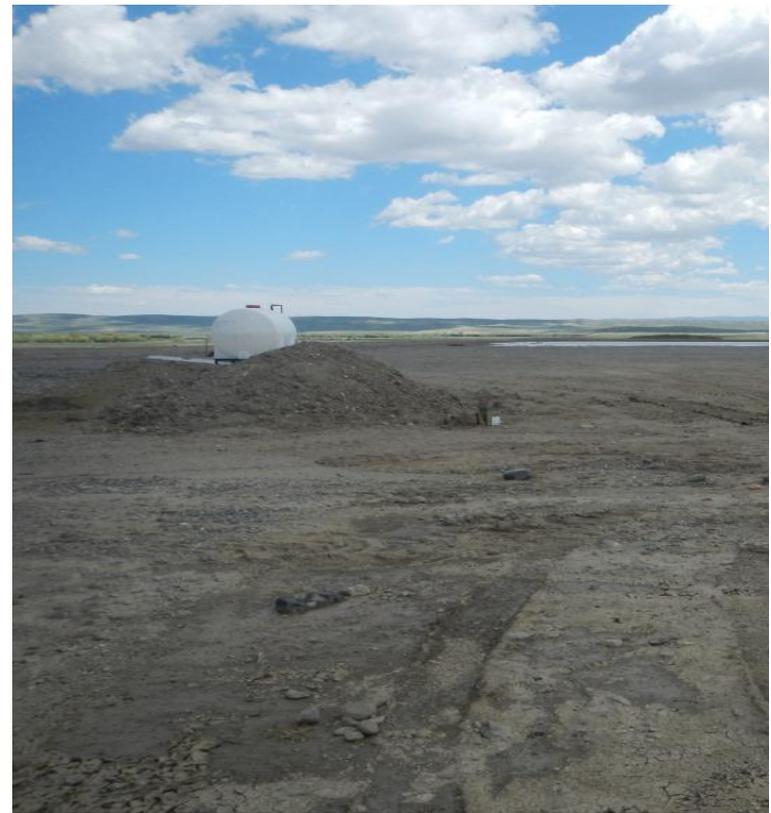
Photo#4:
Unconsolidated stockpile with no BMPs employed.

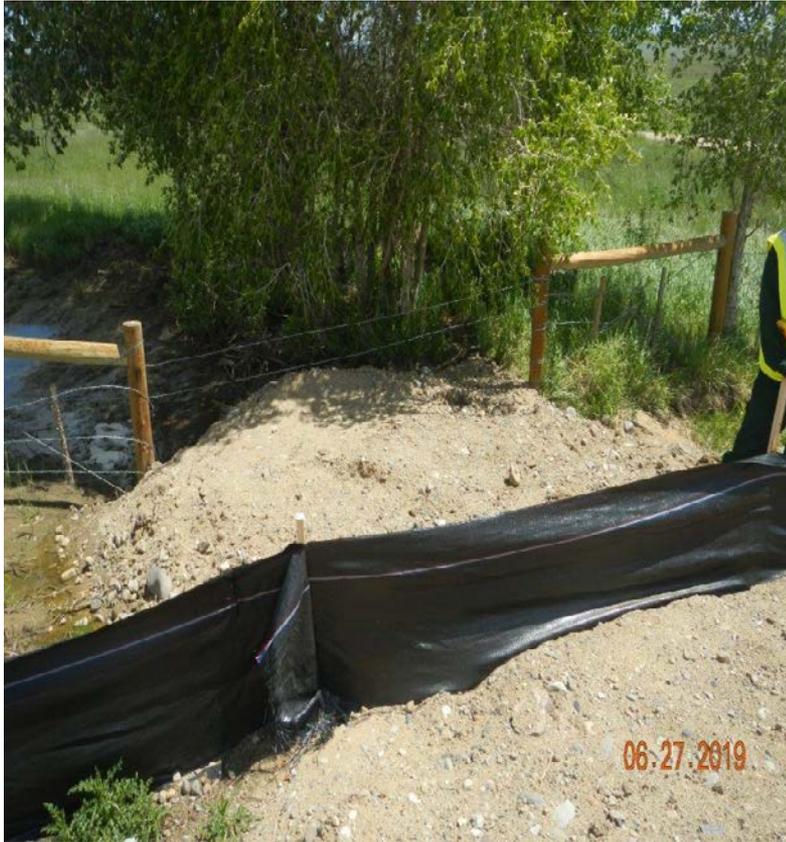
Photo#5:
No sediment controls at culvert installation.

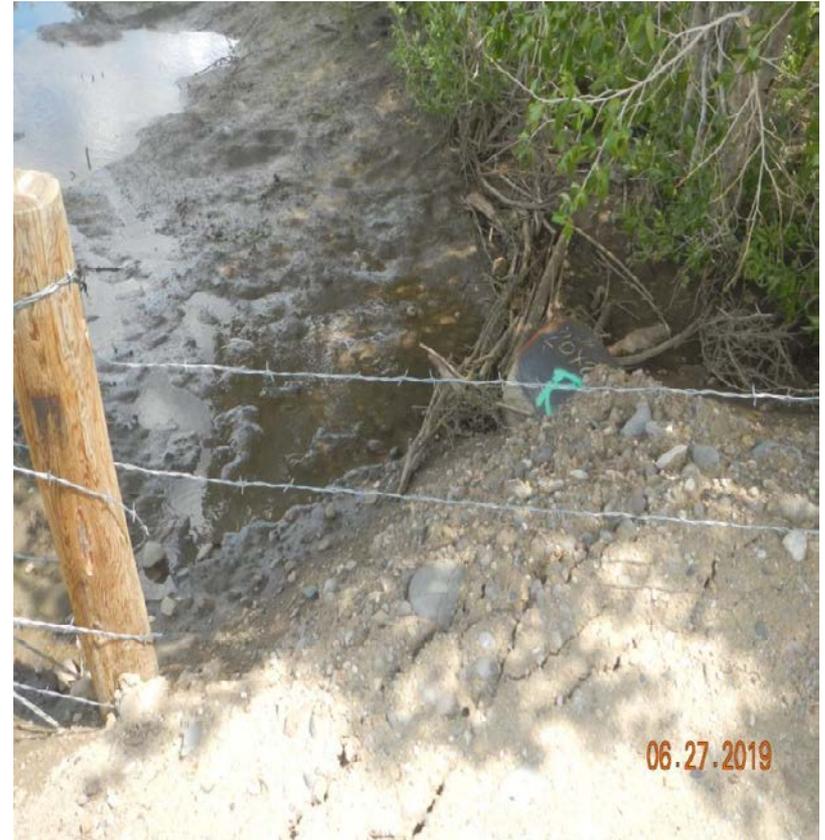
Photo#6:
No sediment controls at culvert installation.

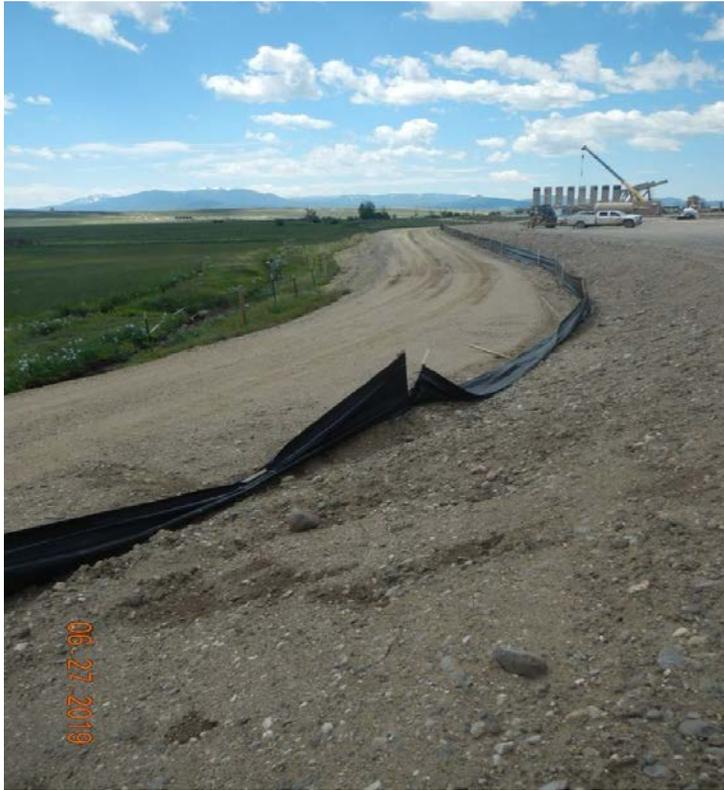
Photo#7:
Silt fence failed.

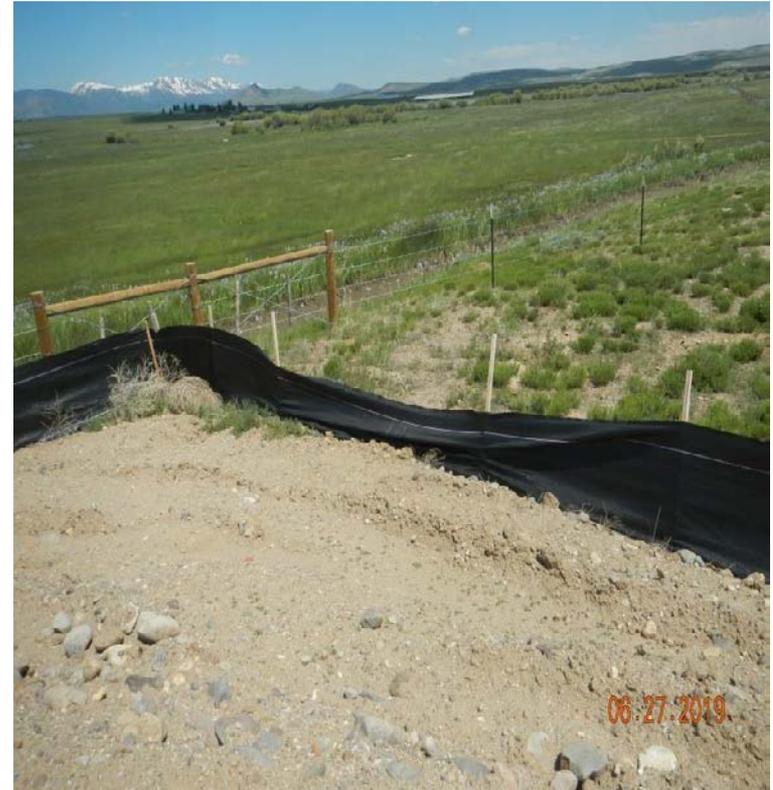
Photo#8:
Silt fence failing.

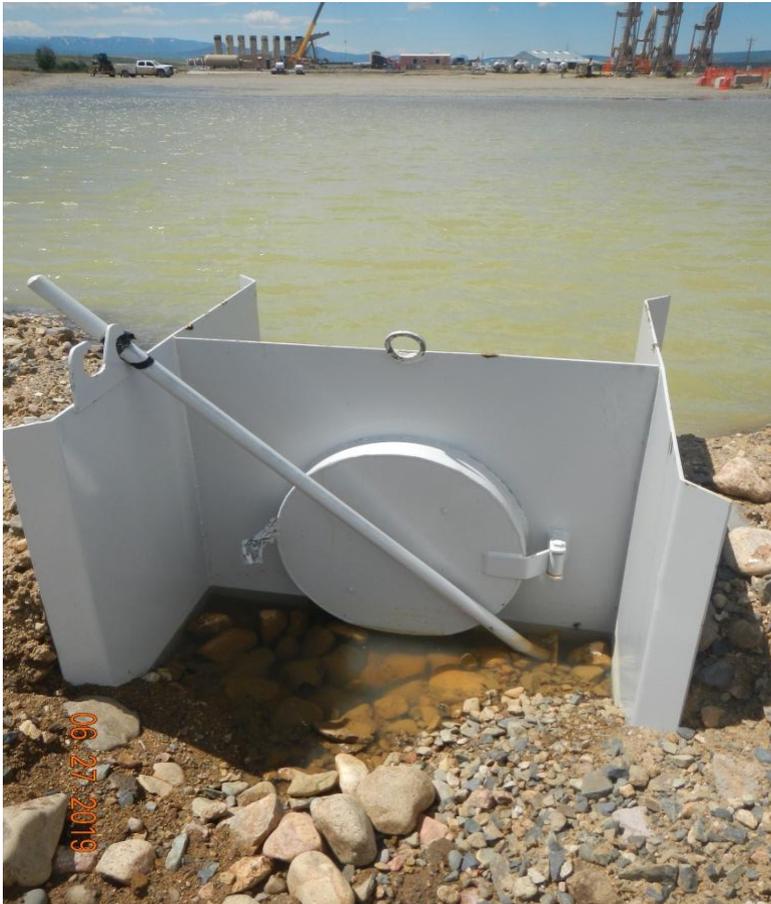
Photo#9:
View over Weir at North end of site into Location.

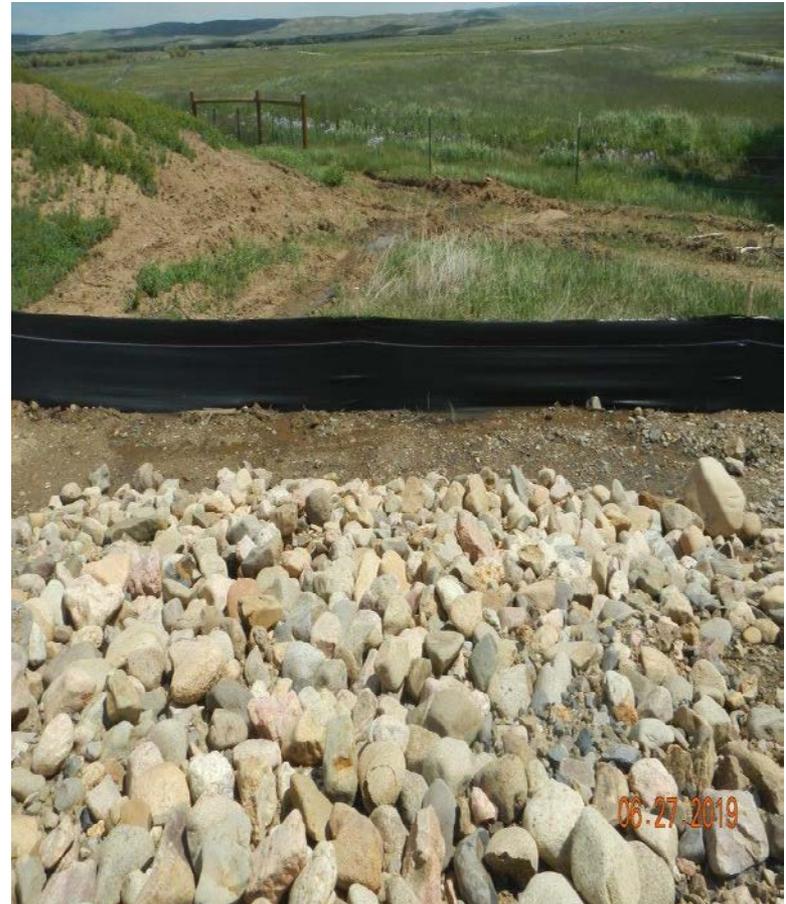
Photo#10:
View over top of Weir to outside of Location; where stormwater would discharge into silt fence; no outlet.

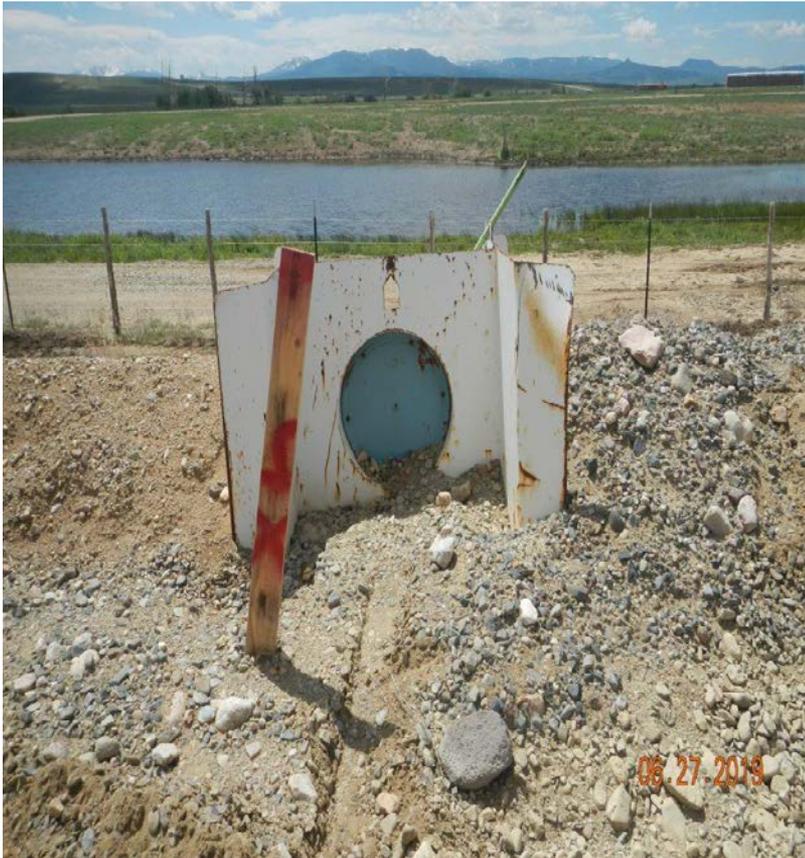
Photo#11:
Weir at South end of site.

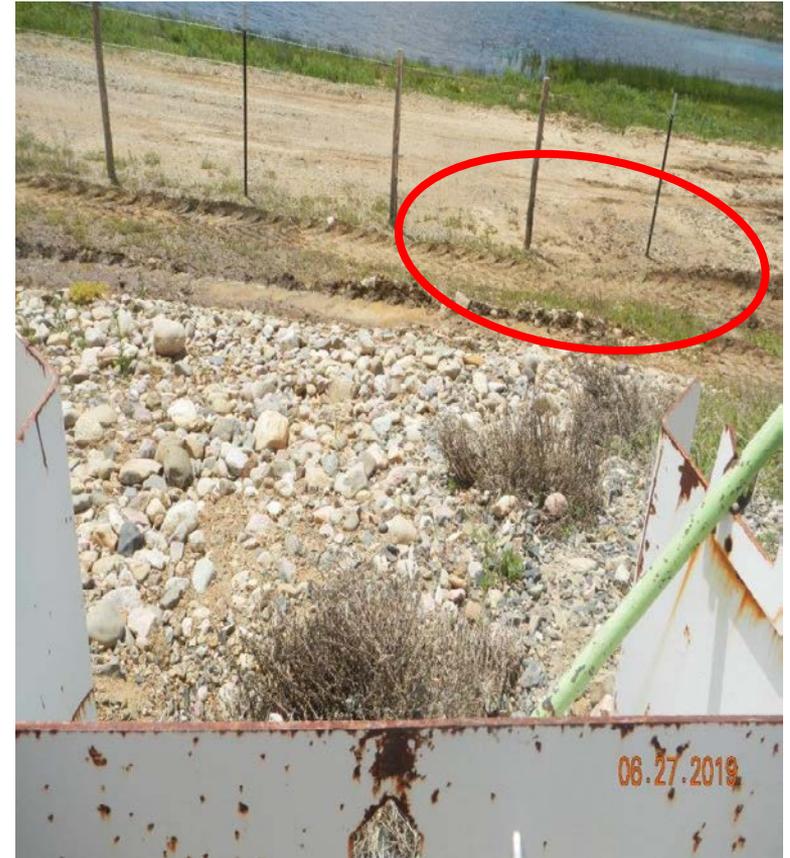
Photo#12:
View to discharge area of South weir. Note no perimeter control, sediment run-off.

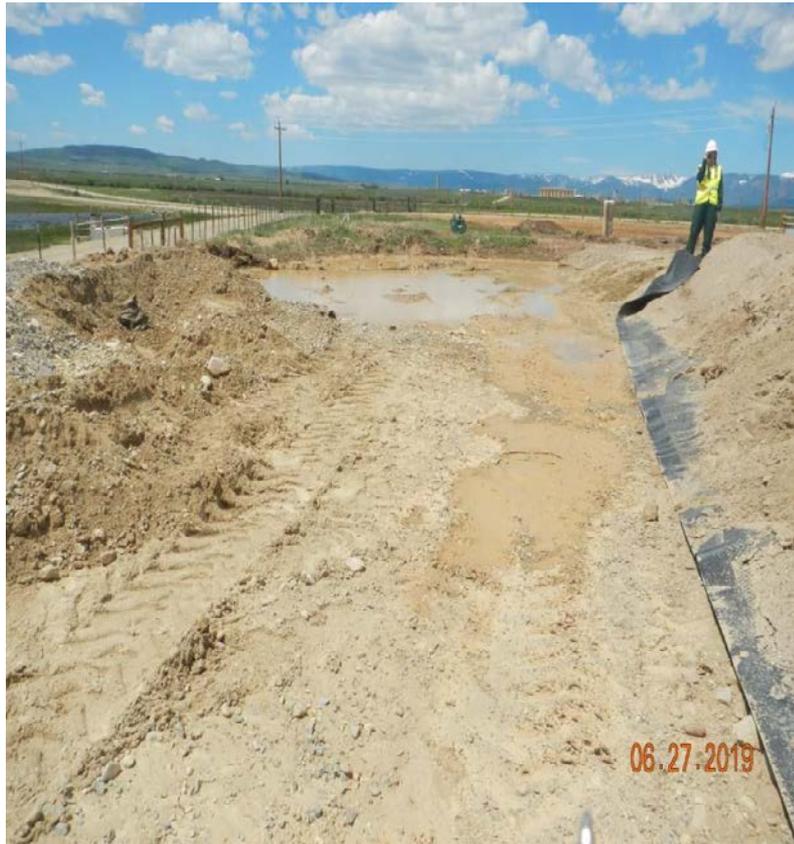
Photo#13:
Ponding and degradation of site.

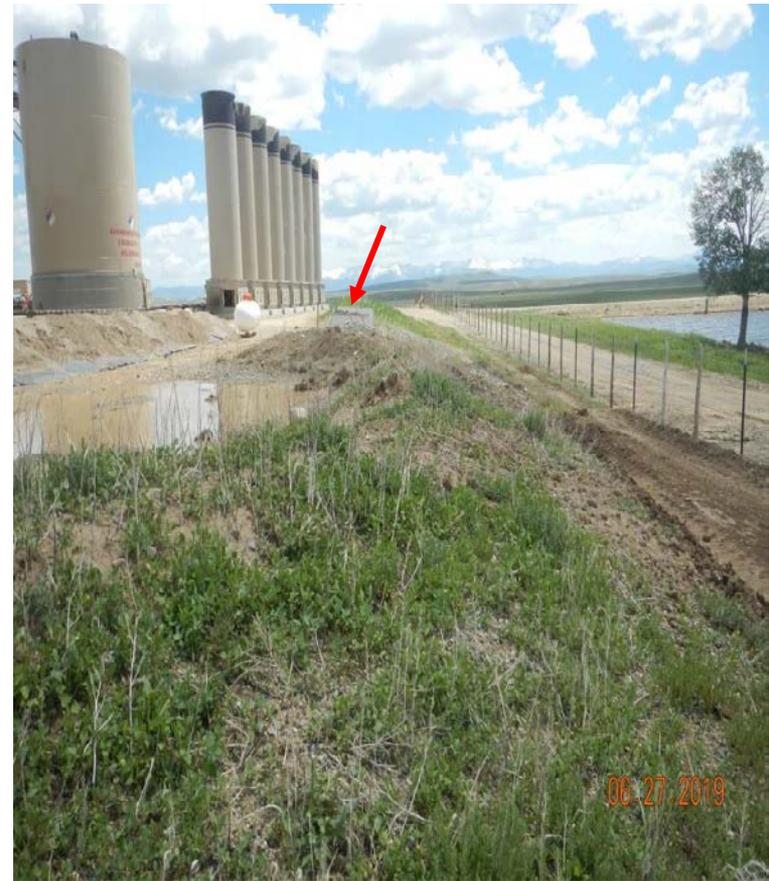
Photo#14:
Stormwater ponding shown in Photo #13,
weir(Photo#11) position indicated with arrow.

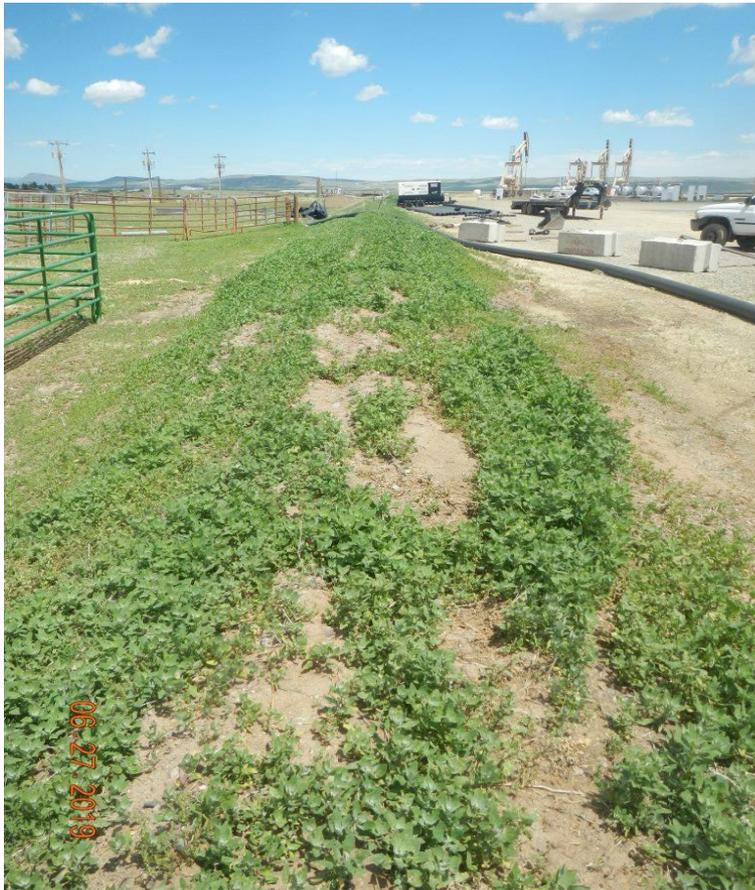
Photo#15:
Berms are weedy & would benefit from Interim Reclamation.

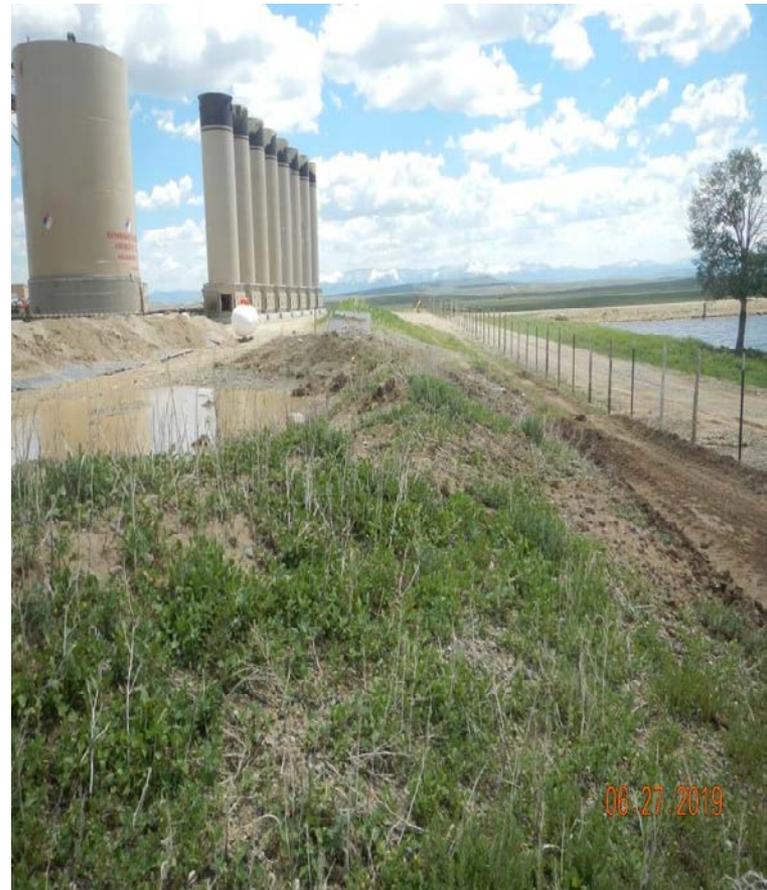
Photo#16:
Berms are weedy & would benefit from Interim Reclamation.
