Inspection Photos

ID: 256456

Operator: EVERGREEN NATURAL RESOURCES

Inspection Date: 7/11/2019

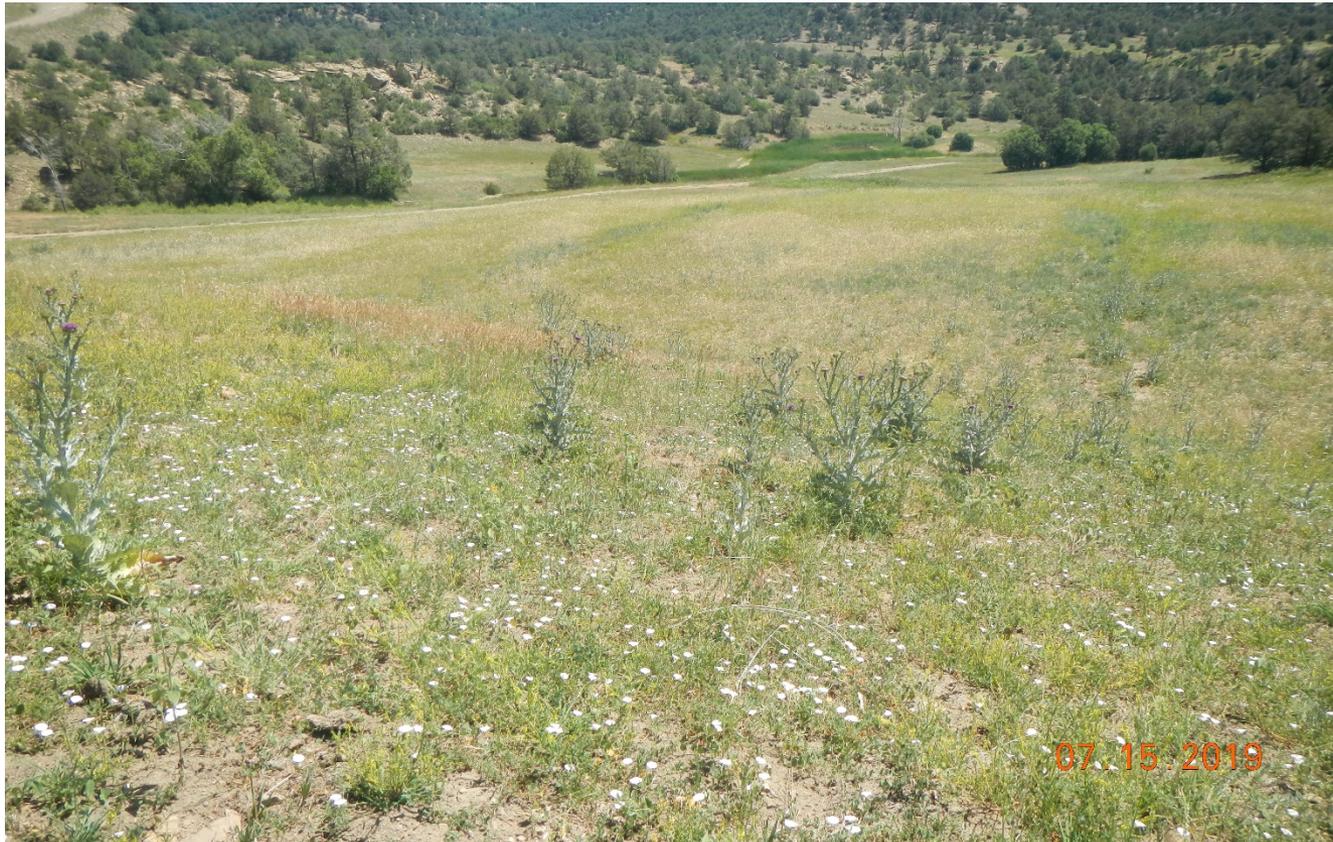
Photo 1. Facing northeast toward the reclaimed pit.

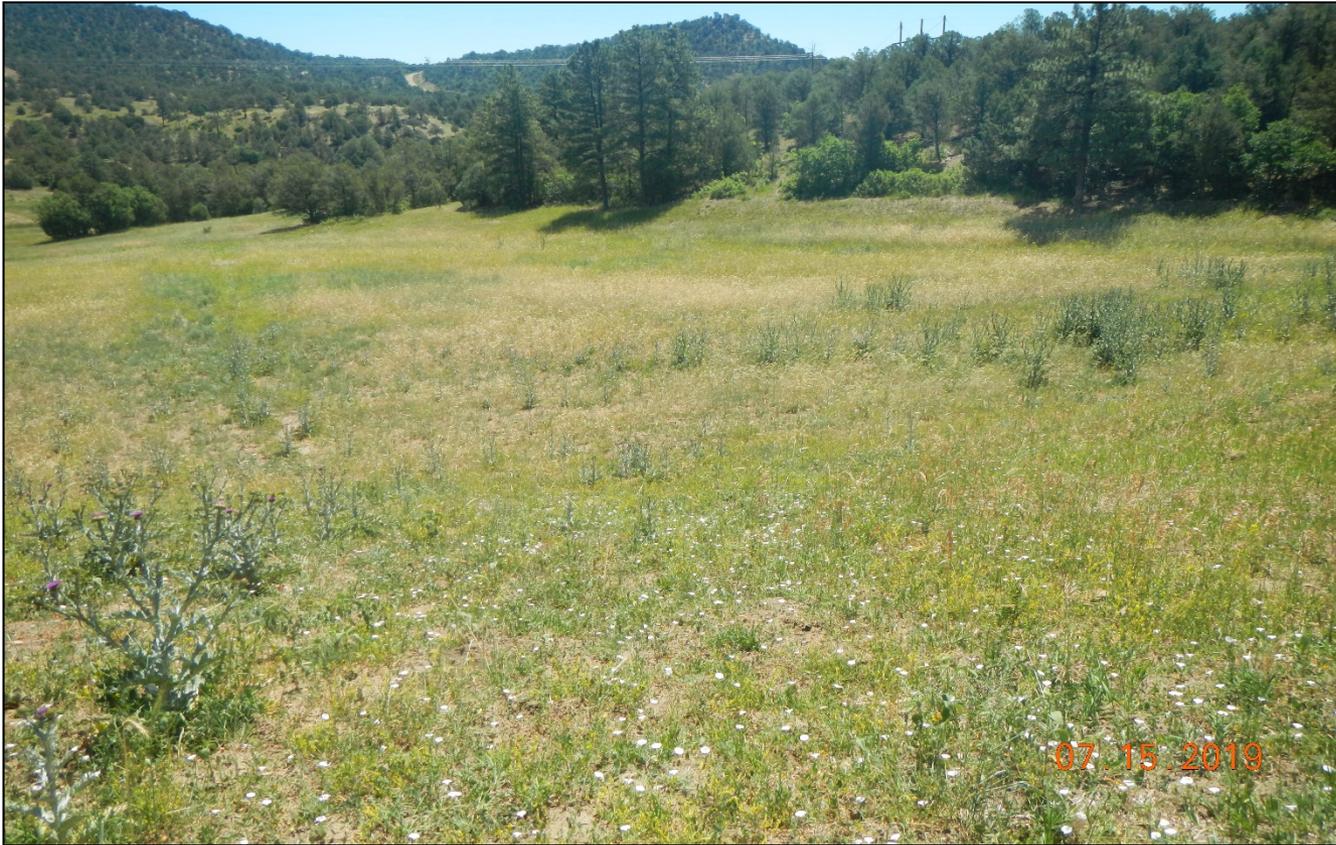
Photo 2. Facing east toward the reclaimed pit.

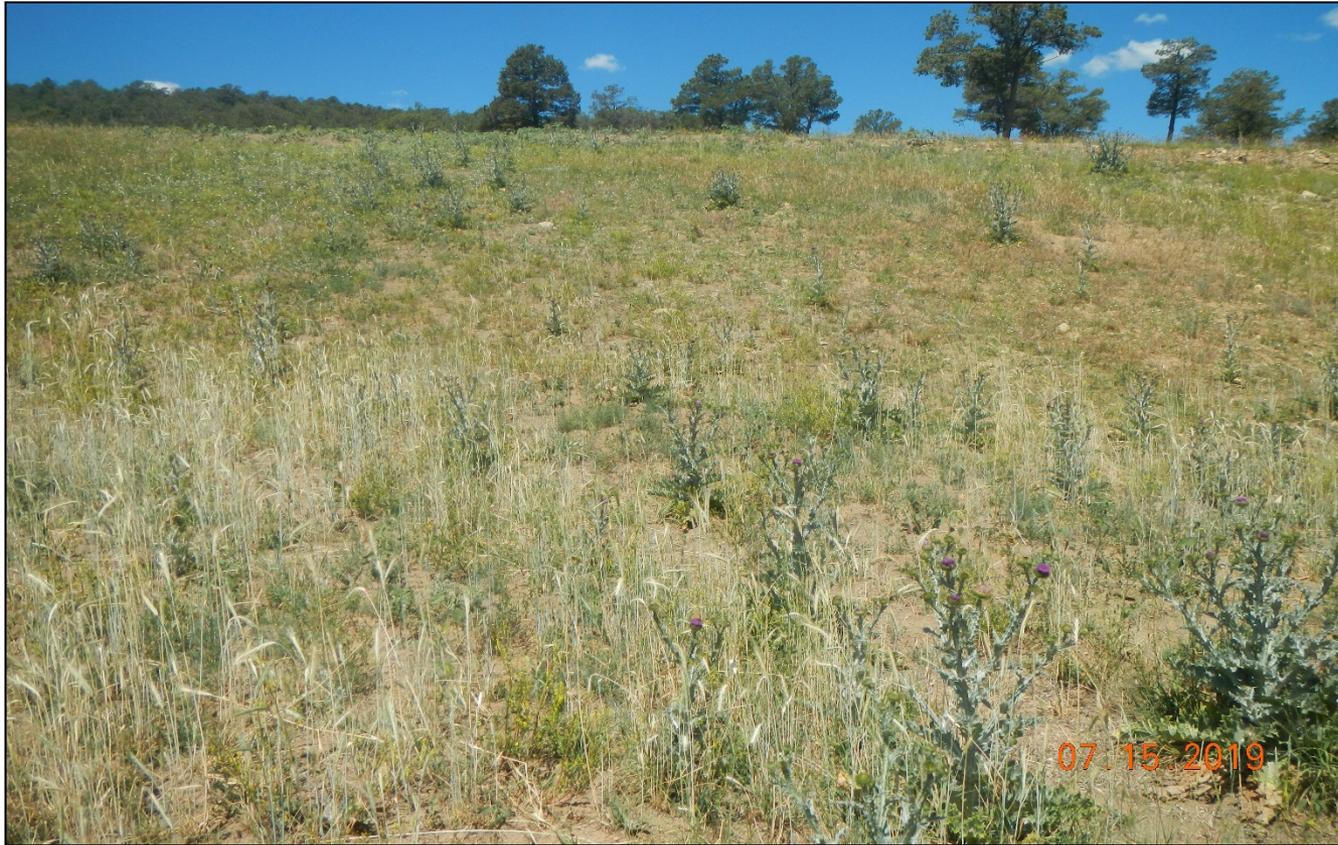
Photo 4. Facing west toward the slope.

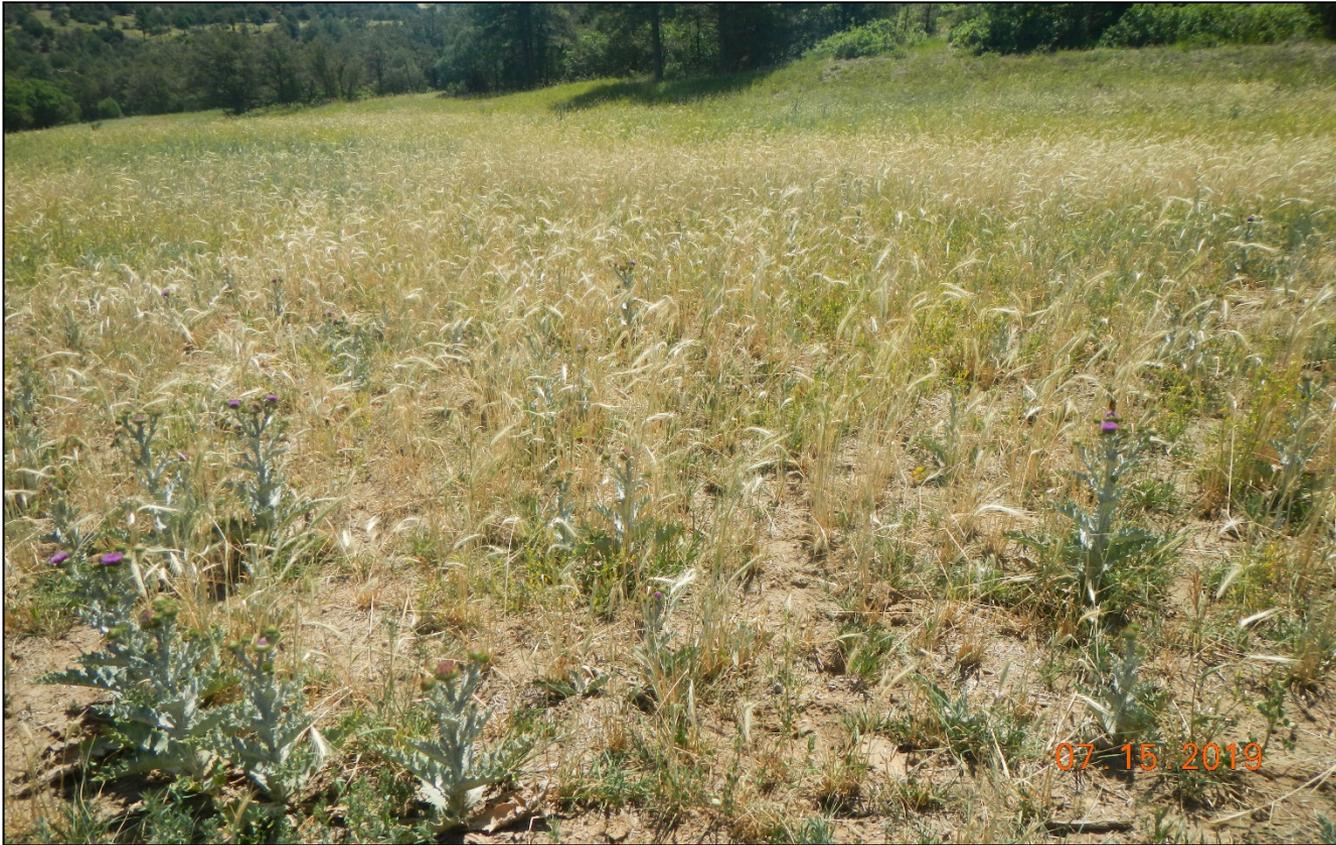
Photo 5. There is predominately wheat growth throughout the site. There are numerous noxious weeds Scotch thistle growing throughout the site.
