## Inspection Photos

Location Name: Razor 26J-2633L SWD Location ID 433131, Spill ID #465887

Inspection Date: 7/17/2019

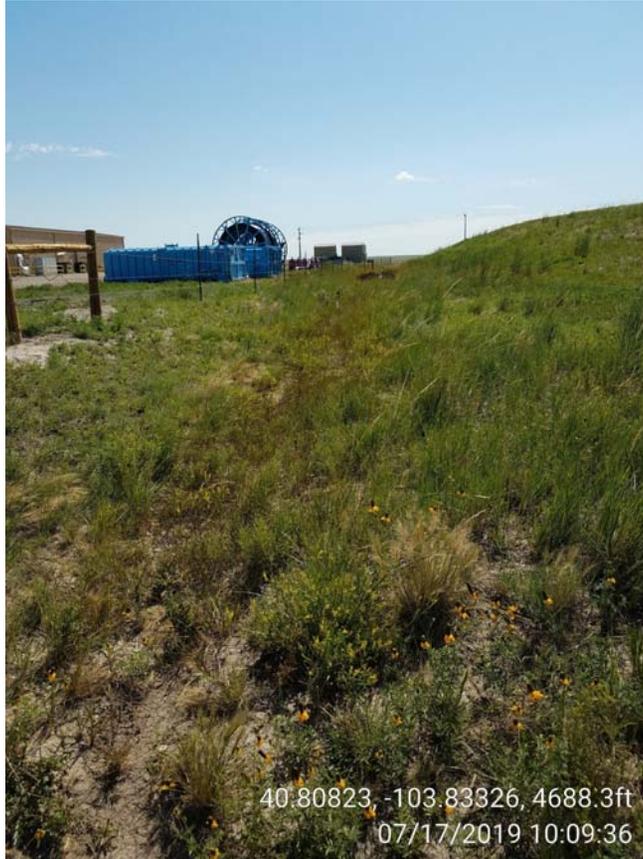
**Photo 1 – Ditch on south side of location, looking east. Vegetation impacted by oil.**

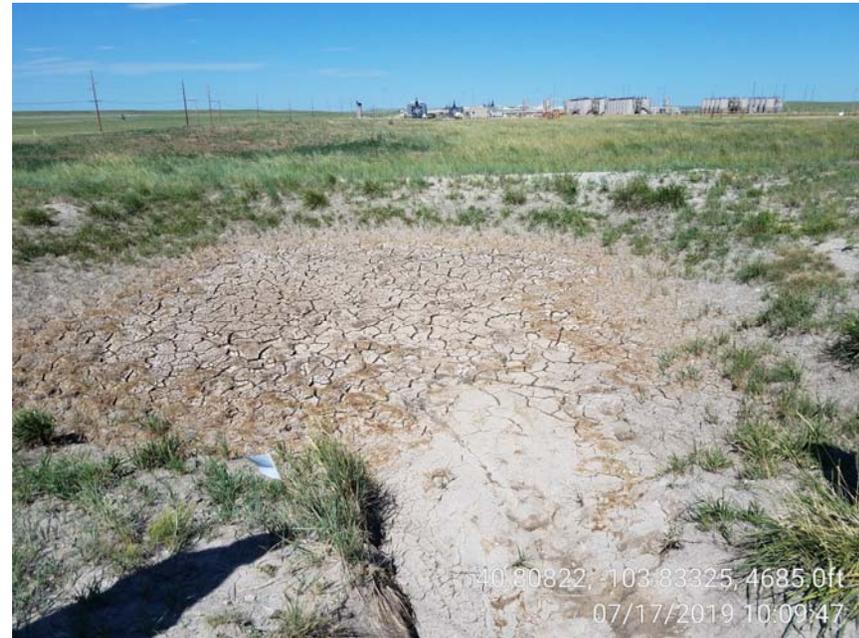
**Photo 2 – Stormwater Detention on southwest corner of location, appears free from oil impacts.**

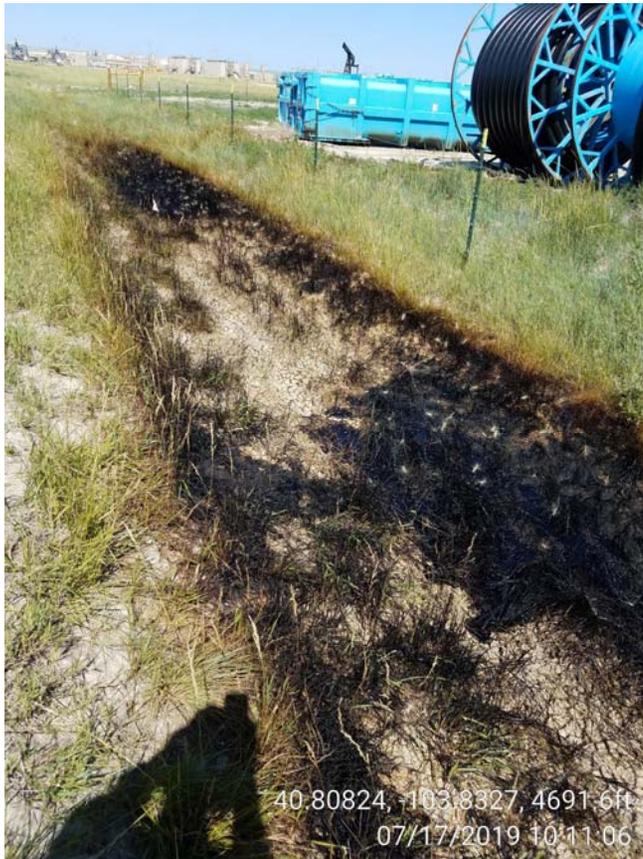
**Photo 3 – Stormwater control ditch on south side of location.**

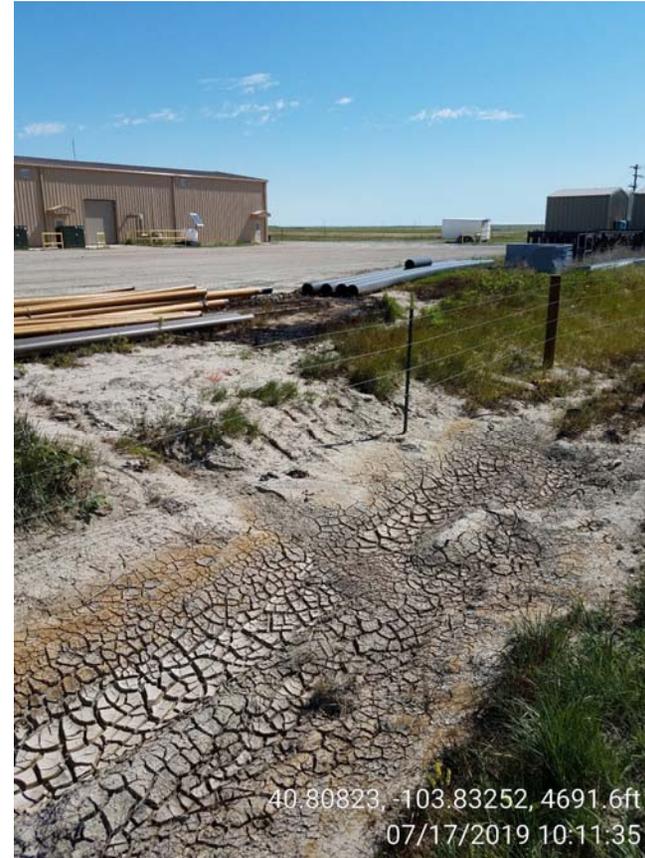
**Photo 4 – Area where spilled water and oil ran off location into stormwater control ditch on southside of location.**

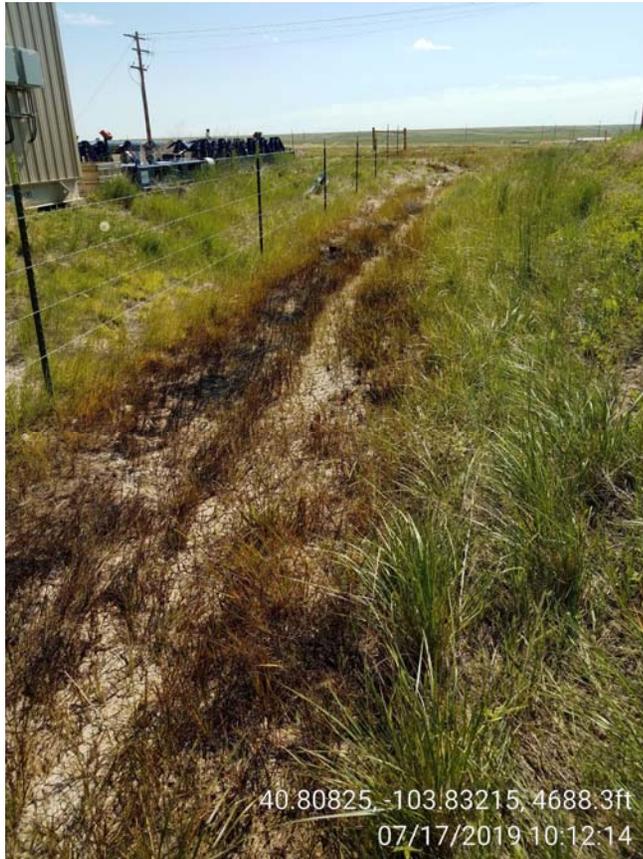
**Photo 5 – Stormwater control ditch on southside of location looking east.**

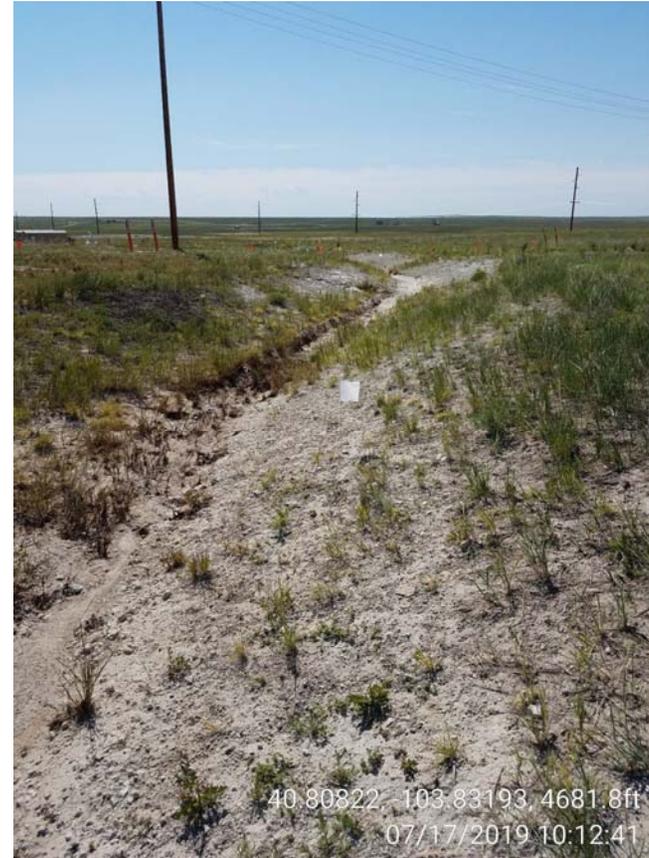
**Photo 6 – Stormwater control ditch continuing east of location, impacted by produced water and oil.**

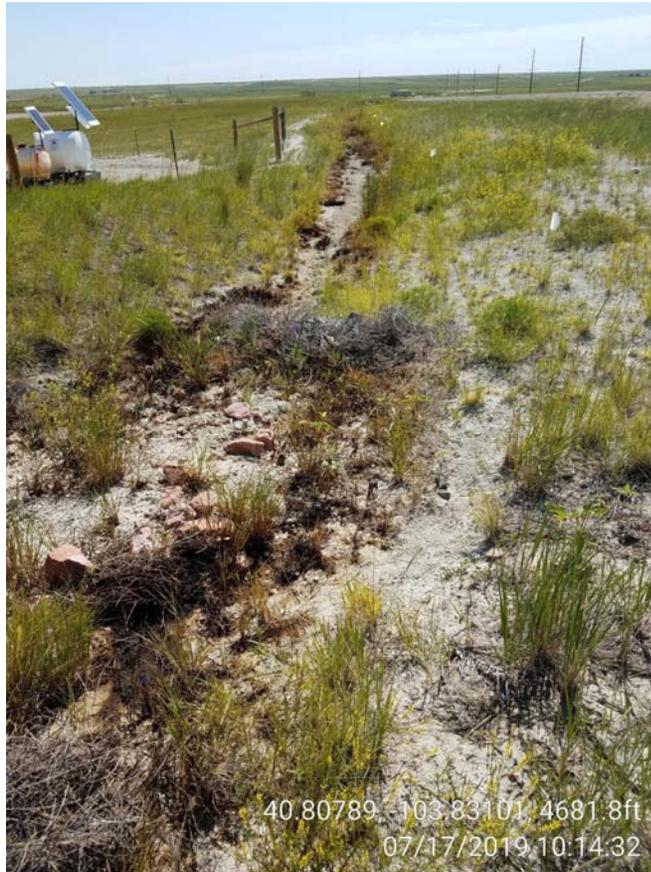
**Photo 7 – Stormwater control ditch on south side of location at southeast corner of location looking east. Produced water and oil exited location near southeast corner into ditch.**

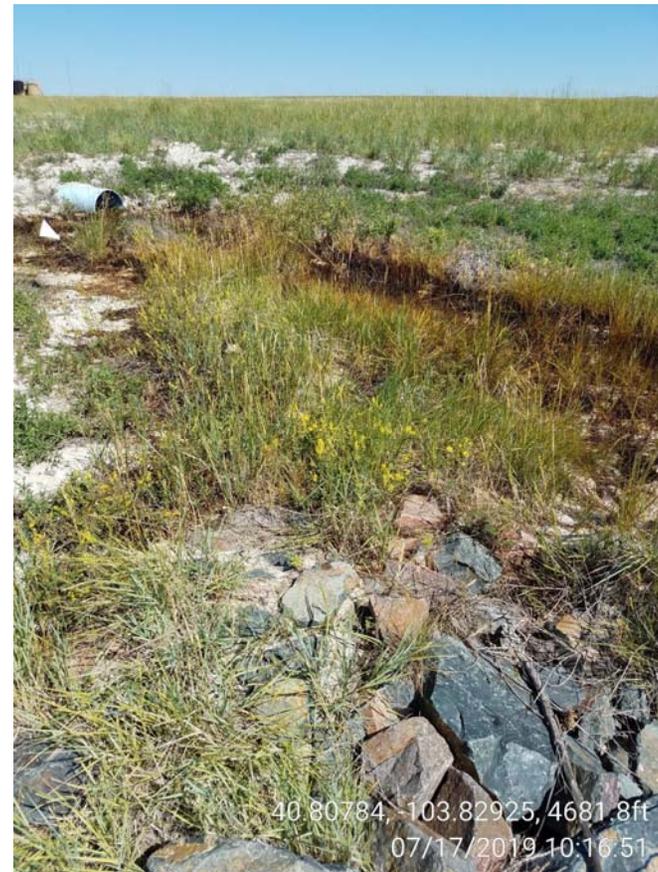
**Photo 8 – Storm water control ditch east of location.**

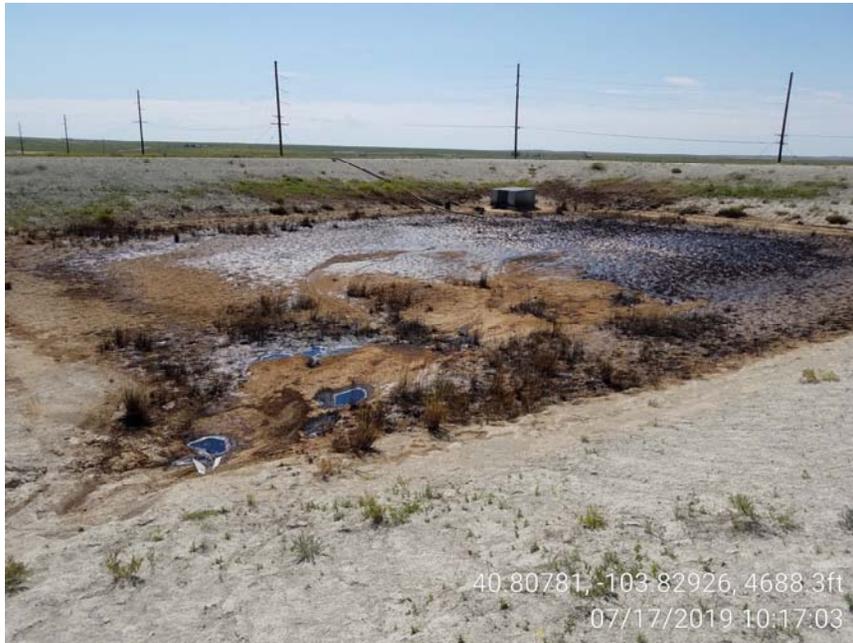
Photo 9 – Stormwater control pond east of location

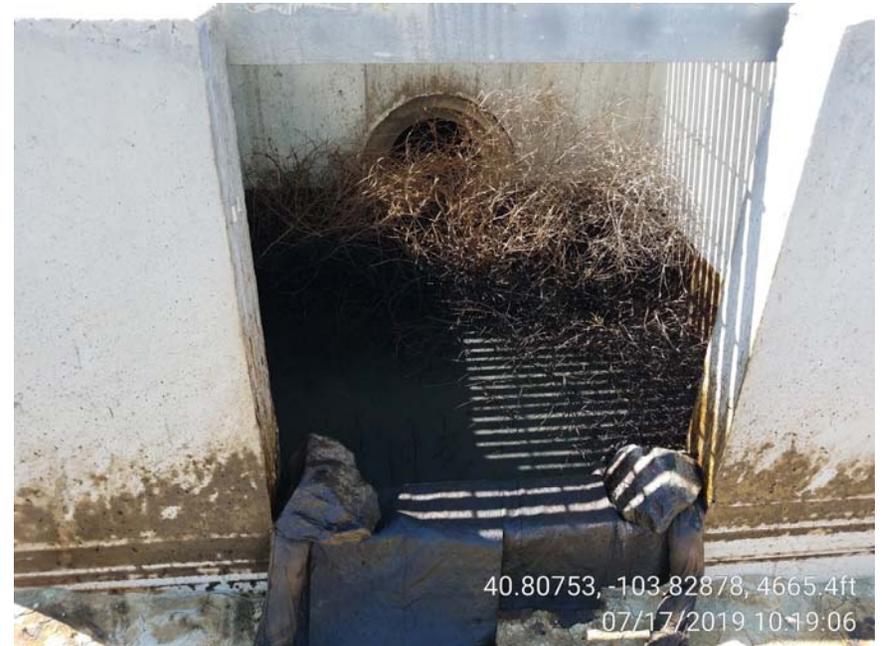
Photo 10 – Stormwater control pond outlet box impacted by oil.

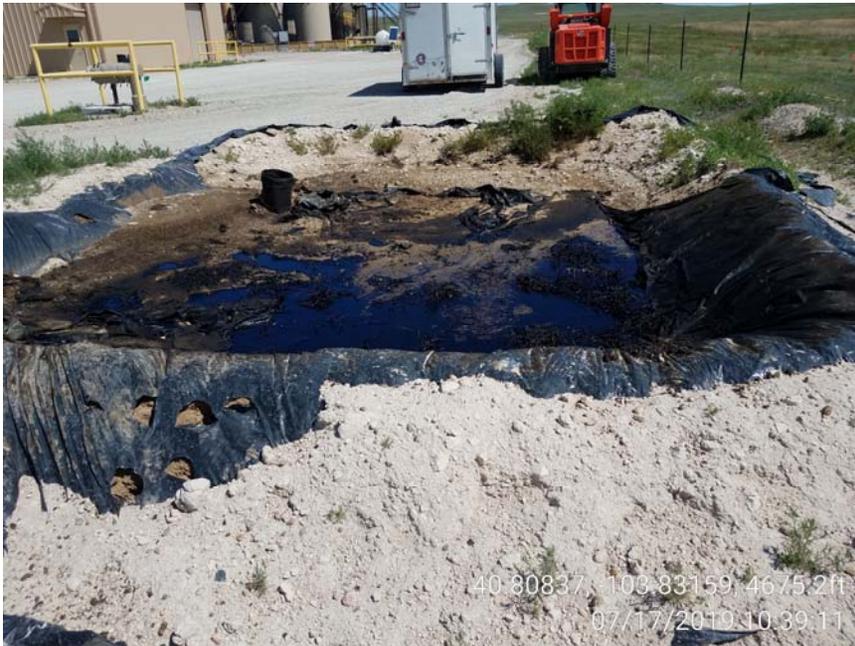
**Photo 11 – Oily waste stockpiled on southeast corner of location.**

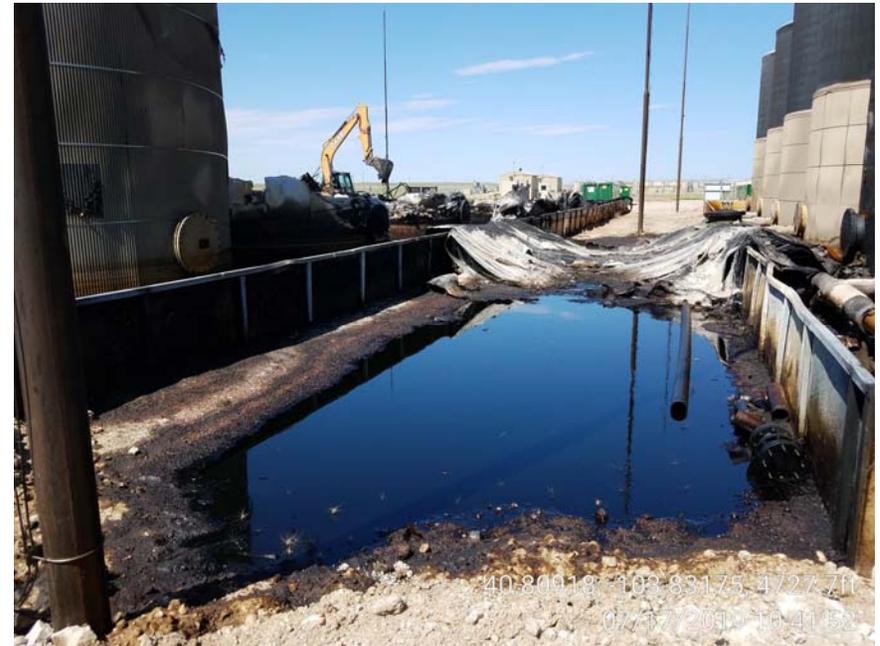
**Photo 12 – Standing crude oil near damaged tank battery.**
